STATEMENT OF HERITAGE IMPACT

North Cronulla SLSC - Project Phoenix

**NORTH CRONULLA SURF CLUB
62 PRINCE STREET
DUNNINGHAM PARK, KINGSWAY
CRONULLA NSW 2230**

FINAL 4 APRIL 2019

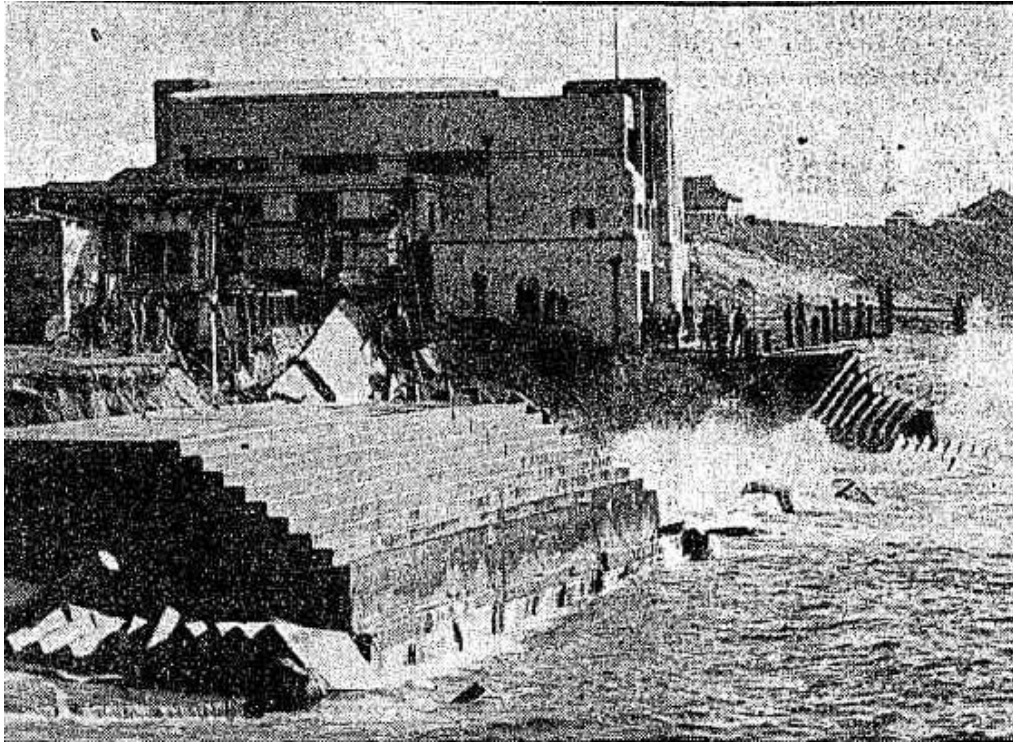
Figure 14 — Collapsed seawall, kiosk and surf pavilion at North Cronulla. (Source: 'Council will Abandon Clubhouse to the Sea', *The Sun*, 27 August 1946, p.3.)

Sutherland Shire Council alleged that the collapse was because of the removal of sand for the tank trap that had been dug in front of the wall. The army, on the other hand, maintained that this had only 'accelerated by a few hours' the inevitable collapse of the wall 'due to its defective design'. The case eventually went to arbitration.

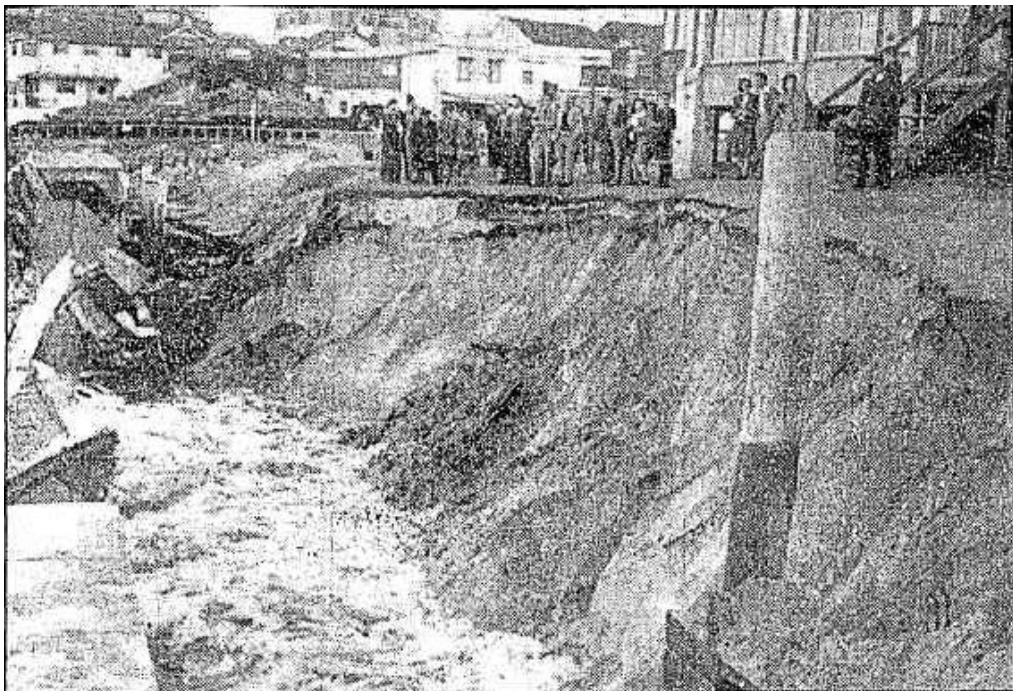
Figure 15 — Collapsed seawall, kiosk and surf pavilion at North Cronulla. (Source: 'Council will Abandon Clubhouse to the Sea', *The Sun*, 25 August 1946, p.1.)

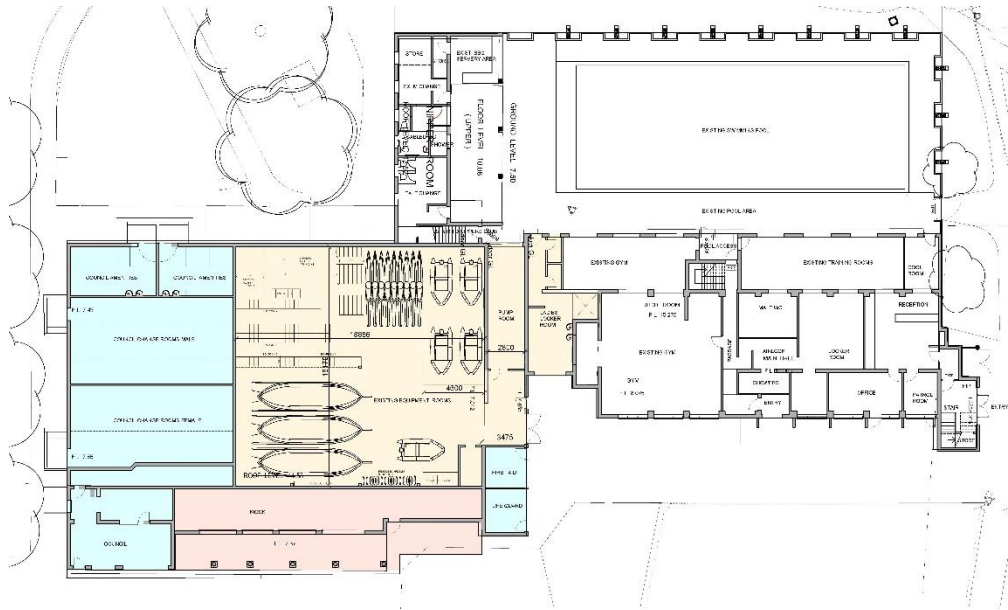
Figure 39 –Ground Floor Plan (extract from plans by Bergstrom Architects 2017)

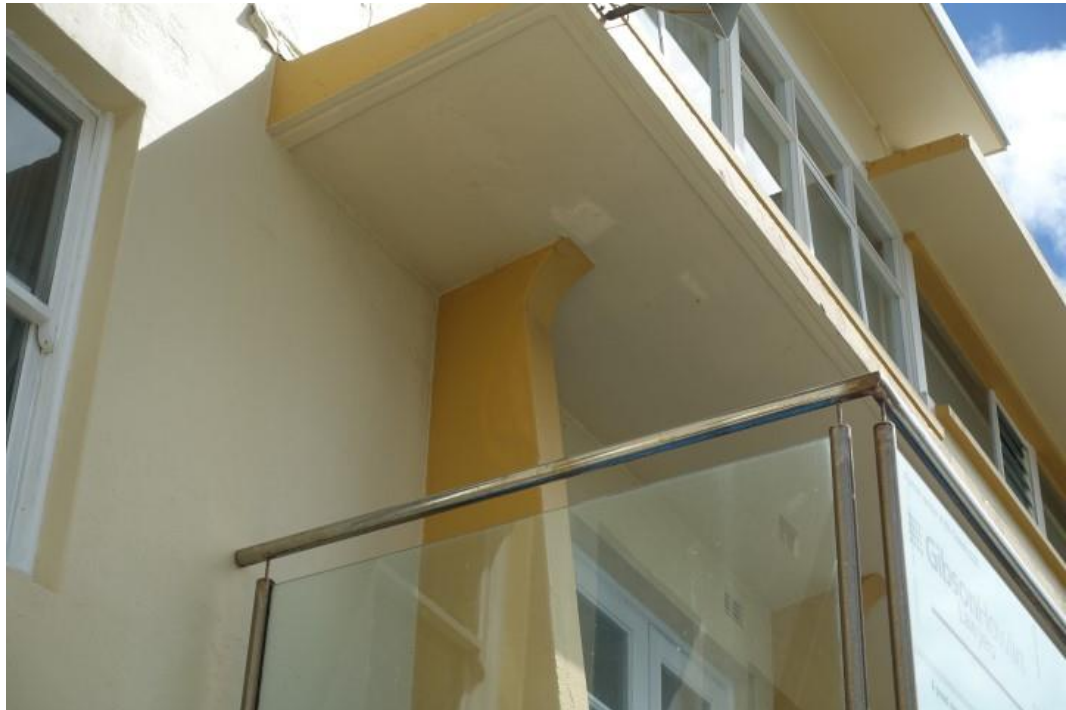
Figure 45 – Detail of reinforced concrete balcony and sunshade on east elevation. (Source NBRSArchitecture, March 2018)

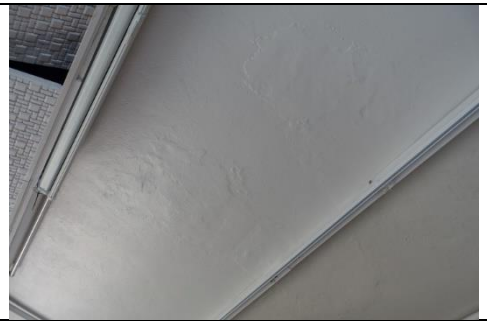
Figure 56 – Damp damage to plaster ceiling over stage in function room. (Source NBRSArchitecture, March 2018)

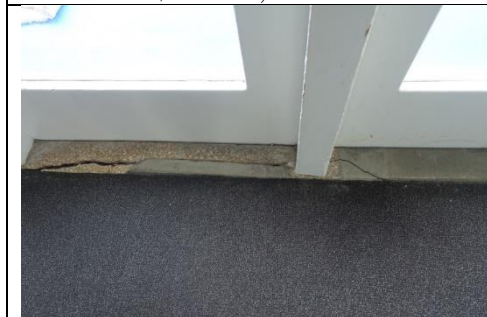
Figure 57 – Cracking in terrazzo door sill to balcony on first floor. (Source NBRSArchitecture, March 2018)

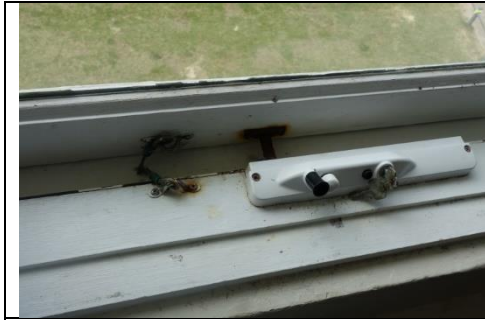
Figure 63 – Corrosion to window winders on second floor. (Source NBRSArchitecture, March 2018)

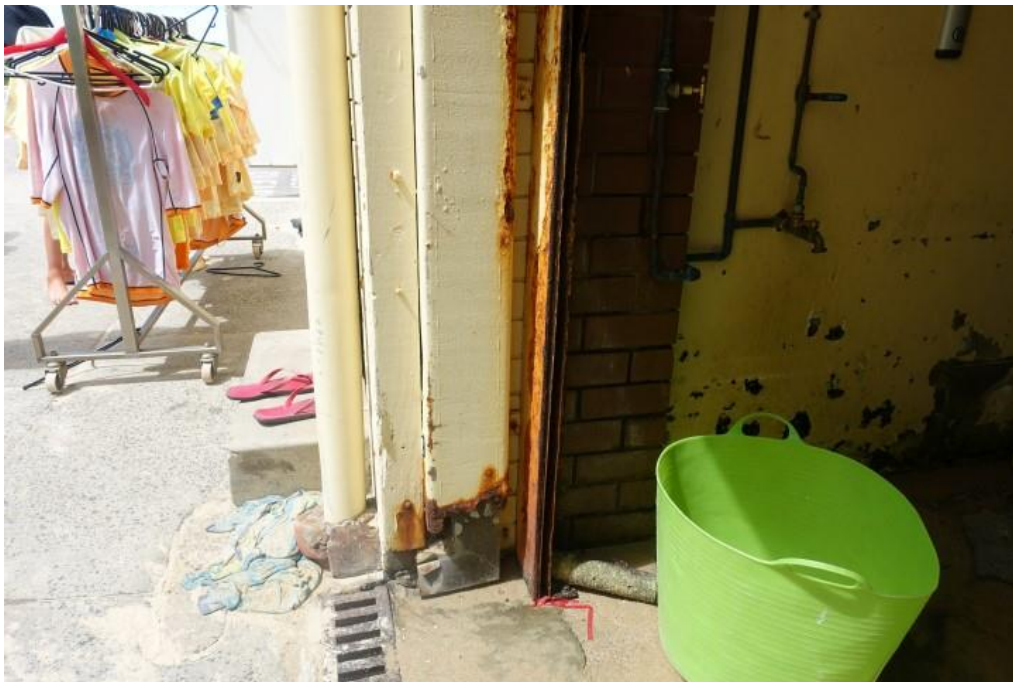
Figure 72 – Corroded door frame to boat shed. (Source NBRSArchitecture, March 2018)

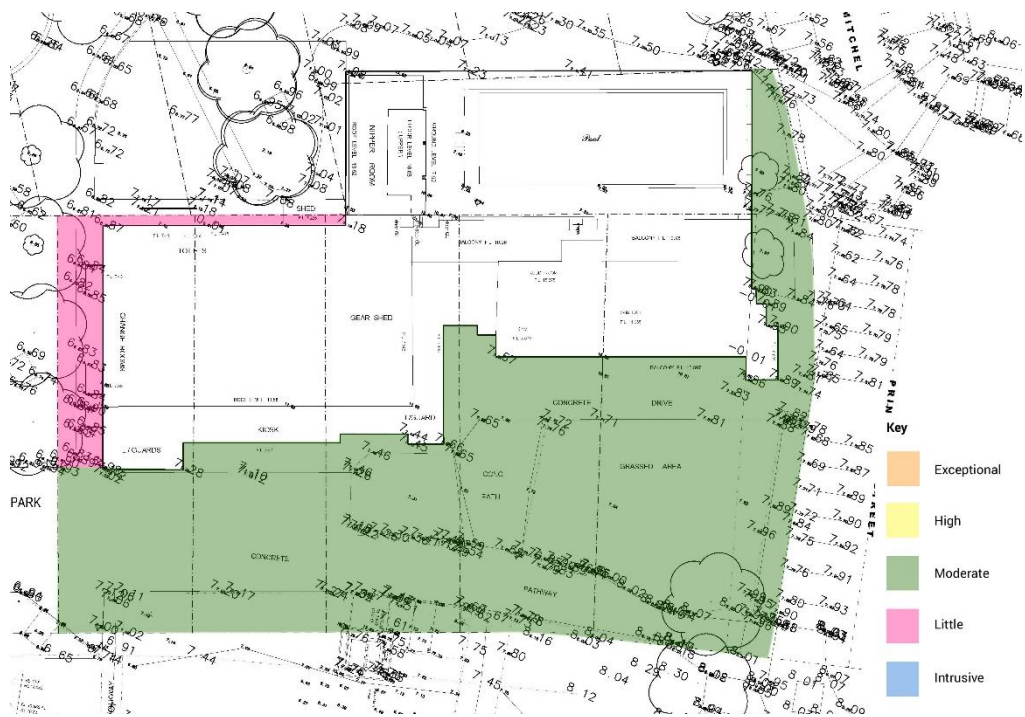
Figure 89 – Site plan showing grading of significance)

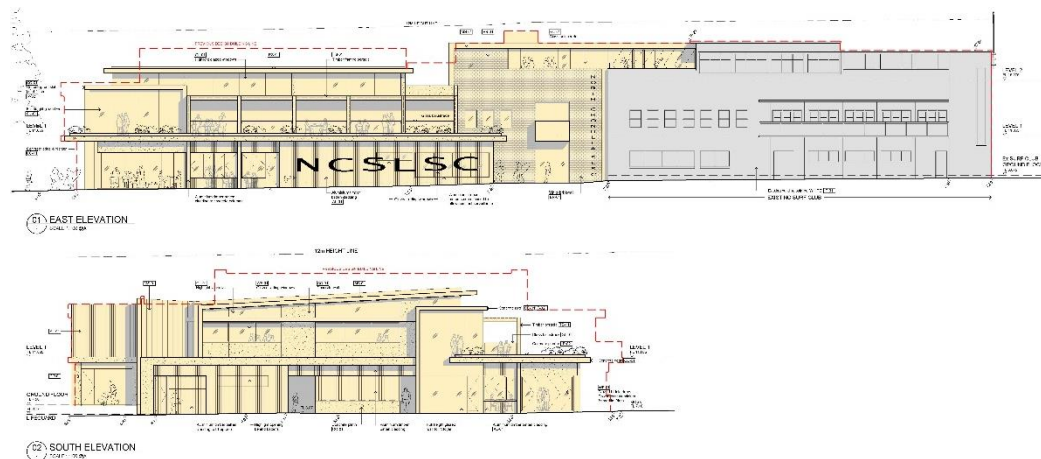
Figure 96 – East and south elevations of the proposed alterations and additions to North Cronulla Surf Club. Earlier surf Club building shaded grey indicating no new works to existing elevation. (Bergstrom Architects)

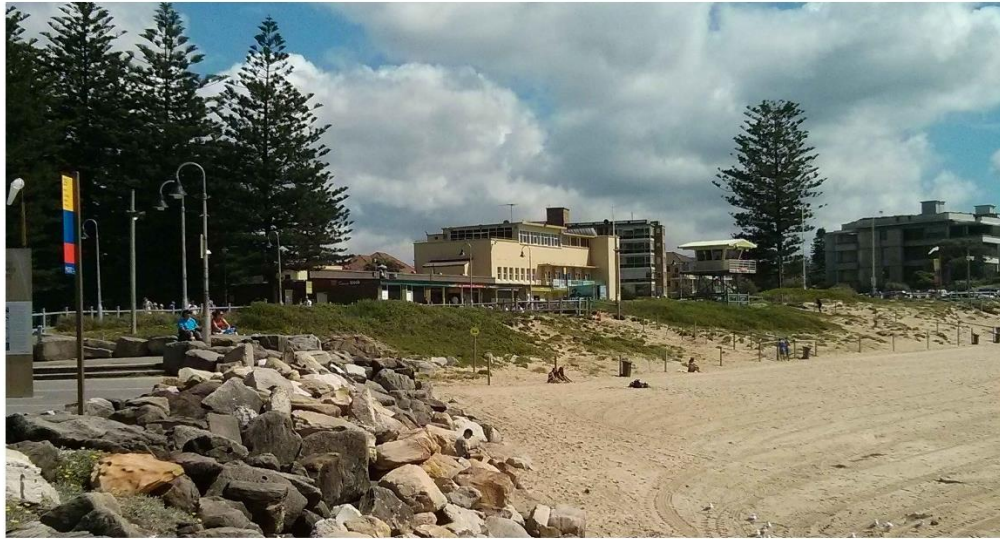
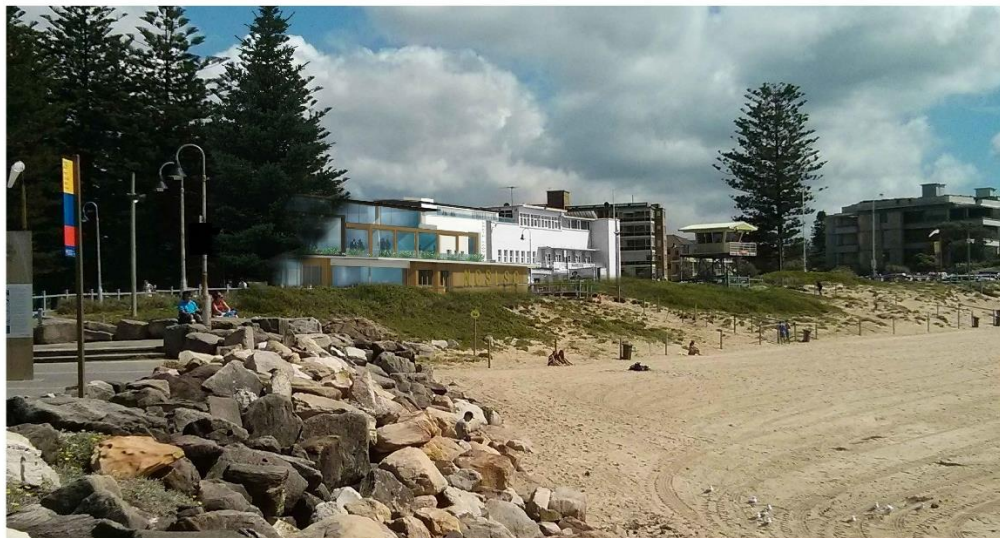
Figure 97 –Photograph and montage showing current and proposed view of the surf club from the south east. (Bergstrom Architects)
