**Proposed Residential Flat Building Development at 61-65 Lucas Avenue, 36 McKay Avenue and 31 Harvey Avenue, Moorebank NSW 2170**

**ACM Inspection, ARCP, Waste Management**

**Conducted and prepared by Jim's Asbestos Removal for A&K Engineering Group**

**26/03/19**

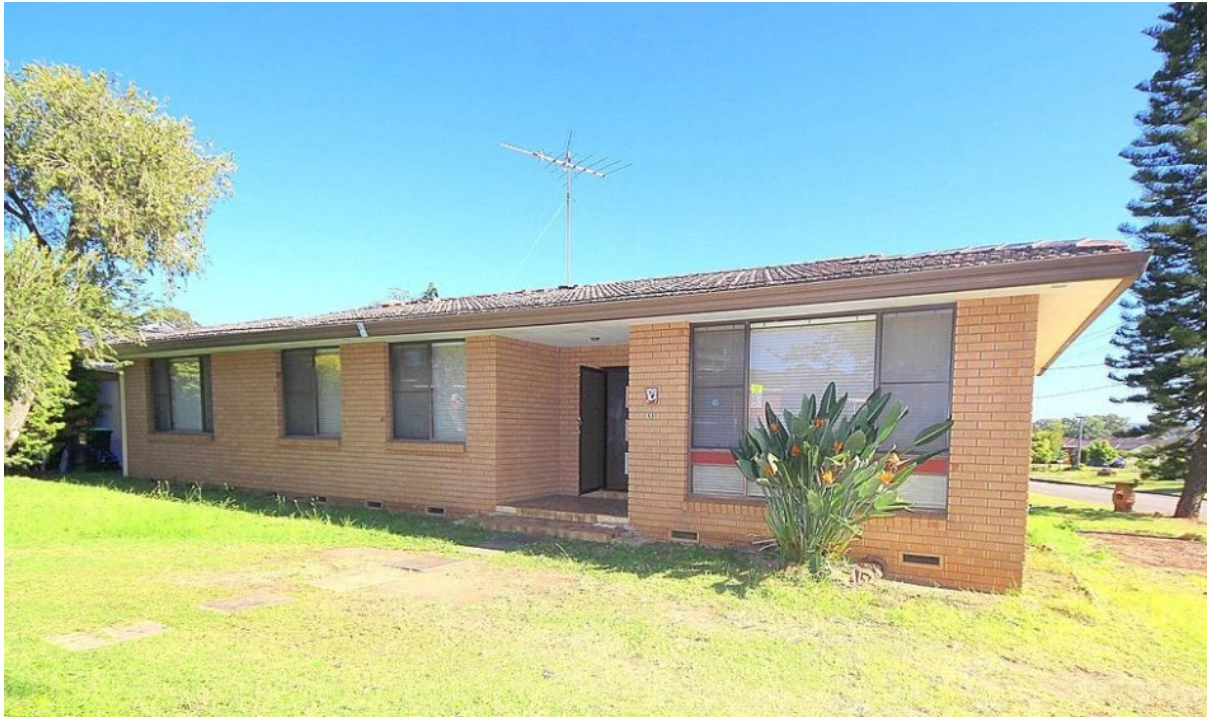
61 Lucas Ave, Moorebank 2170

Location of suspected ACM	Class	Condition
• Eave lining	B (non friable)	Good
• Bathroom walls	B (non friable)	Good
• Toilet walls	B (non friable)	Good
• Laundry walls	B (non friable)	Good
• Kitchen splash back	B (non friable)	Good
• Garage ceiling	B (non friable)	Good
• Garage eave lining	B (non friable)	Good
• Bathroom in garage	B (non friable)	Good

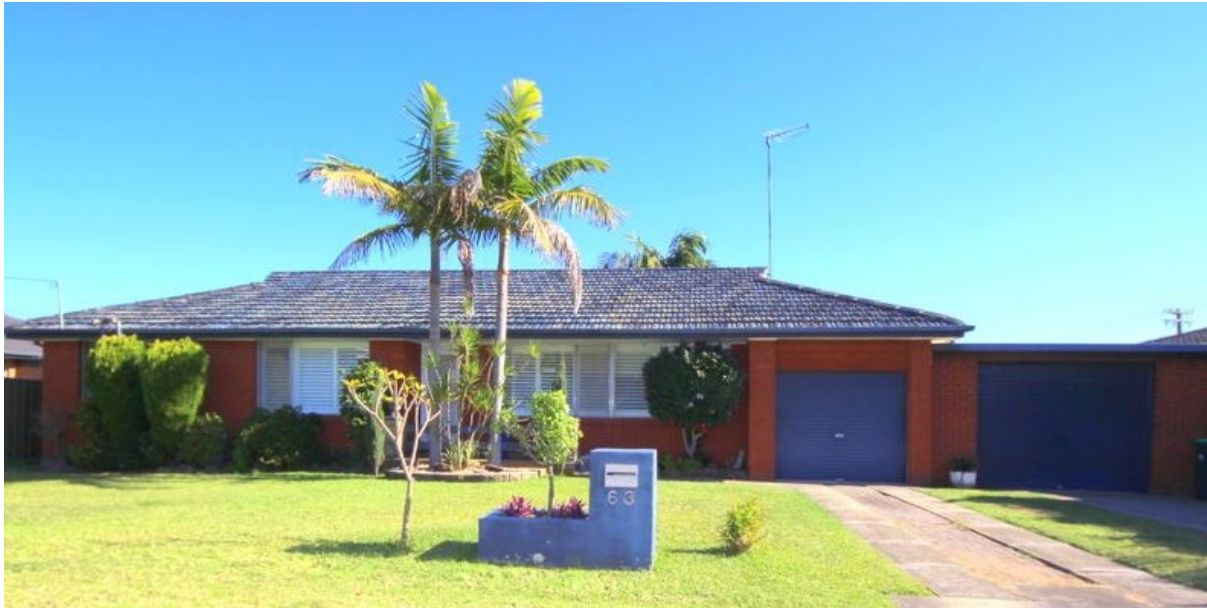
63 Lucas Ave, Moorebank 2170

Location of suspected ACM	Class	Condition
<ul style="list-style-type: none"><li>• Eave lining</li></ul>	B (non friable)	Good
<ul style="list-style-type: none"><li>• All wet areas including kitchen, bathroom, laundry</li></ul>	B (non friable)	Good
<ul style="list-style-type: none"><li>• Garage interior lining</li></ul>	B (non friable)	Good

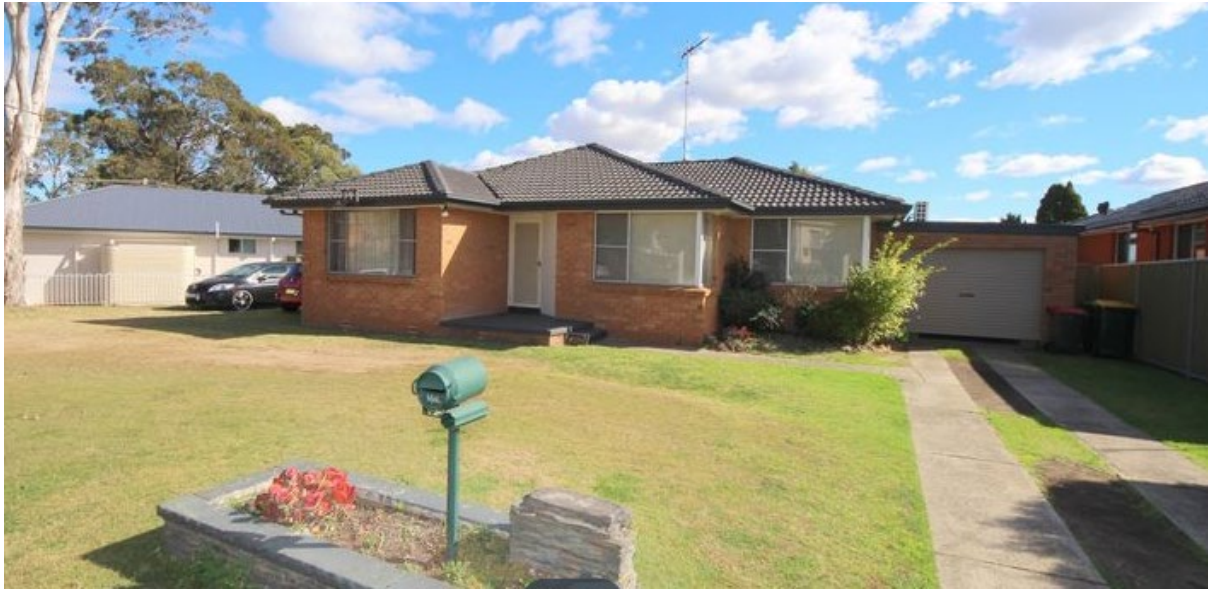
65 Lucas Ave, Moorebank 2170

Location of suspected ACM	Class	Condition
<ul style="list-style-type: none"><li>• Eave lining</li></ul>	B (non friable)	Good
<ul style="list-style-type: none"><li>• Garage interior lining</li></ul>	B (non friable)	Good
<ul style="list-style-type: none"><li>• Wet areas should be suspected as containing ACM products even though they have been recently renovated</li></ul>	B (non friable)	Good

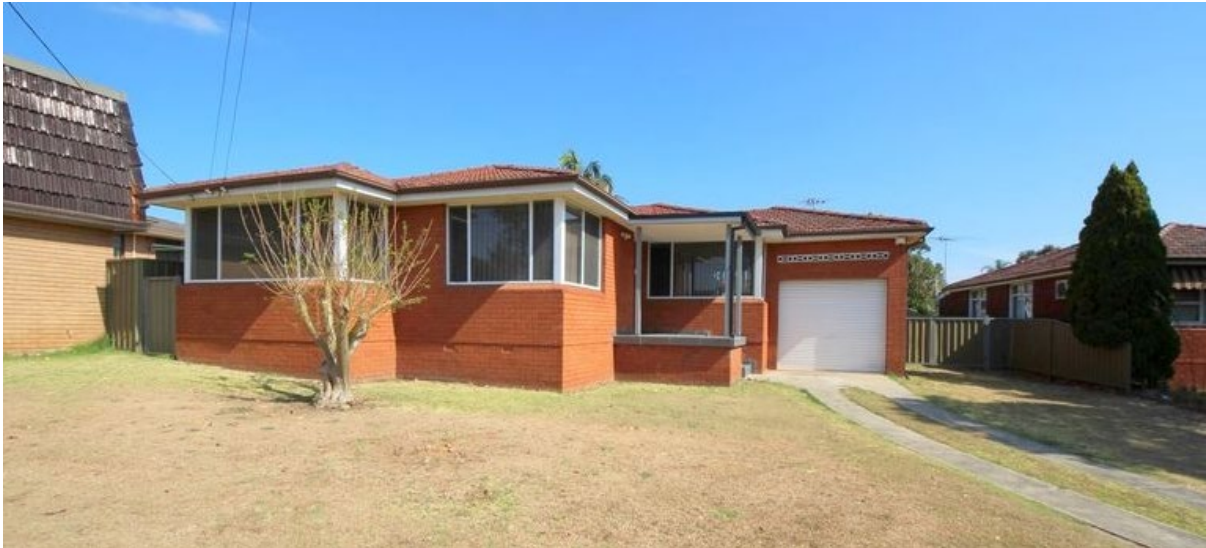
31 Harvey Ave, Moorebank 2170

Location of suspected ACM	Class	Condition
<ul style="list-style-type: none"><li>Eave lining</li></ul>	B (non friable)	Good
<ul style="list-style-type: none"><li>Detached single garage walls and roof</li></ul>	B (non friable)	Poor
<ul style="list-style-type: none"><li>Wet areas should be suspected as containing ACM products even though they have been recently renovated</li></ul>	B (non friable)	Good
<ul style="list-style-type: none"><li>Garage interior lining</li></ul>	B (non friable)	Good

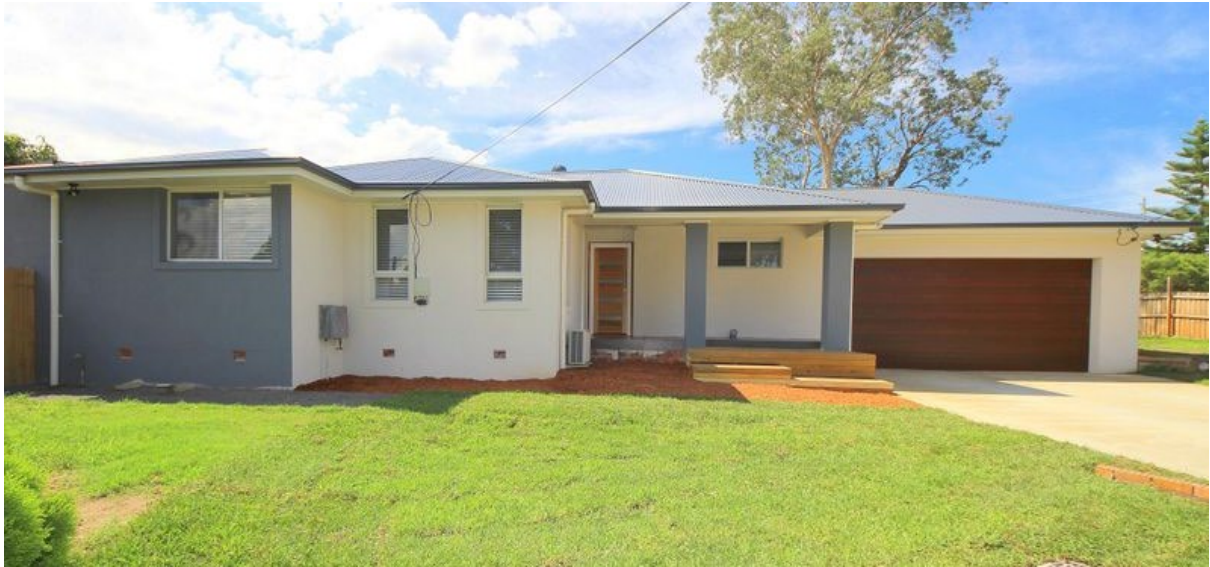
36 McKay Ave, Moorebank 2170

Location of suspected ACM	Class	Condition
<ul style="list-style-type: none"><li>Eave lining</li></ul>	B (non friable)	Good
<ul style="list-style-type: none"><li>Wet areas should be suspected as containing ACM products even though they have been recently renovated</li></ul>	B (non friable)	Good
<ul style="list-style-type: none"><li>Outdoor laundry/toilet internal sheeting should be suspected as ACM.</li></ul>	B (non friable)	Good
