SERVICE DETAILS A) visual evidence is shown to survey accuracy B) inverts & diameters are shown where reasonable access was obtained C) direction of services shown have been derived from visual evidence and when in agreement with Service Authority WAE drawings D) direction of services NOT SHOWN is due to an uncertainty when comparing visual location with service diagrams E) service details should be confirmed with the relevant Service Authorities during design and prior to construction		CAUTION THIS SURVEY HAS BEEN CARRIED OUT FOR THE PRODUCTION OF PLANS AT A REDUCTION RATIO OF 1:250 FOR THE PURPOSE OF DESIGN AND SHOULD NOT BE USED FOR ANY OTHER PURPOSE. DISTANCES SCALED MAY BE INACCURATE. REDUCTION RATIO 1:250 METRES	DATUM AND ORIGIN OF LEVELS PM84896 415049HT TRANSFERRED TO SITE BY GNSS STATIC SURVEY AZIMUTH MGA ZONE 55 FOLDER B7038 LB FB L.G.A. HILLTOPS COUNCIL SURVEYOR D BURNETT SURVEY DATE 4/10/17 FILE CADD F WALKER	SURVEYING & SPATIAL INFORMATION SERVICES LEVEL 13 MCKELL BUILDING 2 - 24 RAWSON PLACE, SYDNEY NSW 2000 TEL: (02) 9372 7980 FAX: (02) 9372 7922 VERIFIED DAVE BURNETT 19/10/2017 VALIDATED JARAD CANNINGS 19/10/2017 APPROVED MANAGER STEPHEN SAUNDERS 19/10/2017		RURAL F

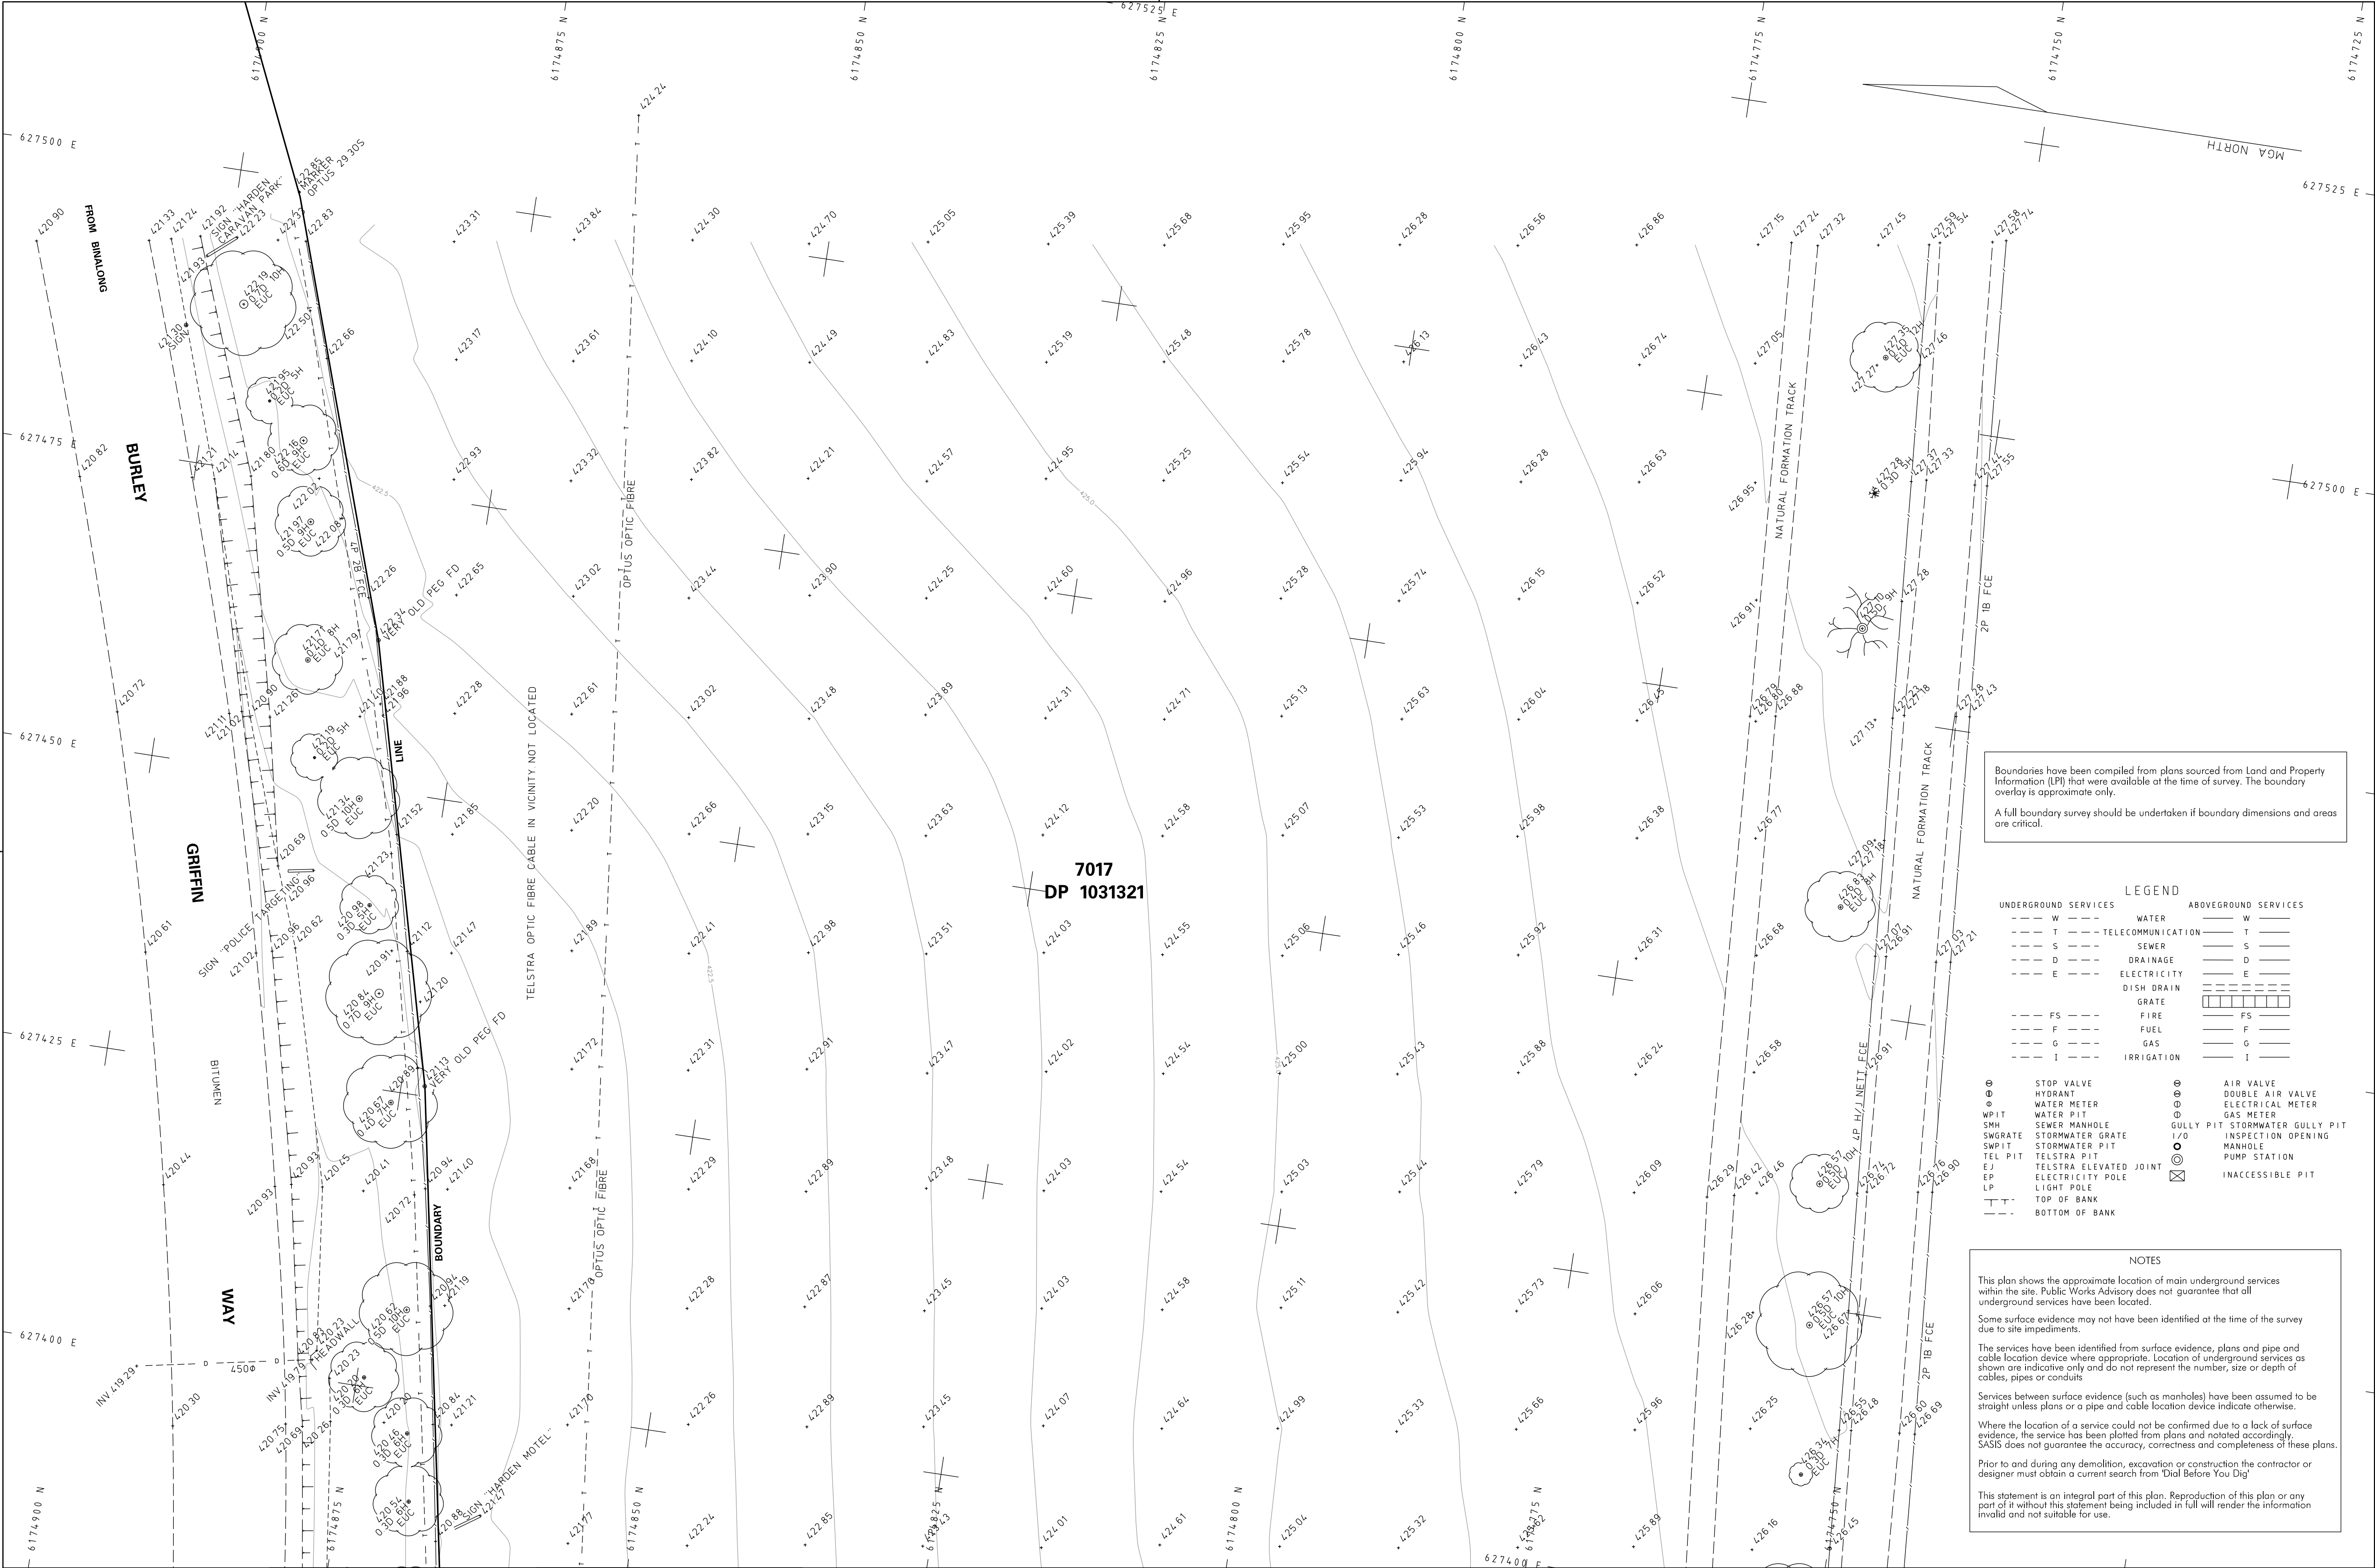
This plan shows the approximate location of main underground services within the site. Public Works Advisory does not guarantee that all underground services have been located.

The services have been identified from surface evidence, plans and pipe and cable location device where appropriate. Location of underground services as shown are indicative only and do not represent the number, size or depth of cables, pipes or conduits.

Services between surface evidence (such as manholes) have been assumed to be straight unless plans or a pipe and cable location device indicate otherwise.

Where the location of a service could not be confirmed due to a lack of surface evidence, the service has been plotted from plans and noted accordingly. SASIS does not guarantee the accuracy, correctness and completeness of these plans.
