Hornsby Quarry Rehabilitation DA Deferral Submissions Report

(Response to Sydney North Planning Panel Record of Deferral - 8 May 2020)

Prepare by Hornsby Shire Council
July 2020

**Vegetation Management Plan
and
Habitat Creation and Enhancement Plan**

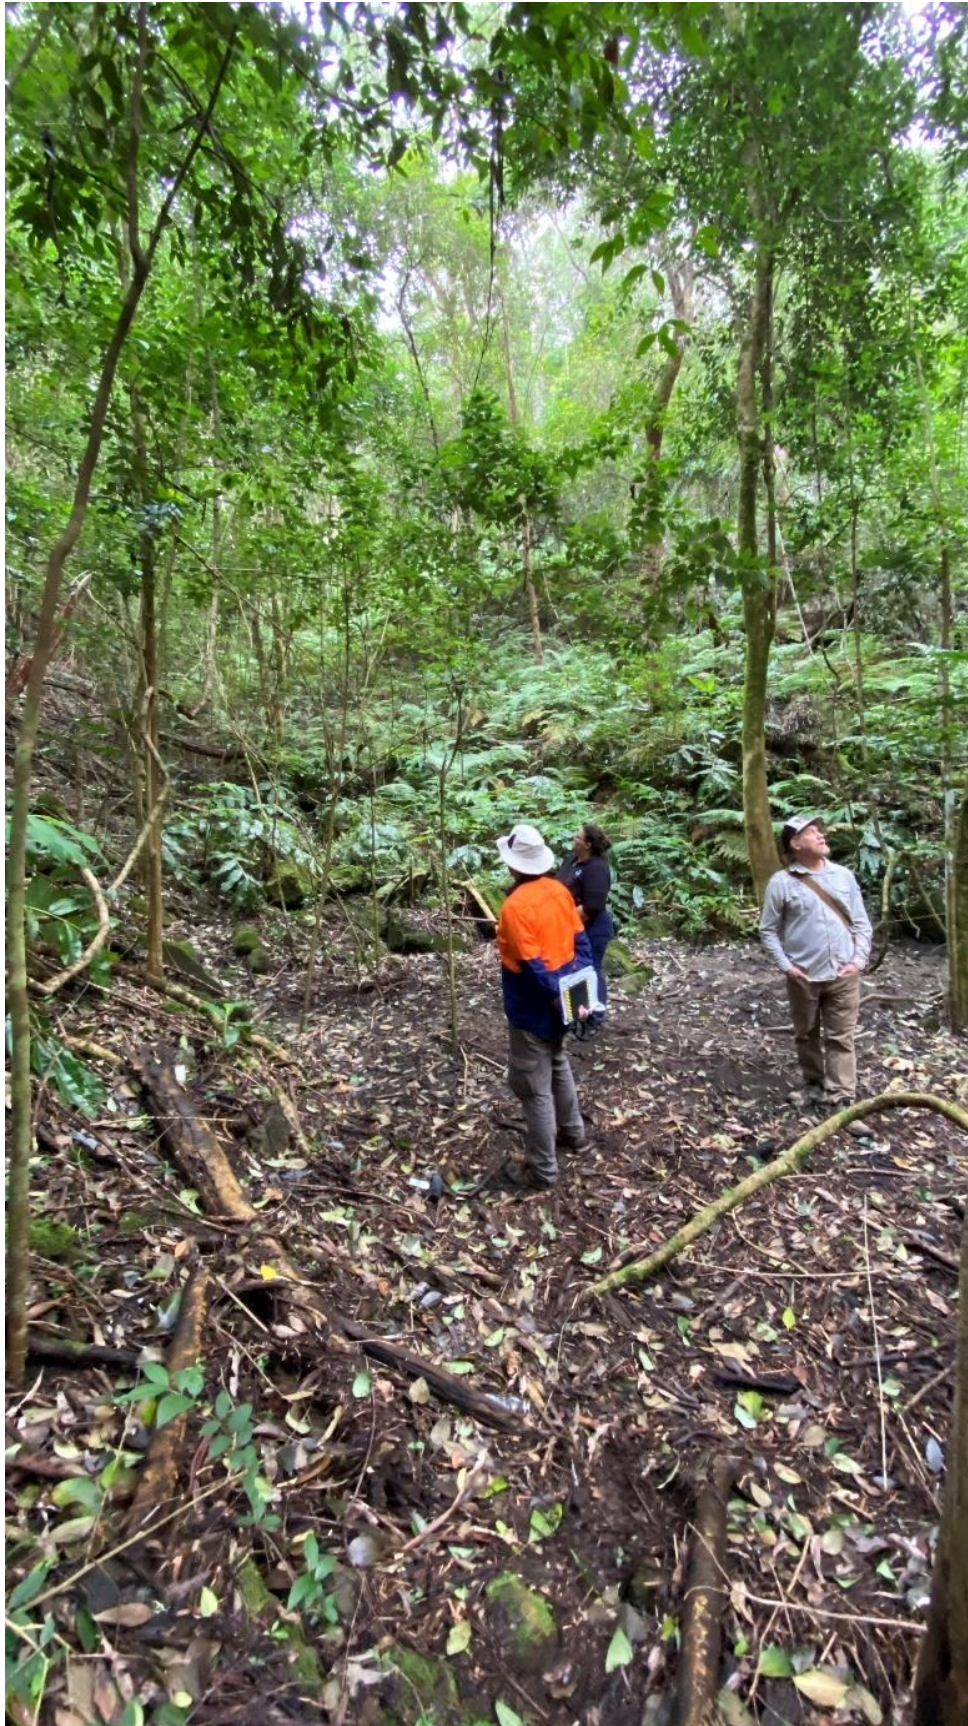
Figure 3. 1 Low Point behind North Spoil Mound

“Culverts represent potential roosting habitat for microbat species such as the Eastern Bentwing Bat extension of these culverts could provide additional roots habitat ...”.

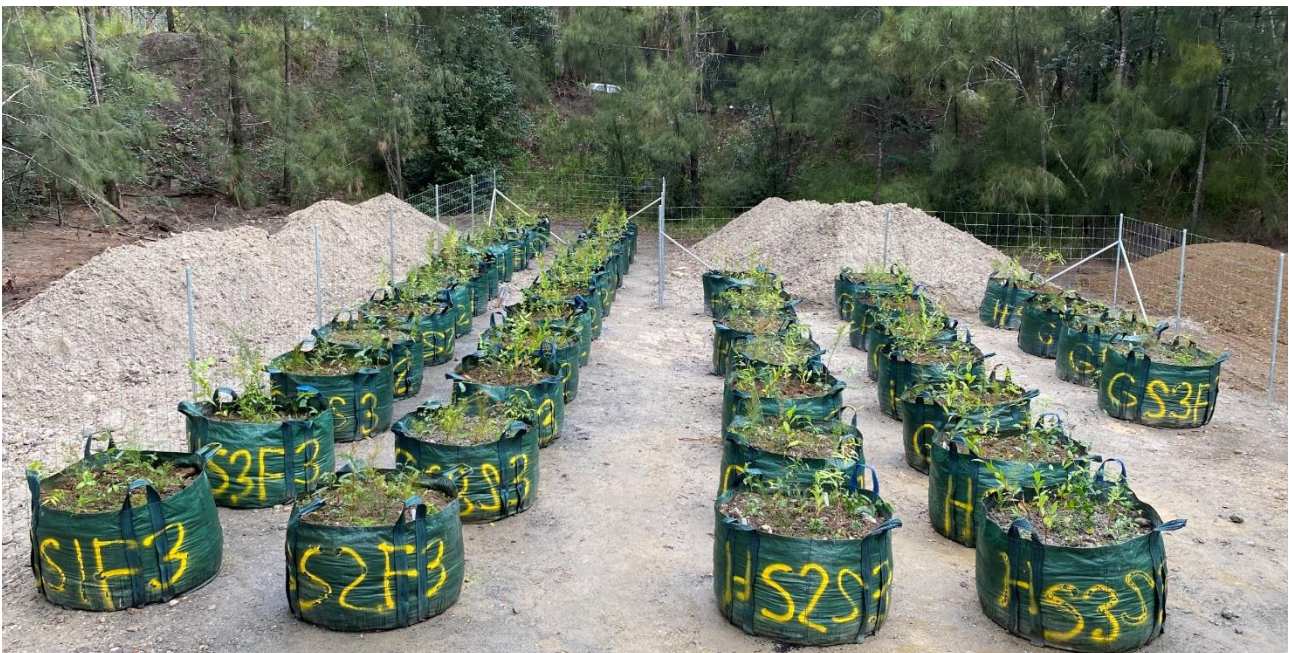
A trial is currently underway to test recommended treatments on both soil types and their ability to support native vegetation (Figure 7.1). Results of the trial will direct soil treatment specifications for revegetation and landscaping.

Figure 7. 1 Planted soil trial plots

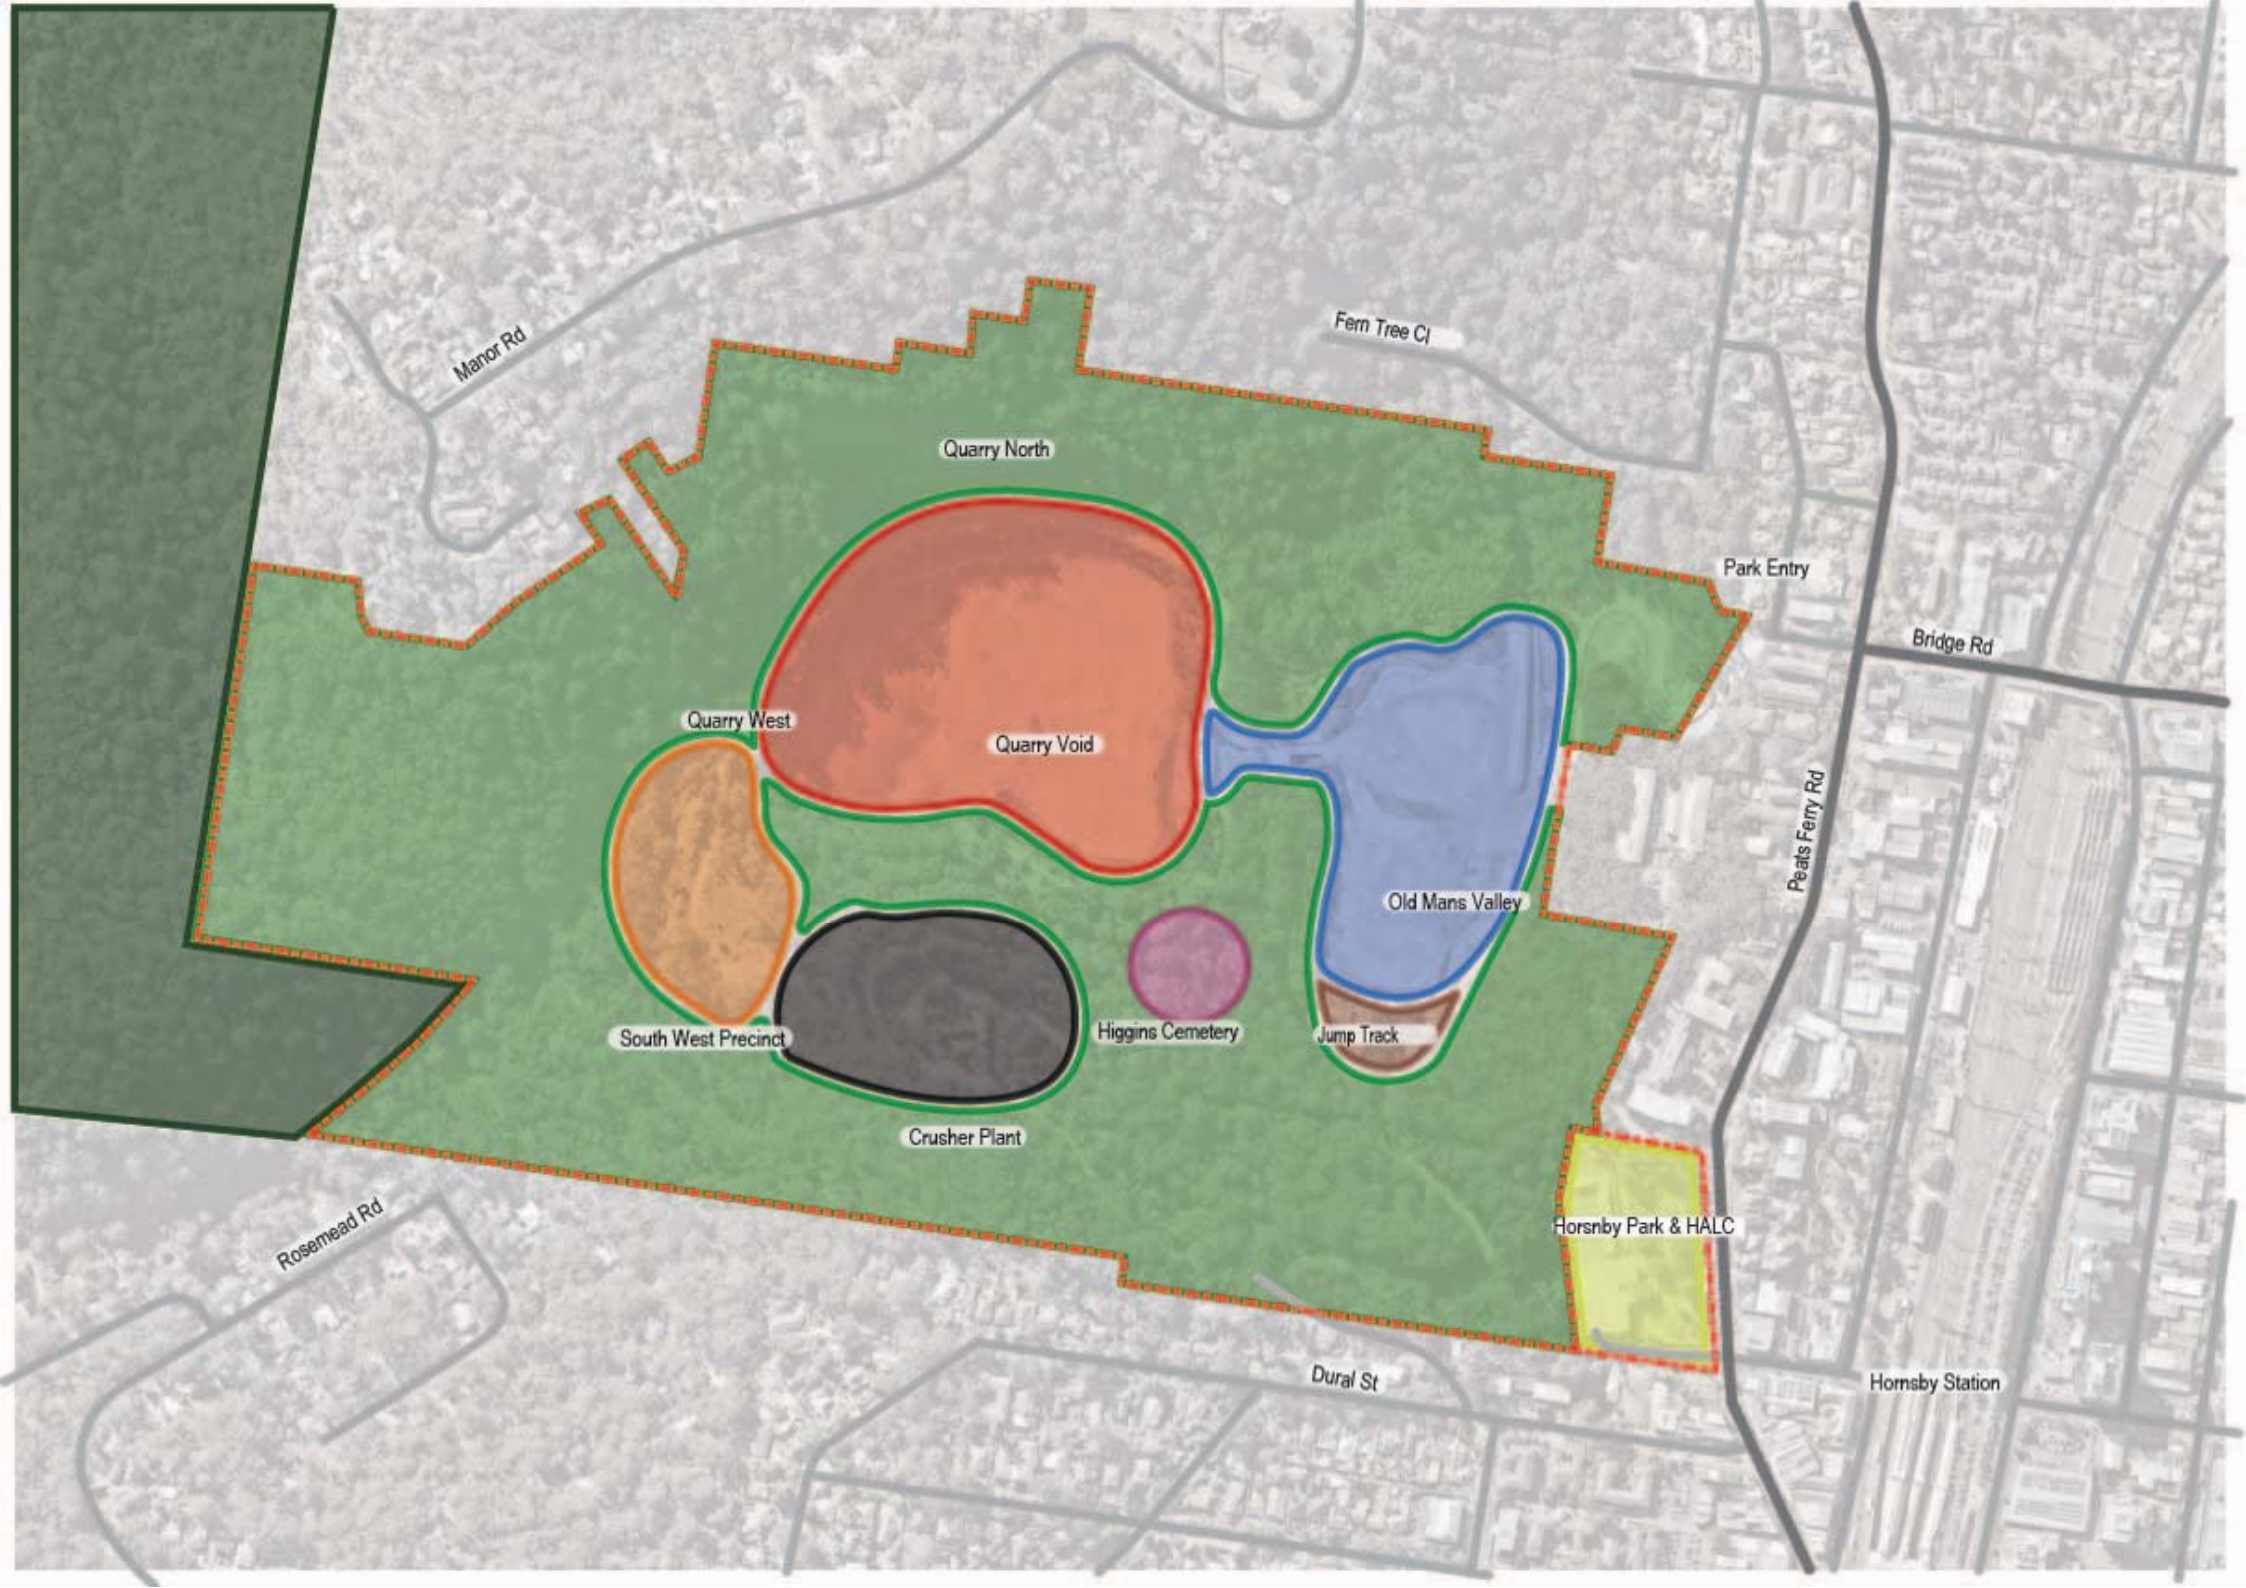
A Staging Plan has been completed highlighting earthworks will not be undertaken within the recommended Powerful Owl exclusion zones if a breeding pair are occupying a nest on Site. The Staging Plan also details revegetation works commencing prior to, during and after earthworks construction. The Staging Plan and plan showing the various areas of the site is shown below.

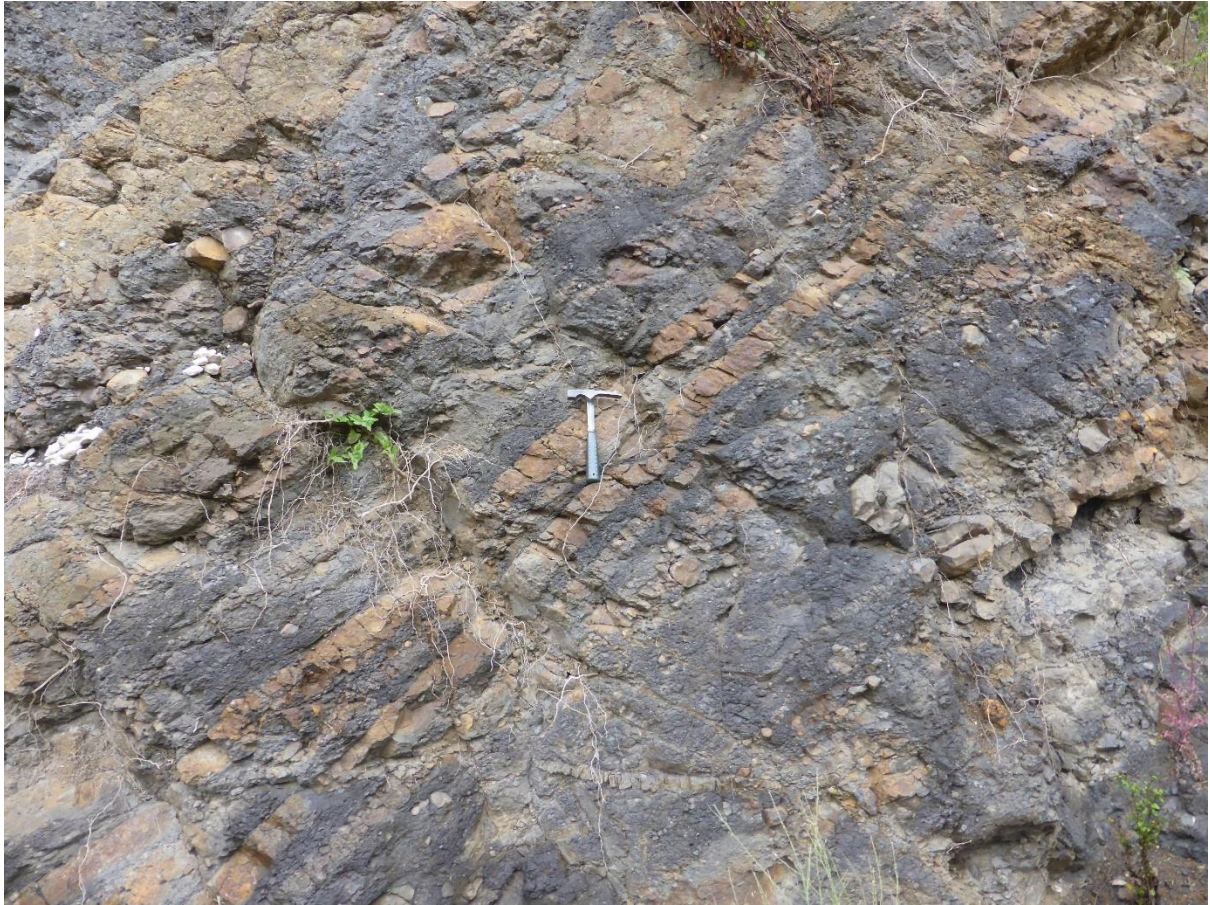
Fig. 1. Close up view of the dipping dish beds of the diatreme and the varied lithological components (including angular clasts and fine-grained volcaniclastic material forming the matrix) of the diatreme. Geological hammer for scale. Image taken on bench at RL88. Note that such a view, displaying details of great significance for researchers and student, would only be possible from a position less than 1m from the quarry face, not behind a chainlink fence. Photograph by Ian Percival on 10th June, 2020.

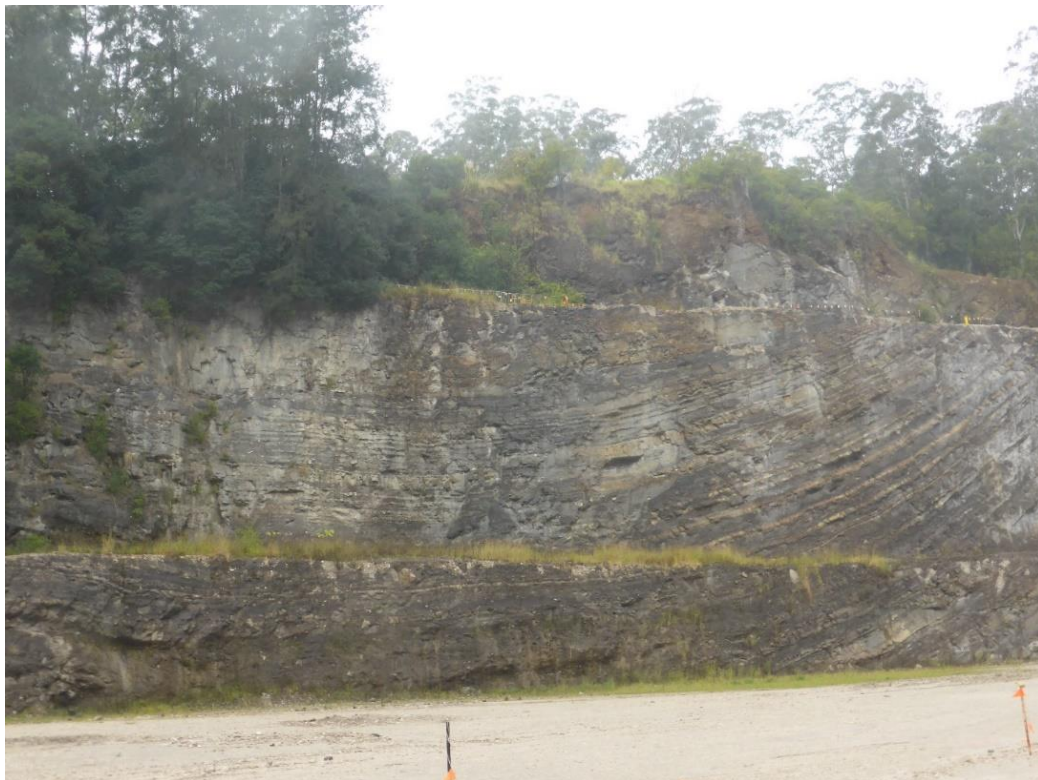
Fig. 3. View of the same eastern face of the now partly-infilled and inactive Hornsby Quarry, taken during the site visit facilitated by Hornsby Shire Council on 10th June 2020, for comparison with Fig. 1. The higher bench at RL88, extending from the dark green vegetation on the left and marked by small flags along the cliff edge, is the site of the proposed boardwalk. The compacted spoil in the foreground of the image will be excavated by a further 5 m. Photograph by Ian Percival (note that the quality of this image was affected by the showery and overcast conditions on the day of the field inspection).
