Visual Impact Assessment NAPL Office Building 1

A-DA-9200
REV B

Williamtown NSW

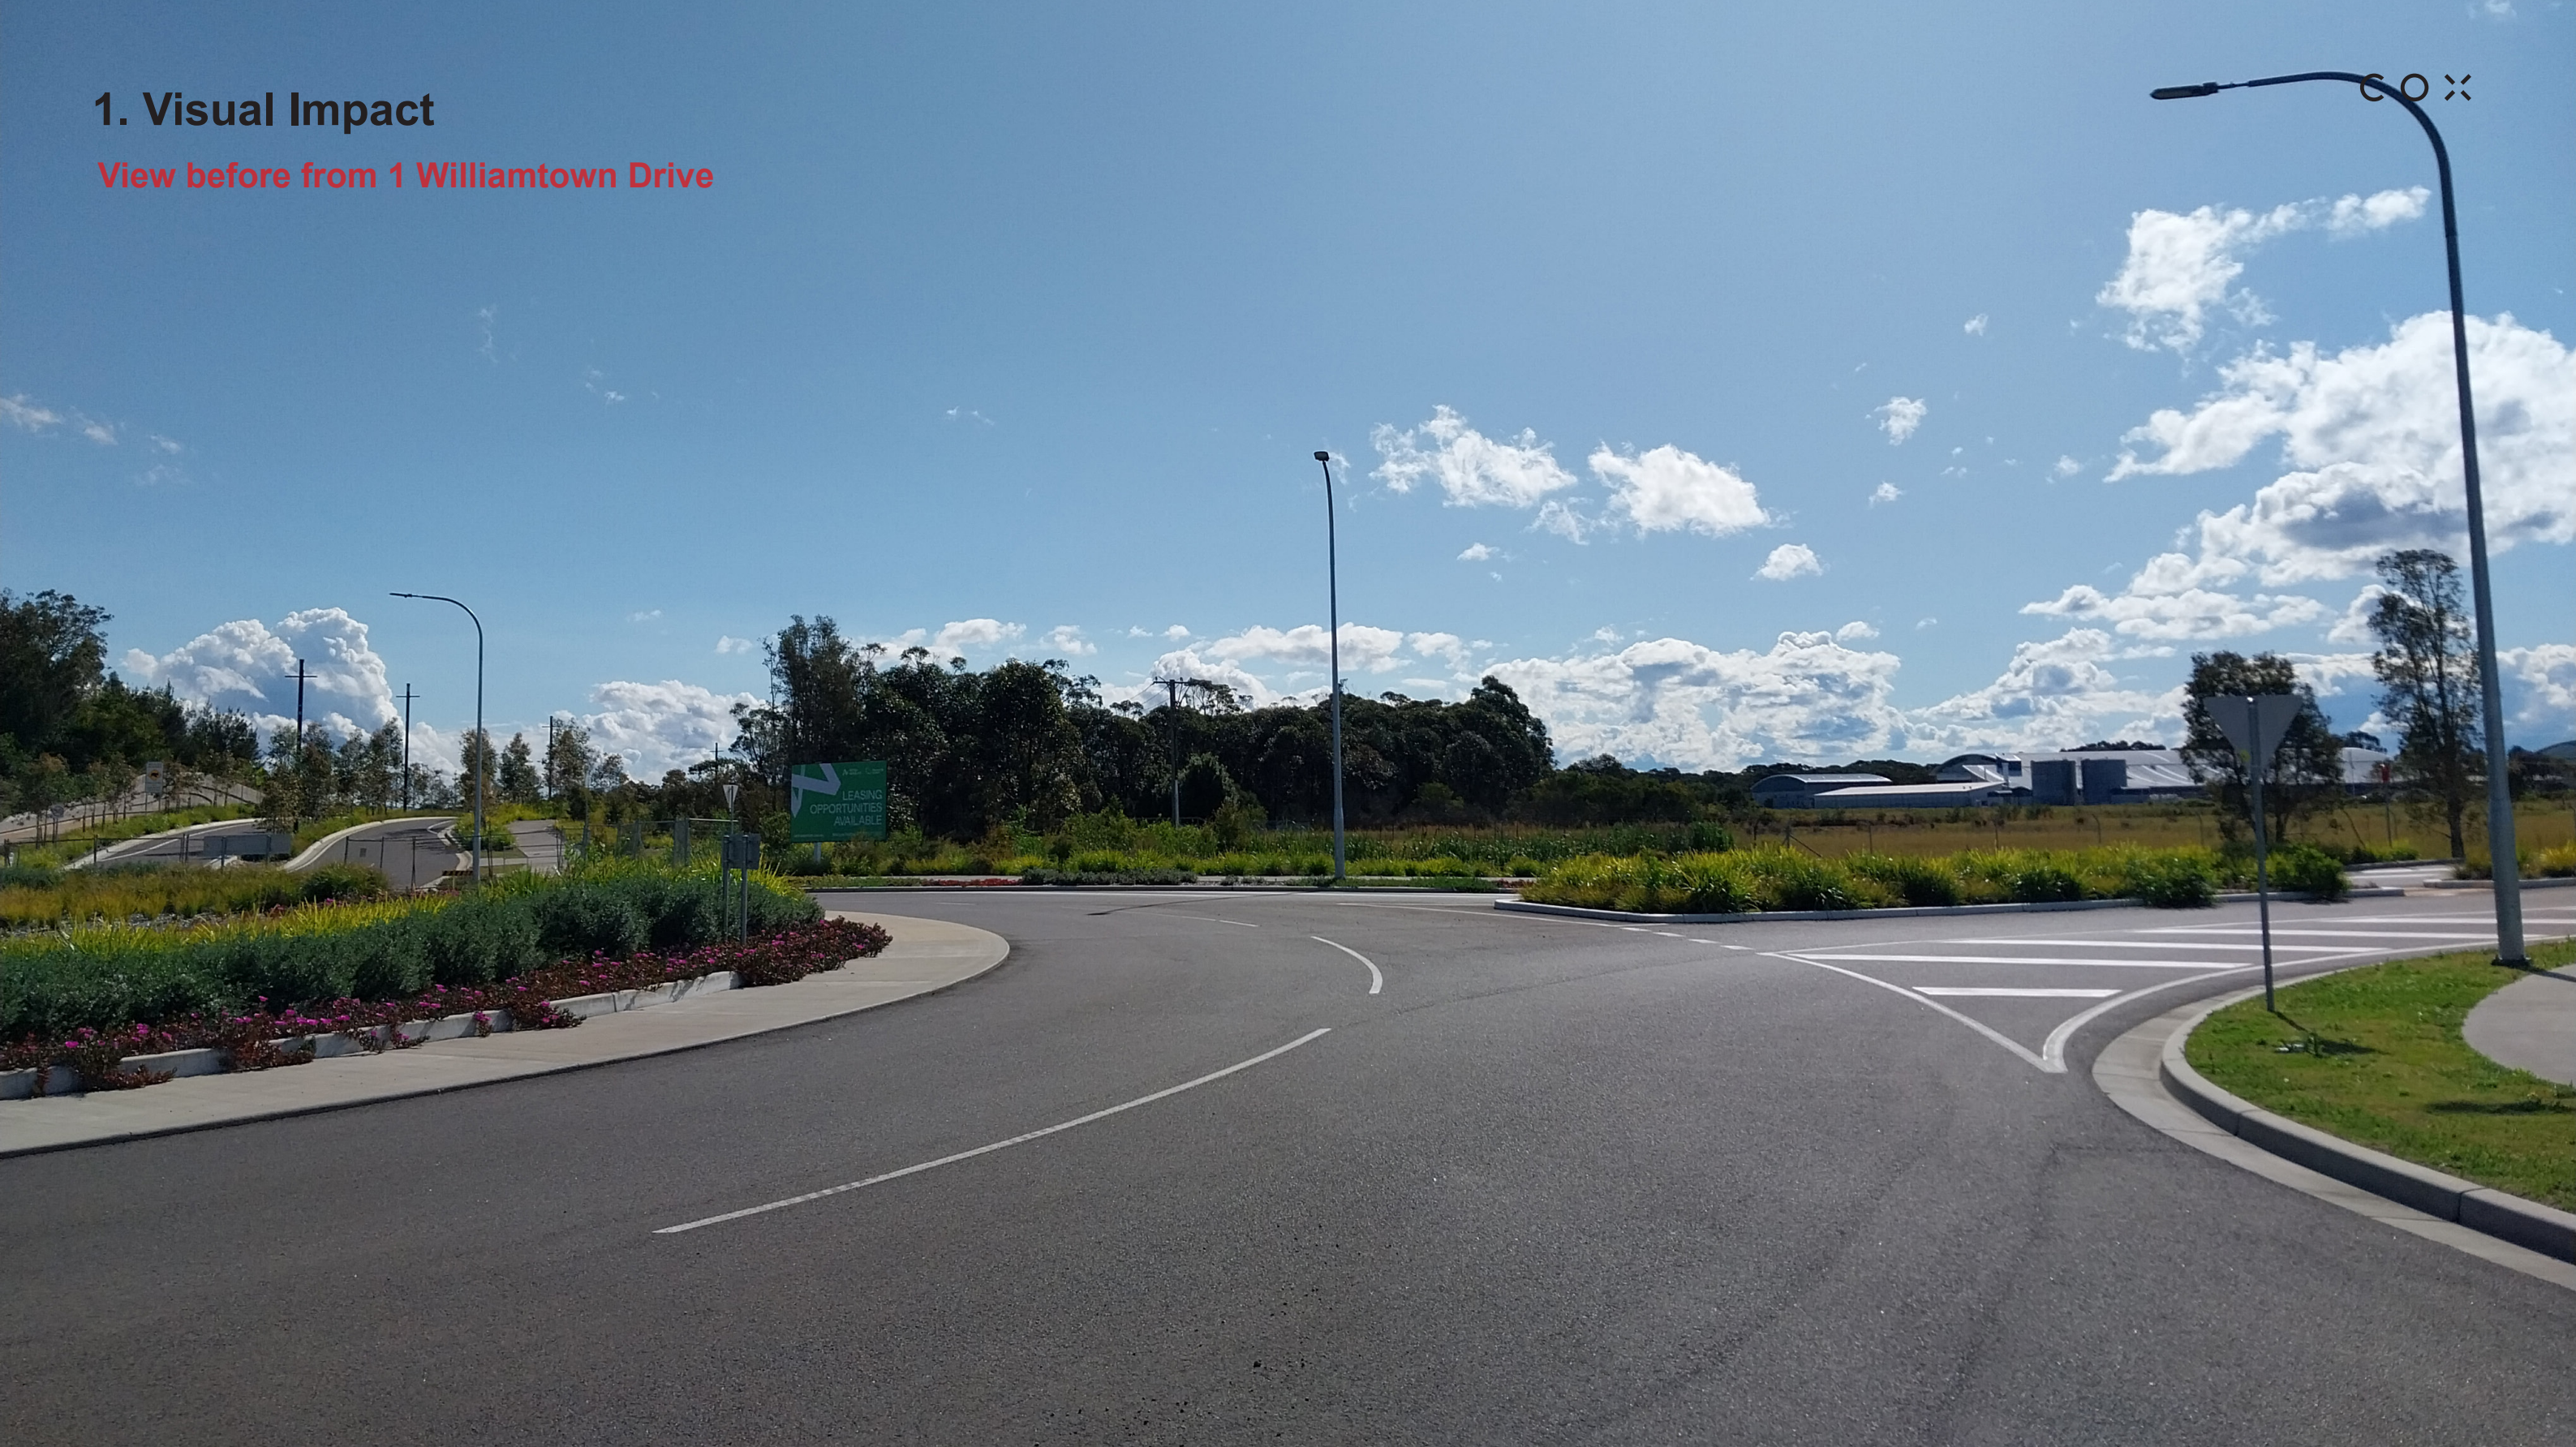
View before from 1 Williamtown Drive

1 View from williamtown drive roundabout, to illustrate the view of the building on approach to the intersection between office and airport zones of the precinct.

GPS location	
Latitude	-32.808464
Longitude	151.841541
Altitude	2m
Focal Length	4mm

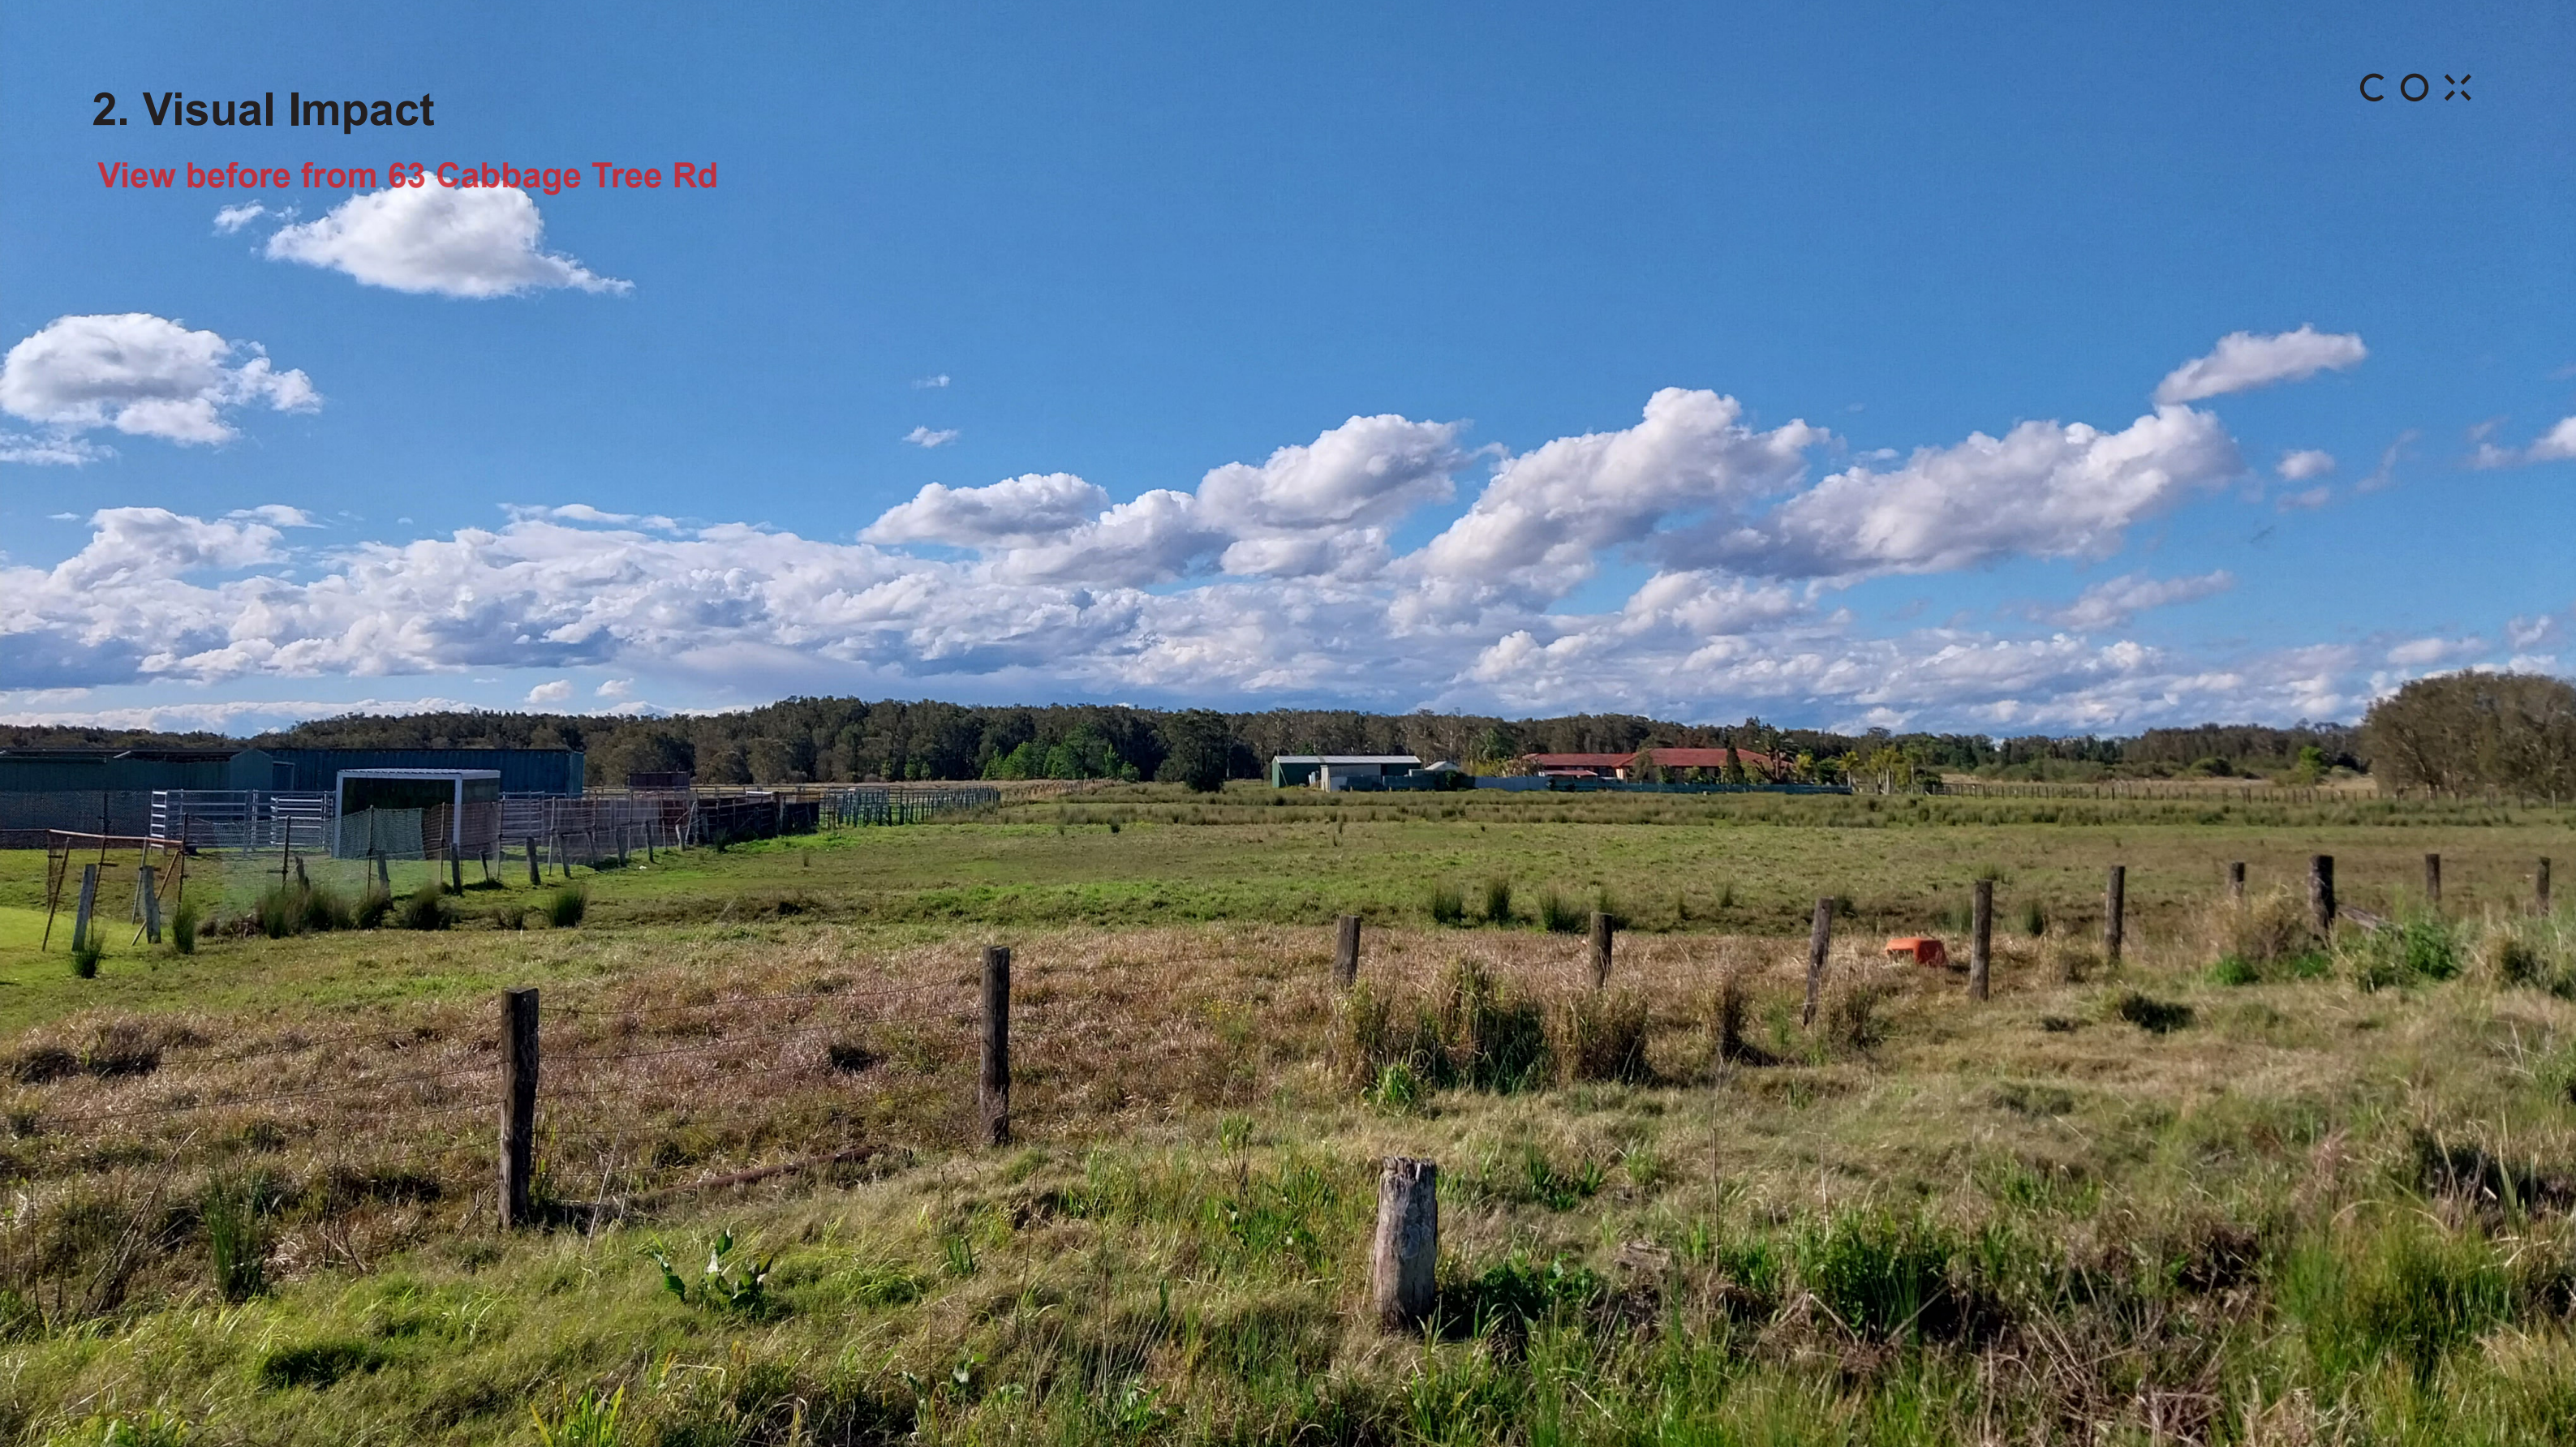
View before from 63 Cabbage Tree Rd

2 View from cabbage tree road. this view illustrates low visual impact from the main road behind the precinct.

GPS location	
Latitude	-32.816106
Longitude	151.836799
Altitude	2m
Focal Length	4mm

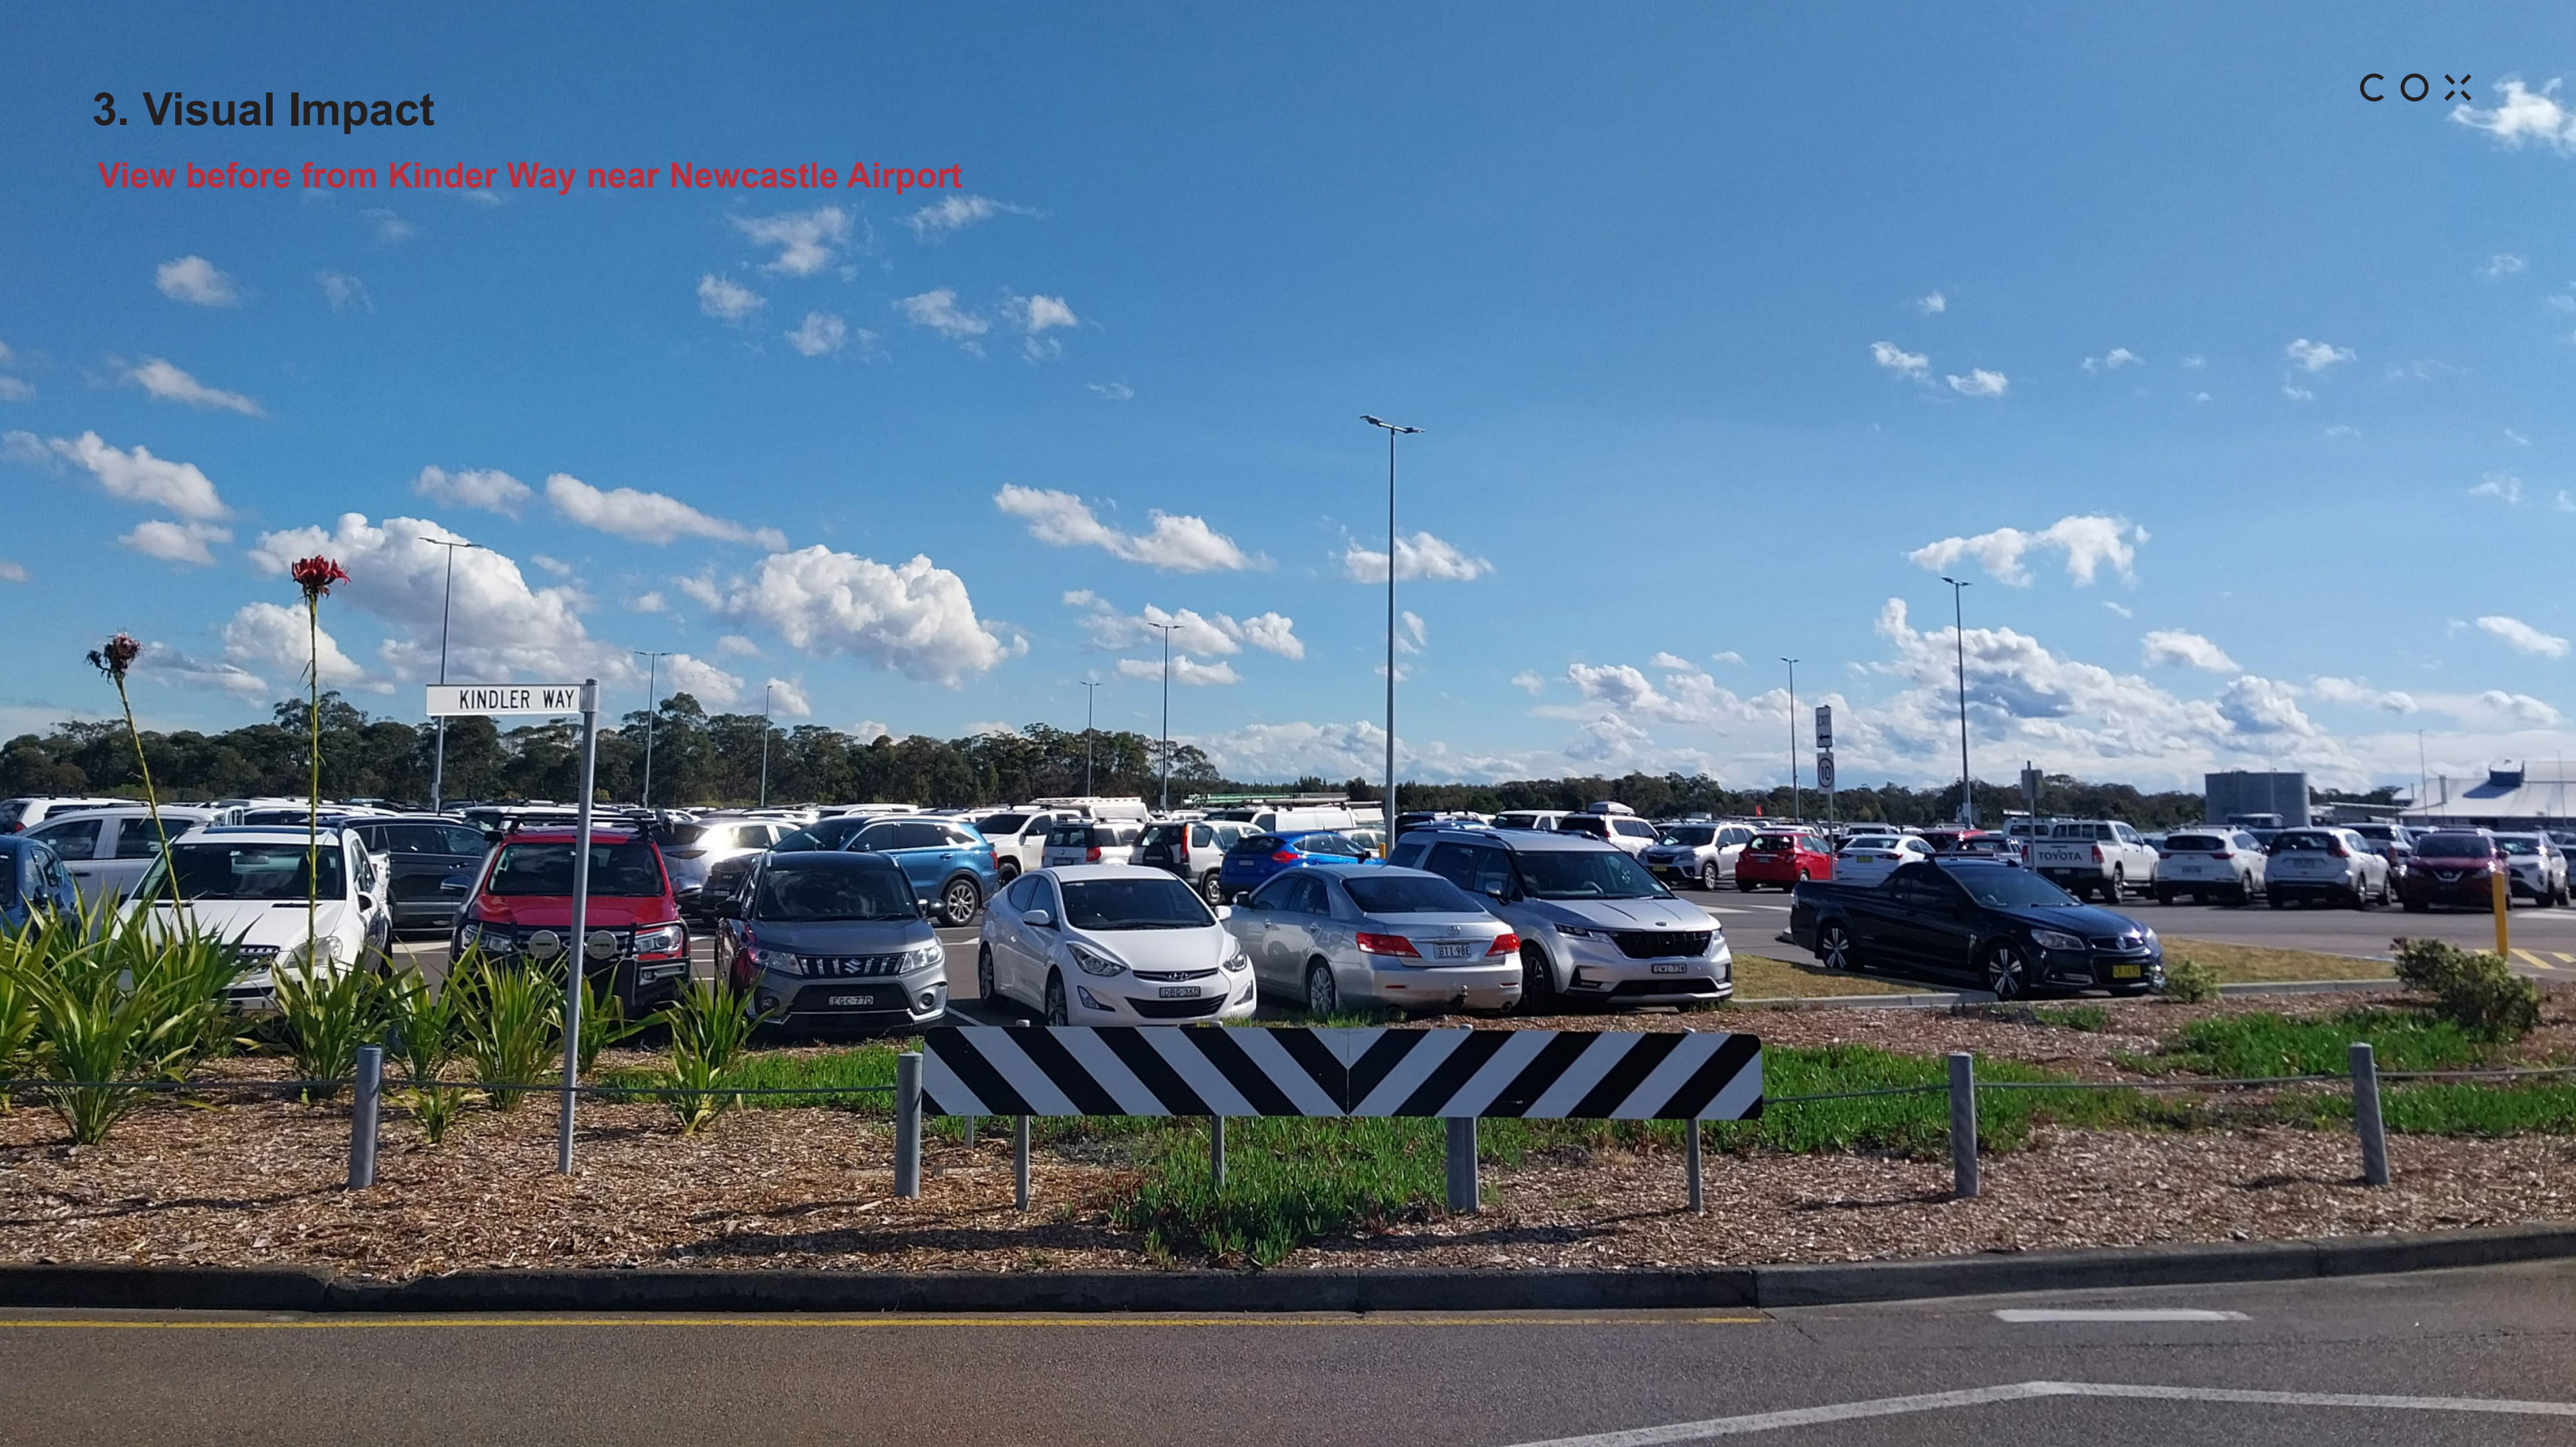
View before from Kinder Way near Newcastle Airport

3 View from car rentals adjacent to the terminal, to assess the impact of the building as viewed in context of the gateway into the future terminal expansion.

GPS location	
Latitude	-32.805569
Longitude	151.840924
Altitude	5m
Focal Length	4mm

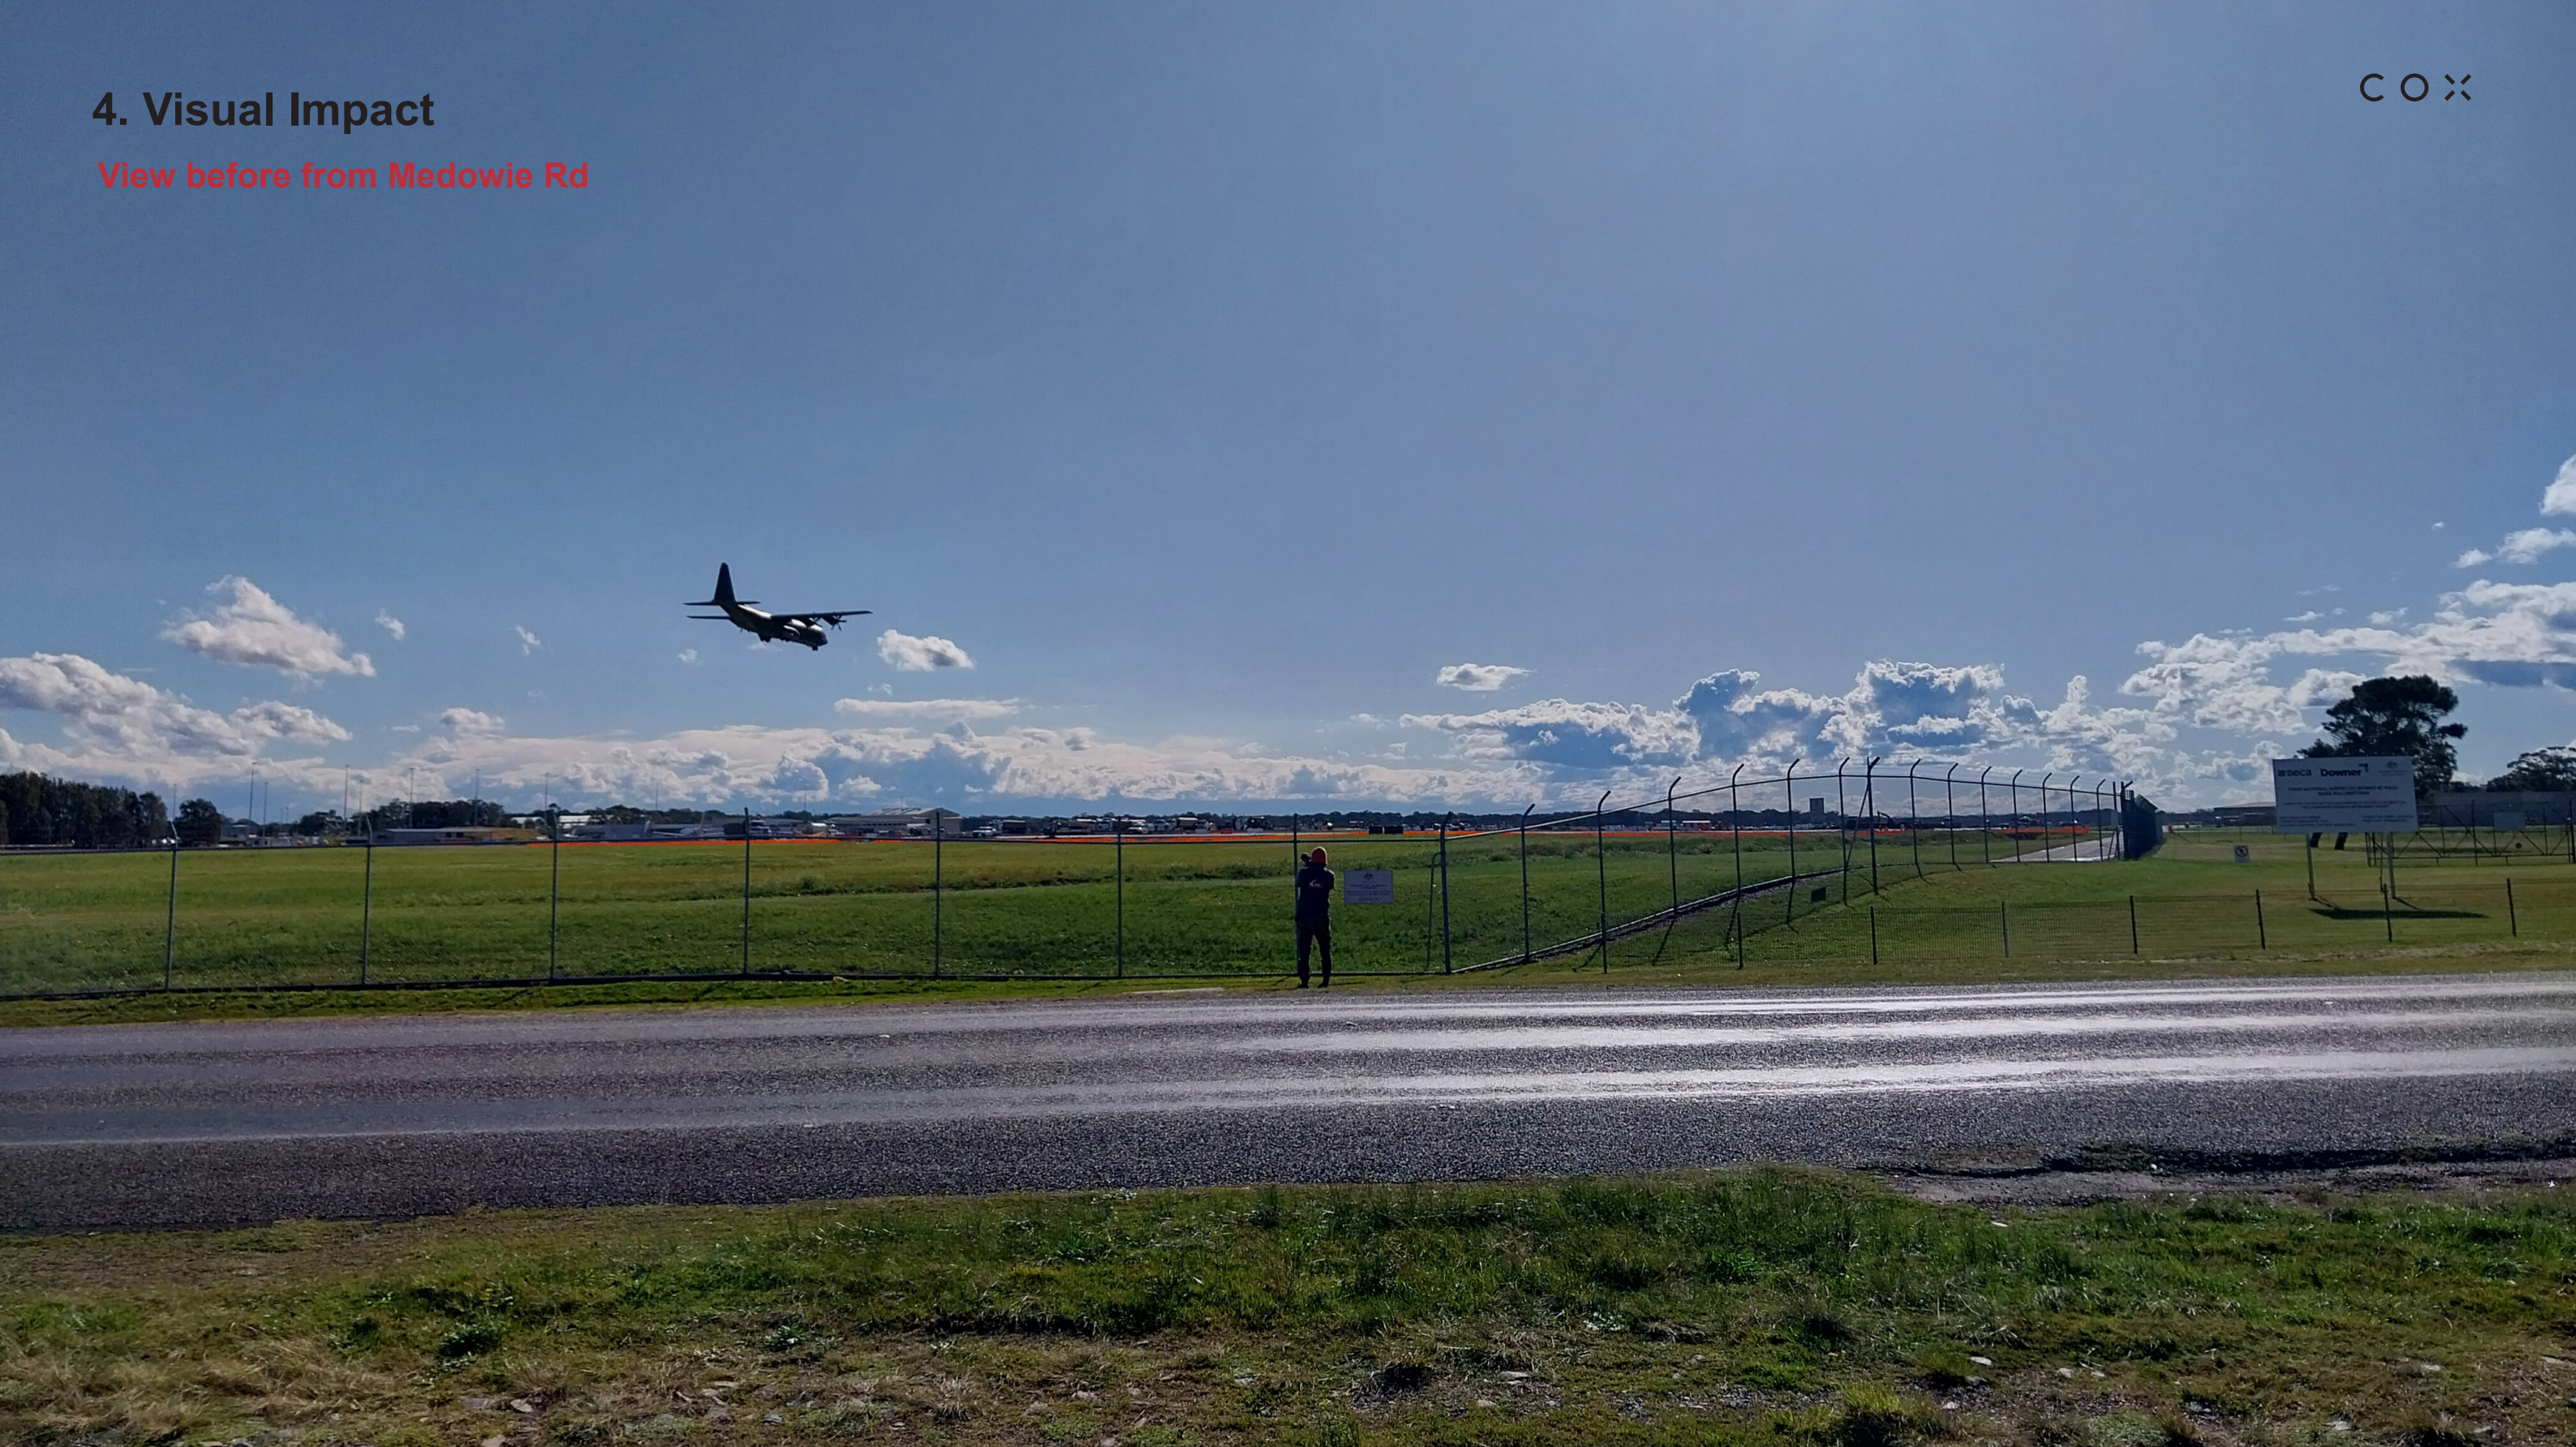
View before from Medowie Rd

4 View from Medowie road, towards the runway, illustrating the view and height of the building in context of the wider airport precinct.

GPS location	
Latitude	-32.805051
Longitude	151.850682
Altitude	4m
Focal Length	4mm

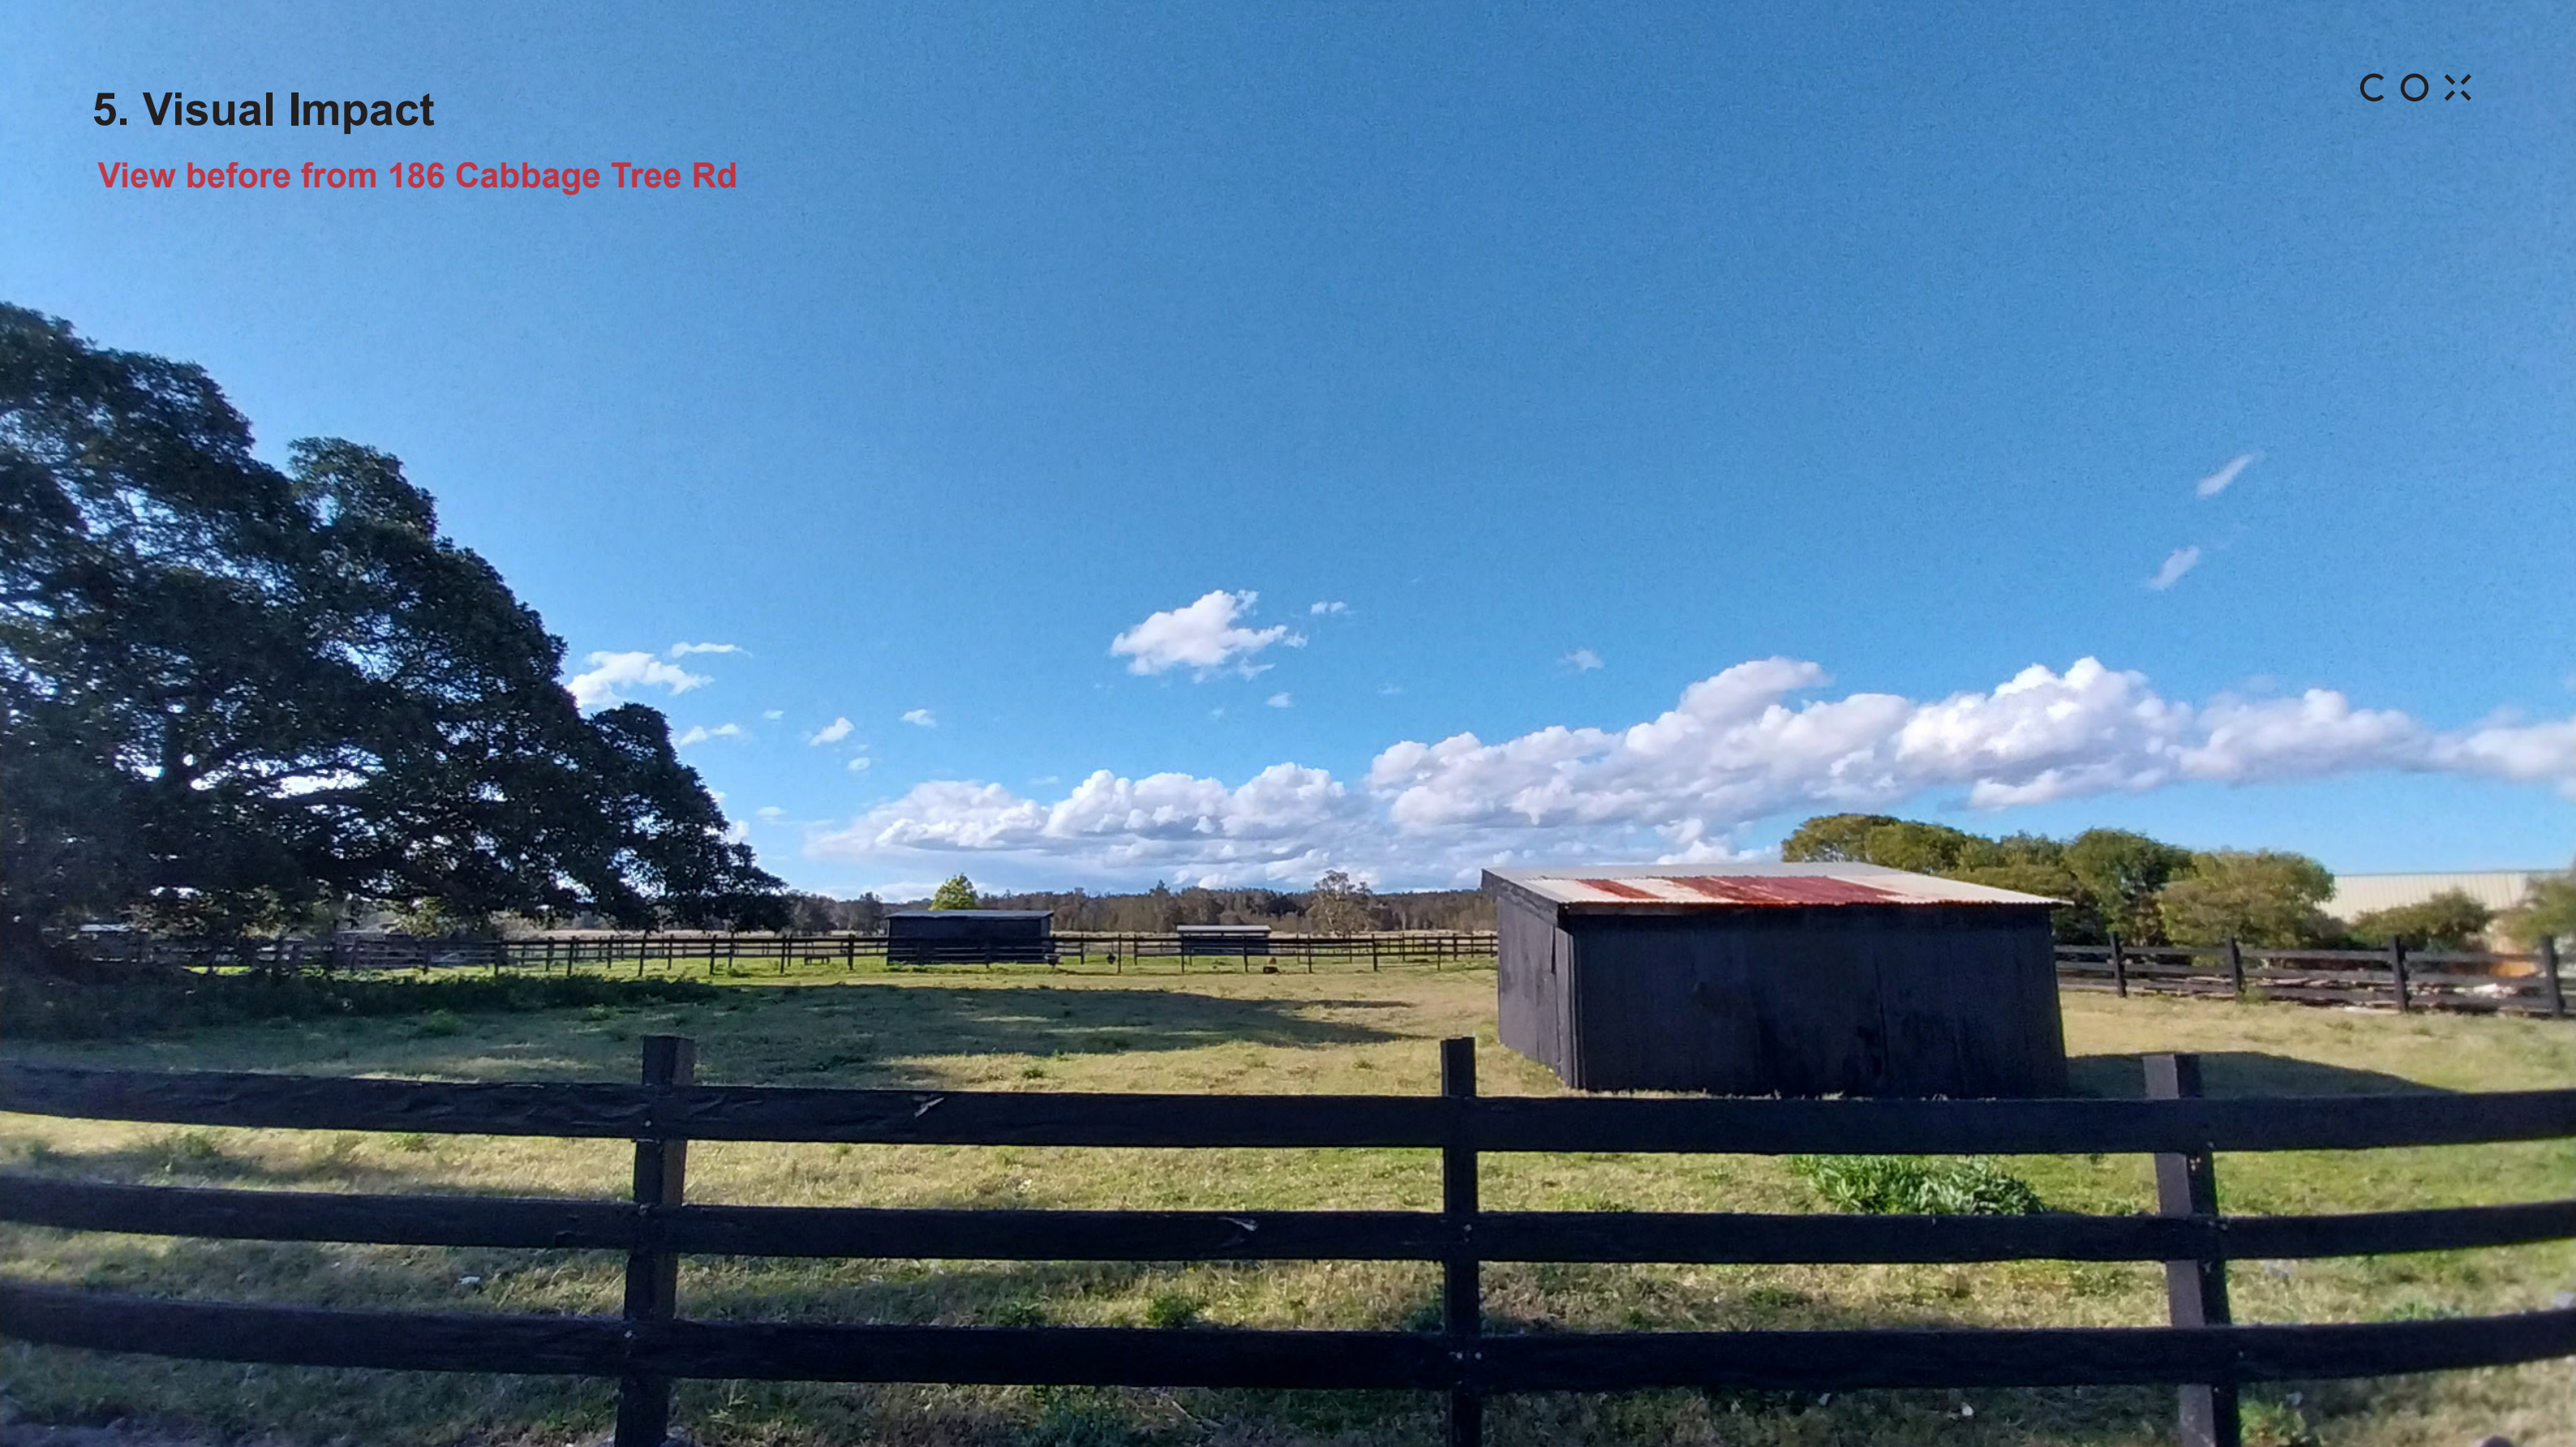
View before from 186 Cabbage Tree Rd

5 View from cabbage tree road. this view illustrates the view of the building within the tree canopy from from the main road behind the precinct.

GPS location	
Latitude	-32.817934
Longitude	151.828162
Altitude	2m
Focal Length	1mm

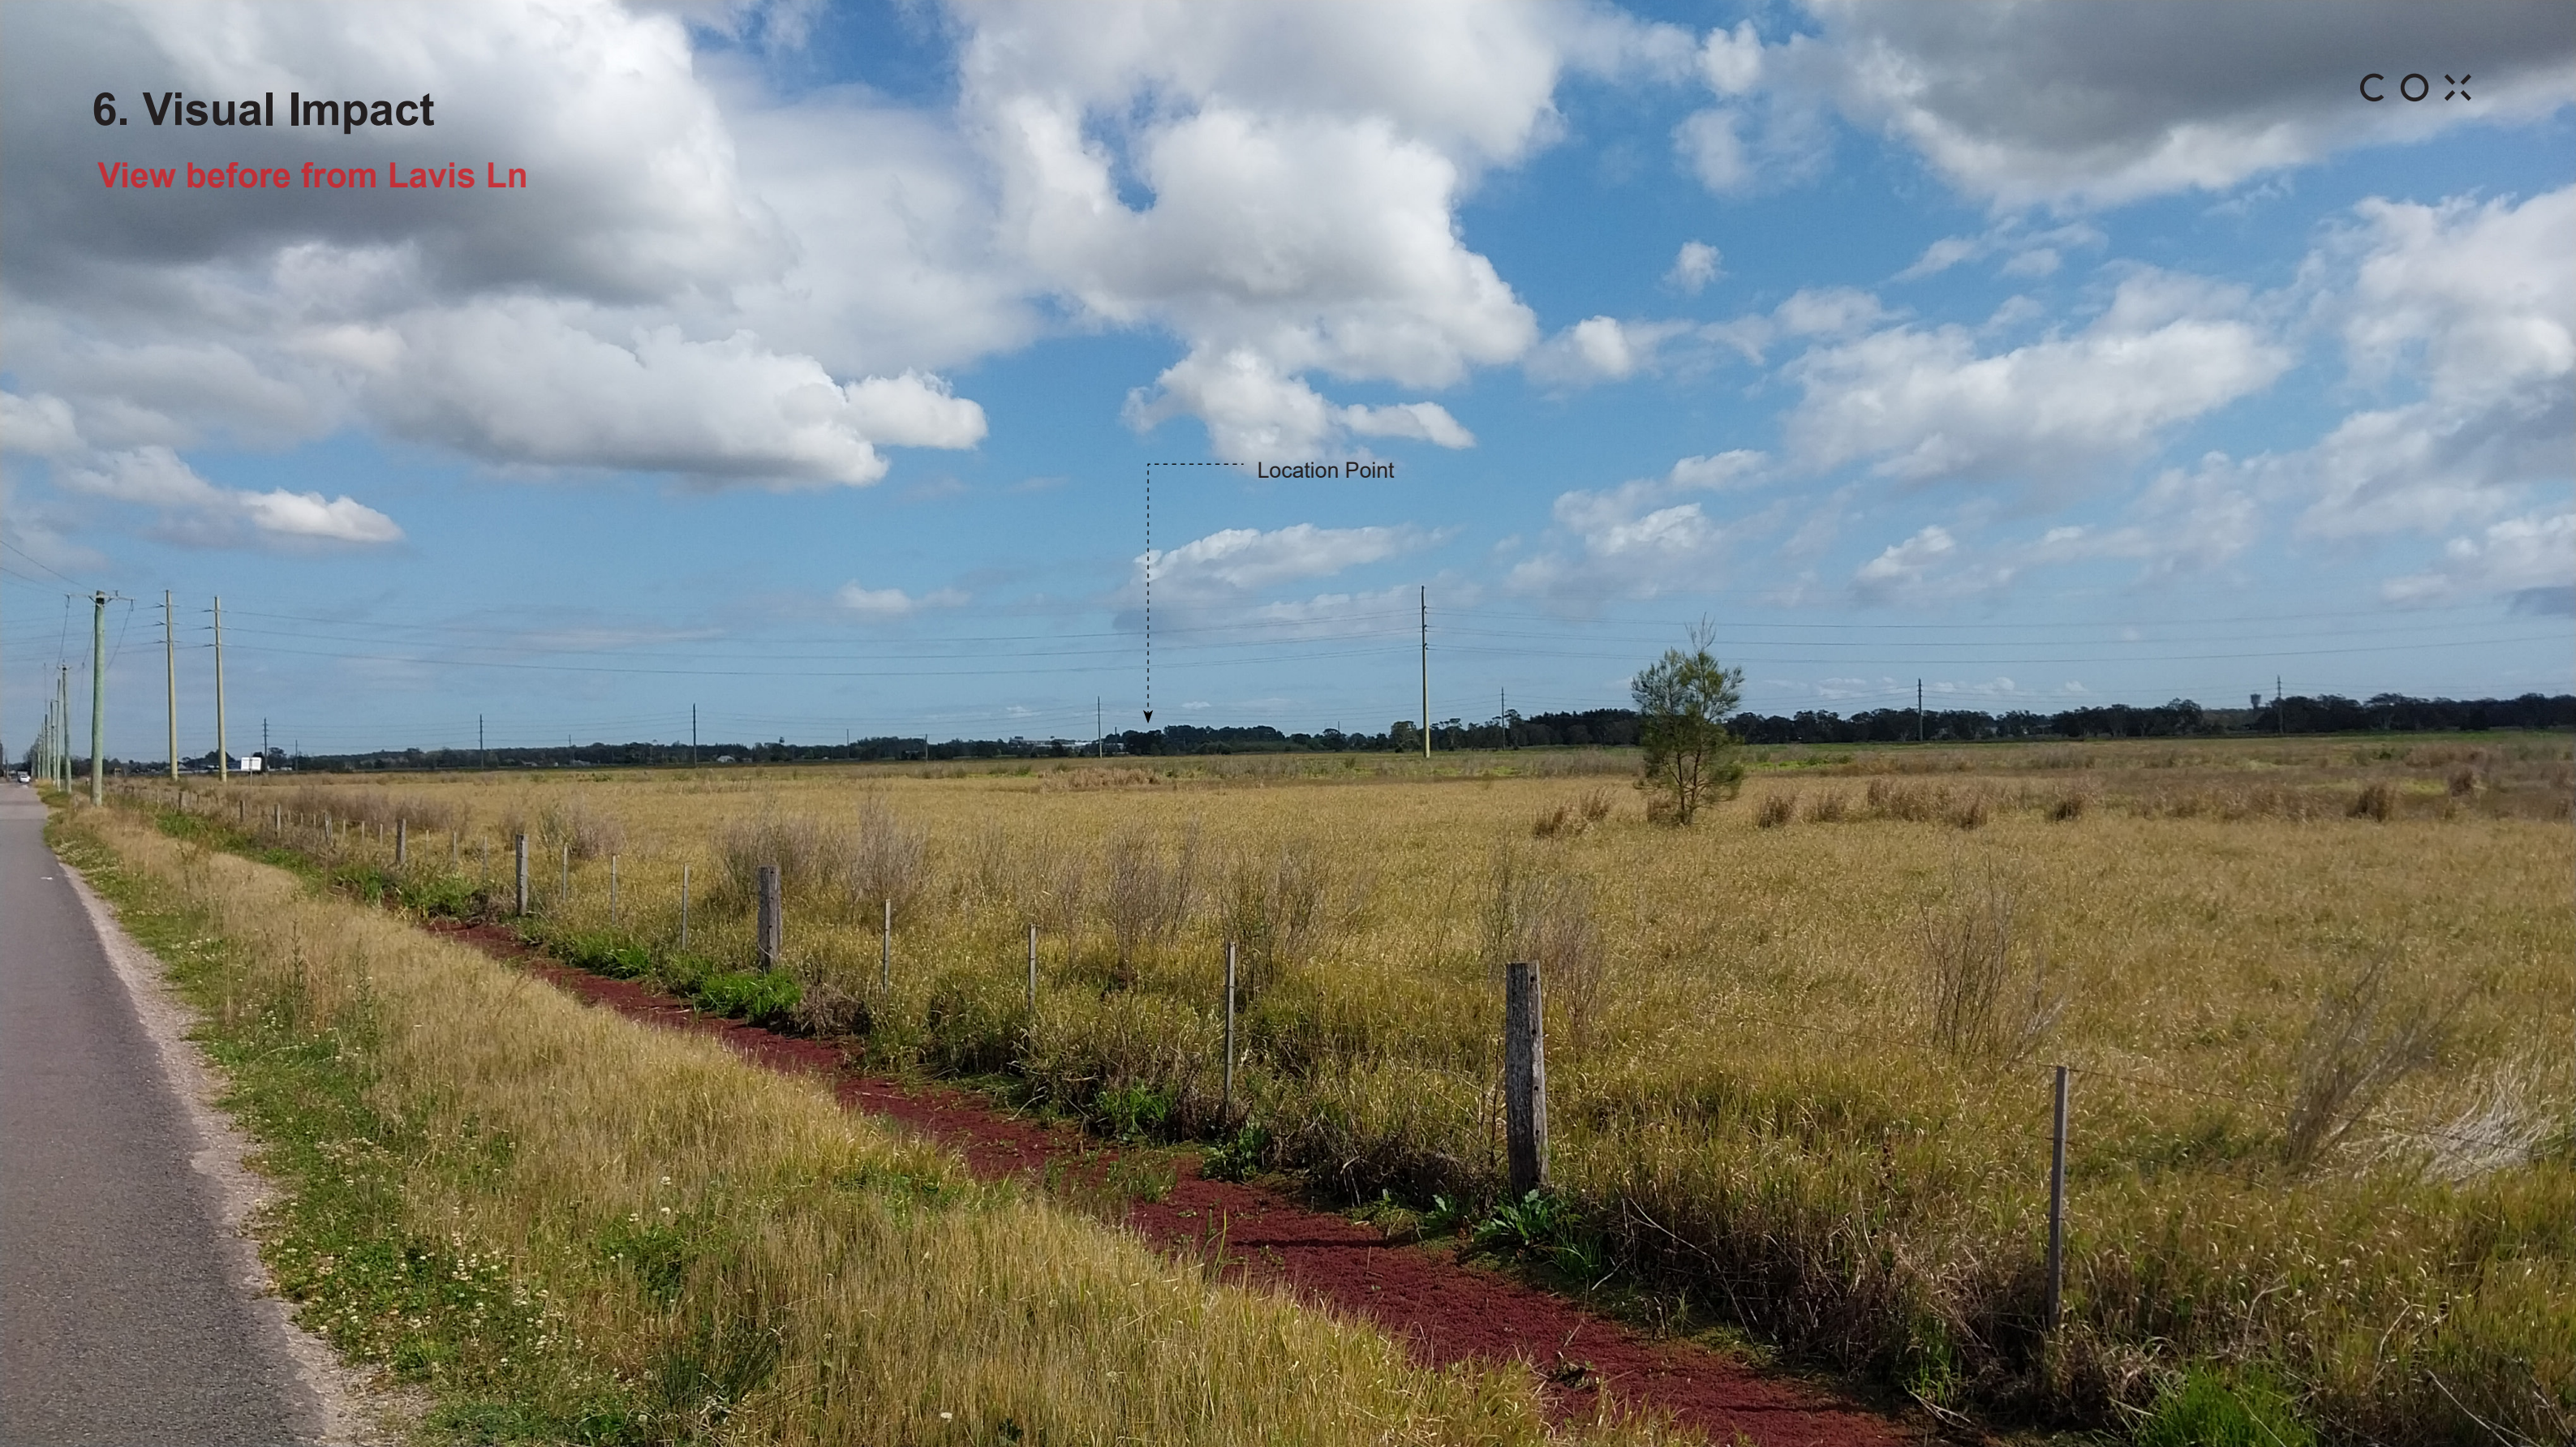
View before from Lavis Ln

6 View from lavis lane, closer to the dunes, to demonstrate low impact to the coastal landscape.

GPS location	
Latitude	-32.820204
Longitude	151.859240
Altitude	1m
Focal Length	-
