Visual Impact Assessment NAPL Office Building 1

A-DA-9200
REV B

Williamtown NSW

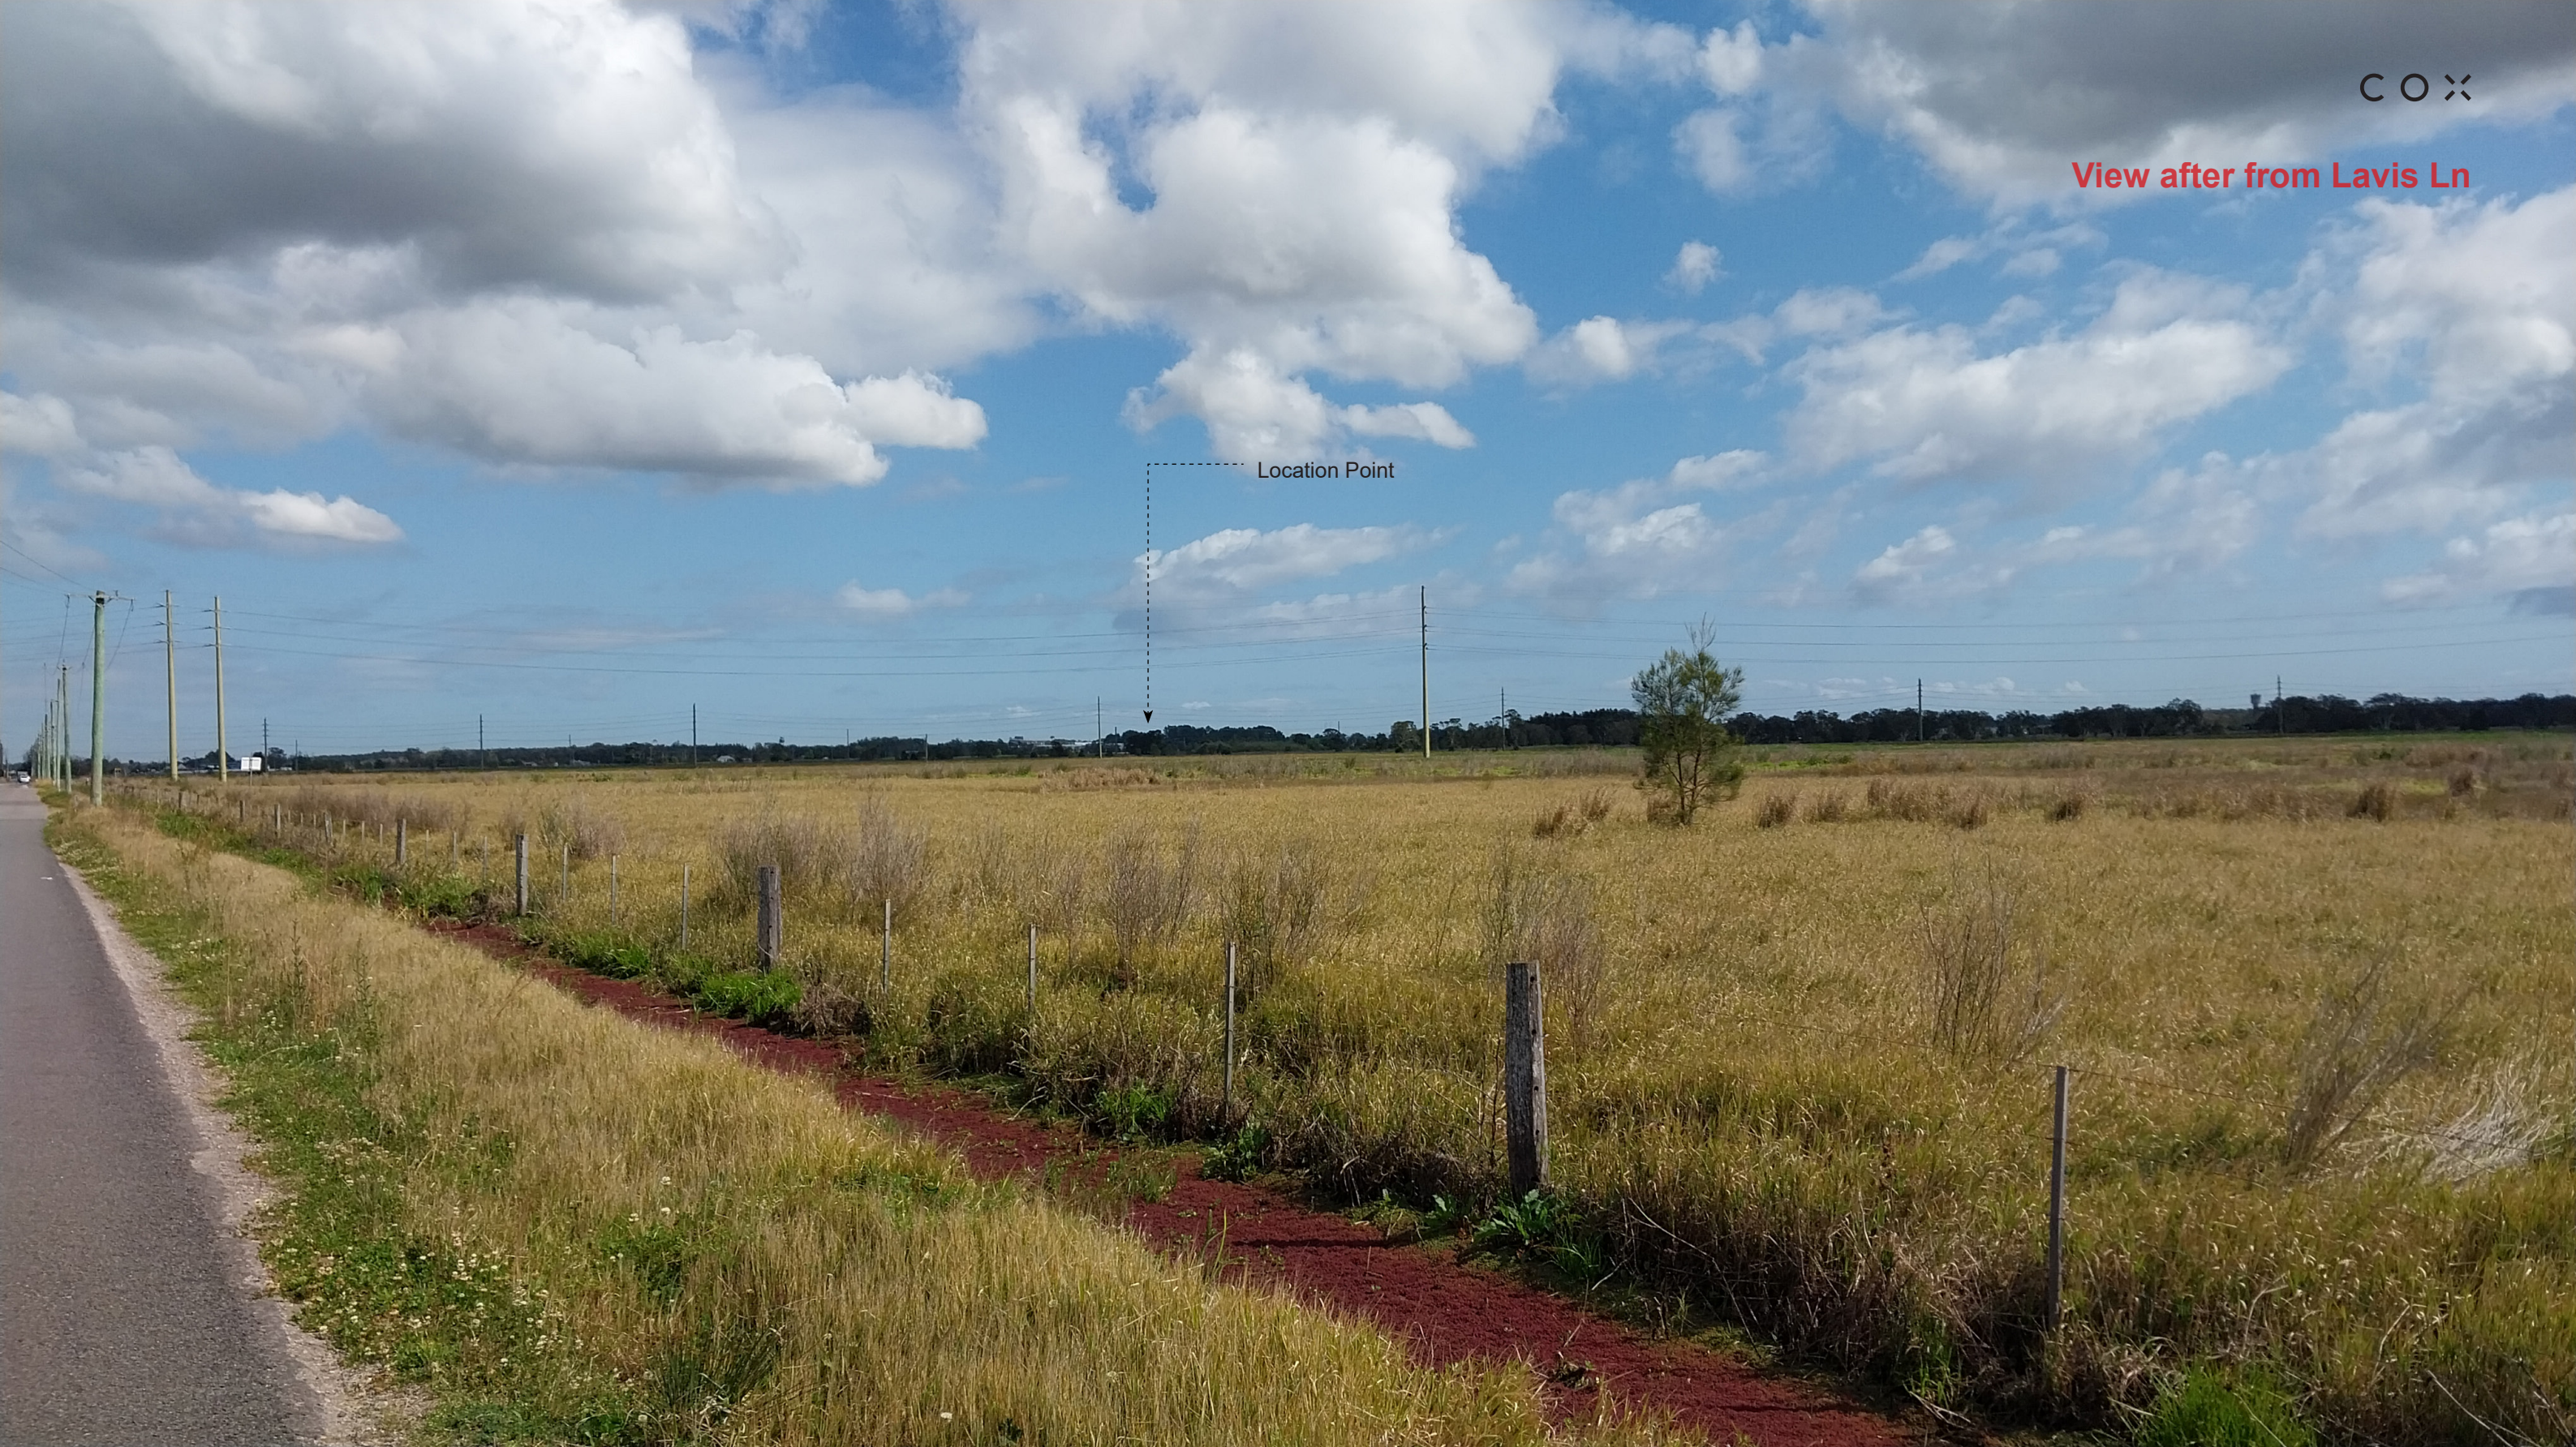
View after from Lavis Ln

6 View from lavis lane, closer to the dunes, to demonstrate low impact to the coastal landscape.
