# Proposed Mixed-Use Development, 711 Hunter Street, Newcastle NSW

## Remedial Action Plan

Reference: 754-NTLGE293239-AH

18 May 2023

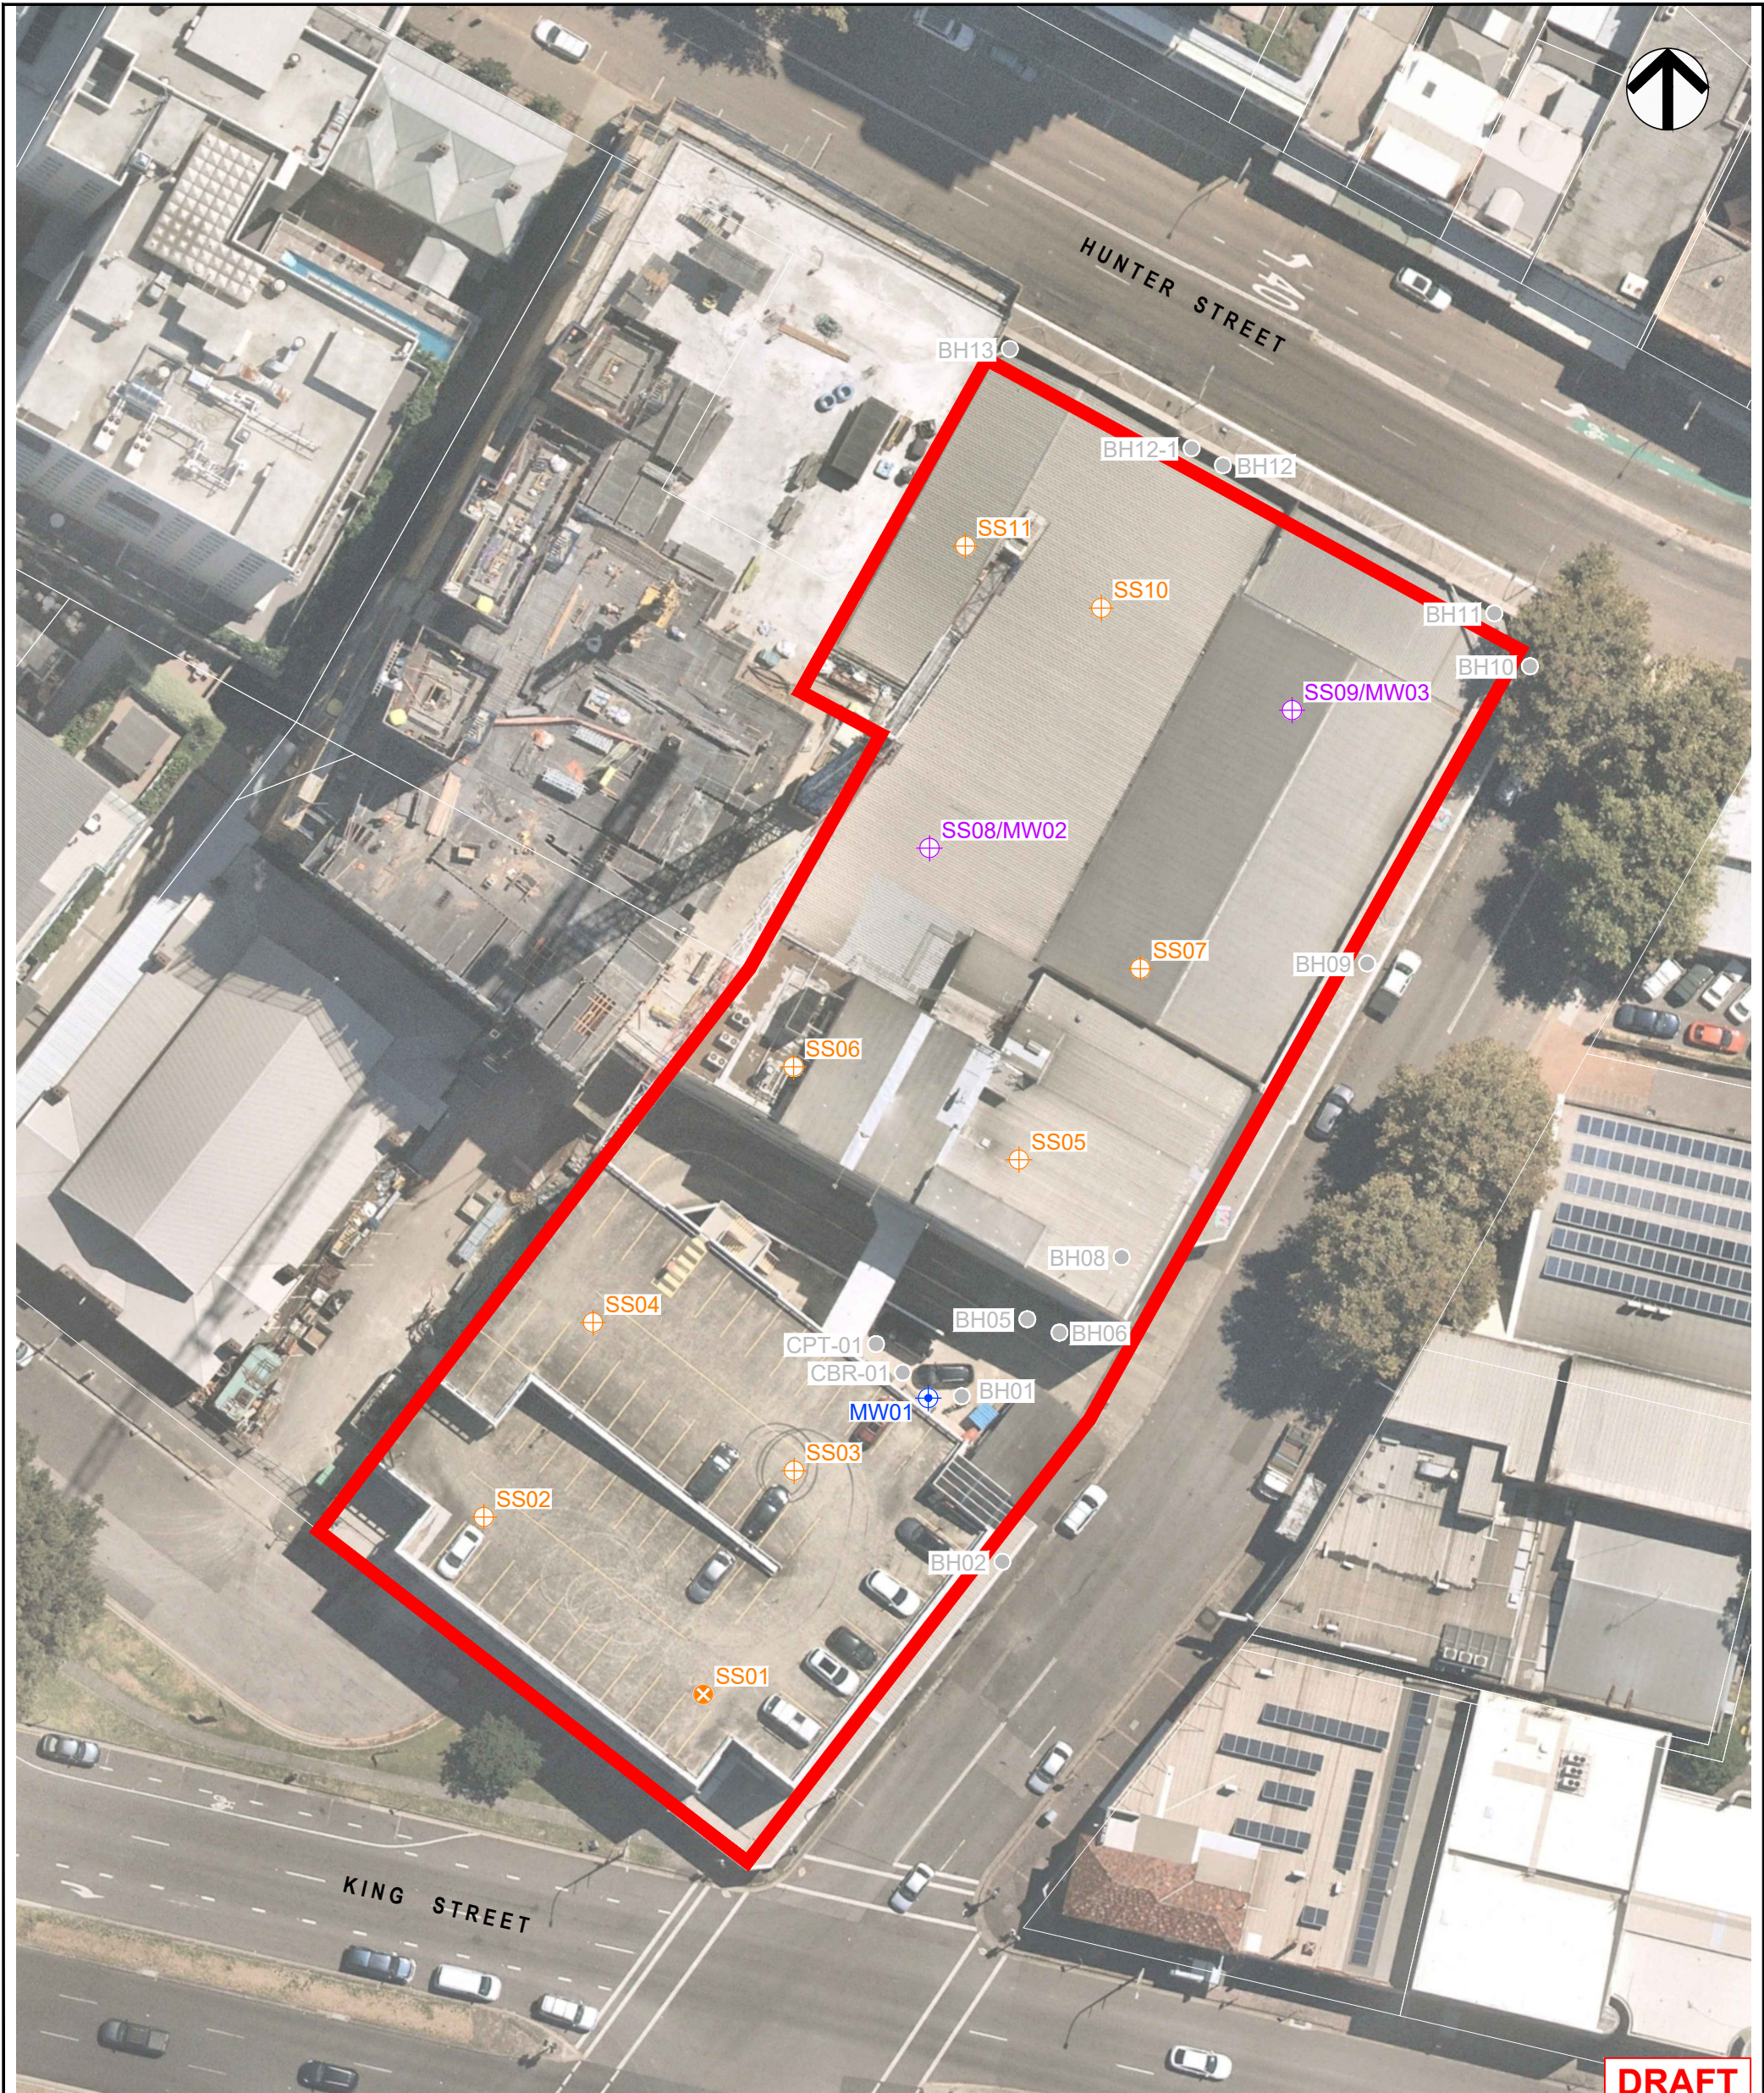
| revision | no. | description | | drawn | approved | date | <div>LEGEND</div> <div><div></div>SITE BOUNDARY</div> <div><div></div>BOREHOLE LOCATION</div> <div><div></div>EXISTING GROUNDWATER MONITORING WELL LOCATION</div> <div><div></div>PROPOSED SOIL SAMPLE LOCATION</div> <div><div></div>PROPOSED GROUNDWATER MONITORING WELL LOCATION</div> |

- A supplemental contamination assessment be completed following demolition of the existing building. It is recommended that the assessment be undertaken across the cleared building footprint using test pits or wide diameter (350mm – 450mm bores) in order to better assess the fill both visually and chemically (to a depth of 2mbgs). The assessment should be completed systematically across the footprint of the demolished building in accordance with the Sampling Design Guidelines.
- Two additional groundwater wells be installed following the demolition of the existing buildings to better assess the groundwater quality beneath the Site.

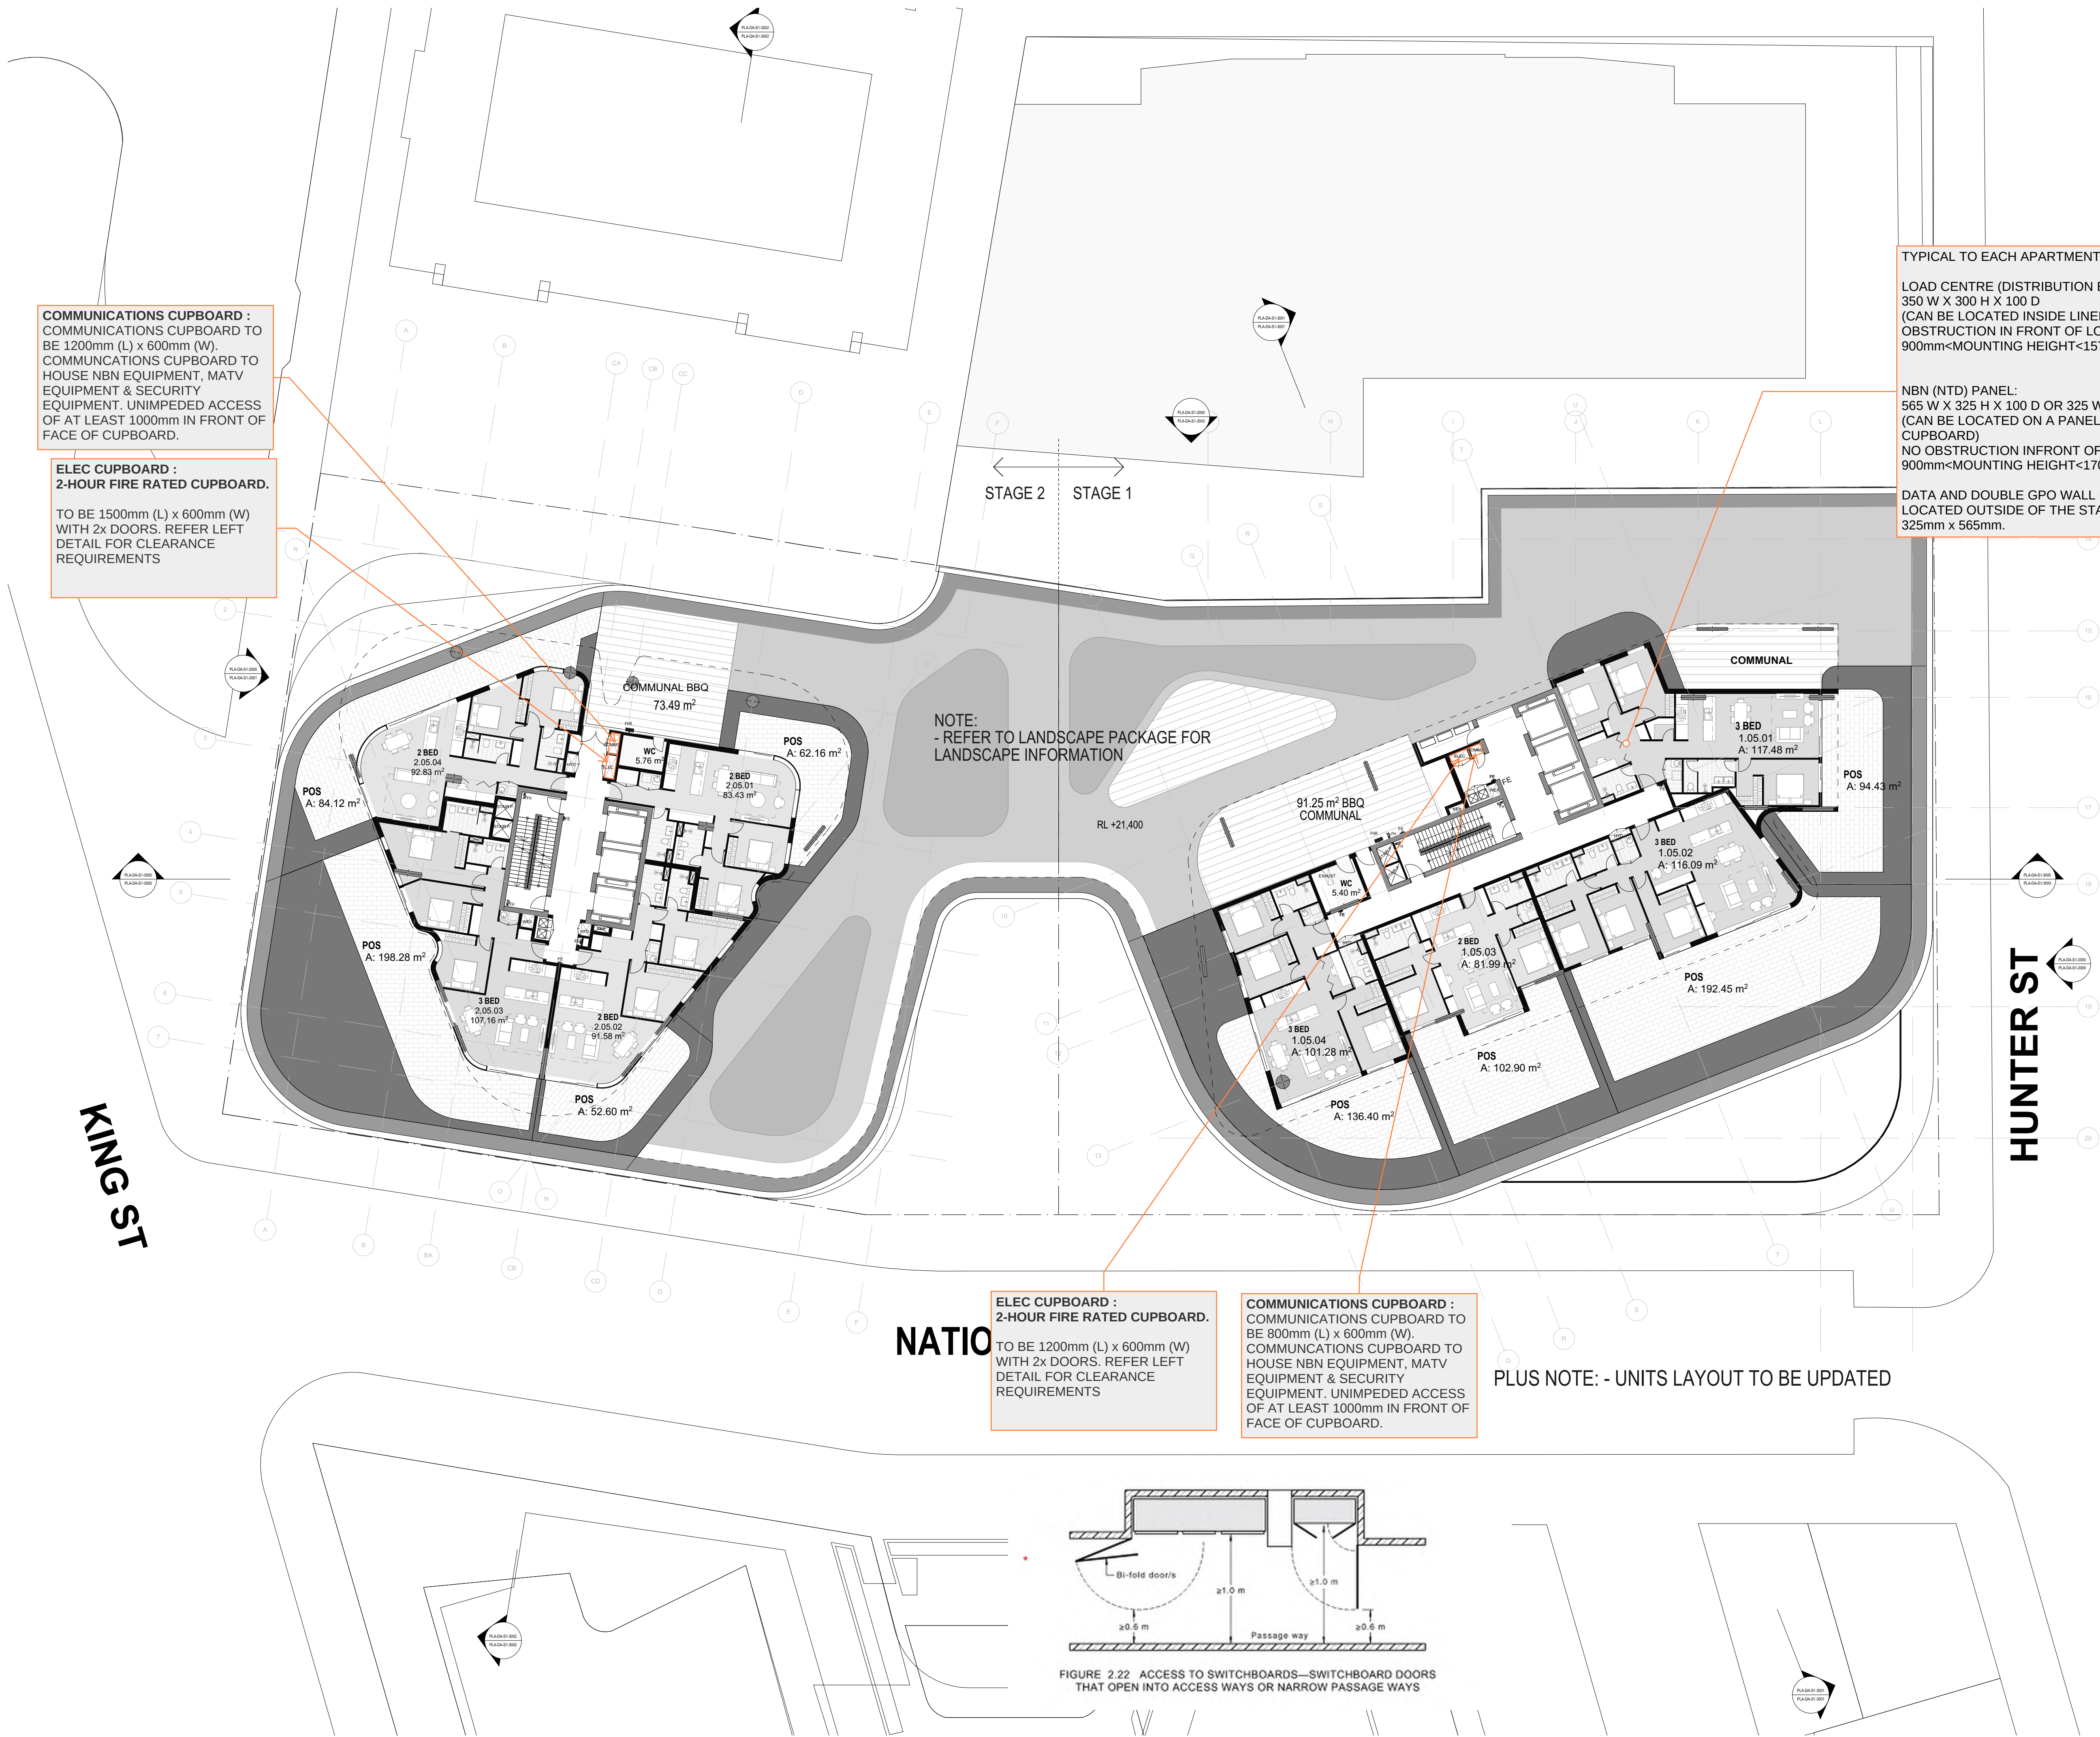
| Dwg No: 106 | Stage: SP 02 |

COMMUNICATIONS CUPBOARD :  
COMMUNICATIONS CUPBOARD TO  
BE 1200mm (L) x 600mm (W).  
COMMUNICATIONS CUPBOARD TO  
HOUSE NBN EQUIPMENT, MATV  
EQUIPMENT & SECURITY  
EQUIPMENT. UNIMPEDED ACCESS  
OF AT LEAST 1000mm IN FRONT OF  
FACE OF CUPBOARD.

ELEC CUPBOARD :  
2-HOUR FIRE RATED CUPBOARD.  
TO BE 1500mm (L) x 600mm (W)  
WITH 2x DOORS. REFER LEFT  
DETAIL FOR CLEARANCE  
REQUIREMENTS

COMMUNICATIONS CUPBOARD :  
COMMUNICATIONS CUPBOARD TO  
BE 800mm (L) x 600mm (W).  
COMMUNICATIONS CUPBOARD TO  
HOUSE NBN EQUIPMENT, MATV  
EQUIPMENT & SECURITY  
EQUIPMENT. UNIMPEDED ACCESS  
OF AT LEAST 1000mm IN FRONT OF  
FACE OF CUPBOARD.
