Fire Incident Management Plan

Site 10 (Magna) - 981 New England Hwy, Aberdeen 2336

Hive Battery Developments Pty Ltd

Riskcon Engineering Pty Ltd

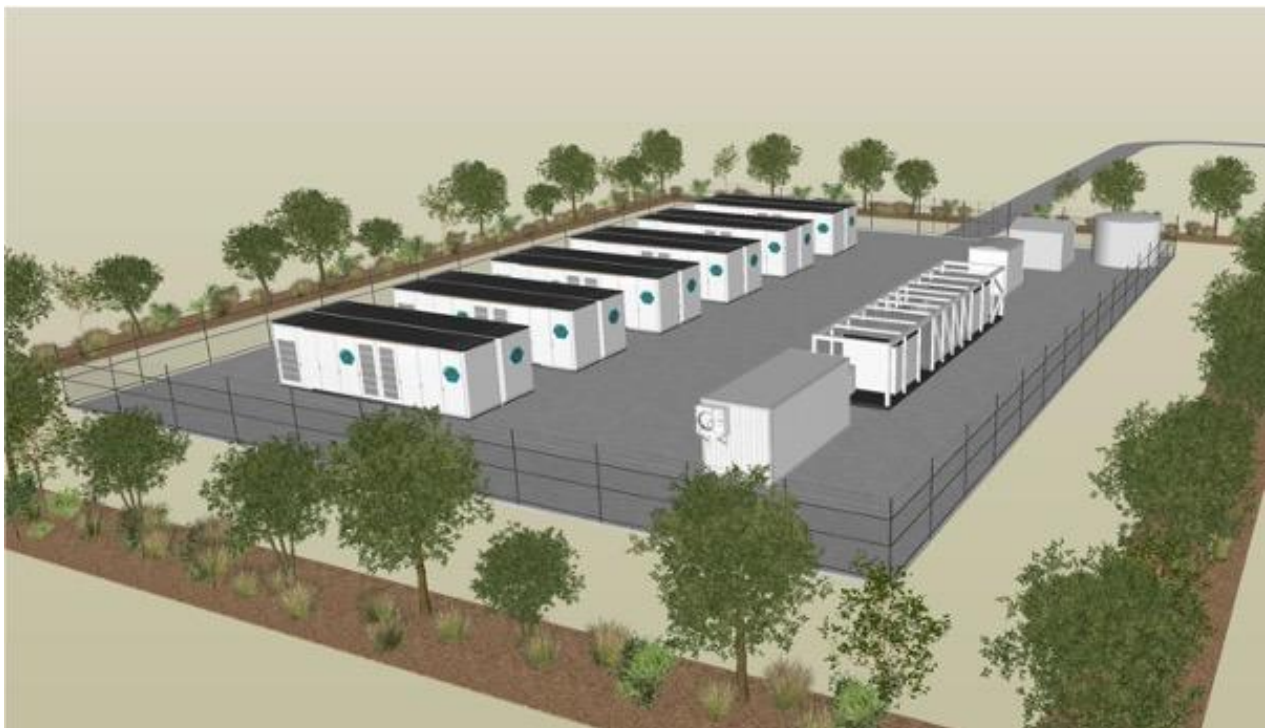
Figure 3-3: Indicative Side View 1

The site layouts are shown in **Figure 3-3** and **Figure 3-4** which includes a compound with dimensions of 33 m x 44 m resulting in an area of 1,435 m². It is bounded by a 2.4 m high fence and has a 10 m wide Asset Protection Zone (APZ).

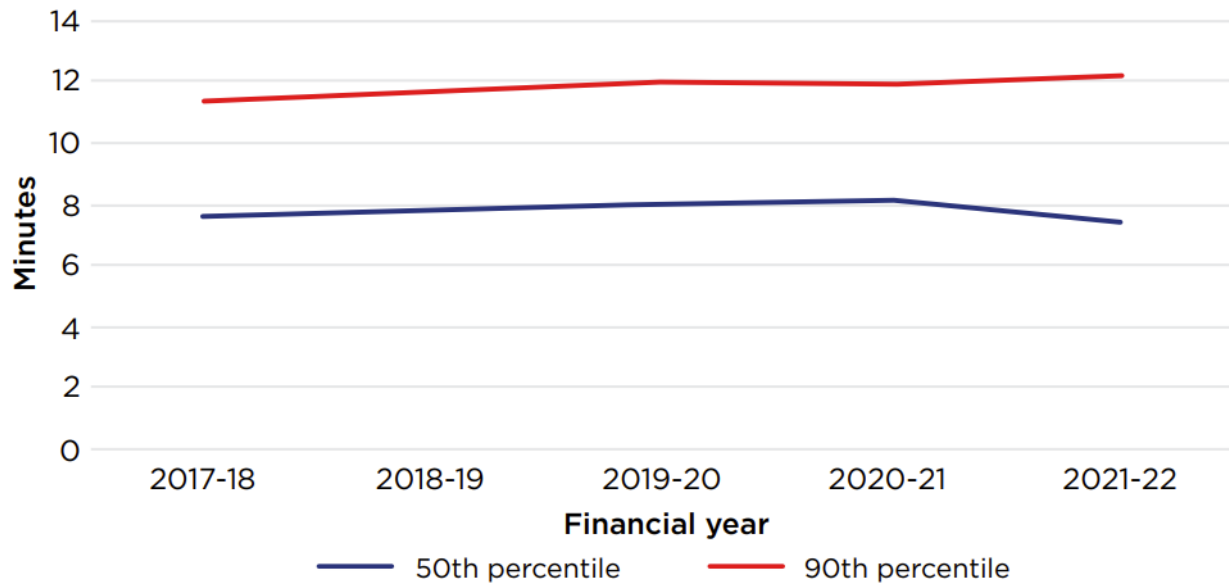
Figure 6-2: FRNSW Response Time from 2021/2022 Annual Report

- The fire station is considered to be manned at the time of the fire.
- Based on FRNSW response times statistics from the 2021/2022 annual report (Ref. [20]), the average time for the fire brigade to respond to an emergency call (including call processing, turnout time and travel time) is less than 8 minutes as shown in **Figure 6-2**. The 90th percentile of response time of approximately 12 minutes. However, as this is for inner city areas and the site is rurally located, it was assumed that RFS would respond 30 minutes later (1,800 s).
