Fire Incident Management Plan

Site 3 (Dawson), 1154 Clarence Town Rd, Seaham NSW 2324

Hive Battery Developments Pty Ltd

Riskcon Engineering Pty Ltd

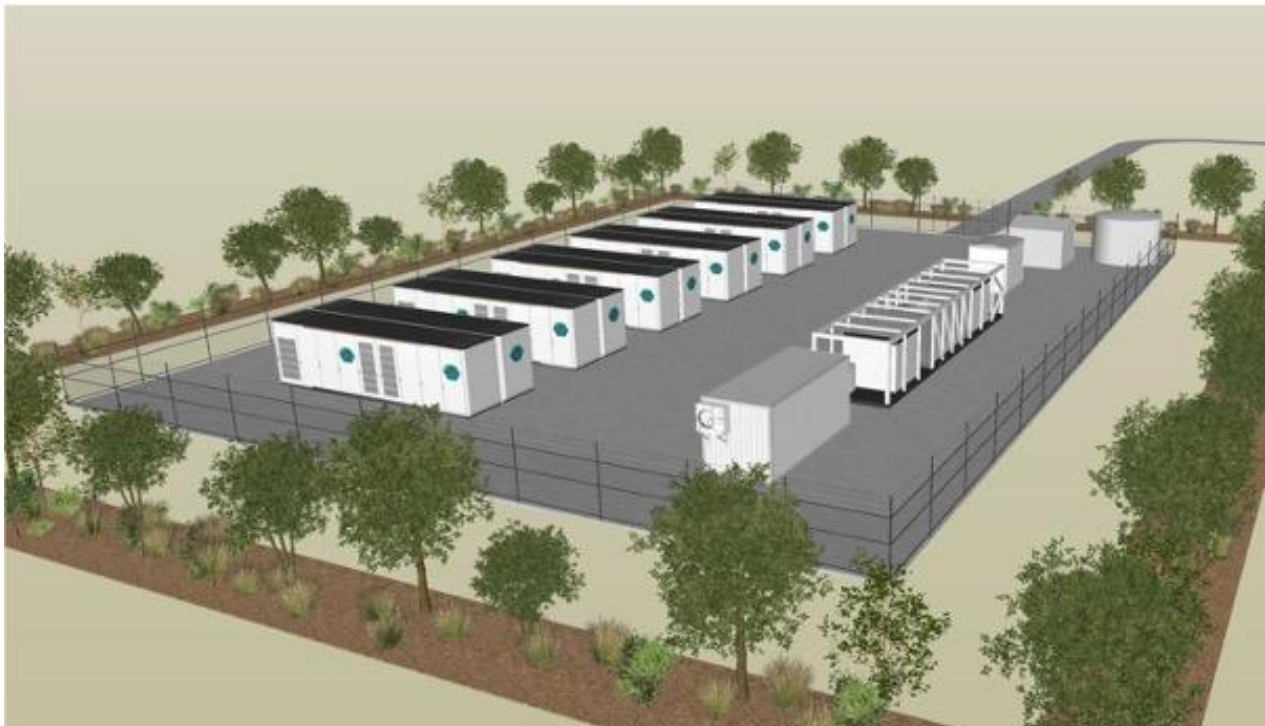
Figure 3-3: Indicative Side View 1

The site layouts are shown in **Figure 3-3** and **Figure 3-4** which includes a compound with dimensions of 33 m x 44 m resulting in an area of 1,435 m². It is bounded by a 2.4 m high fence and has a 10 m wide Asset Protection Zone (APZ).
