Fire Incident Management Plan

Site 2 (Blue Banded), 1154 Clarence Town Rd, Seaham NSW 2324

Site 2 (Blue Banded), 1154 Clarence Town Rd, Seaham NSW 2324 Hive Battery Developments Pty Ltd

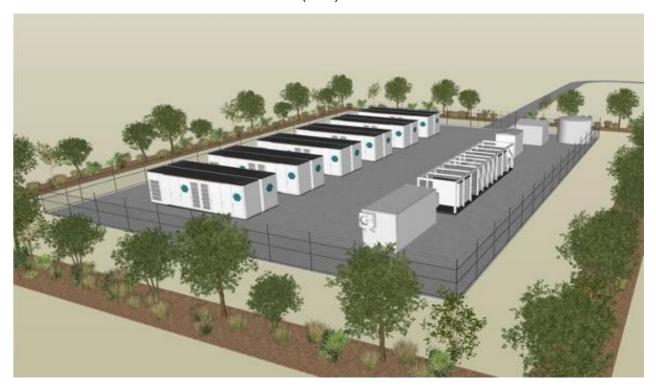
Figure 3-3: Indicative Side View 1

The site layouts are shown in **Figure 3-3** and **Figure 3-4** which includes a compound with dimensions of $33 \text{ m} \times 44 \text{ m}$ resulting in an area of $1,435 \text{ m}^2$. It is bounded by a 2.4 m high fence and has a 10 m wide Asset Protection Zone (APZ).
