Fire Incident Management Plan

Site 5 (Peacock), 1154 Clarence Town Rd, Seaham NSW 2324

Site 5 (Peacock), 1154 Clarence Town Rd, Seaham NSW 2324 Hive Battery Developments Pty Ltd

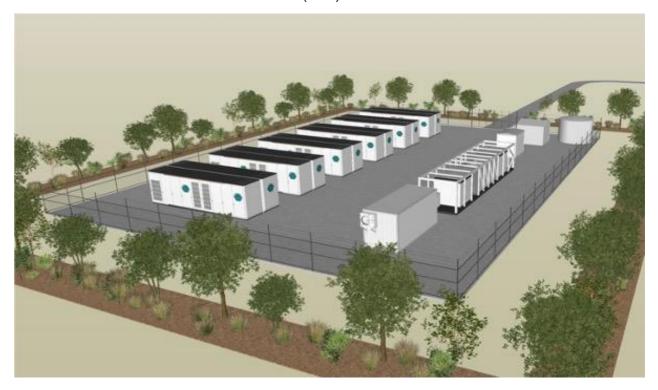
Figure 3-3: Indicative Side View 1

The site layouts are shown in **Figure 3-3** and **Figure 3-4** which includes a compound with dimensions of $33 \text{ m} \times 44 \text{ m}$ resulting in an area of $1,435 \text{ m}^2$. It is bounded by a 2.4 m high fence and has a 10 m wide Asset Protection Zone (APZ).
