Re: Repurposing Existing Quarry to Waste and Resource Management Facility, 220 Black Hill Road, Black Hill (DA 8/2023/622/1) - intersection biodiversity survey

Three Mile Hill Waste Facility
Biodiversity Assessment
Figure 1

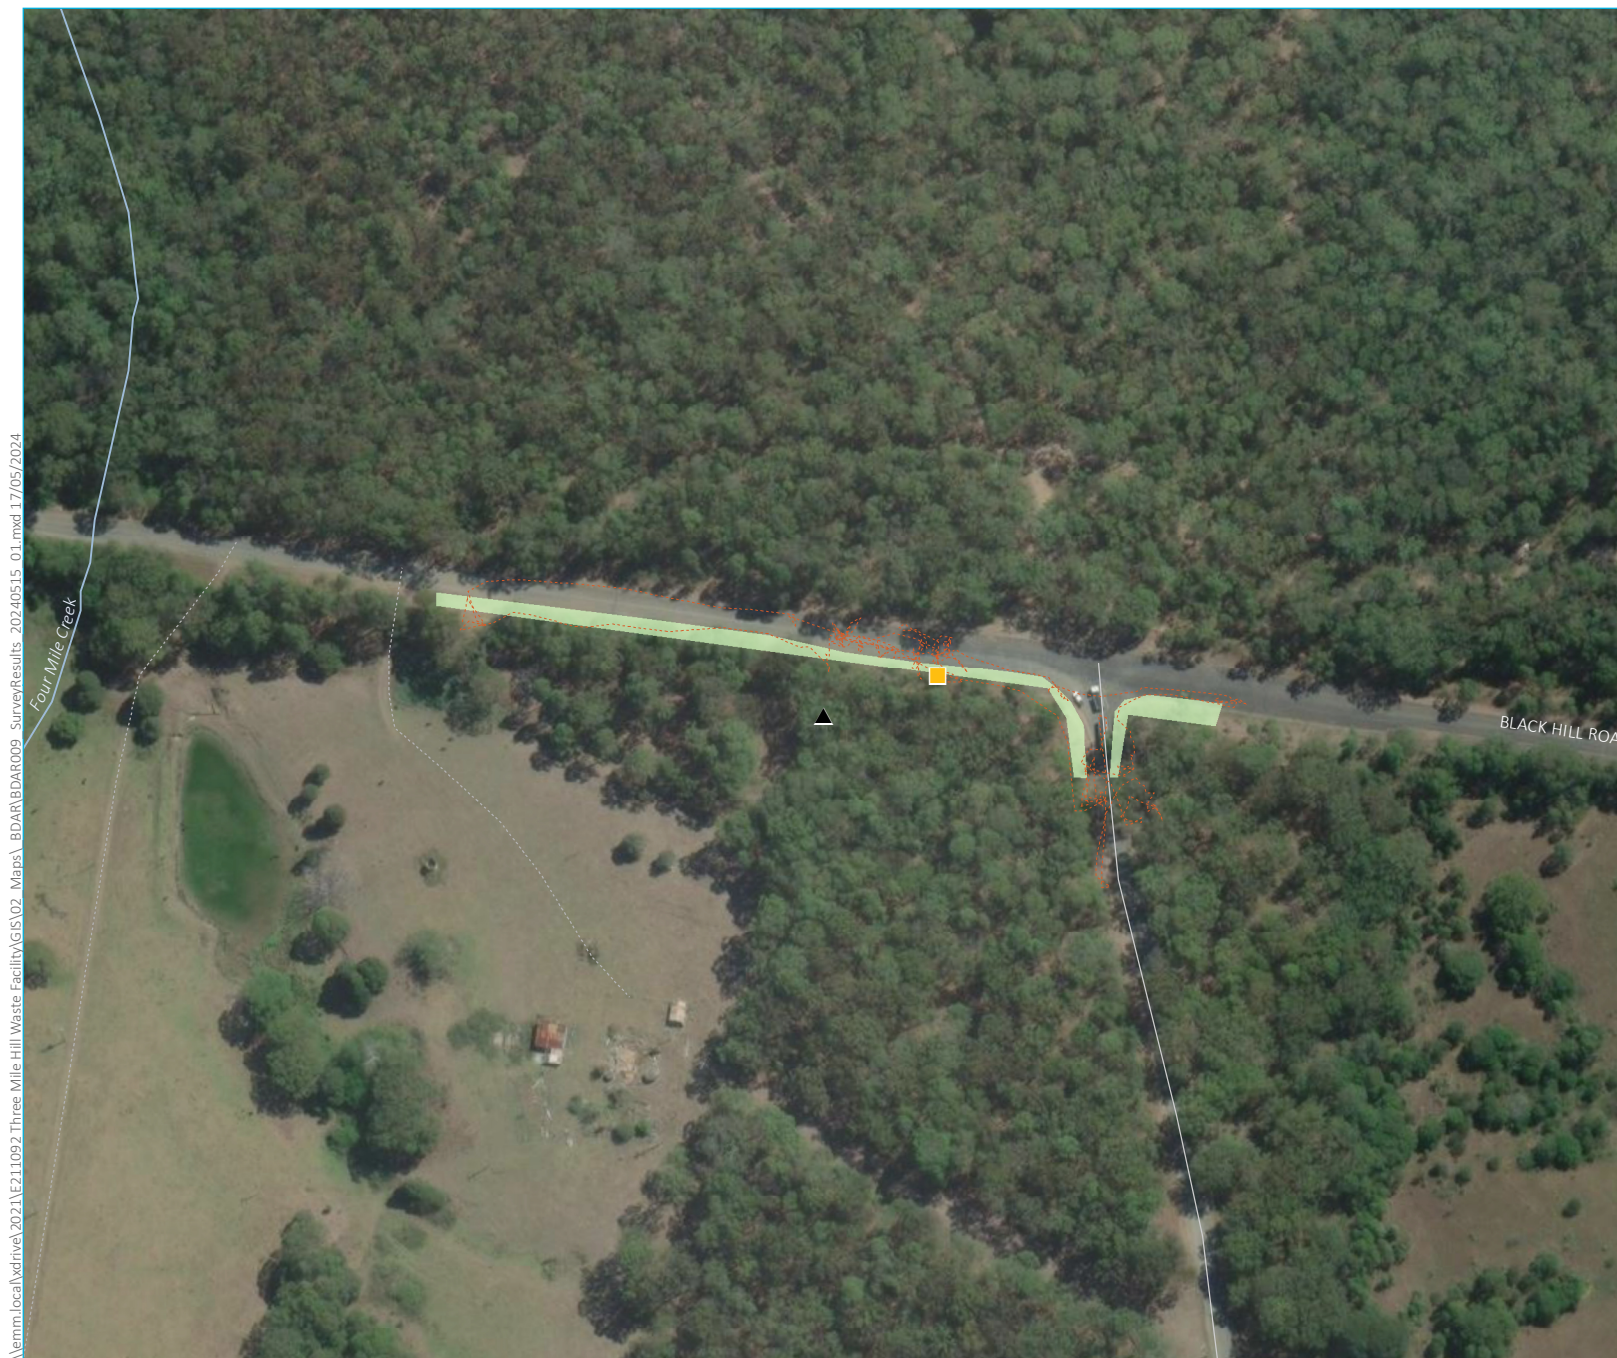
The survey included a Biodiversity Assessment Method (BAM) (DPIE 2020) vegetation integrity plot (Figure 1). This plot provided data on the vegetation composition and structure within the area, supplementing our broader observations.

During the survey, the presence of a large hollow-bearing tree, potentially suitable breeding habitat for large forest owls and cockatoos was recorded. The hollow-bearing tree is located on the south side of the road, within private property, adjacent to the BAM plot location (Figure 1 and Photograph B.3). Given the ecological significance of such trees, it is recommended that mitigation measures are implemented to avoid impacting the tree, these could include:

Biodiversity survey results

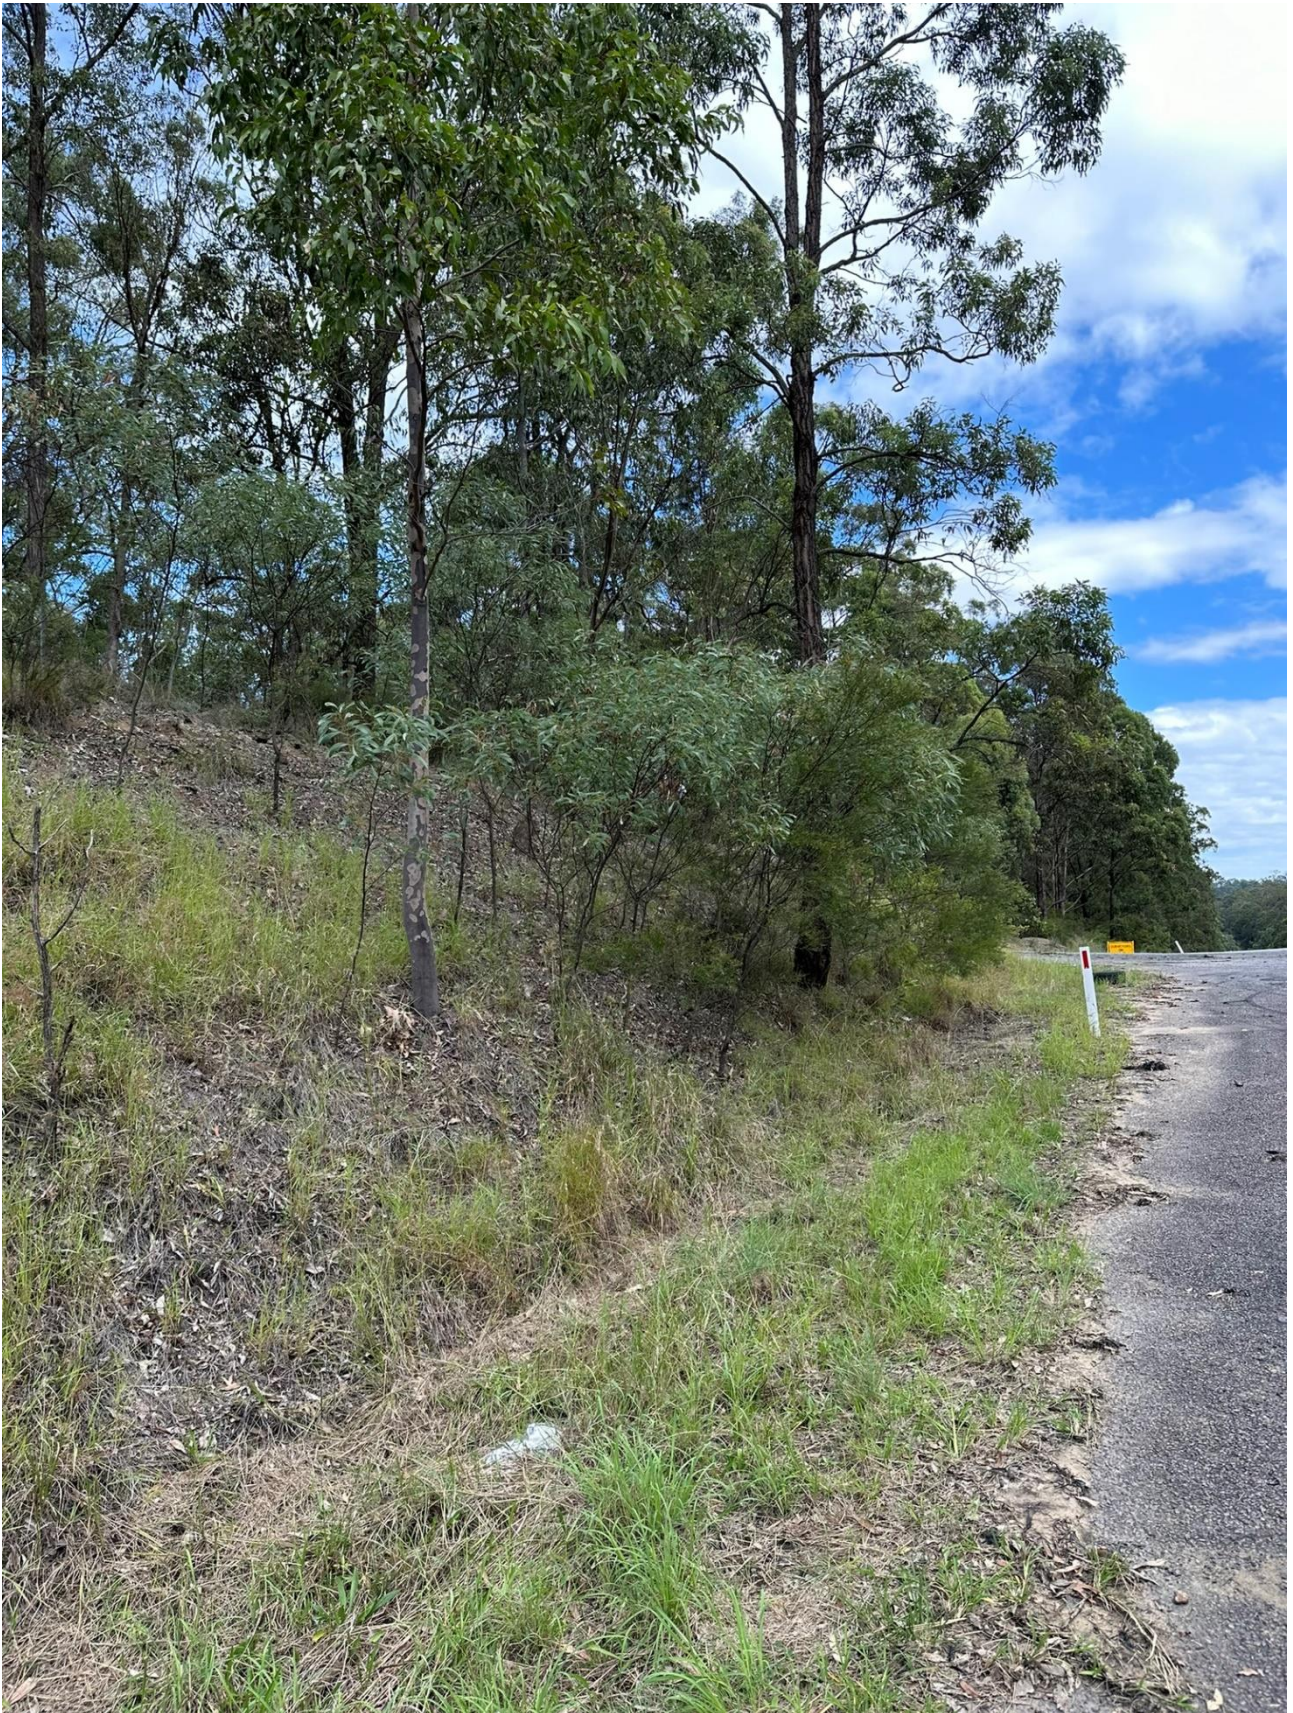
Photograph B.1

The vegetation within the road corridor consists of a maintained and mown road verge closest to the road and a native forest along the boundary of the private property fence (Appendix B). The mown road verge has a high density of exotic grasses and is approximately 2–4 metres in width. Once off the road verge, vegetation consists of native forest trees and shrubs with a moderate diversity of exotic species. This vegetation community has the potential to provide habitat to native flora and fauna in the area.

Photo taken facing west at intersection of Black Hill Quarry entrance road and Black Hill Rd

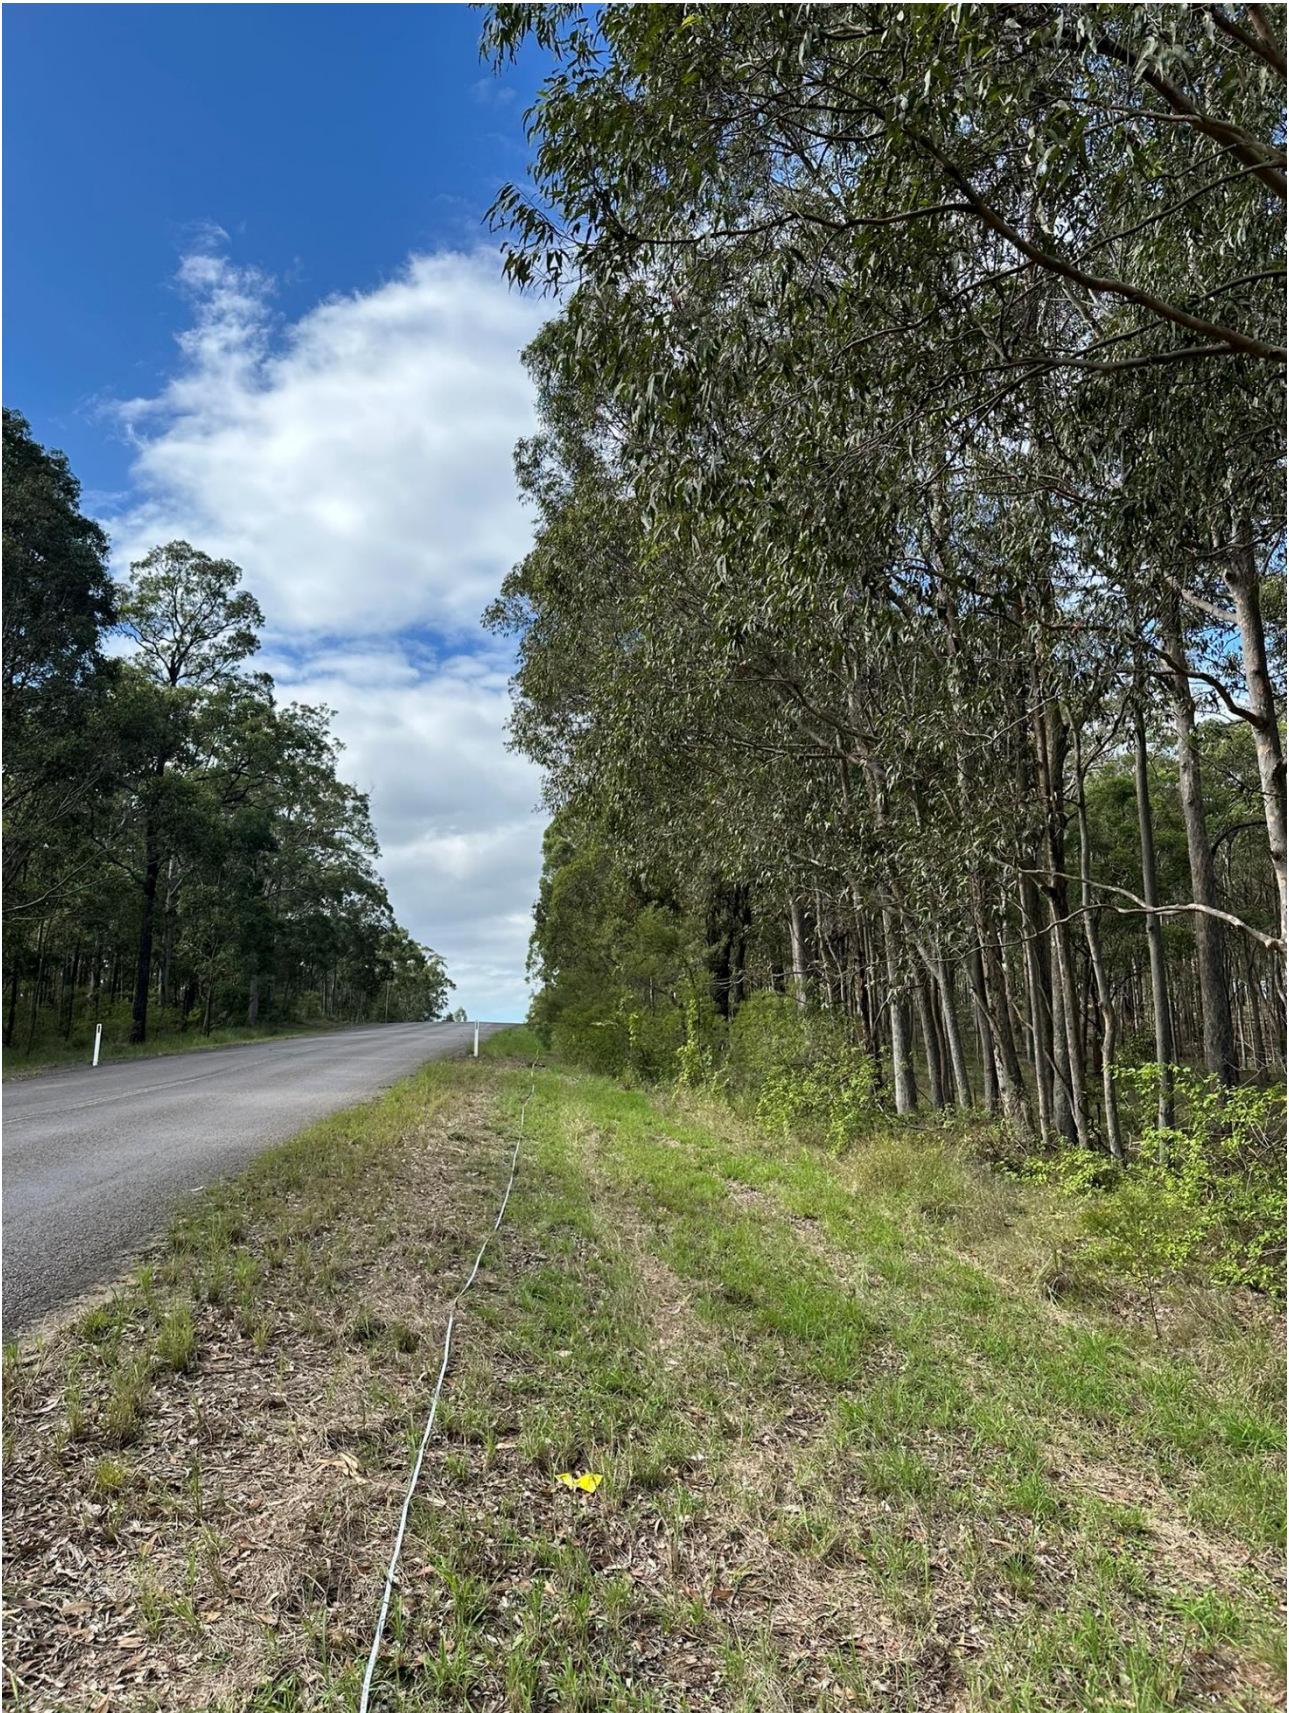
Photograph B.2

Location of BAM Plot TMH-01, facing East towards intersection of Black Hill Quarry Rd and Black Hill Rd

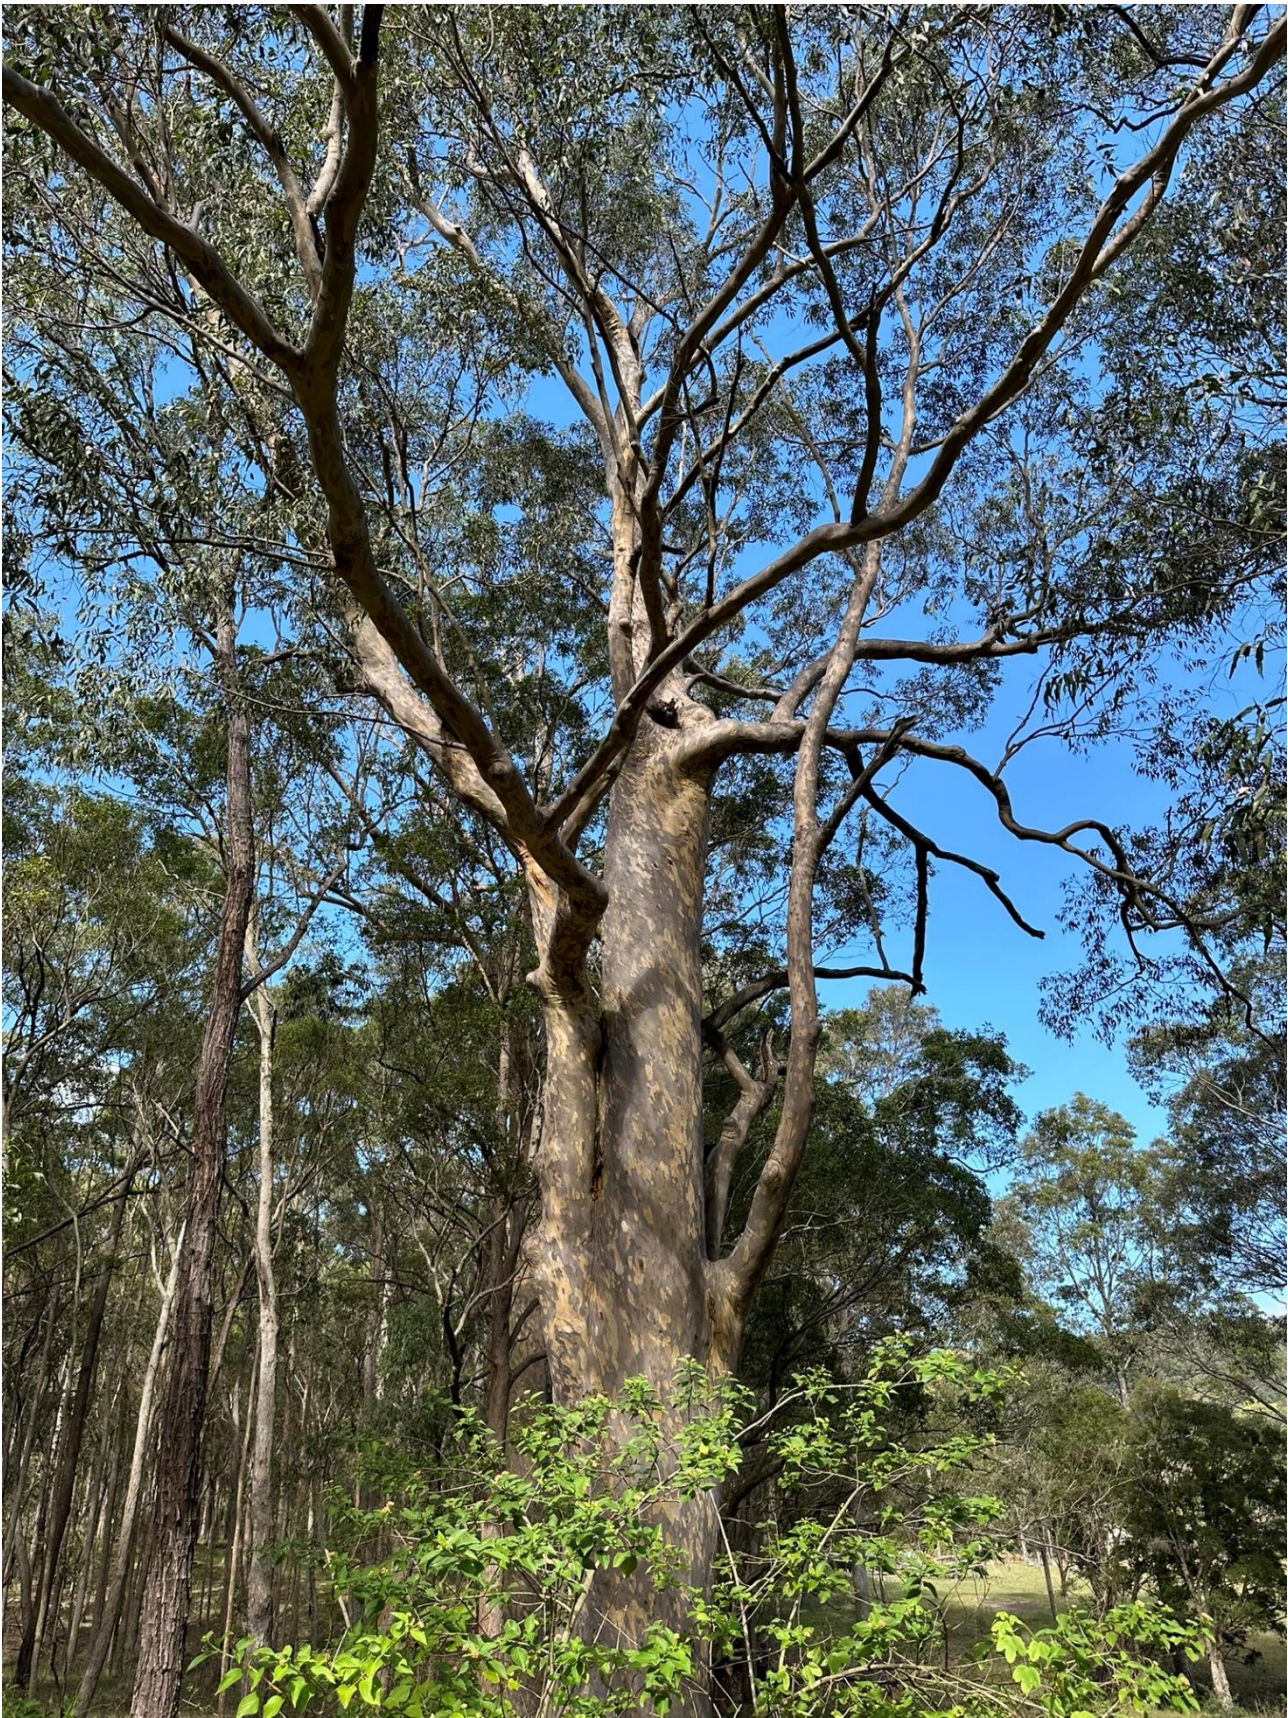
Photograph B.3

Large hollow bearing tree in adjacent property

- adjusting construction plans to maintain a buffer zone around the tree, ensuring its roots and canopy are not disturbed
- implementing temporary fencing or barriers to protect the tree during construction activities
- consulting with an arborist to assess the health and stability of the tree and to provide recommendations for its protection.
