## Fire Incident Management Plan

981 New England Hwy, Aberdeen 2336

Hive Battery Developments Pty Ltd

**Riskcon Engineering Pty Ltd**

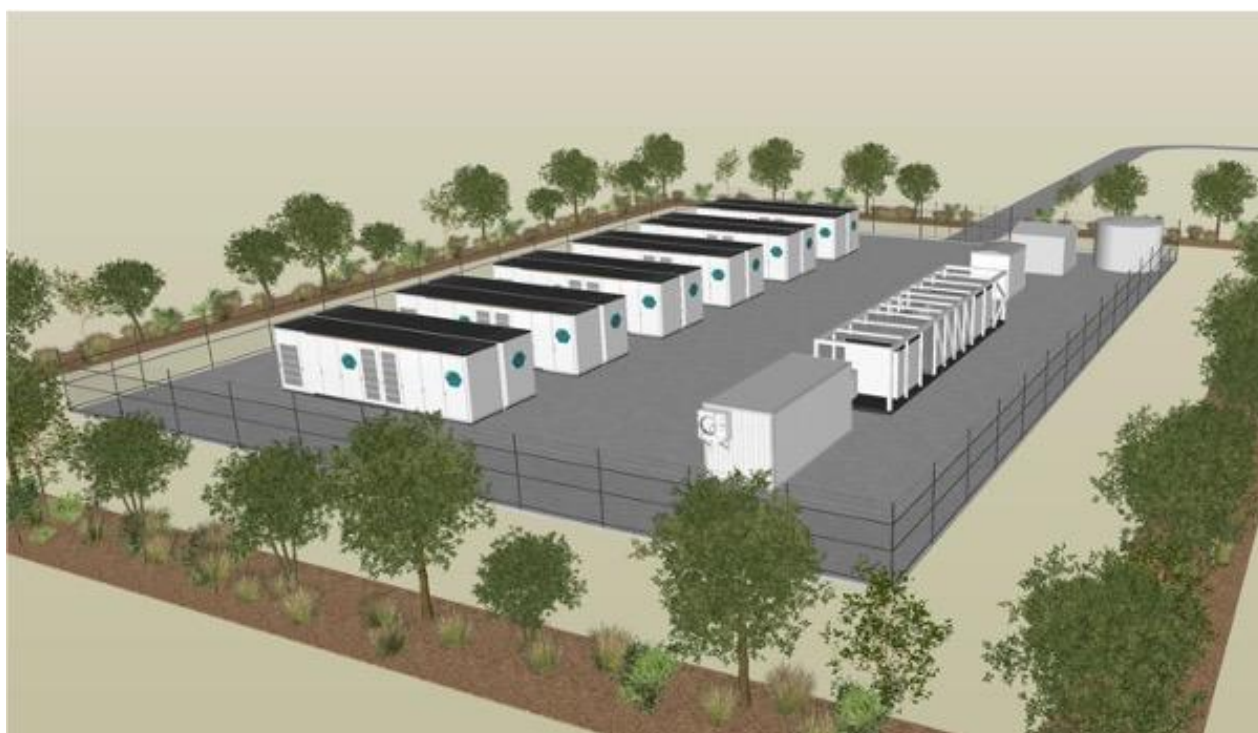
**Figure 3-3: Indicative Side View 1**

The site layouts are shown in **Figure 3-3** and **Figure 3-4** which includes a compound with dimensions of 33 m x 44 m resulting in an area of 1,435 m<sup>2</sup>. It is bounded by a 3 m high hush panel fence and has a 10 m wide Asset Protection Zone (APZ).
