# **Broadwater Public School**

## **9 Byrnes Street, Broadwater NSW 2472**

### **Acid Sulfate Soils Management Plan**

**Report reference number: 754-SYDGE319200-R07**

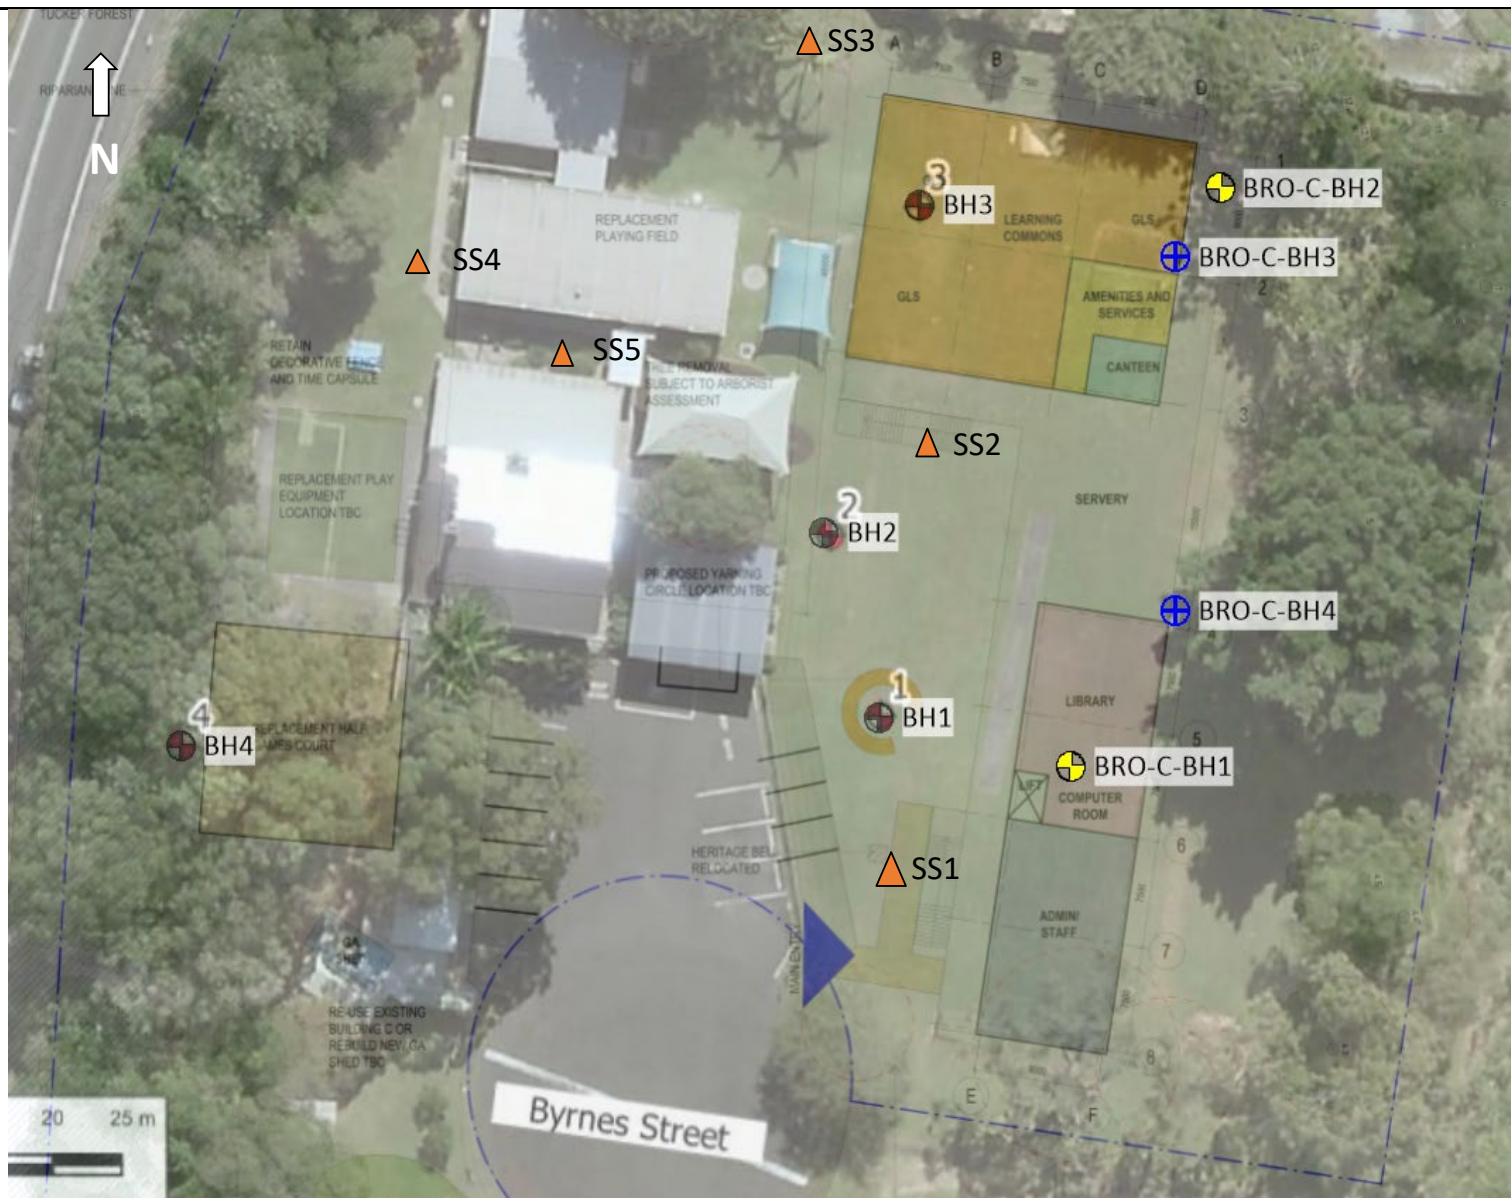
Tetra Tech Coffey Pty Ltd (Coffey) was engaged by ADCO Constructions Pty Ltd (ADCO) to prepare an Acid Sulfate Soils Management Plan (ASSMP) to inform/support a programme of refurbishments and development (referred to as the development area herein) within a portion of Broadwater Public School, 9 Byrnes Street, Broadwater NSW 2472 (the site) previously damaged by flood events in February/March 2022. The site location, development area and site boundary are illustrated in Figure 1.

The site is located along the eastern riverbank of the Richmond River. The site occupies an area of approximately 9,000m<sup>2</sup> and the development area approximately 7,530 m<sup>2</sup>. The location of the site and development area is shown in Figure 1.
