Project:  
Rodan Cutler Retirement Village  
Proposed Redevelopment  
10 Edward St. Gordon NSW 2072

SECTION 4.56

Drawing Name:  
Landscape Tree Replacement Plan

Drawing Name:  
Landscape Tree Management Plan

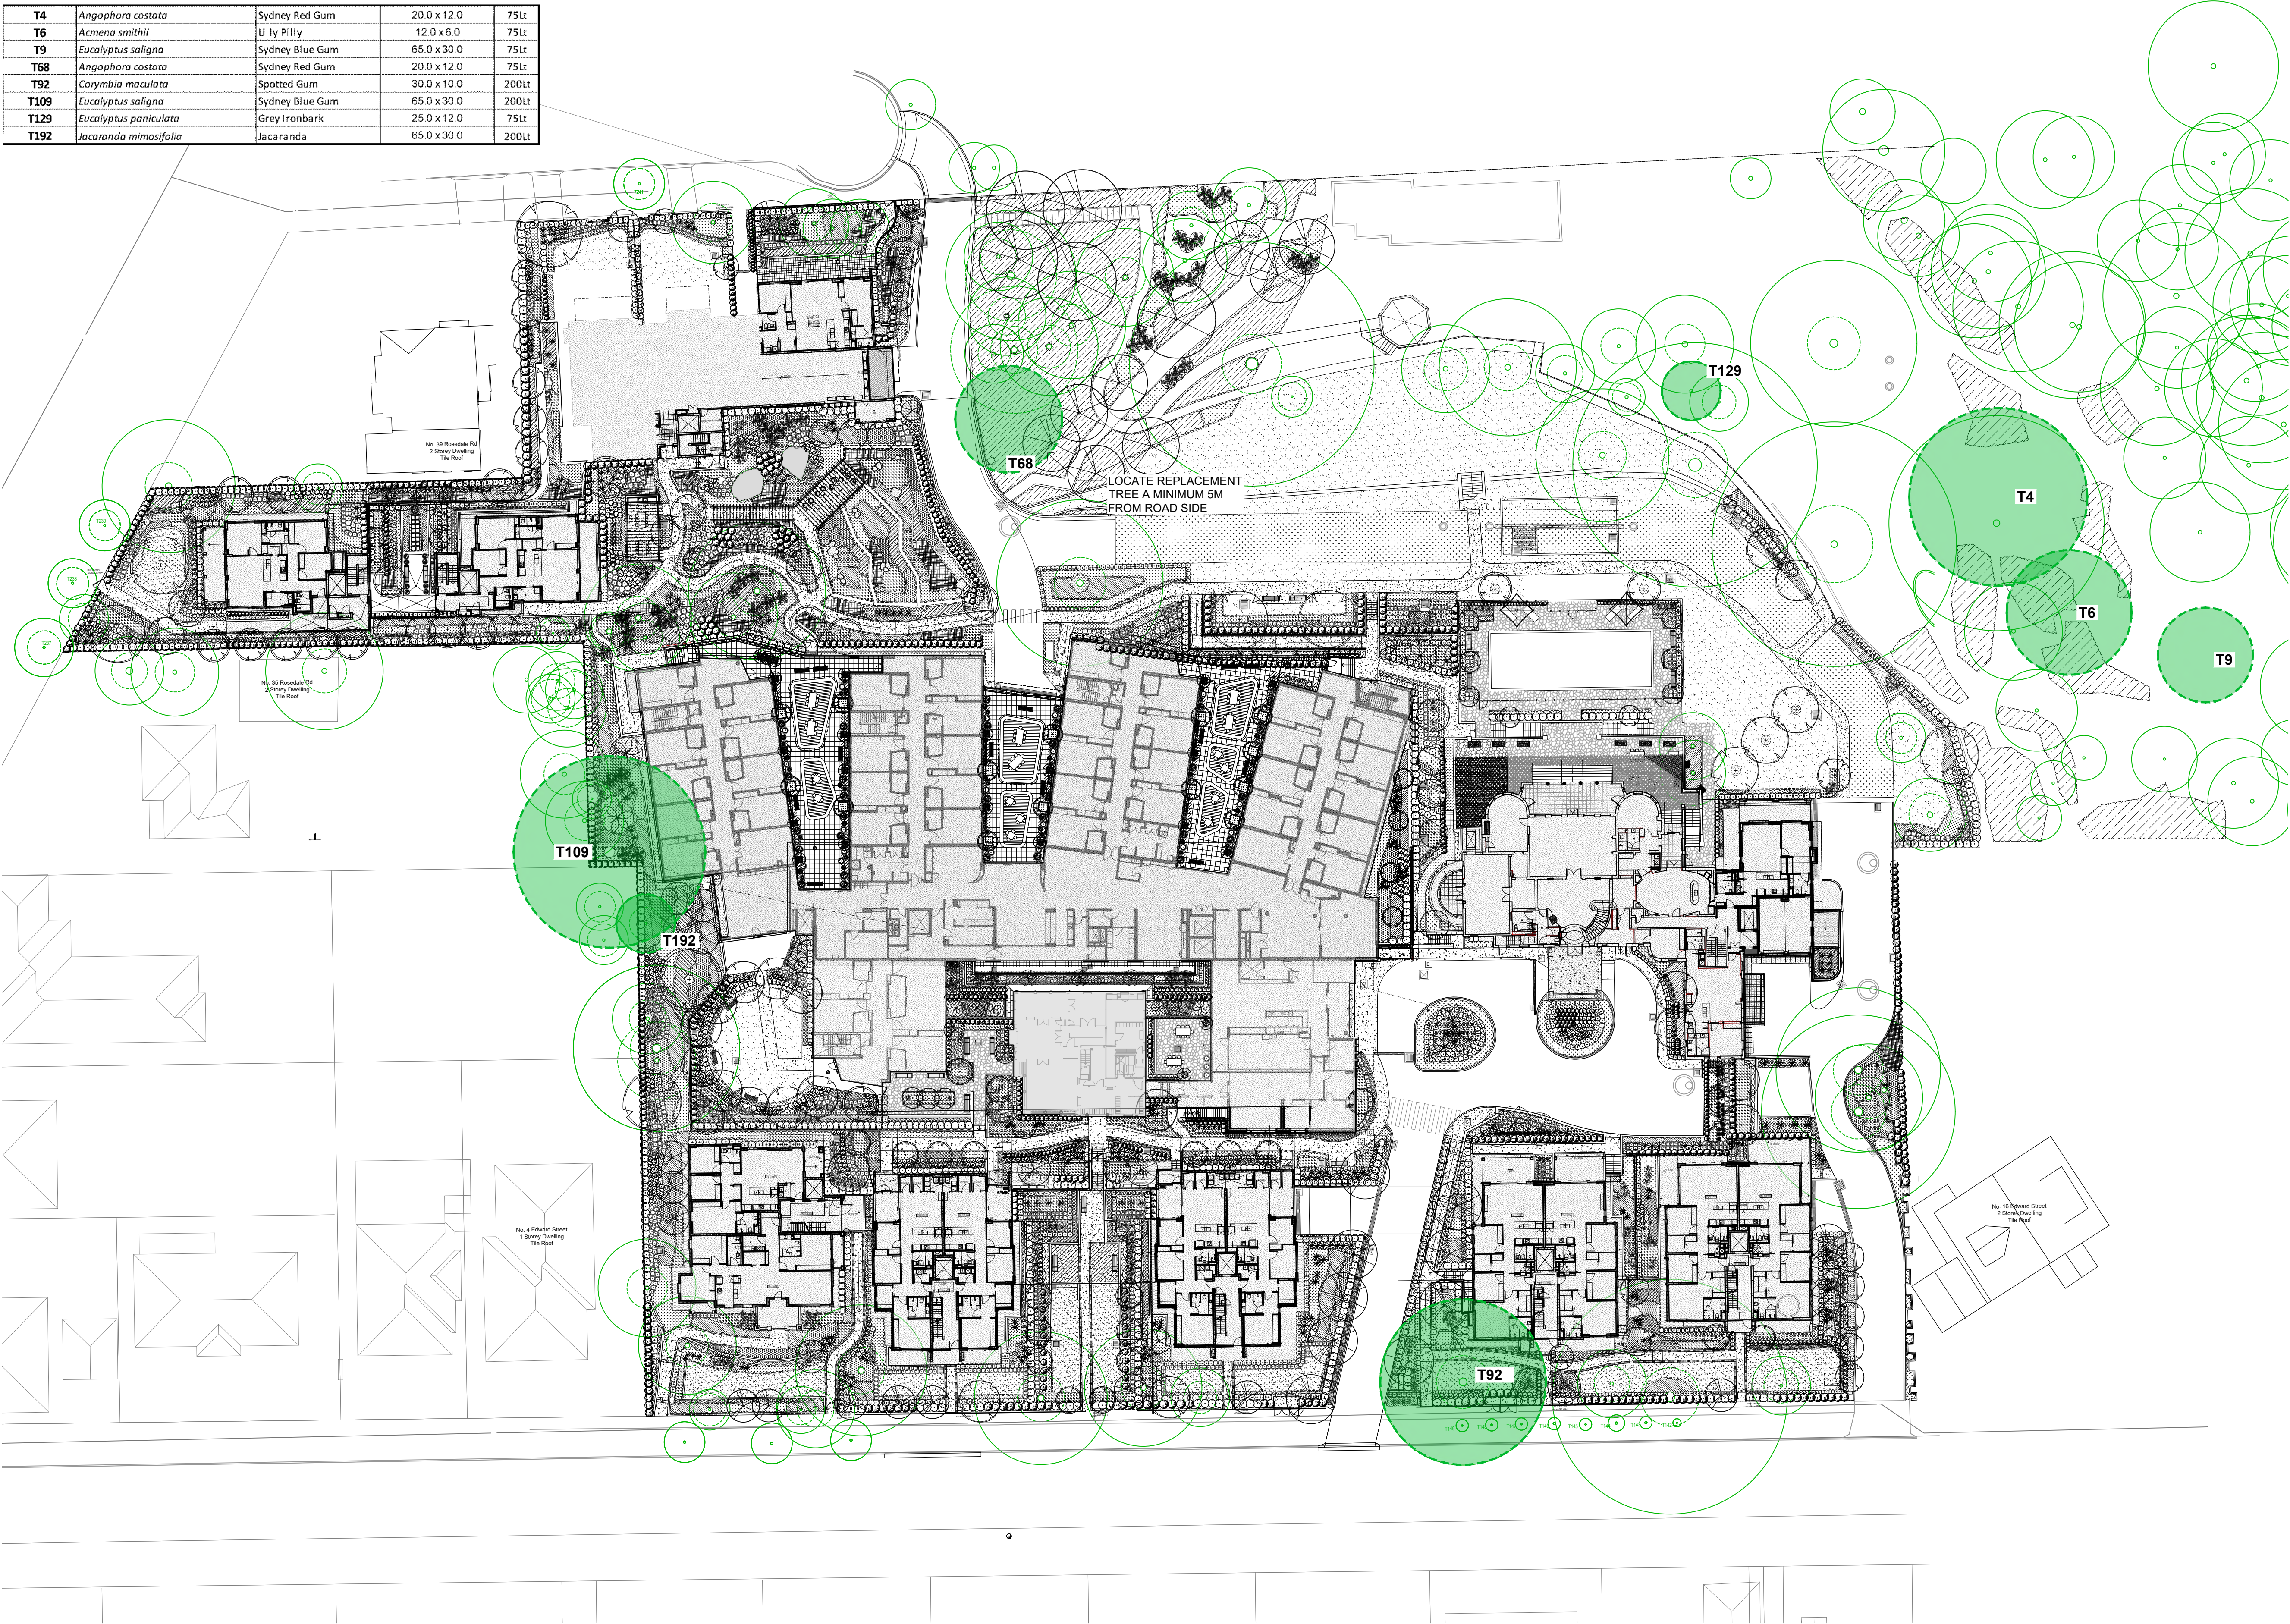
LA1-SIT-0002 B

NOTE: REPLACEMENT TREES ARE PROPOSED TO BE PLANTED IN THE SAME LOCATION AS TREES TO BE REMOVED UNLESS OTHERWISE SPECIFIED

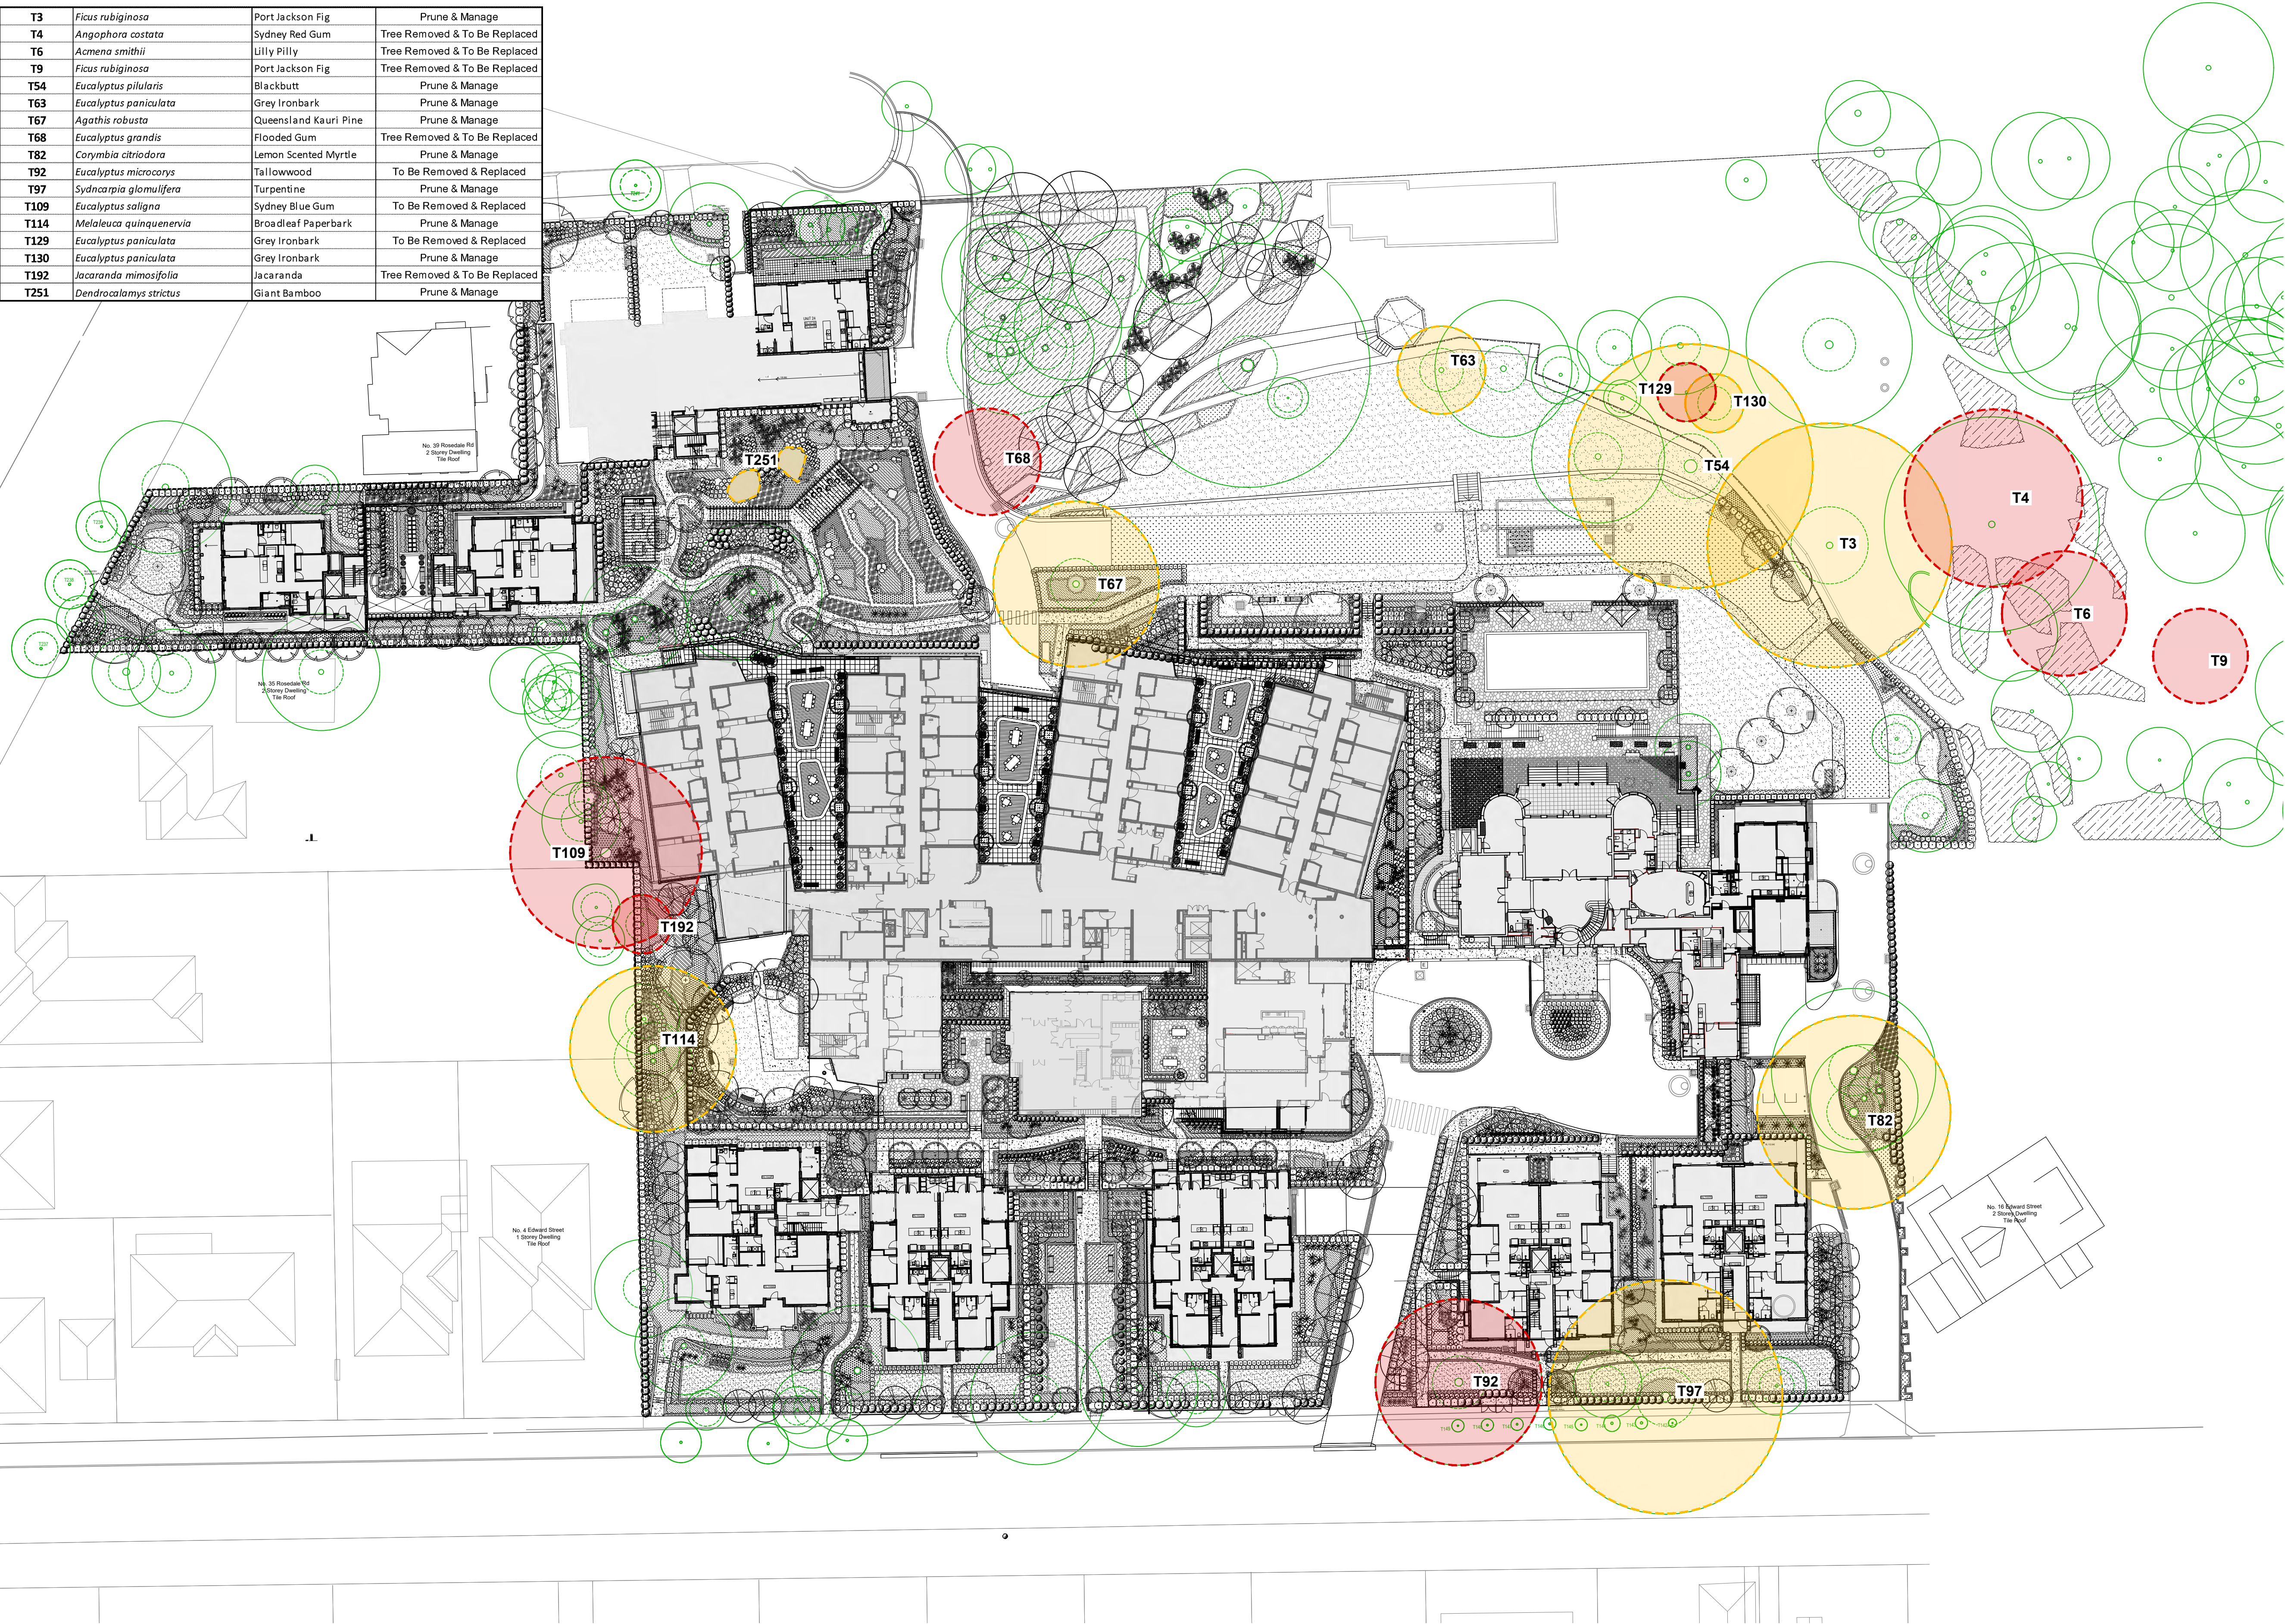
Site Image Job Number:  
SS18-3820  
LA1-SIT-0001 B

- Tree to be removed or has been removed (Refer arborist report)
- Tree to be managed (Refer arborist report)
