## Appendix 3 Revised Acid Sulfate Soils Management Plan

### 1.0 Introduction

An Acid Sulfate Soils Management Plan (ASSMP) is required to accompany a development application for the Batemans Bay Regional Aquatic, Arts and Leisure Centre (the development). This ASSMP has been prepared in accordance with the NSW Acid Sulfate Soils Manual 1998.

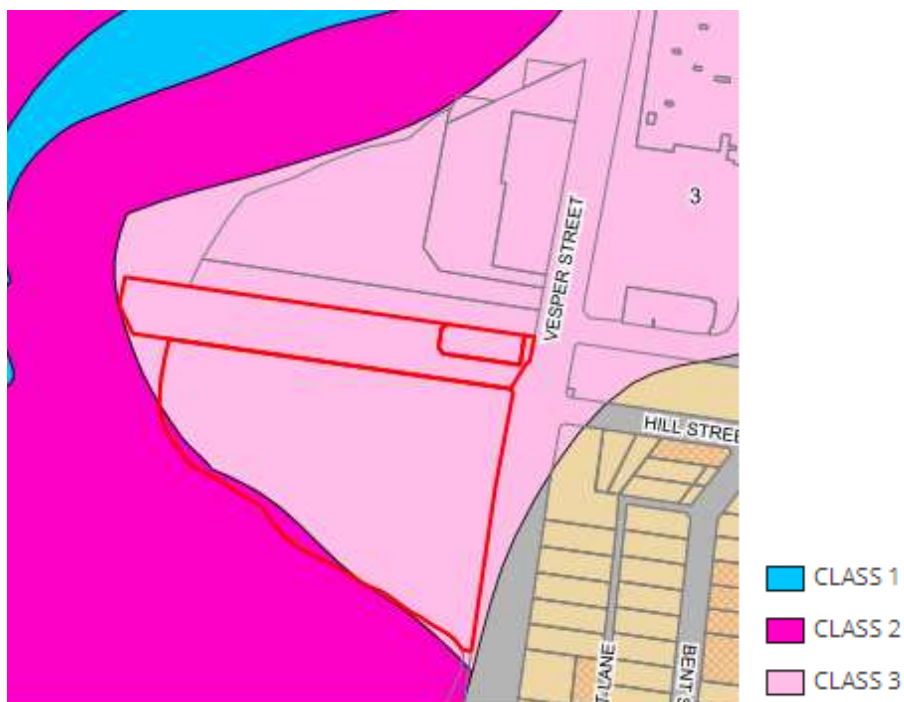
The subject land is predominantly mapped as having class 3 acid sulfate soils. A narrow strip of land is mapped as having class 2 acid sulfate soils, as shown in the map below.
