## **GROUNDWATER IMPACT ASSESSMENT**

**Part Lot 4 in DP834254  
510 Beach Road Berry**

**Rep.No. 17134-B**

**8<sup>th</sup> March 2018**

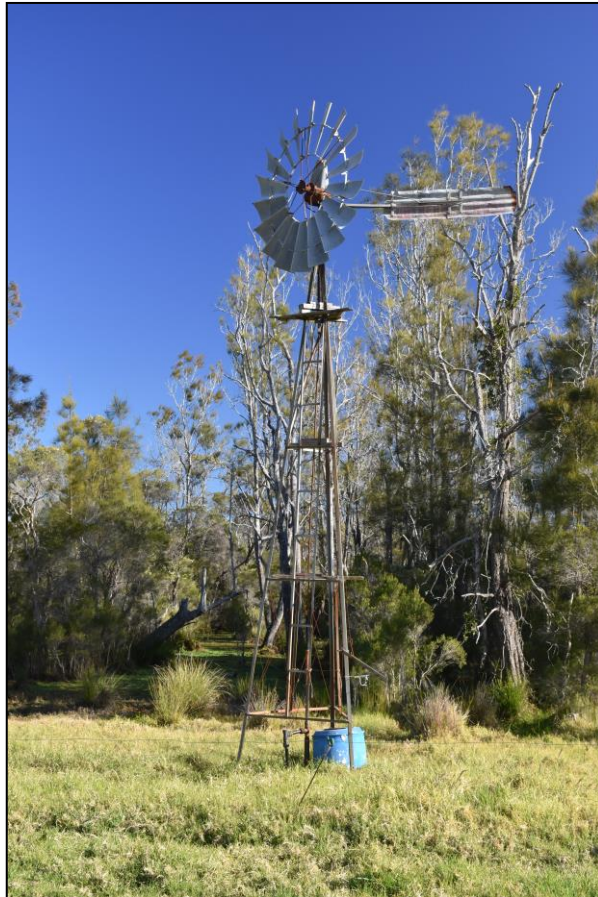
**Plate 1 Windmill**

The Site is a mostly cleared and partly developed parcel of land. A *Google Earth* image over the Site showing existing conditions is presented in **Figure 1**. Fenced paddocks cover the northern 60% of the Site. Three small farm dams are located in the northern part, two of these on the north-eastern fall and the third in the north-western corner. A wind mill is located on the northern edge of Coomonderry Swamp in the southern part of the Site (see **Plate 1**).

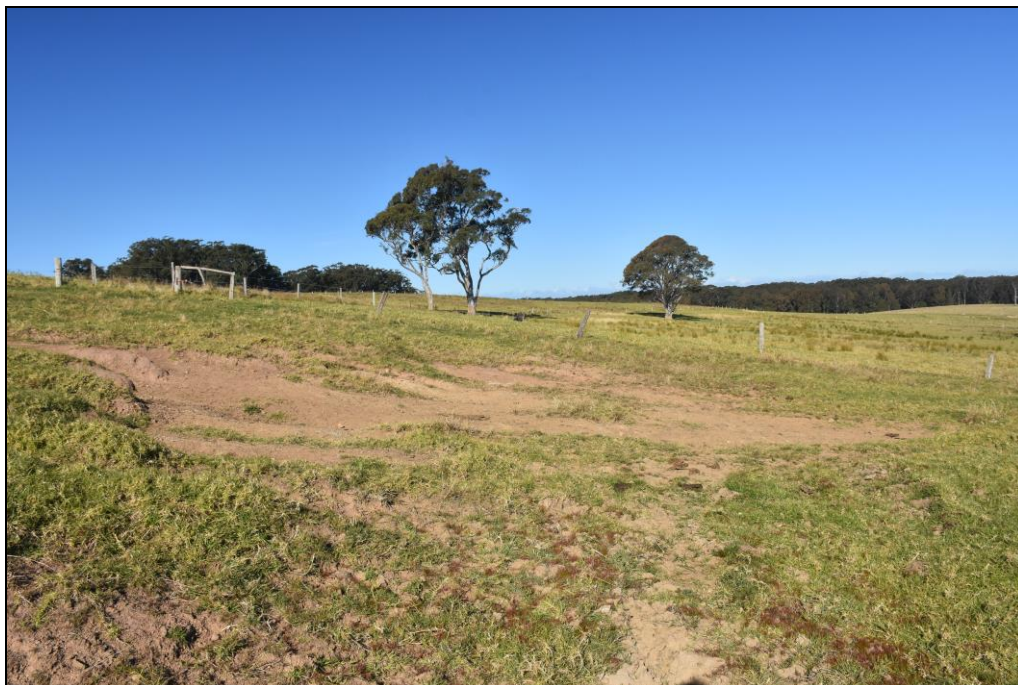
**Plate 2 Spring – Southern Side of Divide**

1. An area of 'dry' exposed, disturbed soil located on the southern elevated side of the central ridge system at about 22 m RL (**see Plate 2**). The spring is located within a 30 m-wide corridor regularly travelled by dairy cows. There was no evidence of any groundwater seeps at the time of the site inspection.

In order to achieve an overall lower potential hazard the nominal buffer setback distance between a known spring on the Site and any proposed application of secondary treated wastewater (effluent management) should be no less than:

- 15 m sideslope
- 30 m upslope
- 50 m downslope

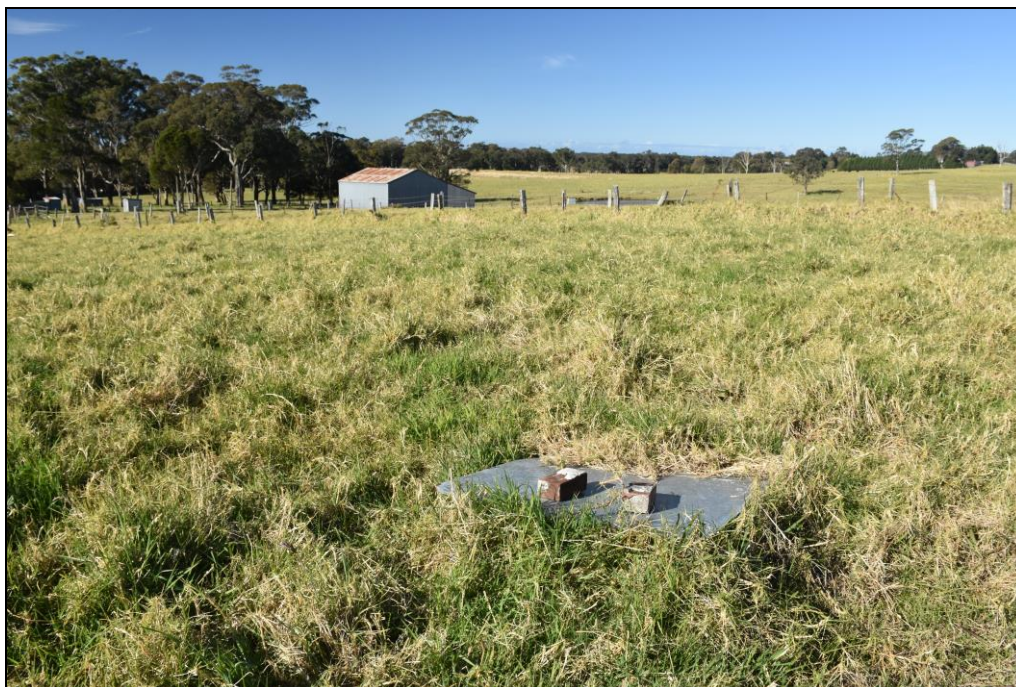
**Plate 3 Spring – Northern Side of Divide North-Western Part of Site**

2. A grassed covered area in a fenced paddock on the northern side of the central ridge south of the dwelling in the north-western part of the Site. The elevation of the spring is approximately 22 m RL (**see Plate 3**). A relatively small covered concrete tank has been historically buried in this location to presumably intercept and detain some of the shallow groundwater discharging at this point.

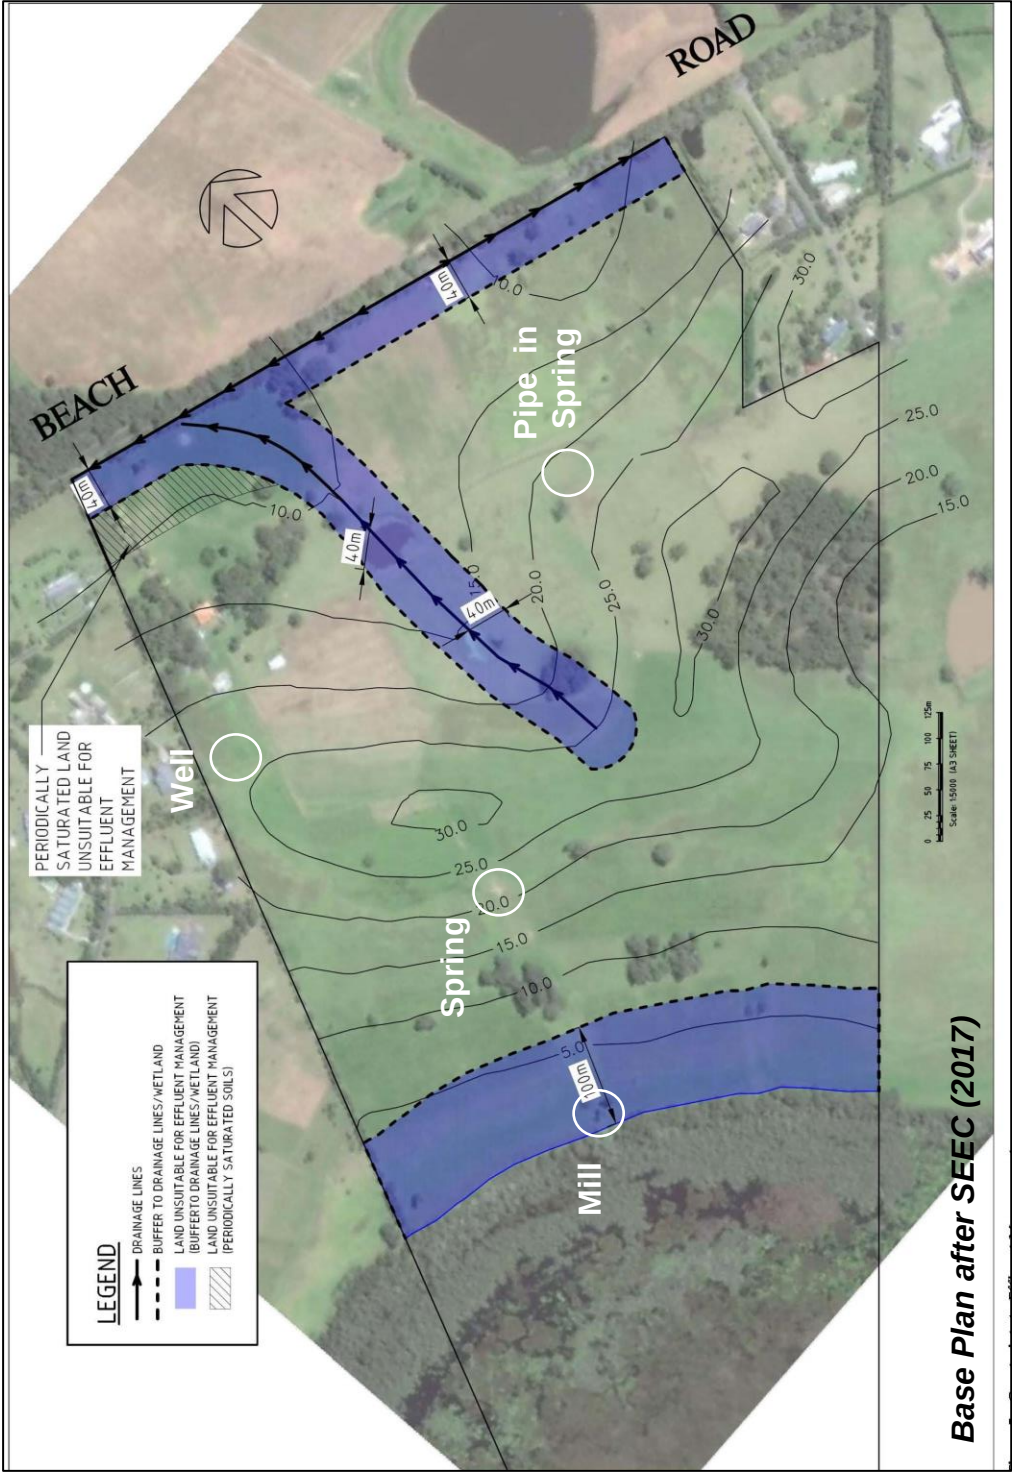
| Hydrogeological Assessment | | Scale: As shown | FIGURE 3 |

The Site is located within undulating low coastal hills and coastal wetlands. The Site is separated into two watersheds by a low-lying northwest-southeast trending ridge system that dissects the central northern part of the Site (**Figure 3**). Although no defined drainages occur on the Site, Coomonderry Swamp covers the southern 30 %. Overland flow north of the divide drains to Beach Road and south of the divide to Coomonderry Swamp. The elevation of the Site ranges from close to sea level at Coomonderry Swamp to about 30.0 m in the central part atop the divide.

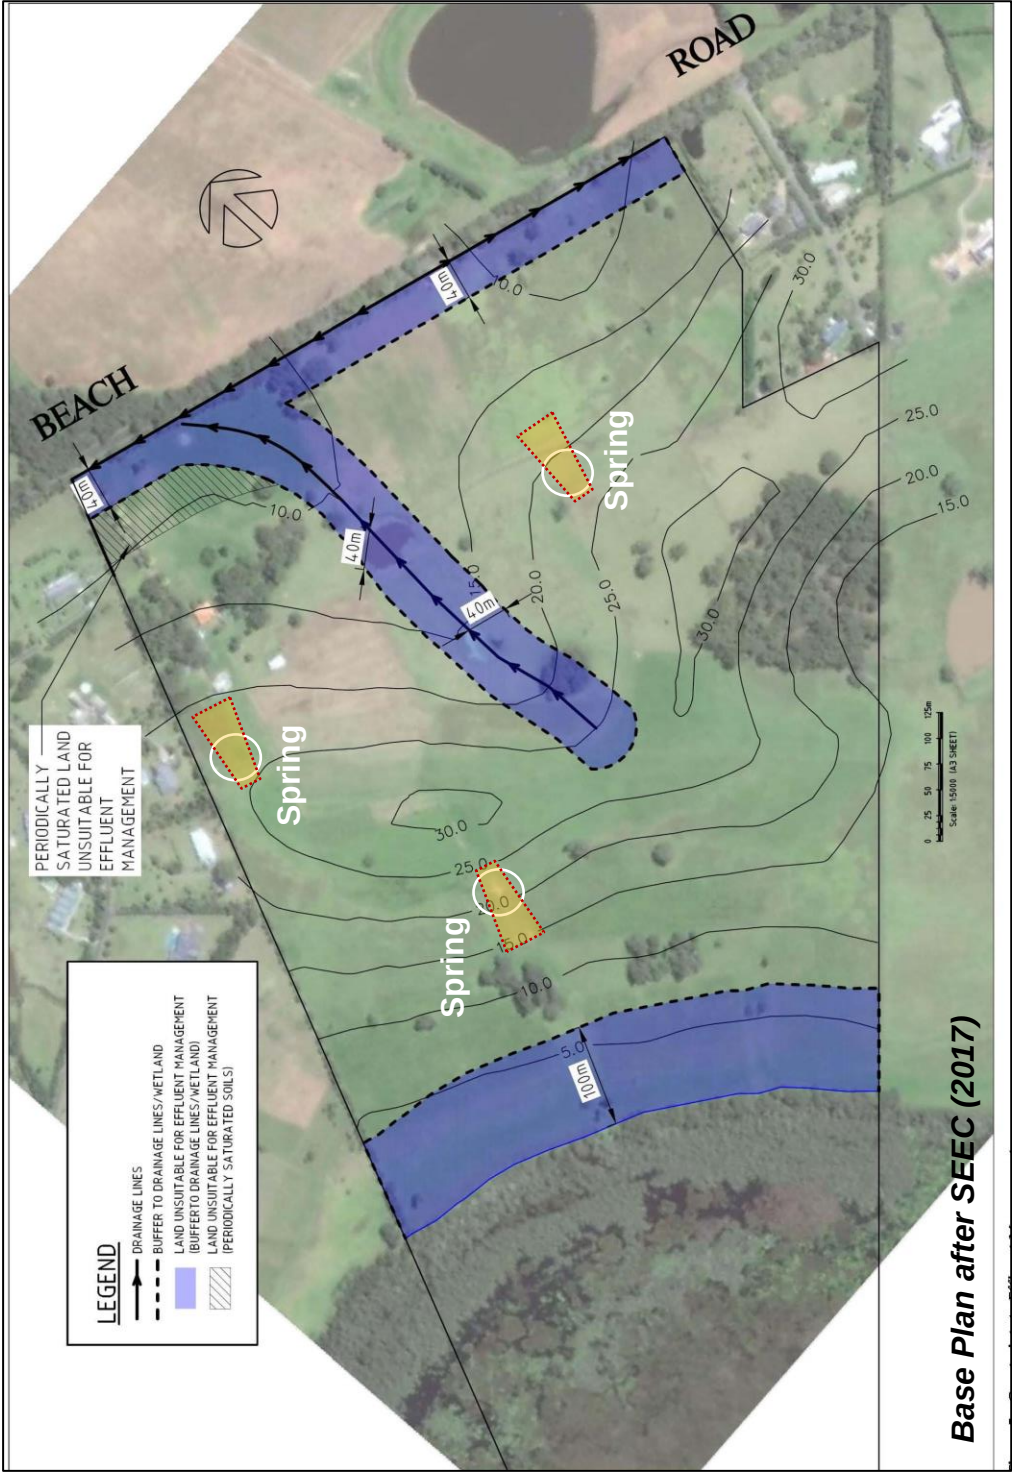
| | Lot 4 in DP834254<br>510 Beach Road Berry<br>Areas Unsuitable for Effluent Disposal | | | |

The reported existence of springs in the more elevated part of the Site indicates the presence of 'shallow' groundwater which is often collectively referred to as 'water features' or 'springs'. Three discharge sites were identified by the owner and inspected in September 2017. The locations of the known springs are shown in **Figure 4**:

The downslope setback is also nominated to prevent any spring flow migrating downslope and impacting the LAA. The areas surrounding the known springs not considered suitable for application of treated wastewater are annotated in **Figure 4**.

Land Considered Unsuitable for Effluent Management (known springs)
