# **Soil and Water Assessment**

# Extension of Friable Granite Quarry; Lot 5 DP 255133 Federal Highway, Wollogorang

Prepared for Divall's Earthmoving and Bulk Storage

Revision B 26 July 2021

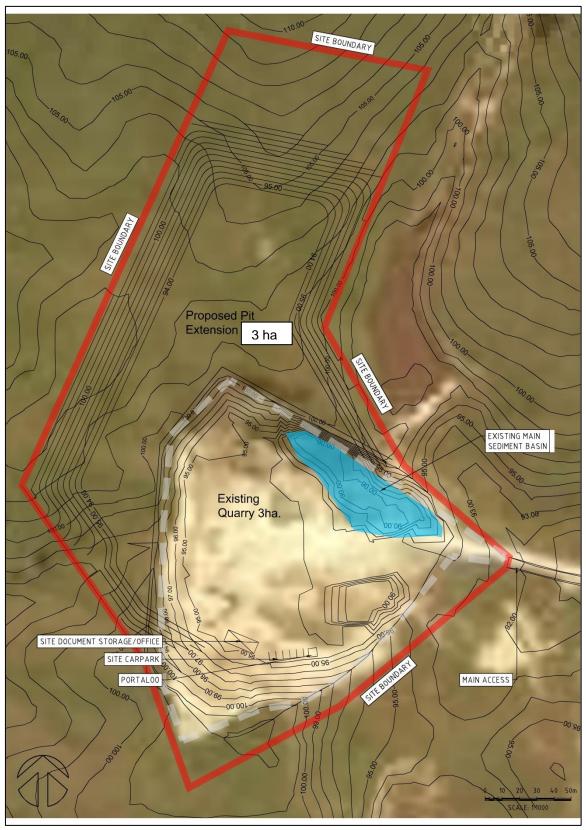
Figure 1 – Site features. Underlying image from Six Maps.

The quarry consists of a number of features, which are shown in **Figure 1** and described in detail in **Table 1**.

Feature	Description
Quarry Area	The quarry extraction area including Main Sediment Basin and Haul Road to the Processing Area
Processing Area	Includes mobile screening equipment that can be progressively moved as required with the staging on the extraction process.
Parking area	Relatively level carpark adjacent to the main access within the quarry area (unsealed)
Amenities	Portaloo toilet with wash basin.
Product Stockpile and Loading area.	Relatively level product stockpile storage and loading area. Also shipping container used for document storage
Main Site Access	Site access driveway to and from the Federal Highway. Unsealed.

The mobile Processing Area, Site Office/Storage container, Parking Area and portaloo are all sited within the base of the excavated quarry area as shown in **Figure 1**.

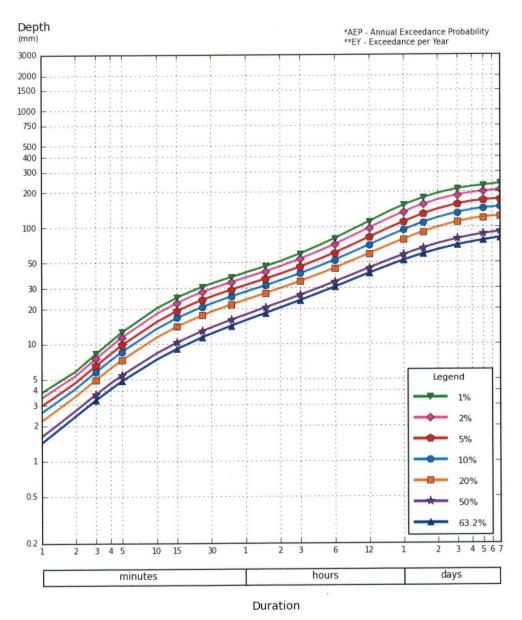
Figure 3 - - 2016 IFD Chart for the Project Site (From BoM)

The IFD chart and table for both the 2016 data sets as derived from the Bureau of Meteorology are given in **Figure 2** and **Figure 3** below.

## IFD Design Rainfall Depth (mm)

Rainfall depth for Durations, Exceedance per Year (EY), and Annual Exceedance Probabilities (AEP).

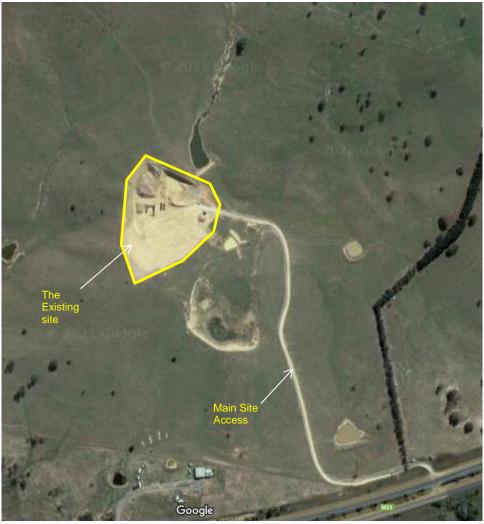
Figure 4 - Local setting. Reproduced from Google Maps, accessed December 2020.

As shown in **Figure 4**, the site is located within existing grazing land with no major vegetation located within the extent of the proposed quarry extension.

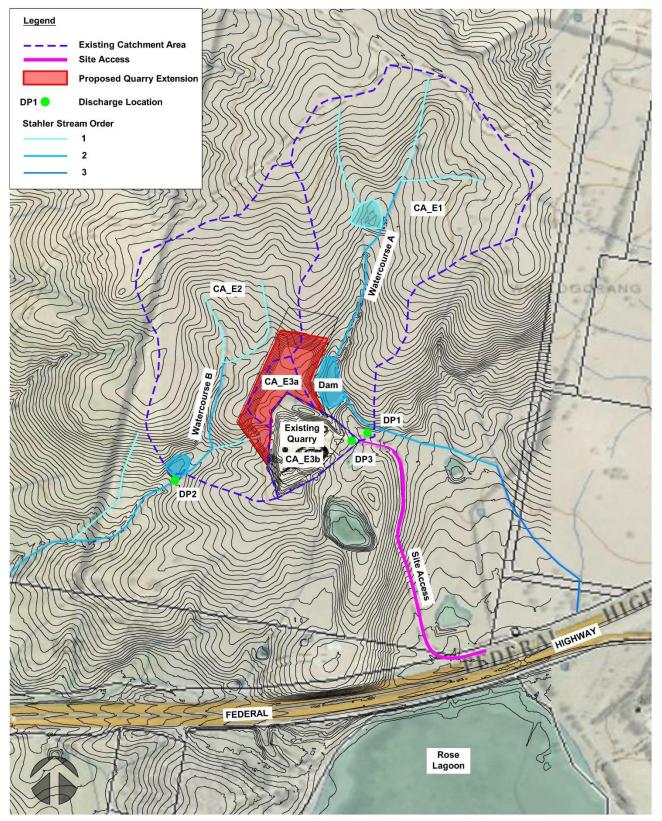
Figure 5 - Existing Site Catchments and Drainage

The site lies on a ridgeline between a first and second order intermittent watercourse located to the east and west of the site as shown in Figure 5. The eastern water course (Watercourse A) drains to Rose Lagoon to the south and from there into Willow Tree Creek and then Collector Creek to the West and ultimately to Lake George located to the south. The western watercourse (Watercourse B) drains directly to Willow Tree Creek.

There is no perimeter bunding located around the top of the existing quarry excavation and therefore there is some minor external catchment run-off contributing to flows within the existing quarry area. The mobile processing area is located within the quarry area and does not require water for its operation. Therefore no additional surface water management is required for the processing of quarry material.

Peak flows from each existing catchment shown in **Figure 5** and at the locations noted as DP1, DP2 and DP3 have been estimated. The predicted peak flows for the various existing sub-catchments as estimated using the Rational Method are shown in **Table 5**.

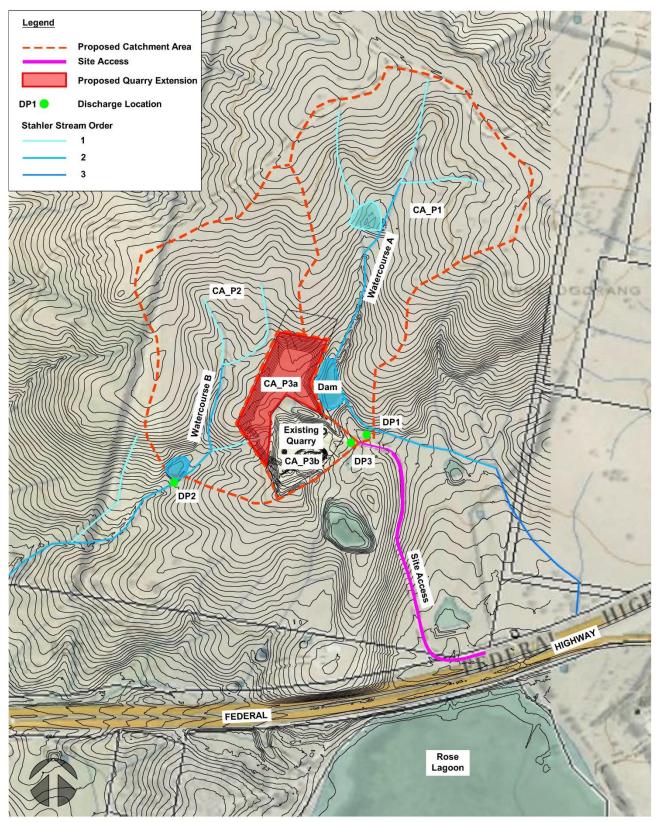
Figure 6 - Proposed Site Catchments and Drainage

Peak flows from each developed catchment shown in **Figure 6** and at the locations noted as DP1, DP2 and DP3 have been estimated. The predicted peak flows for the various existing sub-catchments as estimated using the Rational Method are shown in **Table 5**.

With the exception of rehabilitated, previously-backfilled areas, all these surfaces would be potential sources of sediment-laden runoff and so would be directed to and captured within the Main Sediment Basin in the base of the extraction area.

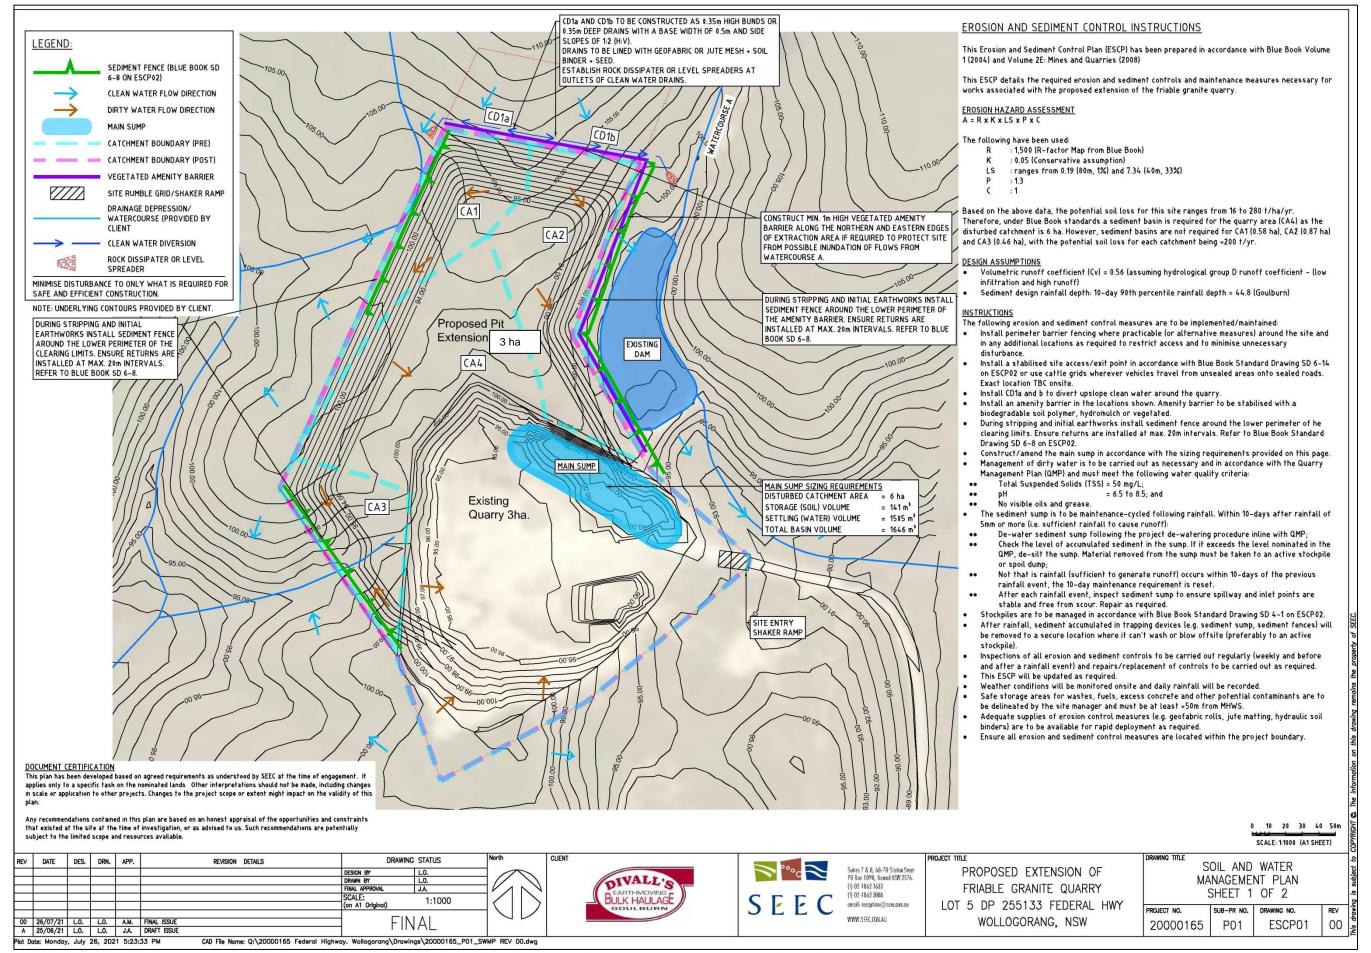
Figure 10 - Location of recommended water management and erosion and sediment control structures

Figure 10 shows the locations for all recommended soil and water management structures.

The Main Sediment Basin is shown in **Figure 10**, and is to be constructed within the base of the quarry floor as required. As noted in **Figure 10**, the Main Sediment Basin requires a minimum capacity of 1,632 m<sup>3</sup> as calculated in **Section 3.5.1**. The Main Sediment Basin is

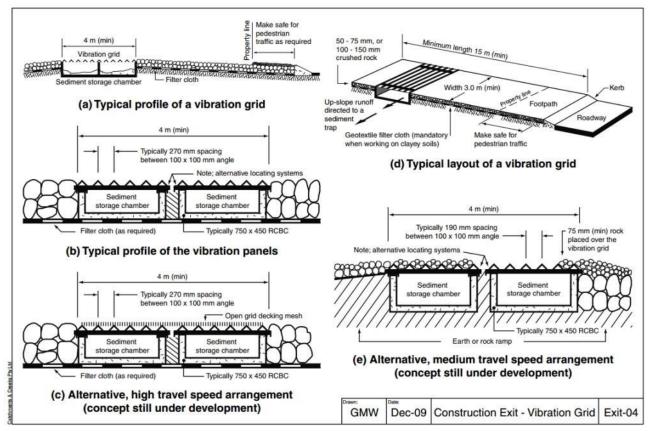
Figure 11 - Rumble grid details (by Catchments and Creeks Pty Ltd, reproduced from IECA, 2008).

There is a low risk of sediments being tracked from the site onto The Federal Highway where they could cause environmental problems (when washed into local waterways). Further, sediments on The Federal Highway could cause safety issues for road users. Rumble grids are in place at the driveway egress point and these will need to be regularly inspected and maintained. In addition, a regime of inspection should be enacted as well as a requirement to undertake street sweeping if sediment tracking becomes problematic. Access from the grid to the Federal Highway is and will be bitumen sealed.

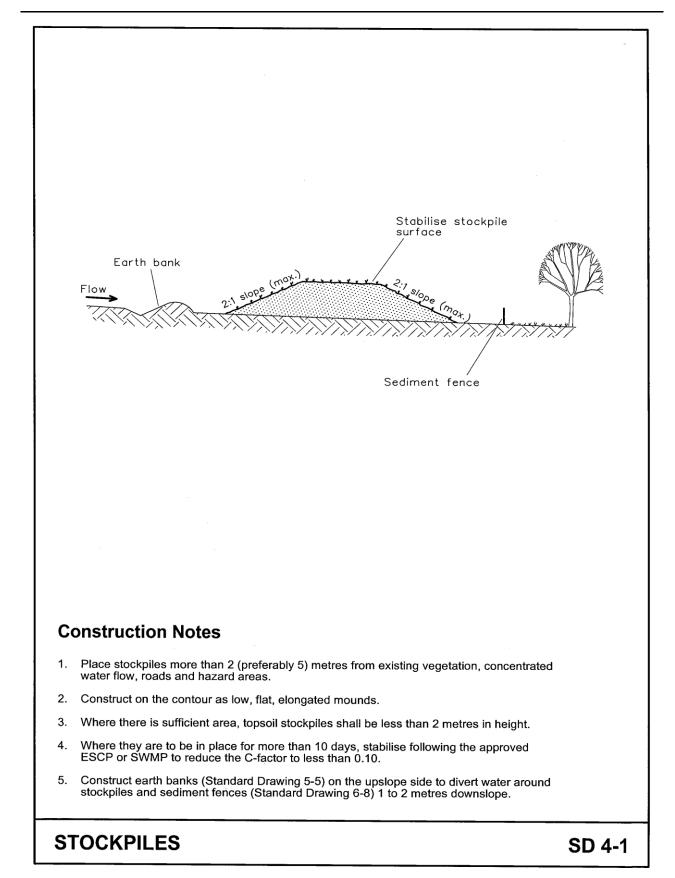
Figure 12 - Stockpile Treatment Standard Drawing (Blue Book - 2004)

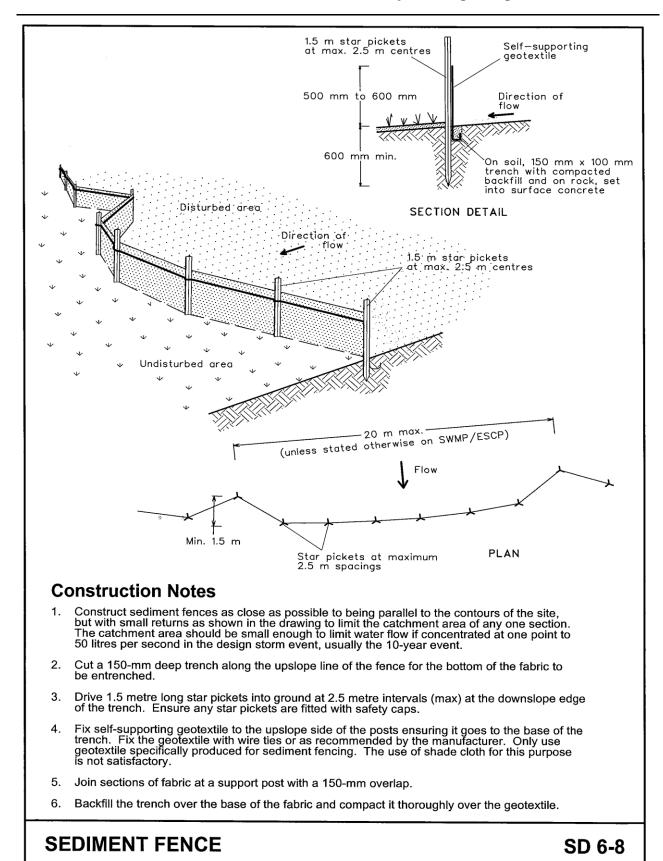
Figure 13 - Sediment Fence Installation Standard Drawing (Blue Book - 2004)
