Remediation Action Plan

Proposed Residential Subdivision
Stages 1 and 2, South East Wilton Junction, NSW

Project 92269.02
May 2019

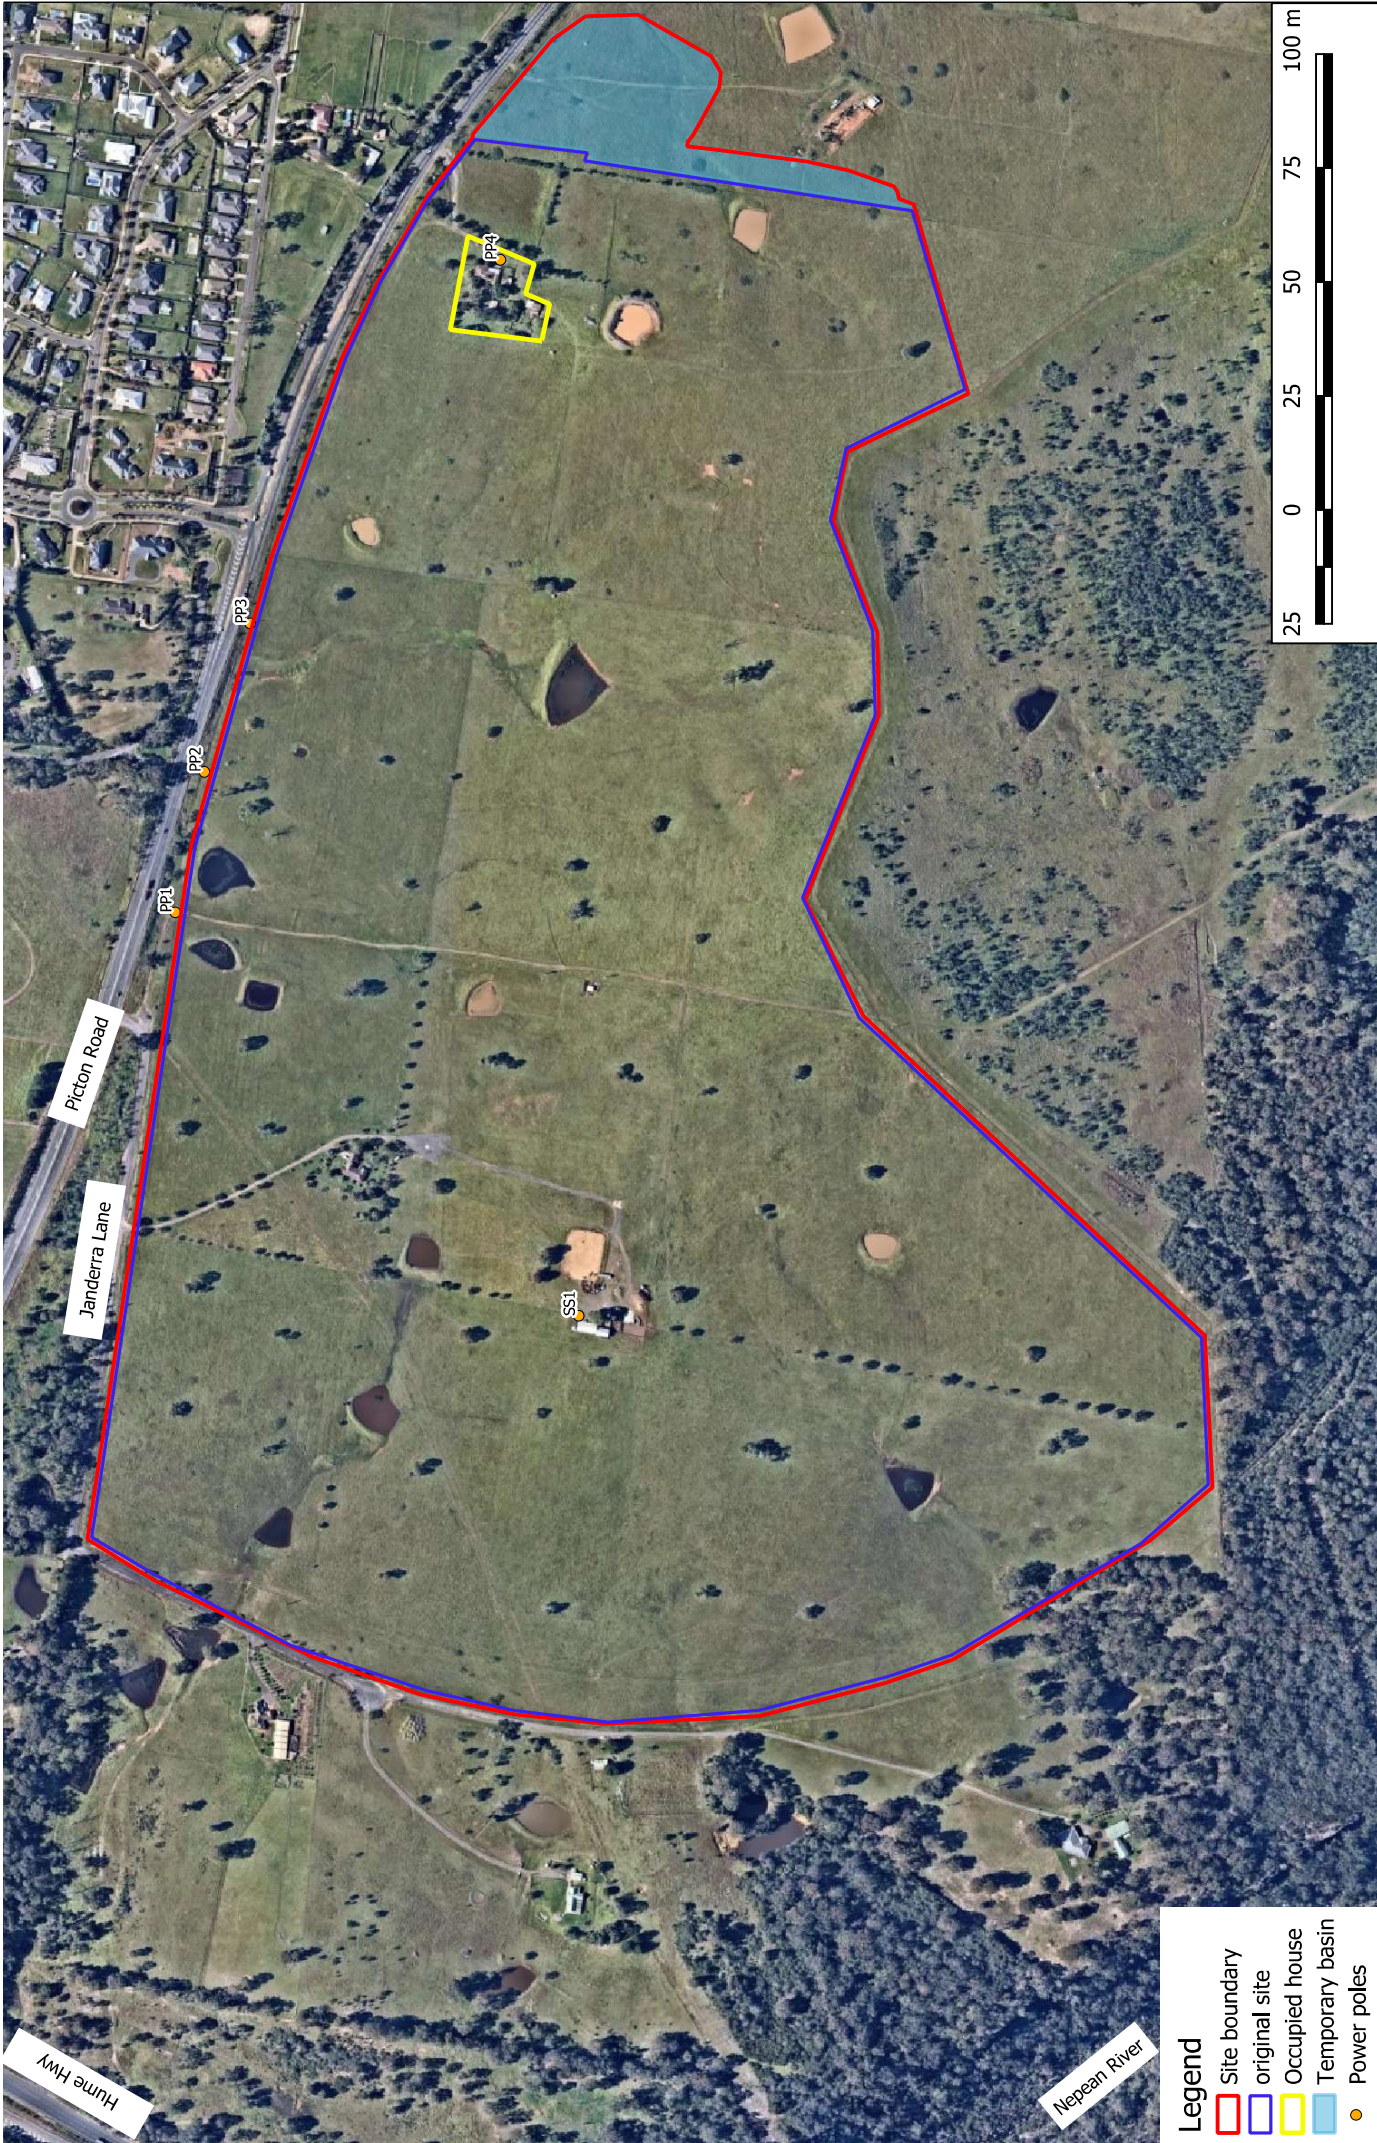
CLIENT: Walker Corporation		TITLE: Site Layout and Remediation Locations Proposed Residential Subdivision Stages 1 and 2, South East Wilton Junction			PROJ. #: 92269.02
OFFICE: Macarthur		DRAWN BY: EMG					DRAWING No: 1
SCALE: As shown		DATE: 9 Apr 2019					REVISION: 1

The site layout is presented in Drawing 1 (Appendix A).

It is noted that the rural residential property located in the north east corner of the site (refer to Drawing 1, Appendix A) will be subject to a contamination investigation once the property is vacated at a later (currently unknown) date.
