Stage 1 Preliminary Site Investigation (PSI)  
160 Burwood Road, Concord

Report Number 610.14168-R1

## Stage 1 Preliminary Site Investigation (PSI)

160 Burwood Road, Concord

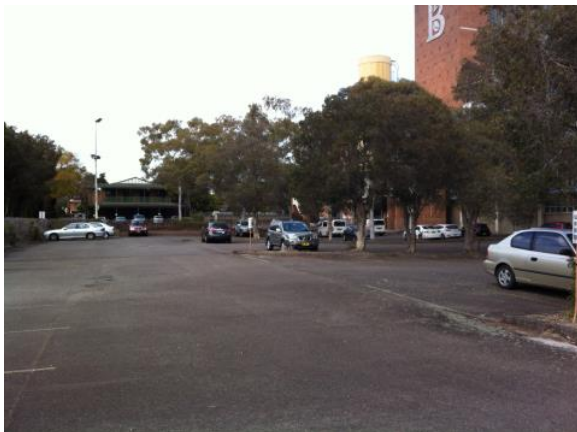
- the main asphalt car park and landscaped areas in the north-eastern portion of the site. The asphalt was in fair to good condition with only minor cracking observed;

Photo 5.1.1 – View of the main car park and the administration building (looking south-west)

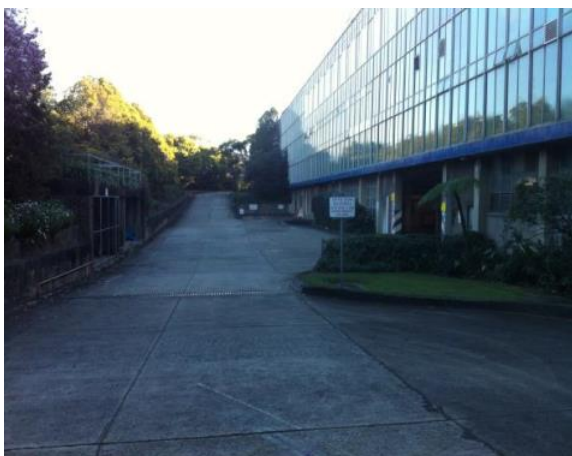
Photo 5.1.2 – Concrete driveway and the southern face of the current site building (looking west)

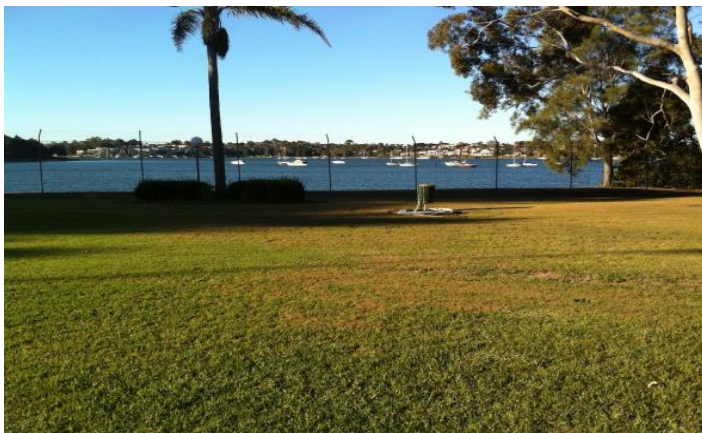
Photo 5.1.9 – View of the reclaimed portion of land

Approximately 20% of the site along the north-eastern portion is reclaimed land. The type and quantity of material used for the reclamation is not known. It was also apparent that the north north-western portion of the site had been subject to some degree of cut. The building pad of the administration building was observed to be located between 1-2m above the existing ground level indicating some amount of fill. Details regarding the type or quantity of the fill material to have been imported to the site remain unknown. If fill had been imported to the site, potential presence of contamination in such fill material cannot be precluded.

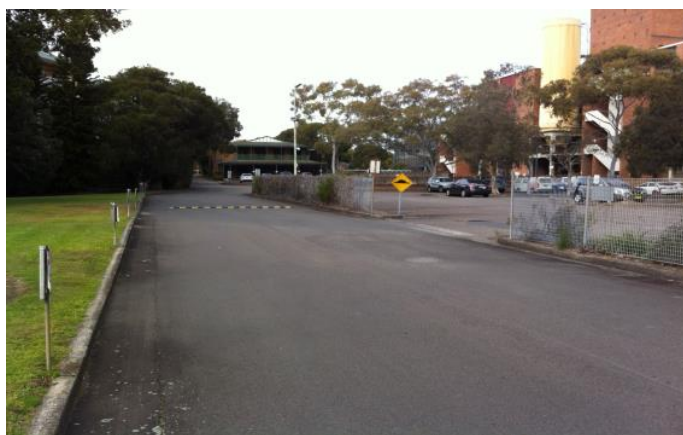
Photo 5.1.11 – View of the asphalt driveway to the east of main car park (looking south). Admin building and the eastern face of the site's main building are also seen

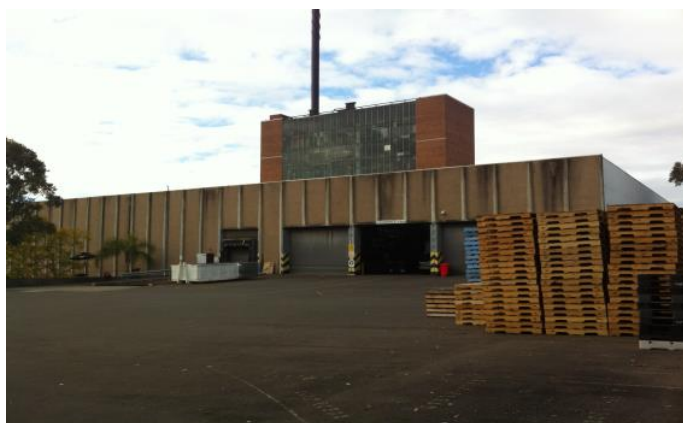
- concrete trucks manoeuvring area and loading docks within the north-western portion of the site. The concrete was in good condition with no cracking observed;

Photo 5.1.12 – View of the site from the north-western corner. Loading docks and trucks manoeuvring area

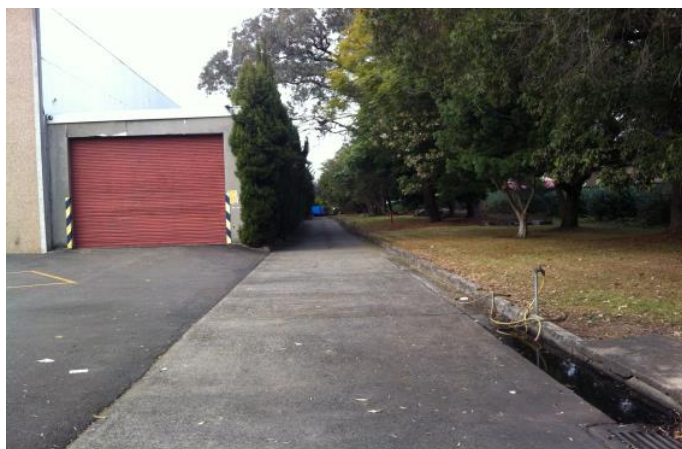
Photo 5.1.13 – View of concrete driveway to the west of the building (looking south)

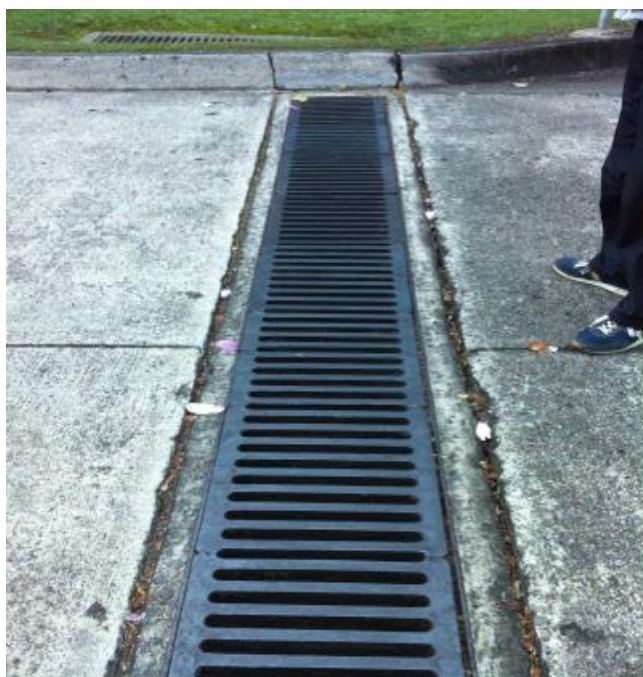
- surface water diversion into a number of stormwater pits located at the site;
- roof water diversion from a series of roof gutters to downpipes and into the stormwater drains located at the site; and
- infiltration of surface water from the permeable areas and into groundwater.

Photo 5.2.1 – Stormwater drainage

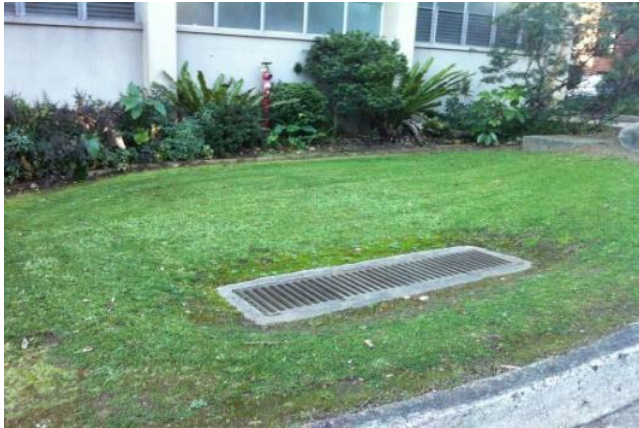
Photo 5.2.2 – Stormwater pit

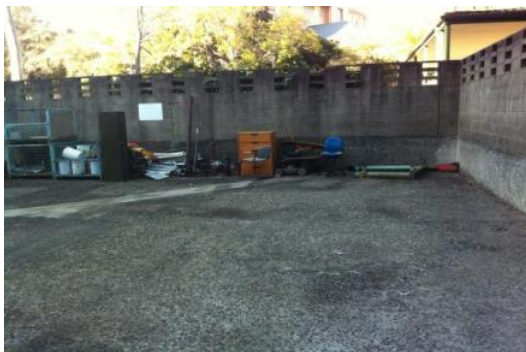
Some scrap metals, broken chairs, fluorescent lamp holders, empty metal buckets, a wooden cabinet, two piles of wooden pallets and multiple large plastic bags containing unidentified material were observed on top of the concrete floor in the trucks turning area and to the west of the loading docks. Multiple stacks of wooden pallets were also observed on the grassy areas in the north-western corner of the site. A dis-used van and a trailer containing unwanted materials including tyre, metal scraps and timber pieces were observed in the main car park area of the site.

Photo 5.3.1 – Waste material on trucks turning area

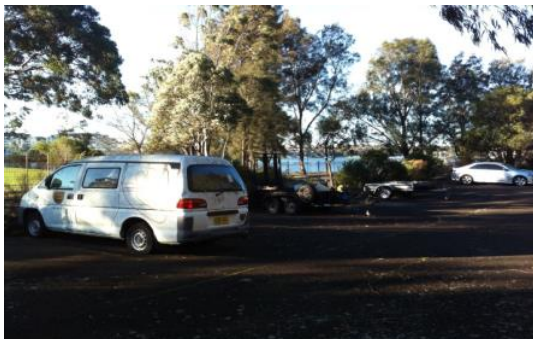
Photo 5.3.2 – A dis-used van and a trailer in main car park area

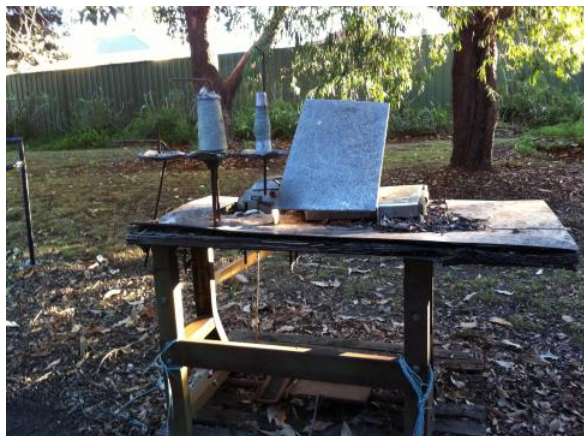
Along the landscaped areas to the west of the site, more evidence of scattered unwanted material were observed in the form of dis-used industrial grade sewing machine, metal sheets and hollow metal cylinders.

Photo 5.3.3 – Waste materials on site along the western landscaped area

In the case of materials stored on the grassy or landscaped areas, although no evidence of stains or leaks was observed, the staining or leaking of contamination such as oil and grease into the ground in the past cannot be precluded.

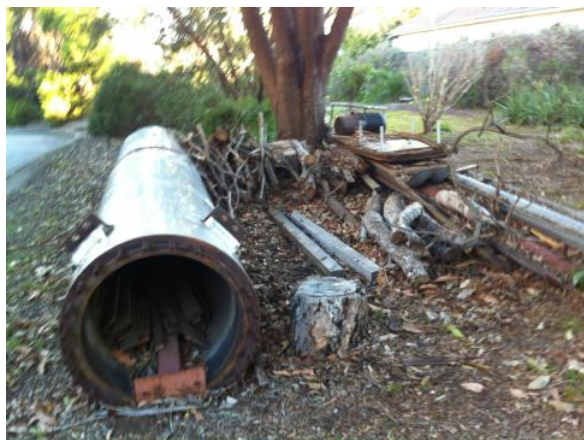
Photo 5.3.4 – View of more waste materials on site along the western landscaped area

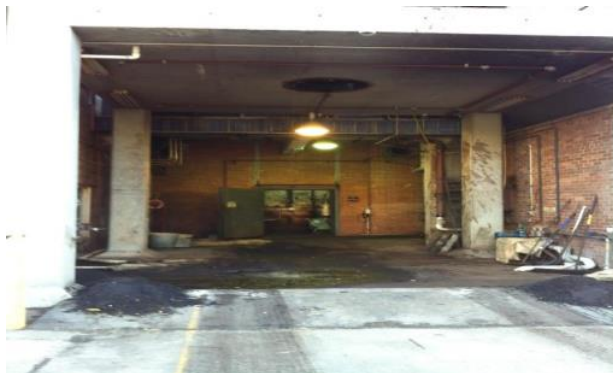
SLR was informed that all the wastes associated with the manufacturing of coffee beans and ground coffee is taken out of the site at least once a day from the waste holding silo located in the grouts area of the site.

Photo 5.3.5 – Grout area and the oil-water separator room at the back. On top of the ceiling is the bottom opening of waste holding silo.

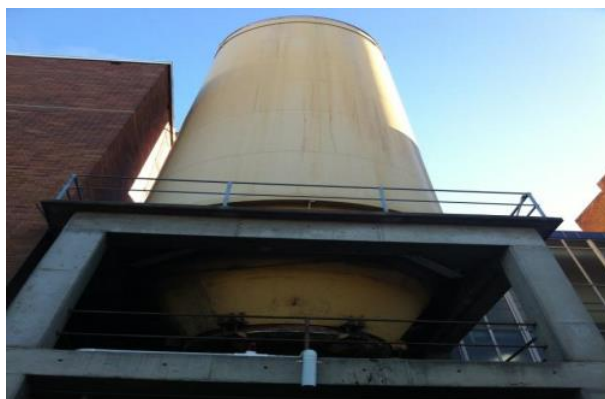
Water was seen dripping from the silo and onto the concrete floor and into the ground via a small hole in the concrete. Dark black staining was observed on the concrete floor in this area.

Photo 5.3.6 –Waste holding silo

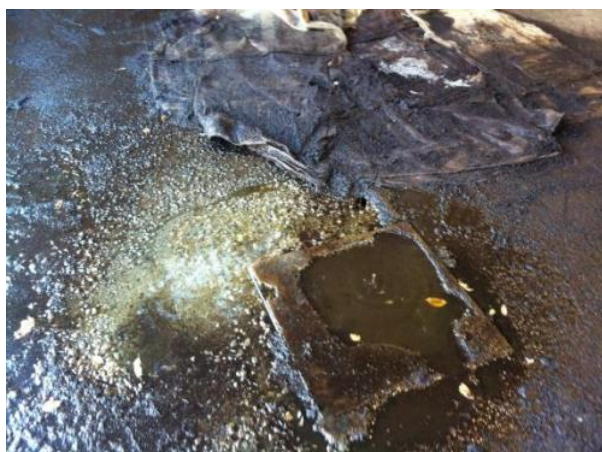
Photo 5.3.7 – Staining of concrete floor and the hole in the concrete in the grout area

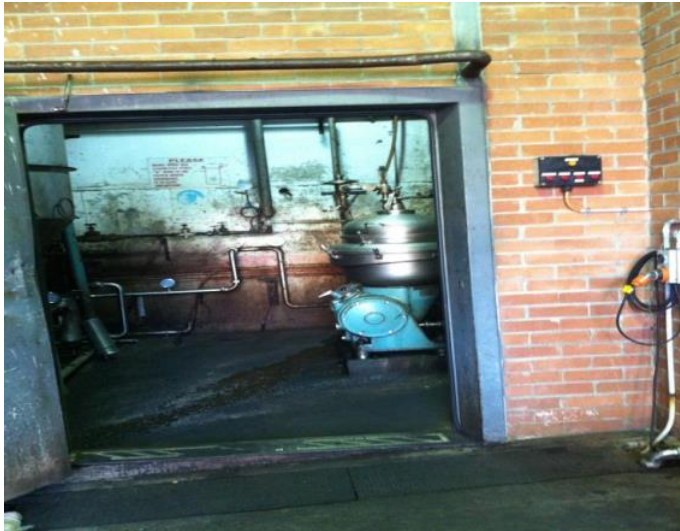
The concrete floor in the oil-water separator room was observed to be in poor condition with dark black staining.

Photo 5.3.8 – Oil-water separator room

AEC09	Grout area and oil water separator room	Hydrocarbons, heavy metals, pesticides	SLR considers that the potential for some level of metals and hydrocarbons to have migrated into the underlying soil and groundwater as a result of spills and leakages is <b>moderate to high</b> .
AEC10	Former stockpile area	Hydrocarbons, heavy metals, asbestos	SLR considers that the potential for some level of metals, hydrocarbons and asbestos contamination to be present in the site soils as a result of the presence of large stockpile in the past is <b>moderate to high</b> .

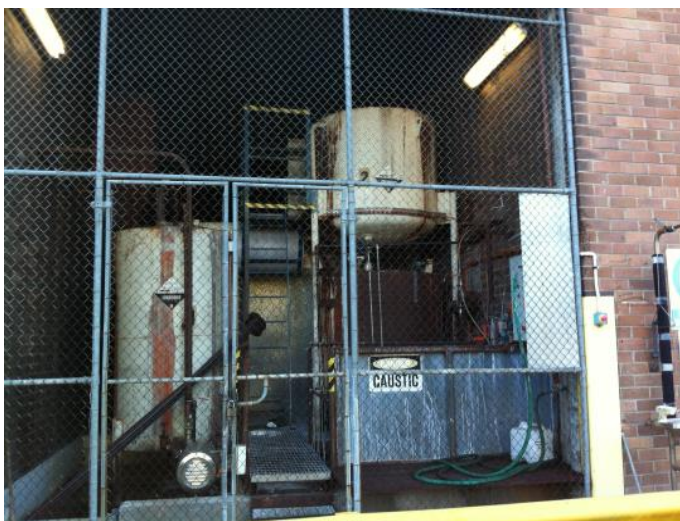
The concrete floor in the caustic soda room was observed to have been slightly degraded as a result of caustic soda leakages. SLR considers that the likelihood of contamination migrating into the underlying soil and groundwater via degraded concrete floor cannot be precluded.

Photo 5.3.9 – Caustic soda room

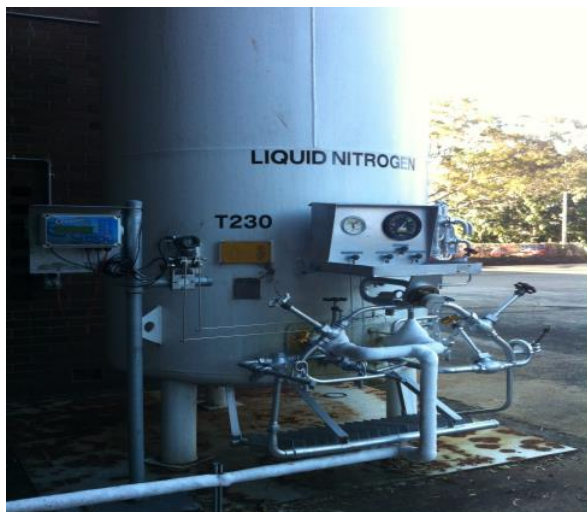
- One AST located at the site near the caustic soda room to store liquid nitrogen;
- Two diesel ASTs (80L each) were located at two pump rooms on site; and
- Three ASTs located inside caustic soda room (see photo 5.3.9) to store caustic soda

Photo 5.5.1 – Liquid nitrogen AST

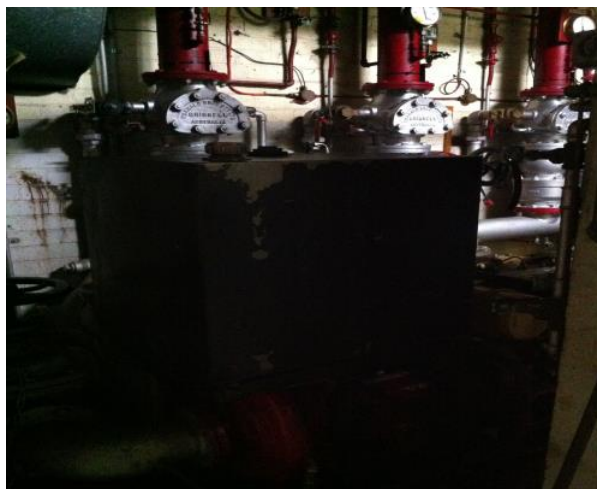
Photo 5.5.2 – 80L diesel AST in the southern pump room

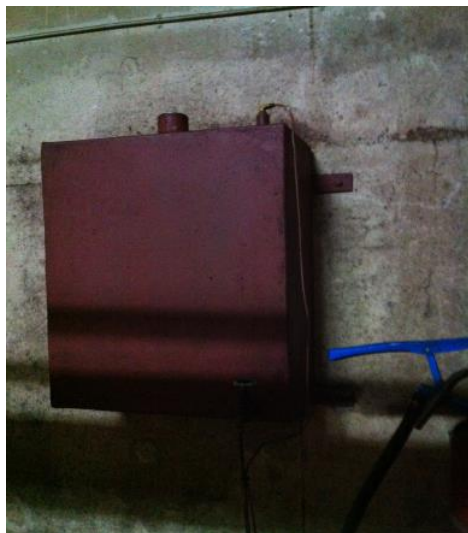
Photo 5.5.3 – 80L diesel AST in the northern pump room

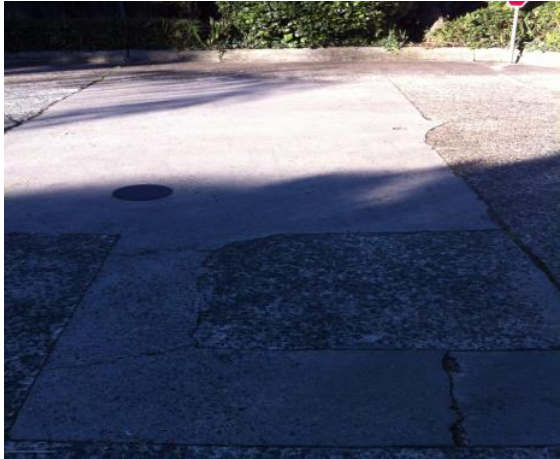
Evidence of a decommissioned tank pit was observed in an area immediately north-east of the site's security shed. Three fill points and a dipping point sealed with concrete were observed within this area. A dipping point and a possible UST were also observed outside the southern pump room entry door at the site.

Photo 5.5.4 – Evidence of a decommissioned UST pit

SLR considers that the likelihood of contamination migrating into the soil and groundwater as a result of possible leakages of USTs and ASTs used to store substances other than Sydney Water cannot be precluded. The potential for unidentified USTs to be present on the site cannot be precluded.

AEC05	Potential UST to the south of southern pump room door	Hydrocarbons, heavy metals	SLR considers that potential for some level of metals and hydrocarbon contamination to be present on site as a result of potential spills and leakages is <b>high</b> .
AEC06	Filled area underneath the administration building	Hydrocarbons, heavy metals, pesticides, asbestos	SLR considers that the potential for some level of metals, hydrocarbons, pesticides and asbestos contamination to be present in the site soils as a result of potential fill is <b>moderate</b> .
AEC07	Storage area for liquid nitrogen, phosphorous acid, hydrochloric acid and a mechanical gear	Hydrocarbons, heavy metals	SLR considers that the potential for some level of metals and hydrocarbons to have migrated into the underlying soil and groundwater as a result of the potential degradation of concrete is <b>low to moderate</b> .
AEC08	Caustic soda room and ejector's room	Hydrocarbons, heavy metals	SLR considers that the potential for some level of metals and hydrocarbons to have migrated into the underlying soil and groundwater as a result of the potential degradation of concrete is <b>low to moderate</b> .

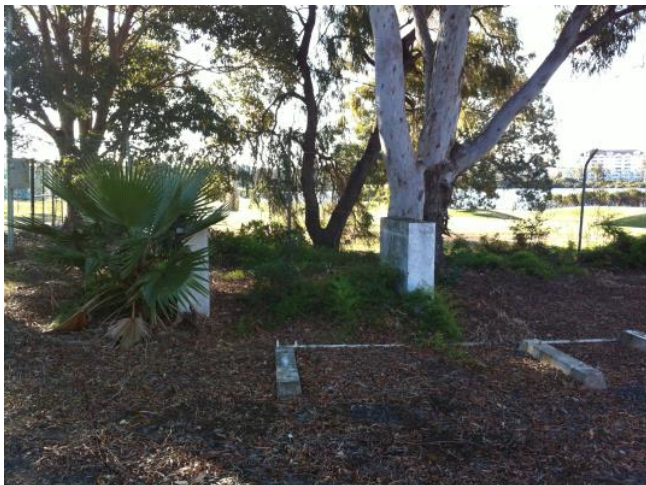
Evidence of footings for the storage of former ASTs were observed in the north-western corner of the site. Fifteen large LPG cylinders were also observed inside a shed at this location.

Photo 5.5.5 – Footings for former ASTs on site

AEC ID	AEC	Contaminant of Potential Concern	Potential for the Contaminant to be present
AEC01	Former ASTs	Hydrocarbons, heavy metals, asbestos	SLR considers that the potential for some level of hydrocarbon and metals contamination to be present in the site soil as a result of leakages and spills is <b>moderate to high</b> .
AEC02	Demolished former building at the site	Heavy metals, hydrocarbons, asbestos and pesticides	SLR considers that the potential for some level of metals, pesticide or asbestos contamination to be present in site's original soils is <b>moderate to high</b> .
AEC03	Reclaimed land	Heavy metals, hydrocarbons, pesticides, asbestos	SLR considers that the potential for some level of metals, hydrocarbons, pesticides or asbestos contamination to be present in the site soils as a result of the reclamation is <b>high</b> .
AEC04	Decommissioned USTs and its associated infrastructures	Hydrocarbons, heavy metals	SLR considers that potential for some level of metals and hydrocarbon contamination to be present on site as a result of spills and leakages is <b>high</b> .

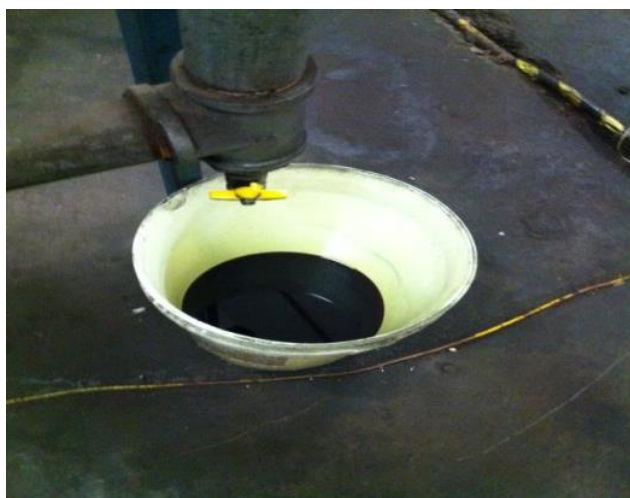
- storage of leaked compressor oil in two buckets in the compressor room. The concrete floor in the compressor room appeared to be in fair condition with minor cracking observed. Oil stains were observed on the concrete floor;
- two containers of phosphoric acid and one container of hydrochloric acid near the liquid nitrogen AST. White stains were observed on the concrete indicating some degree of degradation; and
- sodium hydroxide (caustic soda) in caustic soda room. White staining of concrete was observed in this area.

Photo 5.7.1 – Storage of leaked compressor oil in a bucket

Further assessment of these areas is considered warranted.

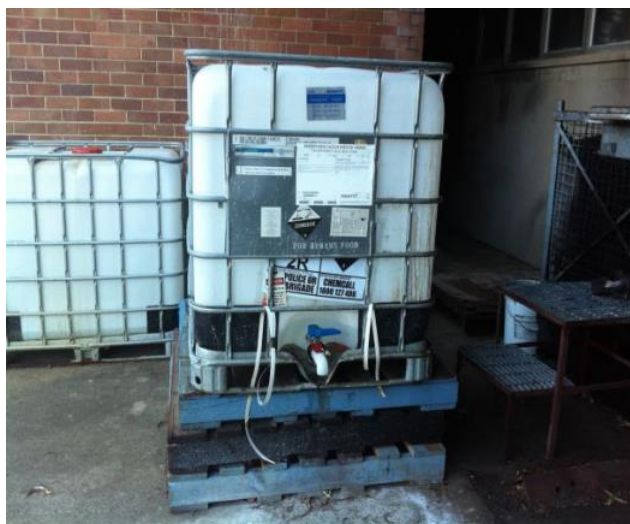
Photo 5.7.3 – Storage of acid containers on site

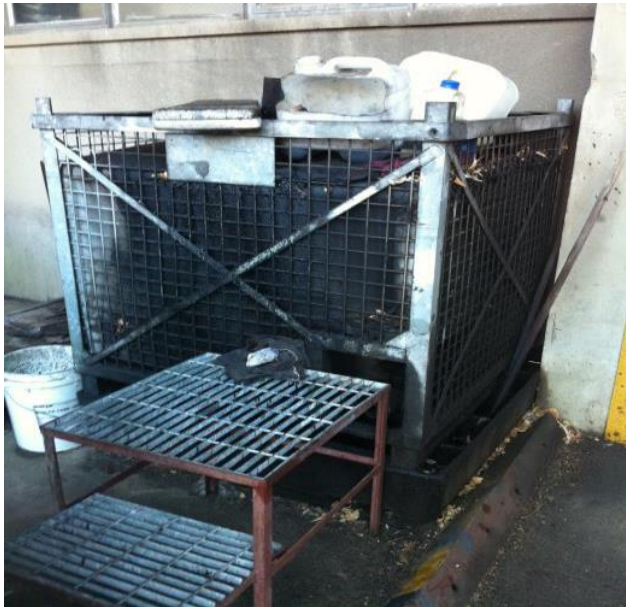
Black oily substance was observed to have been leaked from a mechanical equipment stored near the acid containers. Dark oil stains were observed on the concrete floor in this area.

Photo 5.9.1 – Black oily substance observed to have been leaked from a mechanical equipment

The concrete floor in the above cases was observed to be in poor to fair condition with some cracks. The migration of contamination to soil and groundwater underneath the concrete slab as a result of past activities cannot be precluded.

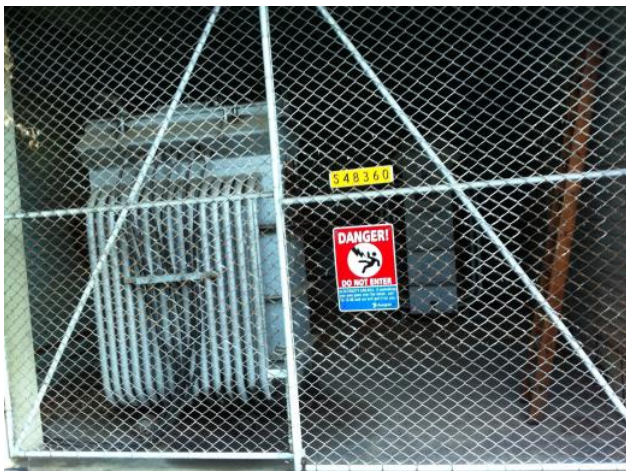
A dark brown oily substance was also observed to have leaked from the transformer inside the transformer room. Dark brown staining of concrete floor was observed in this area.

Photo 5.9.2 – View of the Transformer room and the staining of floor at the bottom

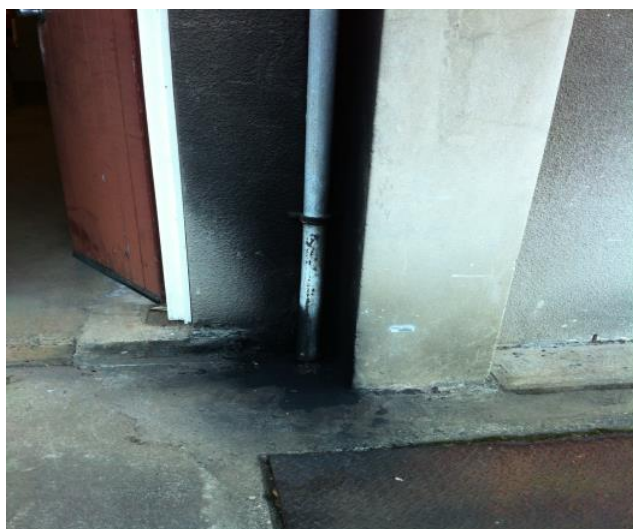
Black staining of concrete was observed outside the southern pump room door. The exhaust pipe from the diesel pump stored in the southern pump room was directed towards the ground resulting in dark staining. The concrete floor in this area was observed to have minor cracks.

Photo 5.9.3 – Black staining of floor outside southern pump room door
