**Meriton Properties  
Level 11 Meriton Tower  
528 Kent Street  
Sydney NSW 2000**

**Project 85009.01  
85009.01.R.001.Rev2  
30 March 2017  
PMM:PG:jlb**

**Summary of Previous Investigations  
Pagewood Part II  
128, 130-150 Bunnerong Road, Pagewood**

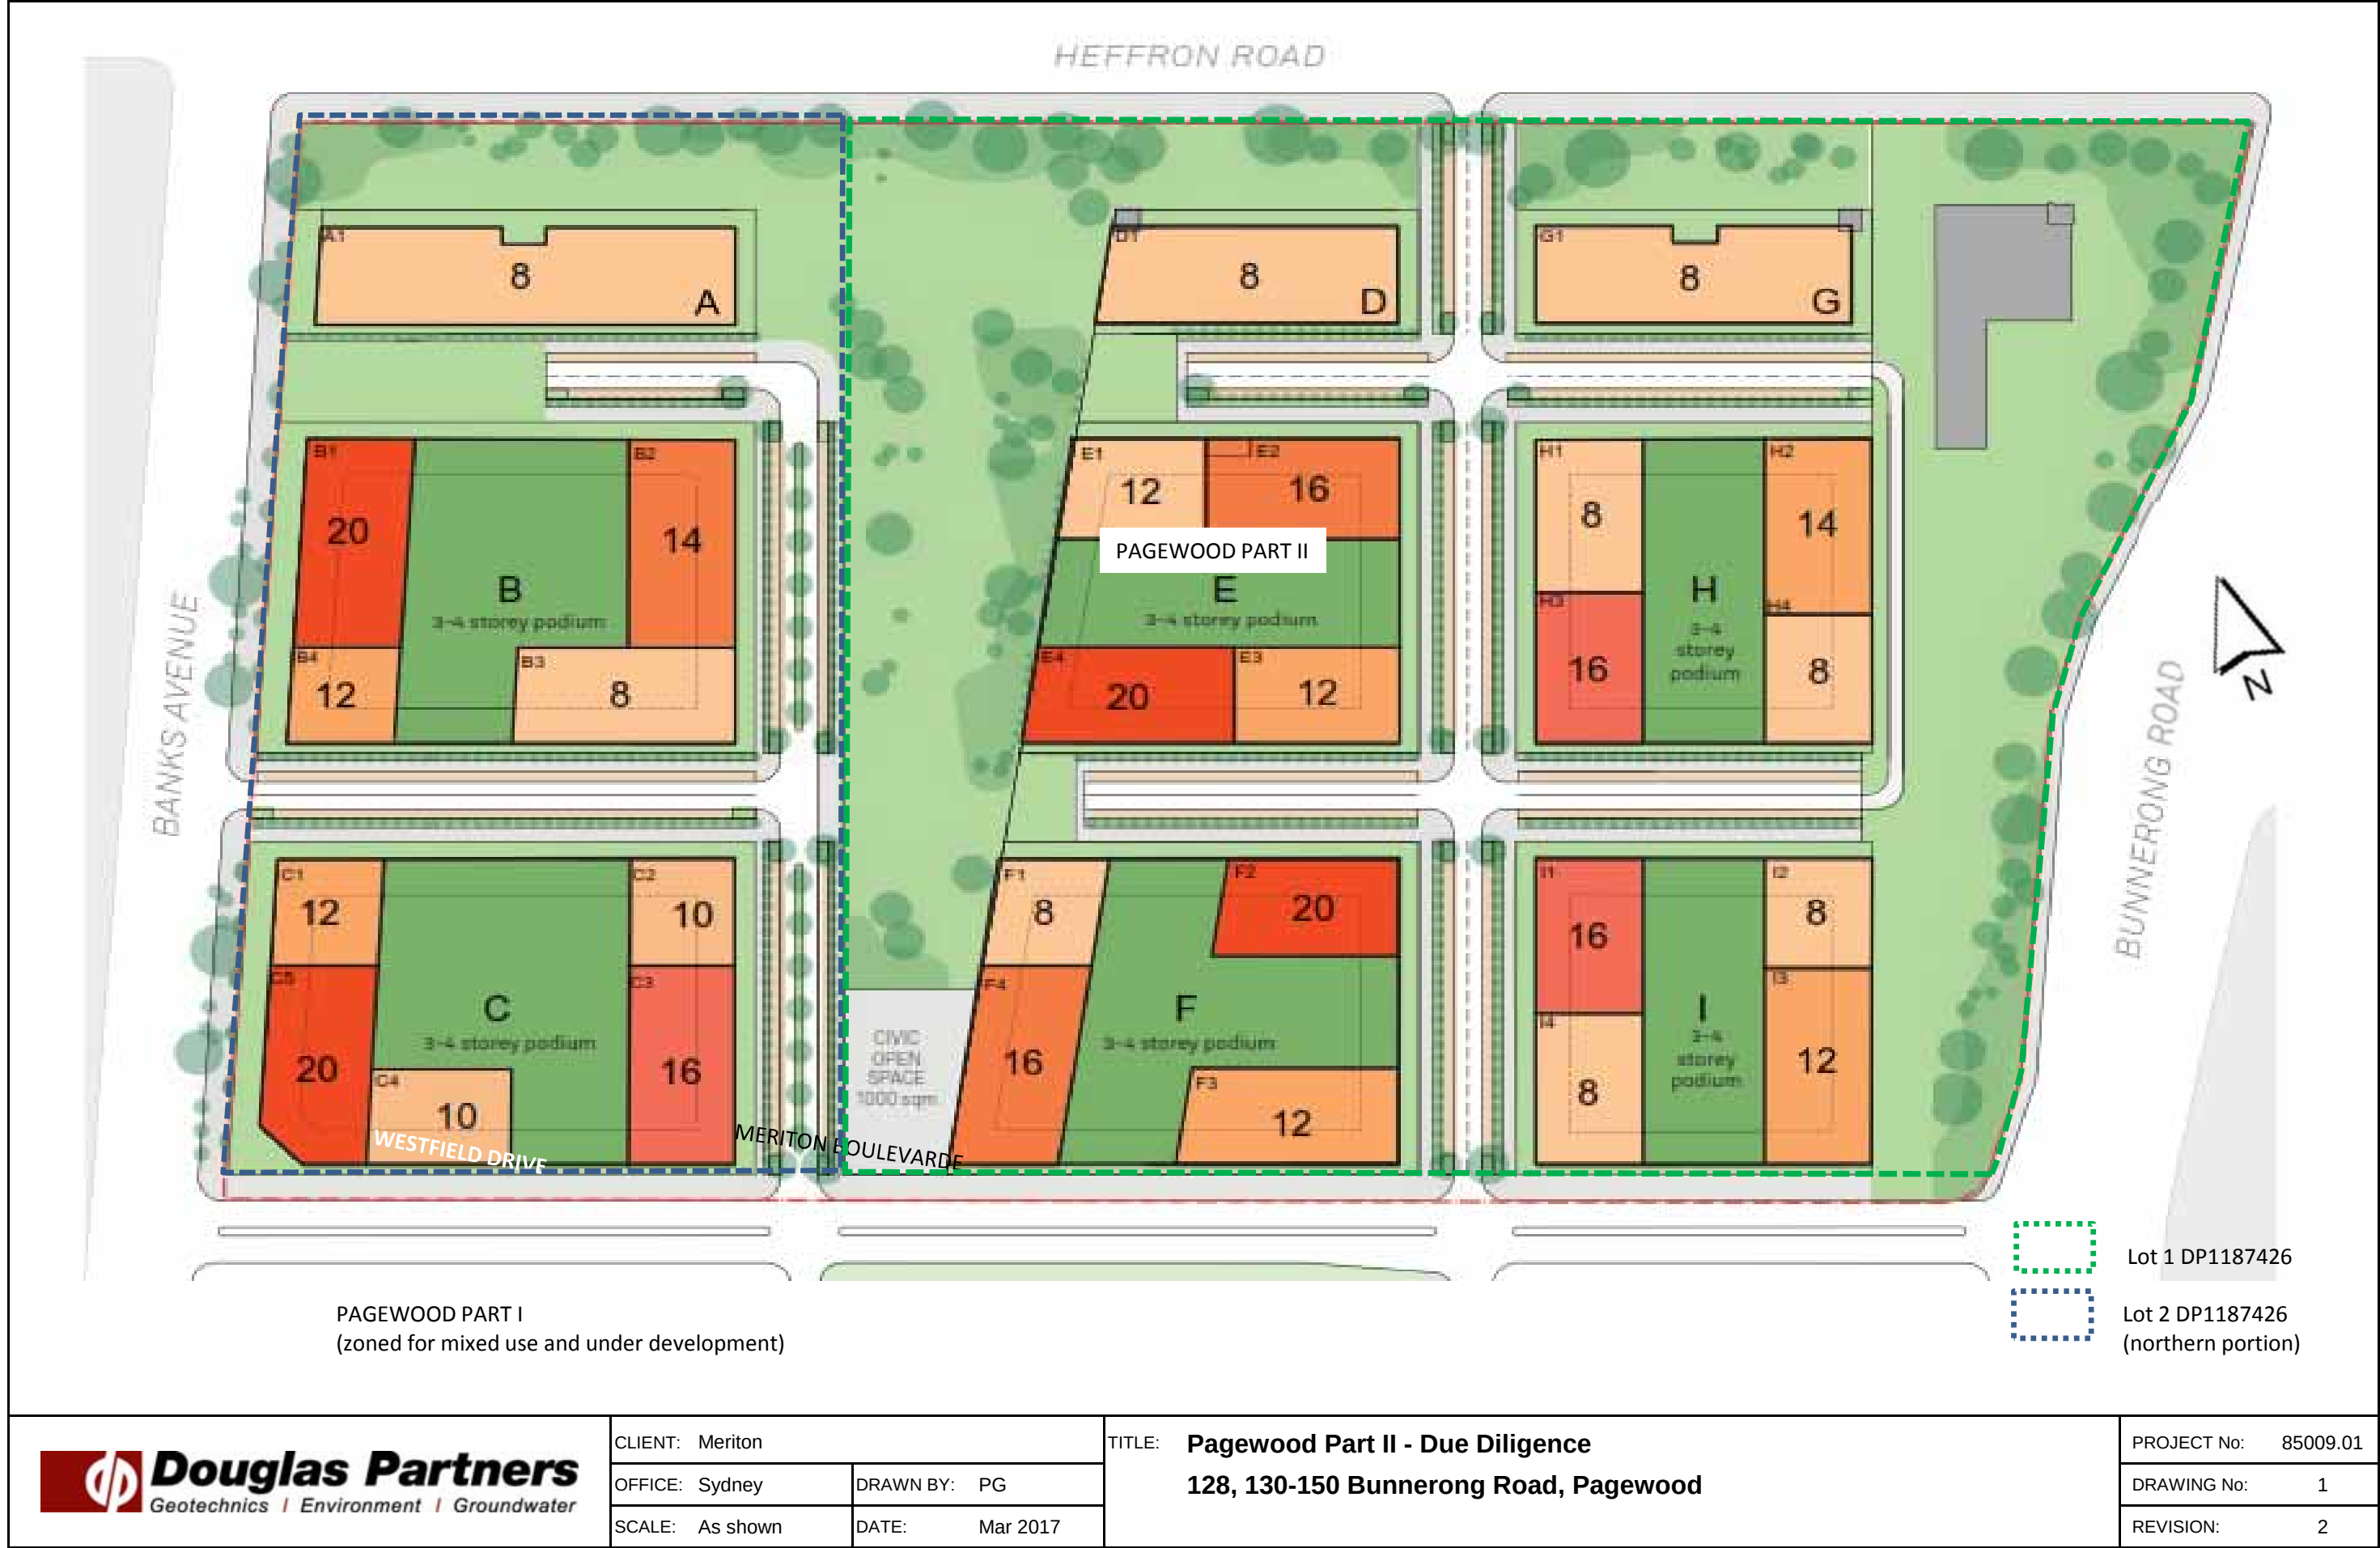
This report presents the results of a contamination desktop study of part of 128, 130-150 Bunnerong Road, Pagewood, referred to herein as Pagewood Part II (or "the site"), as shown on the attached Drawing 1. The site comprises the whole of Lot 1 in DP1187426 (Lot 1) and the northern portion of Lot 2 in DP118746 (Lot 2) and covers an area of approximately 8.95 hectares (ha).

The site is bound by Heffron Road to the north, Bunnerong Road to the east, Banks Avenue to the west and an internal road (Meriton Boulevard) to the south. At the time of preparing this report, the eastern portion of the site was occupied by commercial / industrial buildings and pavements and was being used for storage. The western portion was occupied by a large warehouse building and was being utilised for materials storage associated with the ongoing development of Pagewood Part I (refer attached Drawing 1).

Preparation of this report was commissioned by Mr Matthew Lennartz of Meriton via email on 11 January 2017 and undertaken in general accordance with Douglas Partners Pty Ltd (DP) standard conditions of engagement. It is understood that the report will be used for due diligence purposes and in support of a rezoning application for mixed uses including residential (refer to proposed Masterplan layout shown on Drawing 1).
