**Project:** North Terrace Rezoning – Access Report – Technical Memorandum

**Our Ref:** 16-001551– North Terrace – Access Report – Final

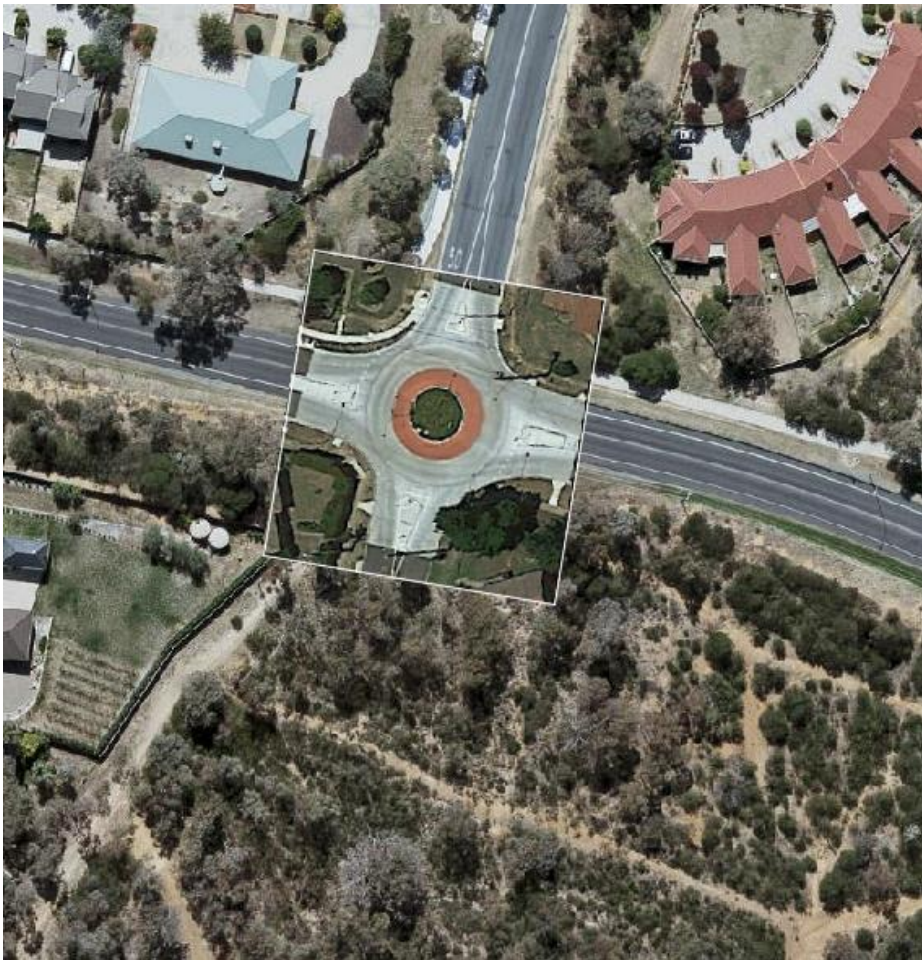
Figure 2-1: Intersection - Option 1 – Roundabout

Based on the above analysis it is recommended that a roundabout be adopted for Option 1. The nearby intersection of Donald Road / Southbar Road has been overlaid with an aerial image to indicate the potential intersection arrangements to provide access to the Site. Refer Figure 2-1 for the future intersection. It is noted that the exact configuration of the intersection will need to be confirmed by undertaking traffic analysis and further design work.

Existing services could be relocated to accommodate the proposed roundabout. Earthworks to the existing earth mounding within the southern verge of Southbar Road could be undertaken to achieve appropriate sight distance requirements for the proposed access road approach. Trimming or removal of existing vegetation could be undertaken to assist in sight distance requirements for the Tharwa Road approach could also be undertaken. Provision of providing access via the existing intersection of Southbar Road / Tharwa Drive may reduce the amount of developable area within the Site due to the requirement to grade the southern verge of Southbar Road.

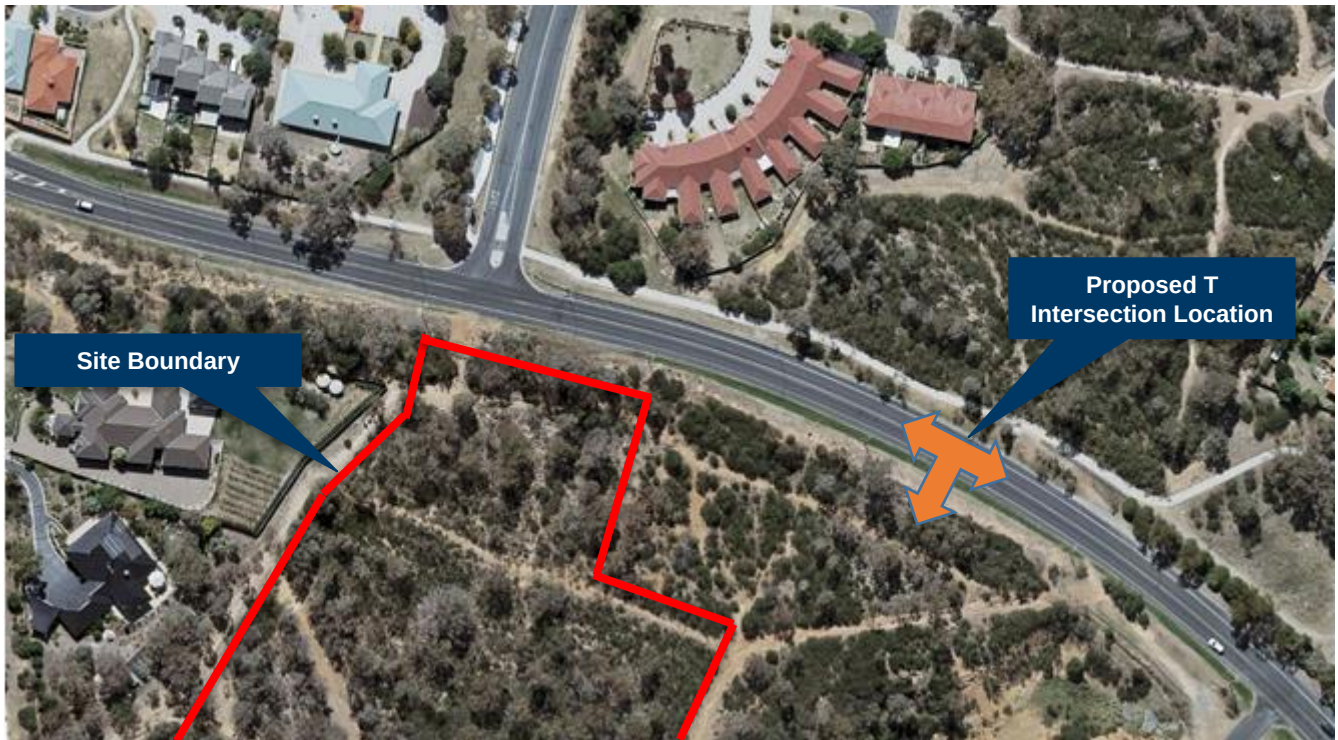
Figure 2-2: Intersection - Option 2 – Staggered T Intersection

The proposed location of the staggered T intersection is provided in Figure 2-2. It is noted that the exact configuration of the intersection will need to be confirmed by undertaking traffic analysis.

The existing services could be relocated or protection provided to accommodate the proposed intersection and access road. Earthworks within the southern verge of Southbar Road will be required to provide the access road to the Site. Earthworks to the existing earth mounding within the southern verge of Southbar Road would be minimised as the proposed intersection is located at the bend in Southbar Road and would achieve the appropriate sight distance requirements. Despite this, significant earthworks will be required to provide an access road from this location due to the topography of the Site. It is noted that Option 2 would have less impact on the developable area than intersections considered in Option 1, as grading to provide access to the Site will not be required.

The proposed staggered T intersection arrangement (Option 2) is a suitable engineering means of providing access to the Site as it minimises the amount of potential conflicting traffic movements and is likely to require less services adjustments than what may be required in Option 1. Despite this, it may be difficult or expensive to obtain approval or purchase land from the adjacent land owner to provide an access road to the Site. On this basis it is recommended that the existing intersection of Southbar Road / Tharwa Road be adjusted to encompass a roundabout, and provide a fourth leg at this intersection to access the Site.
