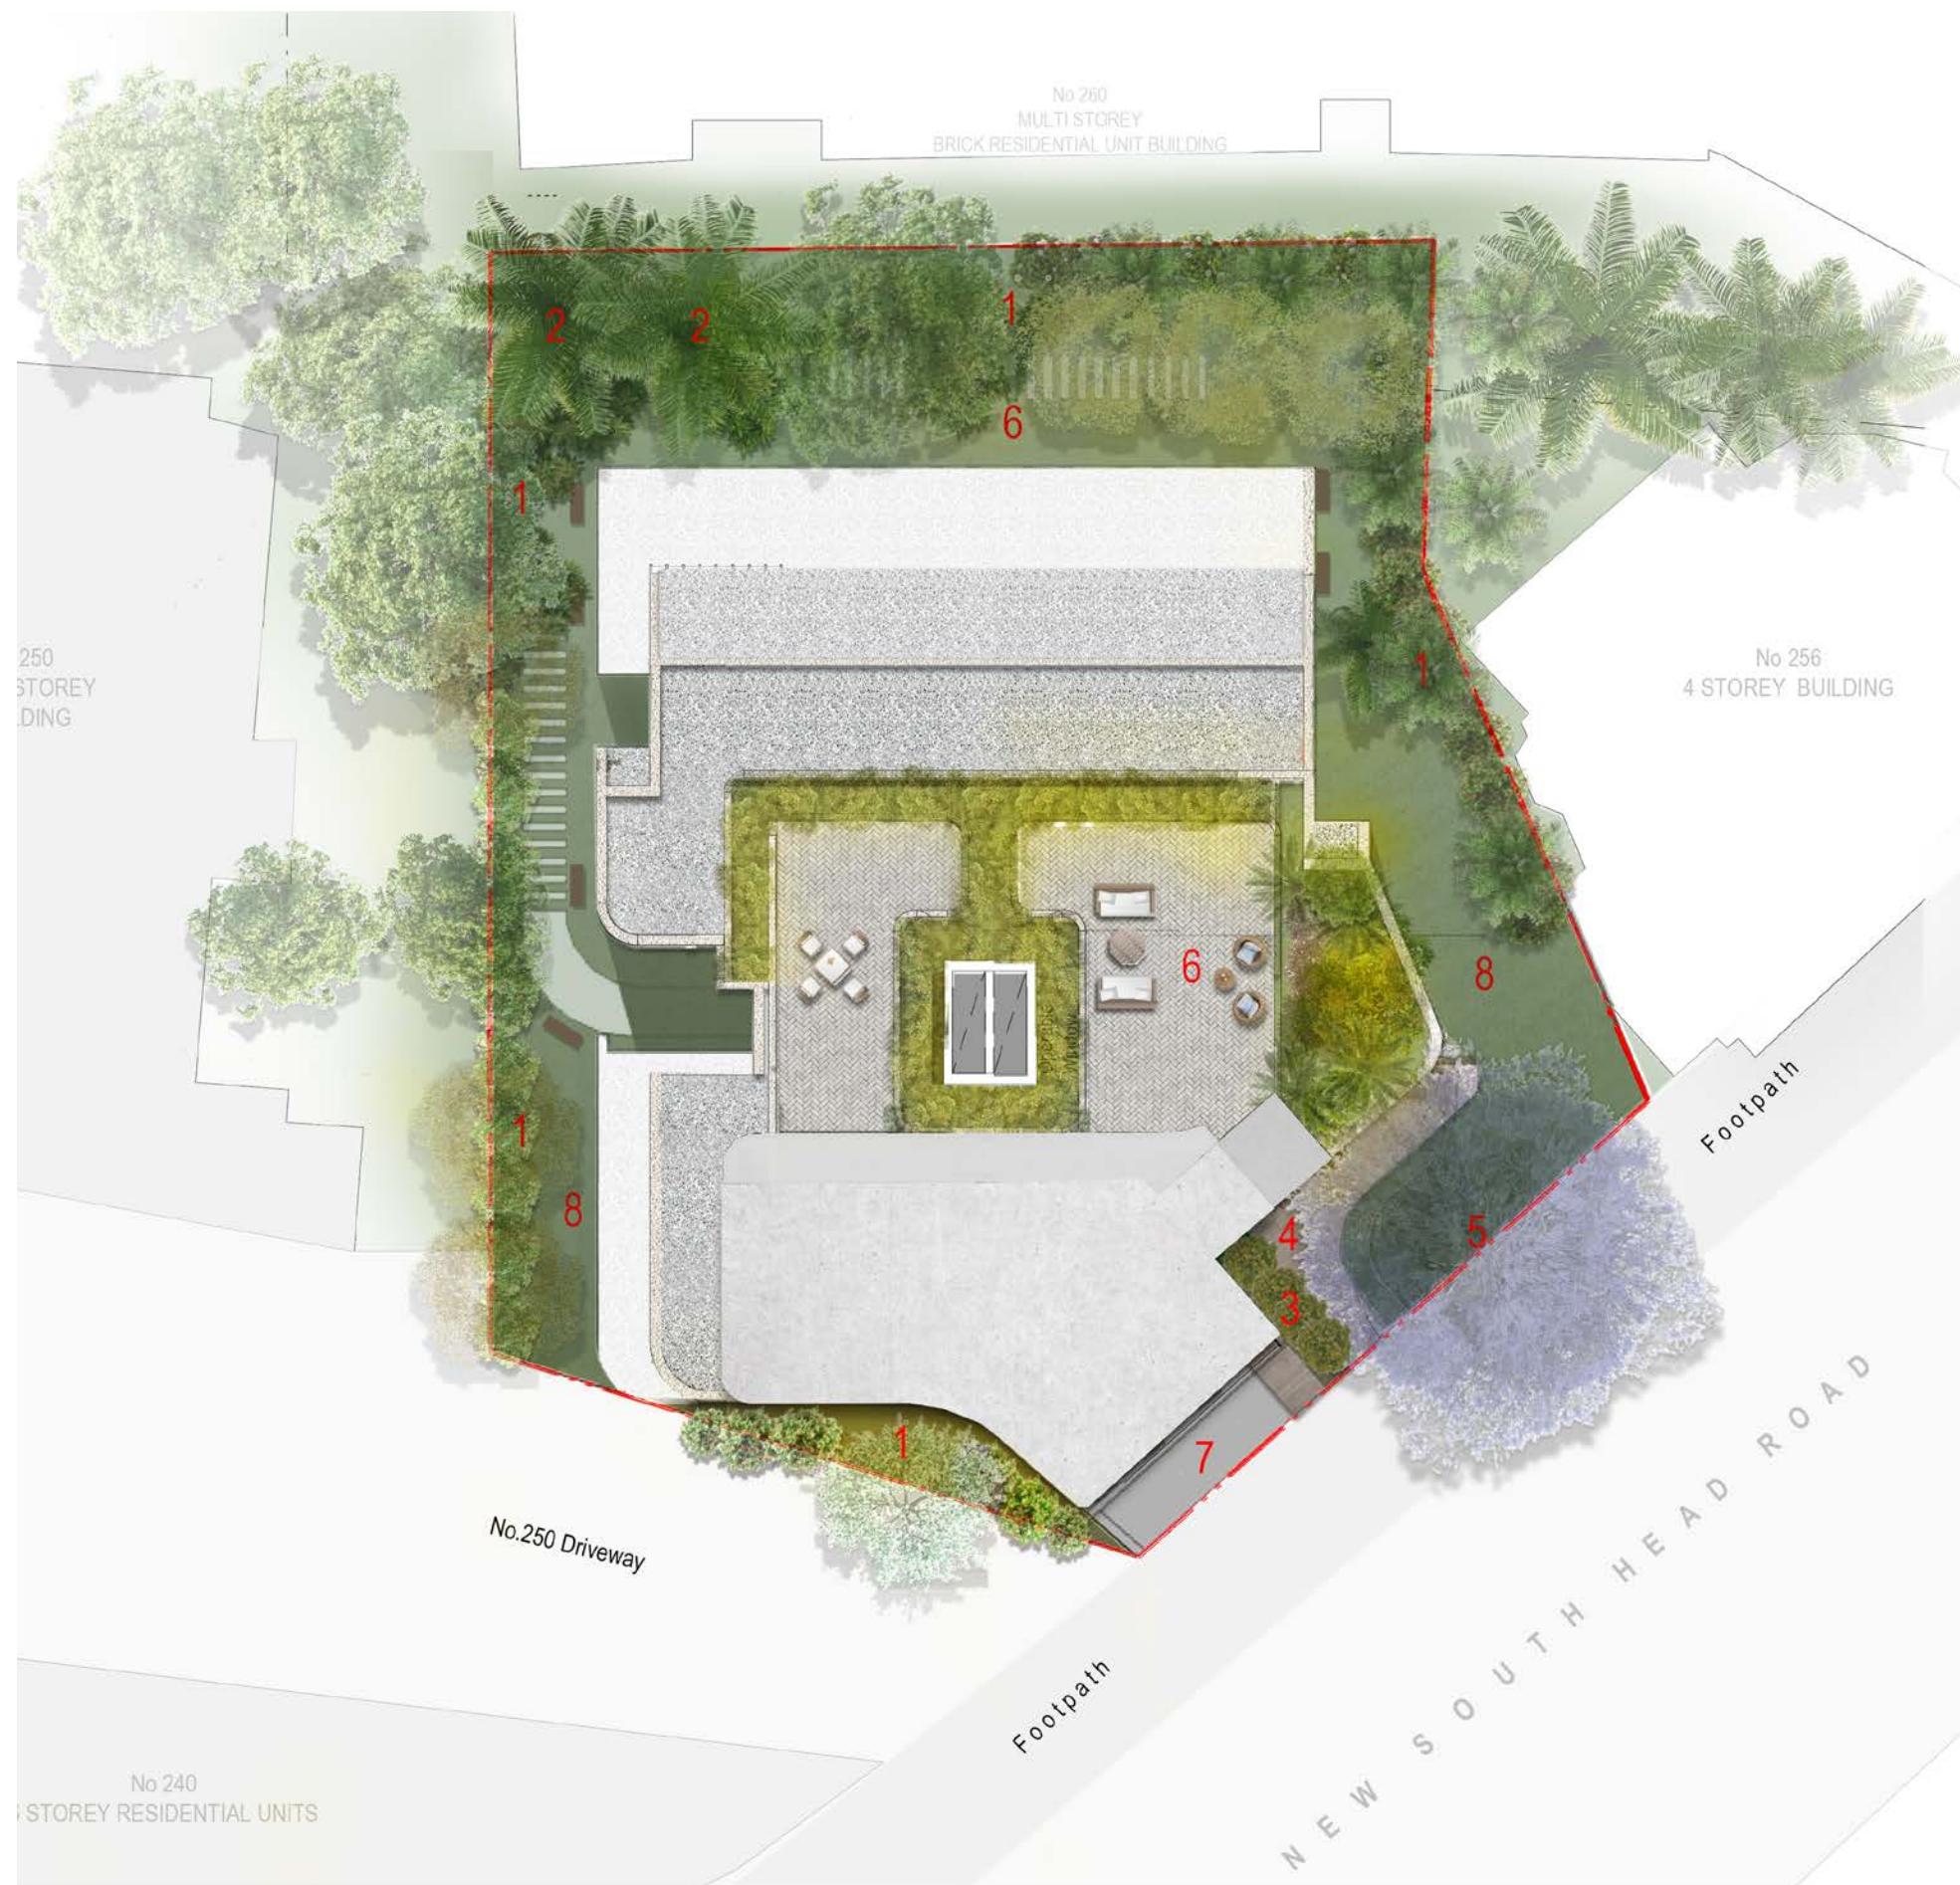
- 1 Buffer Planting
- 2 Relocated Palm Trees
- 3 Garden Bed
- 4 Access Deck from Street to Entry
- 5 Existing Jacaranda Tree
- 6 Communal Open Space
- 7 Driveway
- 8 Lawn
- Landscape on Structure
- Deep Soil

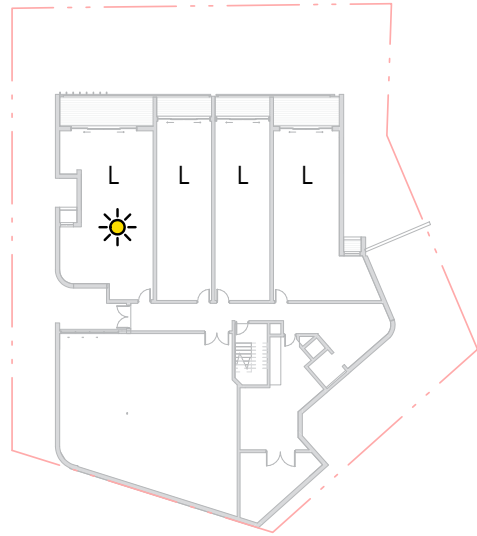
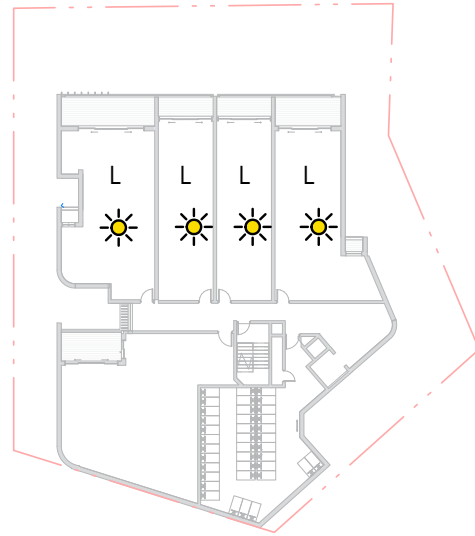
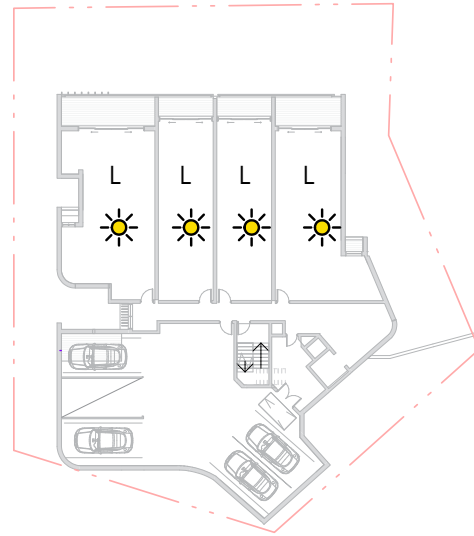
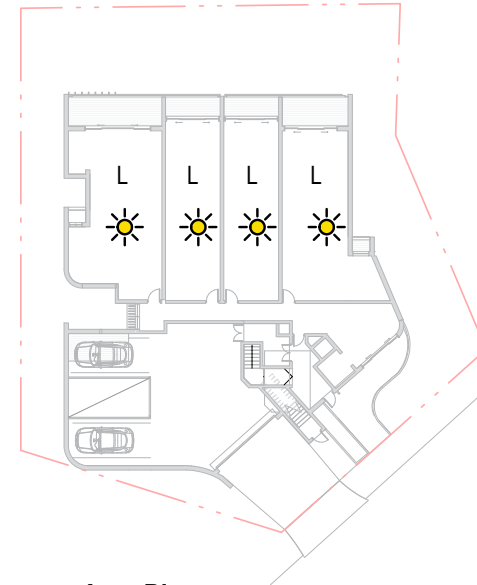
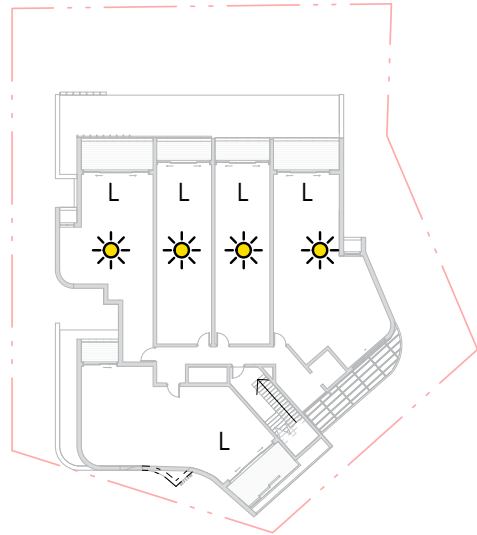
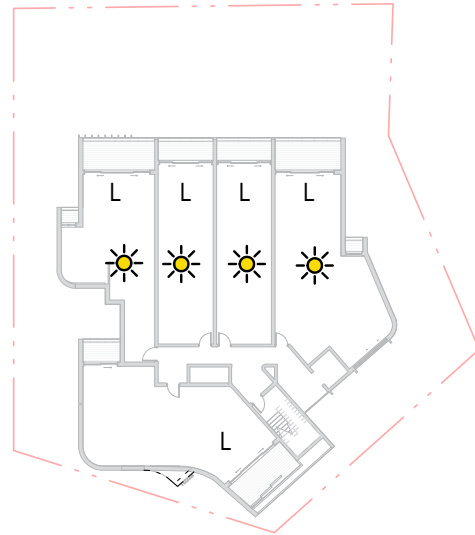
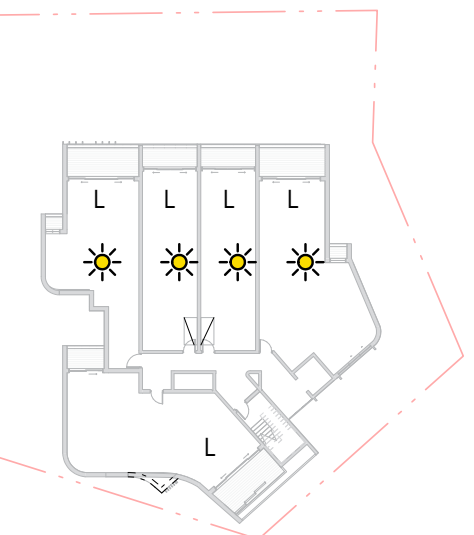
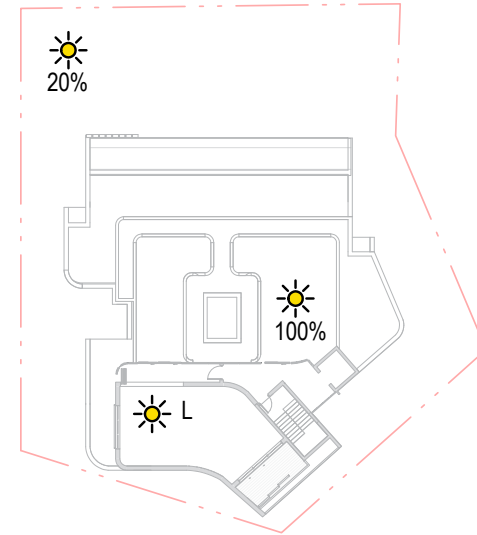
Total Units 33
Solar Access Units (>2hrs) 26 (78.8%)
Solar Access Units (<15mins) 2 (6%)
100 % of Roof Top Communal Open Space
that receives 2 hrs sun
20 % of Ground Floor Communal Open Space
that receives 2 hrs sun
37 % of Total Communal Open Space
that receives 2 hrs sun

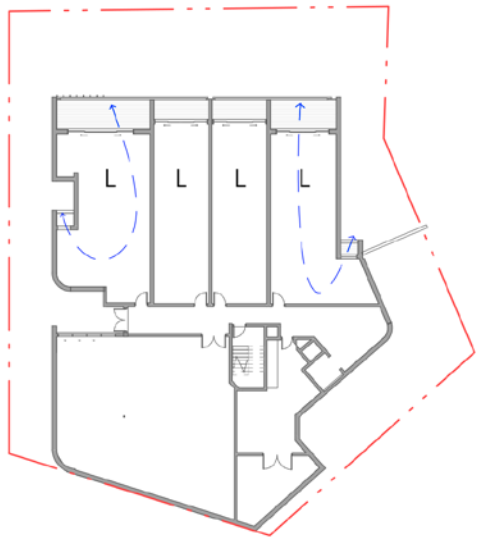
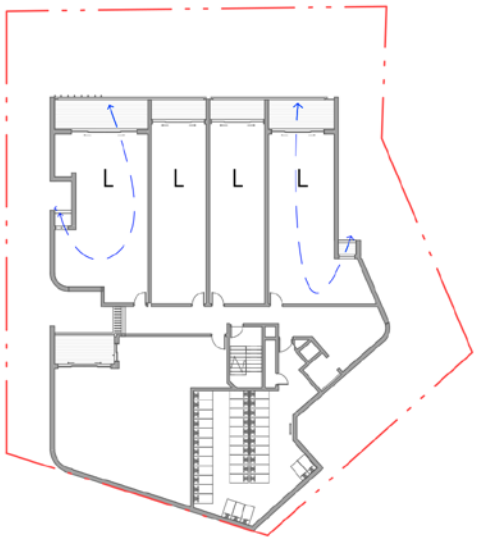
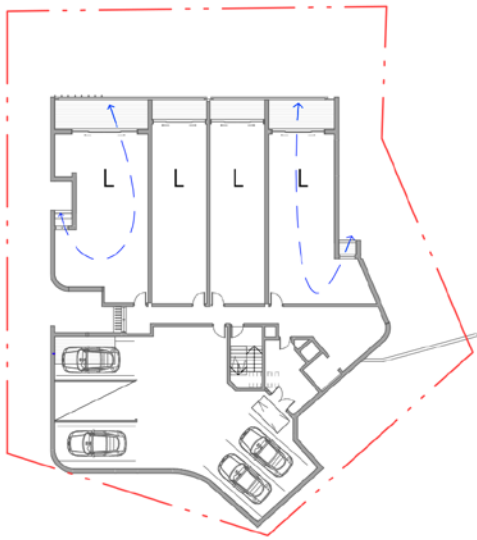
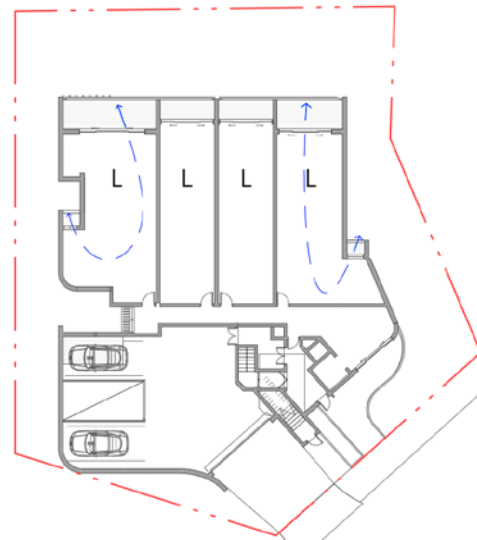
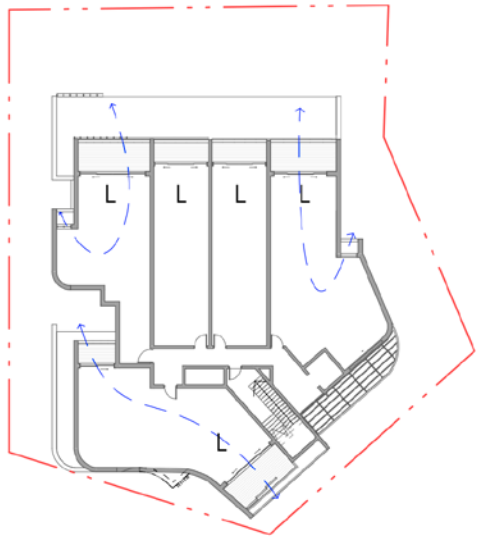
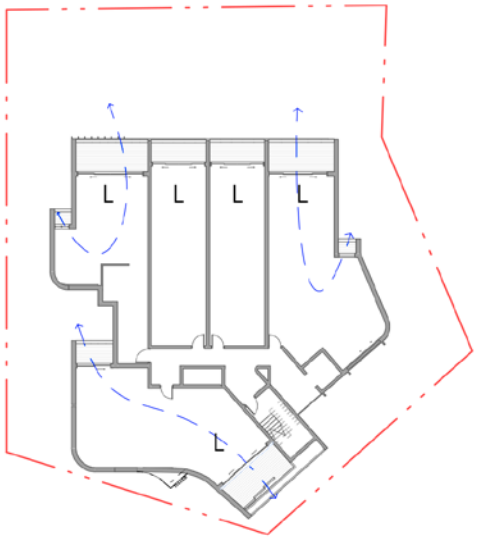
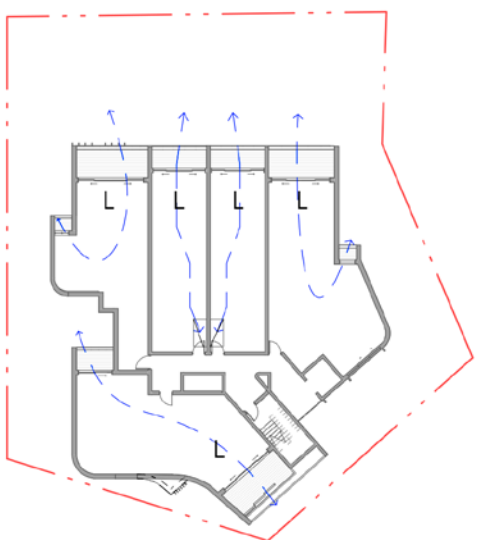
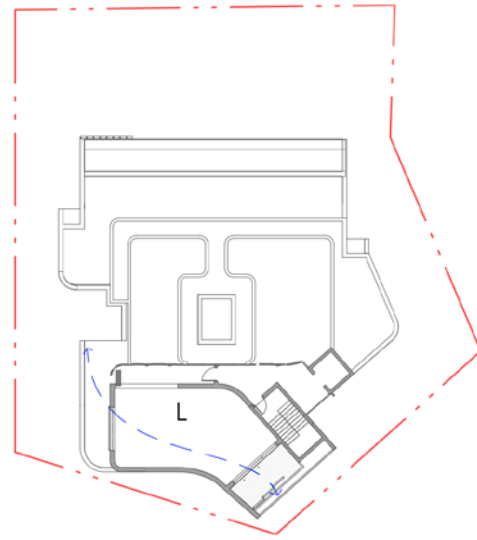
Total Units 33
Cross Ventilation Units 20 (60.6 %)
