Sealark Road, Callala Bay (Lot 5 DP 1225356) Preliminary Site Investigation (Desk Top)

Our Ref: TERRA19258.Rep 2 Rev 0

22 August 2019

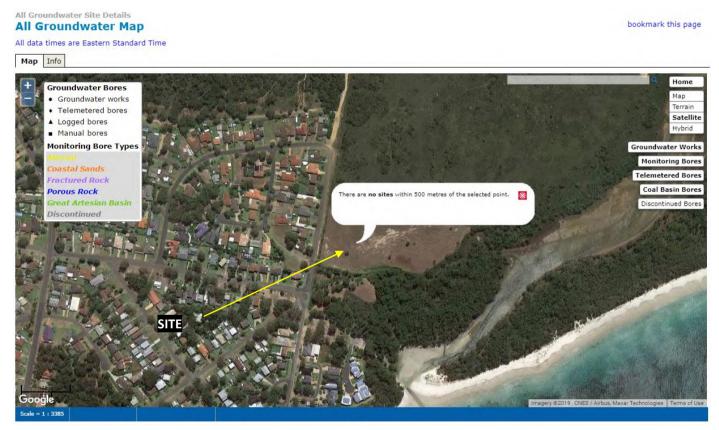
Image 1 Ground Water Map, NSW Real Time Water Data

No ground water bores were identified (by NSW State online water mapping services) within 500m of the Site as shown on Image 1.

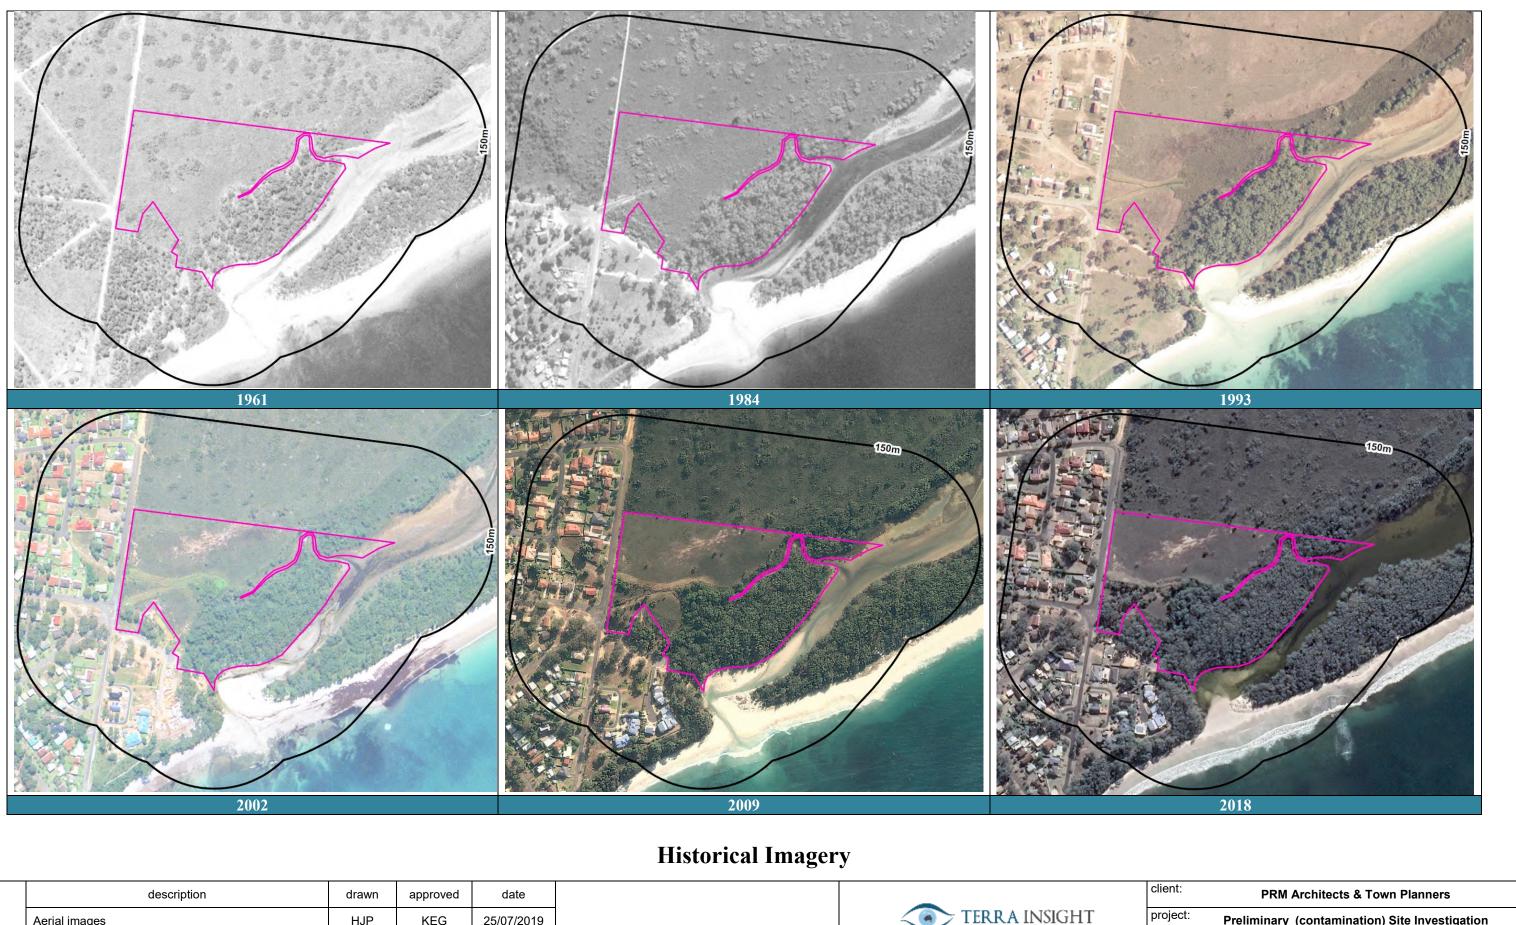
project no: TERRA19258	figure no: FIGURE 2

Historical Imagery

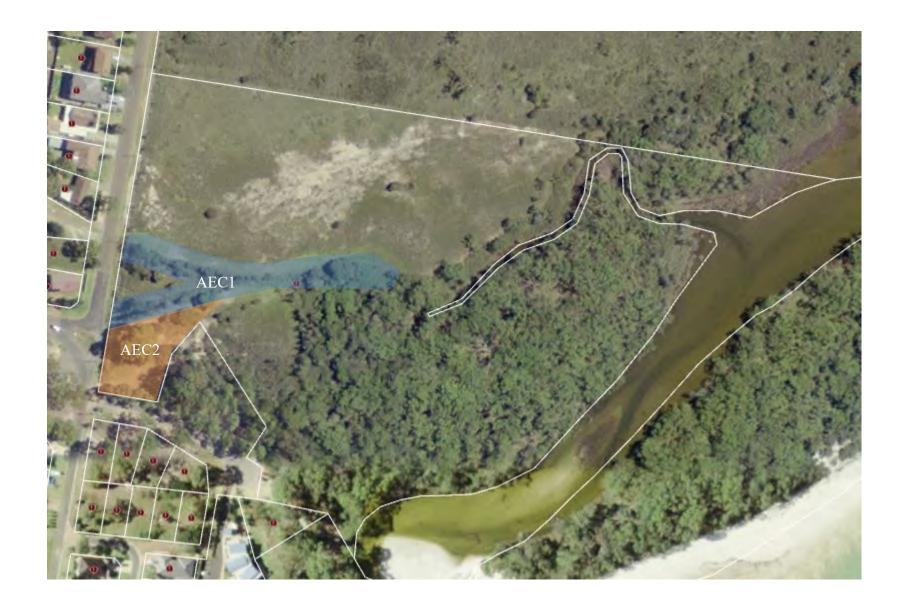
AEC 2	Illegal fly tipping	Potential illegal fly tipping near easily accessible points on the site.	Mainly Area 2 which is open for public access and is well vegetated. However, historically could have occurred as isolated events of fly tipping anywhere on the site.	LOW likelihood of potential soil contamination on the site as there was no evidence of a history of large-scale illegal dumping of waste material on the site. Some localised area of isolated house hold rubbish (Drink bottles and cans and plastic bags) were only observed in Area 2.	Foreign materials (mainly inert), Asbestos.

Areas of Environmental Concern

- Limited soil sampling within AEC 1 is recommended to allow waste classification to facilitate off-site disposal of the natural soils within this area and to establish if this area is impacted by:
 - Any residue from the historical use of pesticides to manage vegetation along the drainage channels;
 - low level hydrocarbon, BTEX, PAH or PCB contamination due to the use of these drainage depression to manage stormwater from the residential developments to the west of Sealark Road.
- Limited soil sampling across the remainder of the site is recommended to allow waste classification of the near surface soils for off-site disposal (if required). THs should be undertaken post removal of any inert debris found on the Site.
- An unexpected finds protocol should be established for the site.

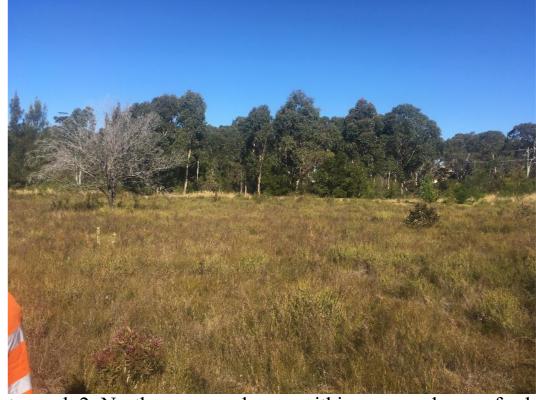
Photograph 2: Northern grassed area, within proposed area of subdivision, looking south west. Creek is located along tree line.

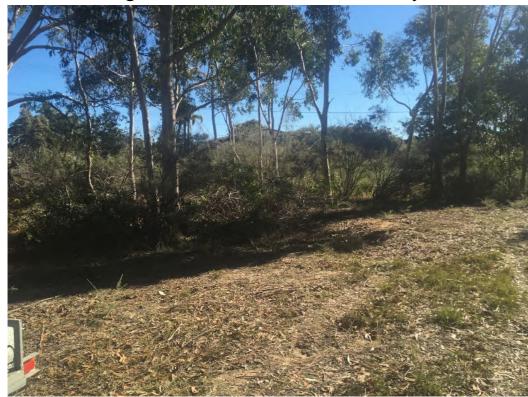
Photograph 7: Bushy area on the south west corner of the site, looking north west. A creek is amongst bushes in centre of picture.

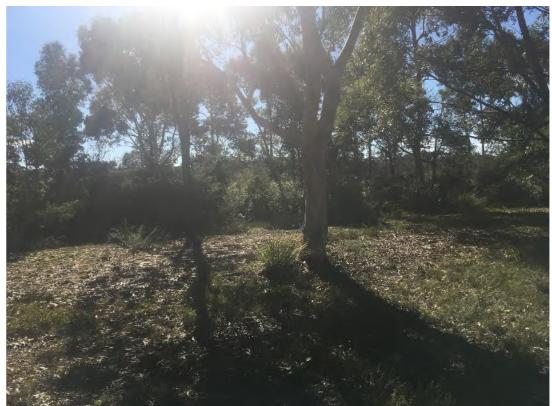
Photograph 8: Bushy area on the south west corner of the site, looking north. A creek is amongst bushes in centre of picture.

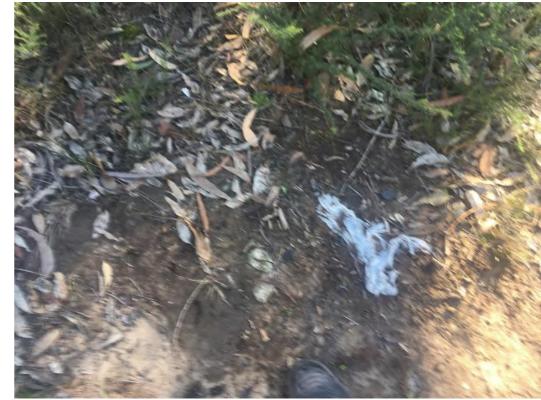
- This area is near level, vegetated with mature trees, bushes and grass.
 - Some litter was observed in this area, including plastic and glass bottles, tin drink cans and plastic bags.

- There were no observations of loose asbestos containing materials on the ground within areas 1 or 2. There were no observation indicative of historical illegal dumping of waste materials (car bodies, building materials etc) other than some house hold rubbish (Glass and plastic bottles, plastic bags and tin cans).

Photograph 13: Minor rubbish found on the surface, within bushy area on the south western corner of the site.
