Preliminary Watercourse and Riparian  
Assessment:  
Proposed Seniors Living Development;  
25 Laitoki Road, Terrey Hills, NSW.

P1806682JR04V01  
January 2019

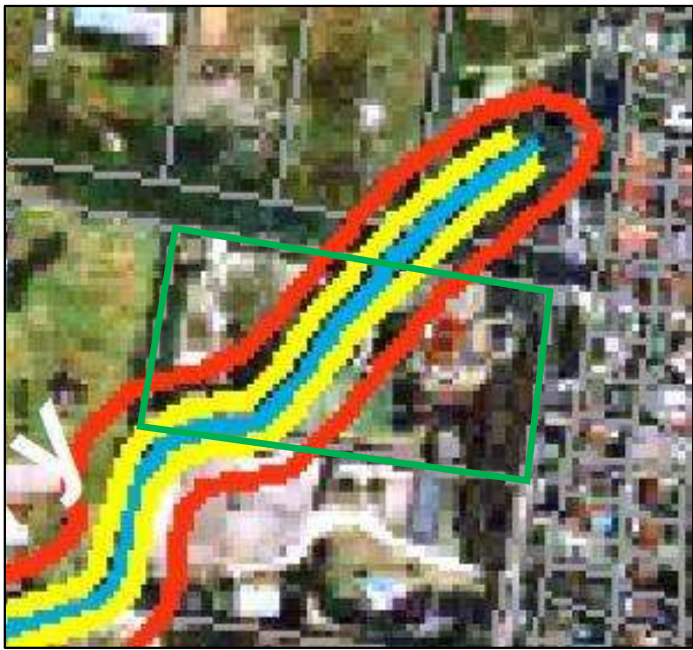
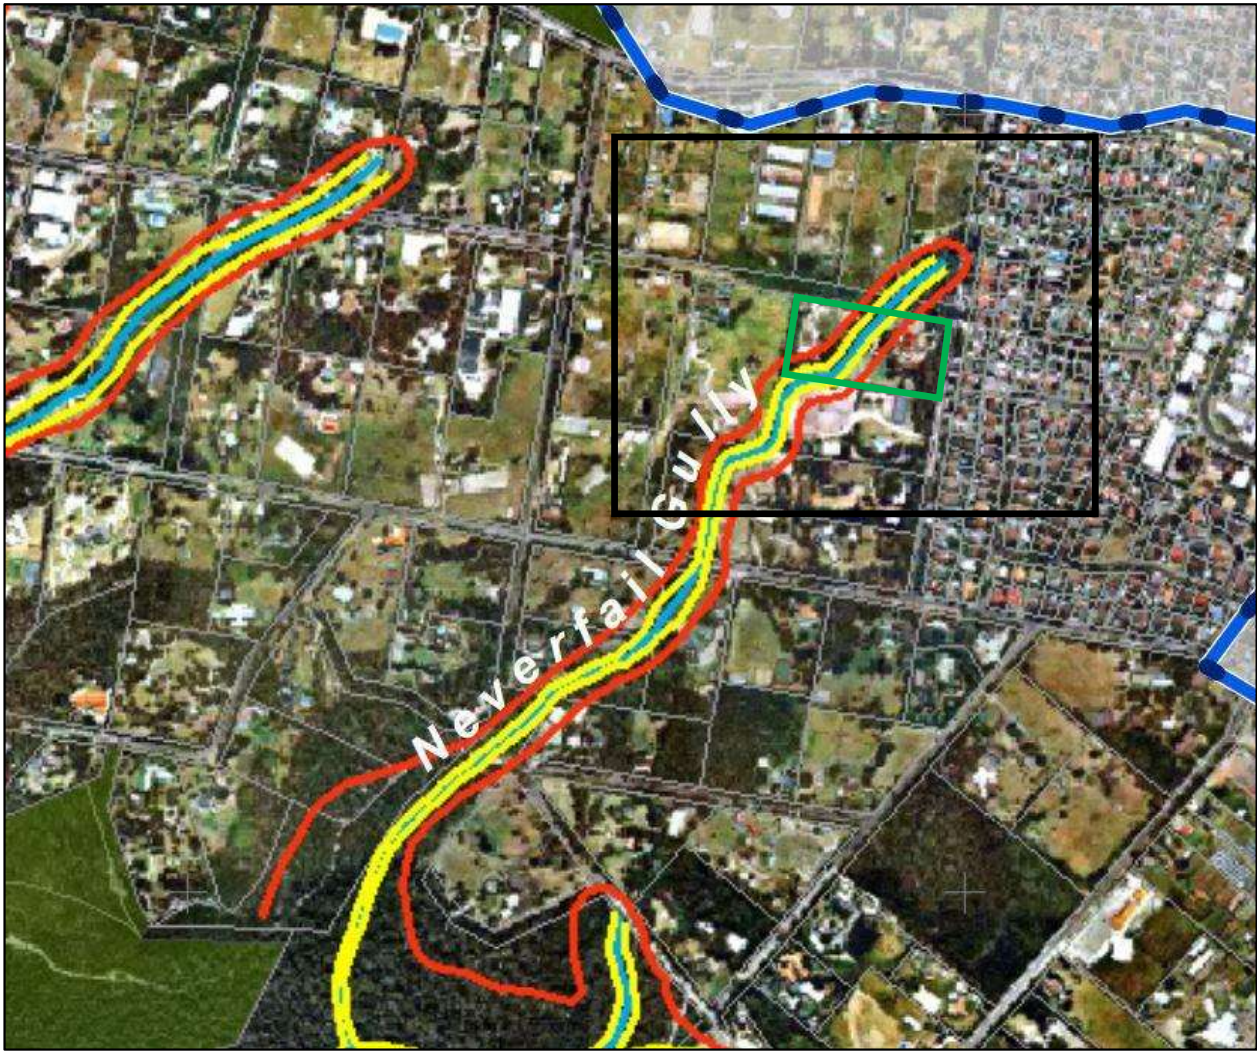
FIGURE 1

| Site Boundary | Riparian Zone | Catchment Extent |

Table 1 summarises the location and extent of likely construction and operational activities (associated with the development proposal) relative to riparian lands as identified in Figures 1 and 2 (Attachment B).

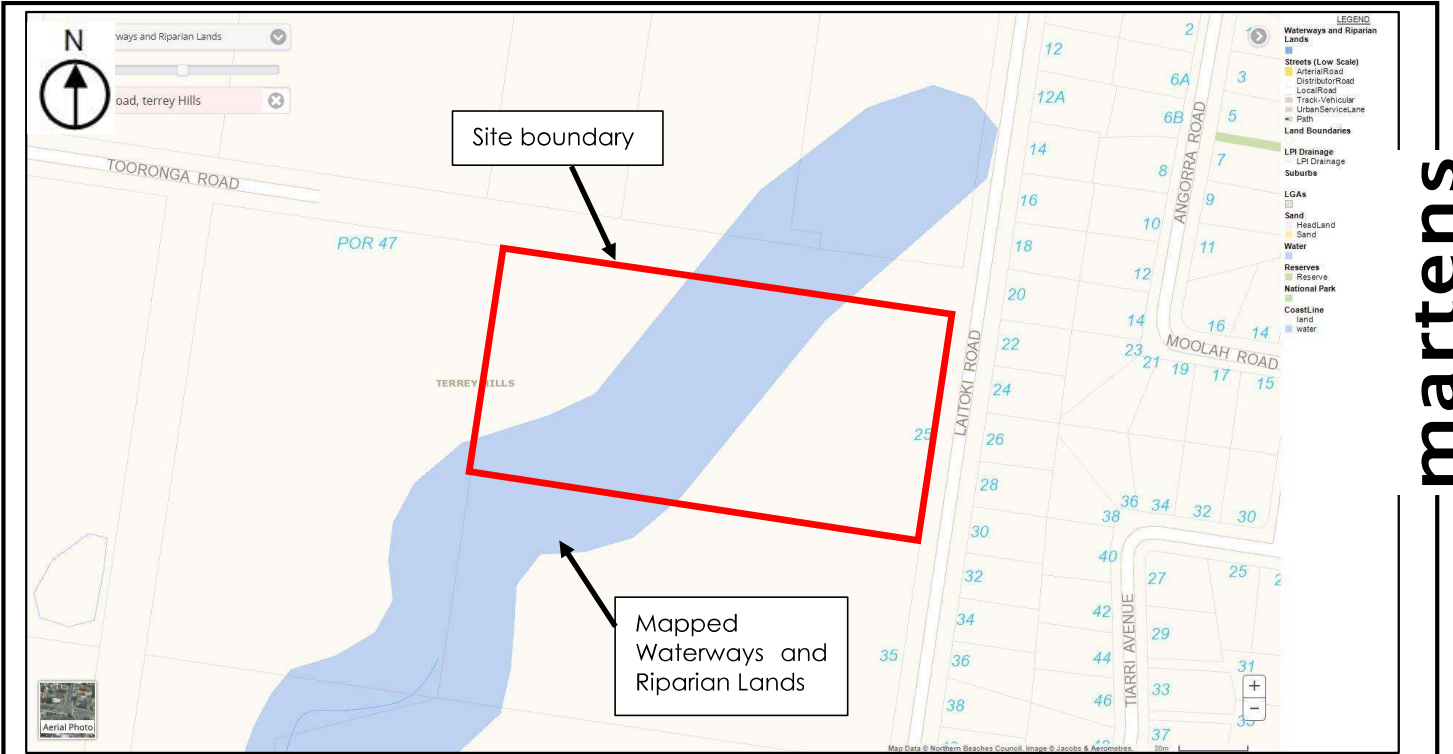
A central portion of the site is mapped as Waterways and Riparian Land by NBC, and this document addresses impacts to the waterway and proposed riparian management works within the mapped area onsite (refer to Figure 2, Attachment B).

**Waterways and Riparian Lands Mapping**  
Source: Northern Beaches Council website, 2018

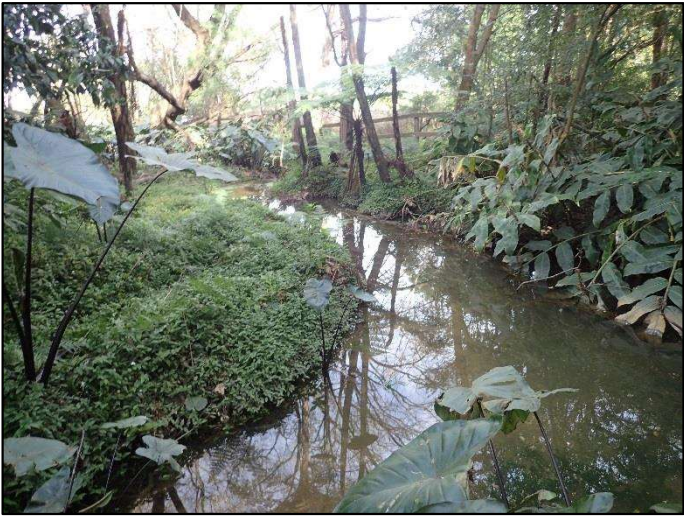
**Plate 1:** View north east of creek near northern site boundary.

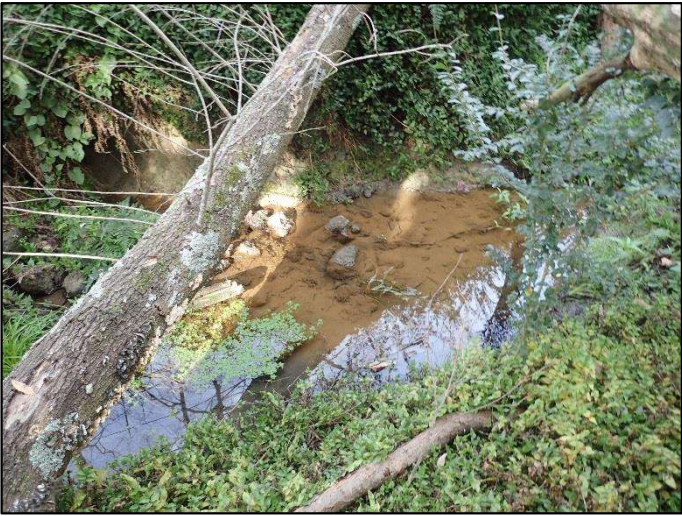
**Plate 2:** View south west of creek and vegetated banks, near northern site boundary.

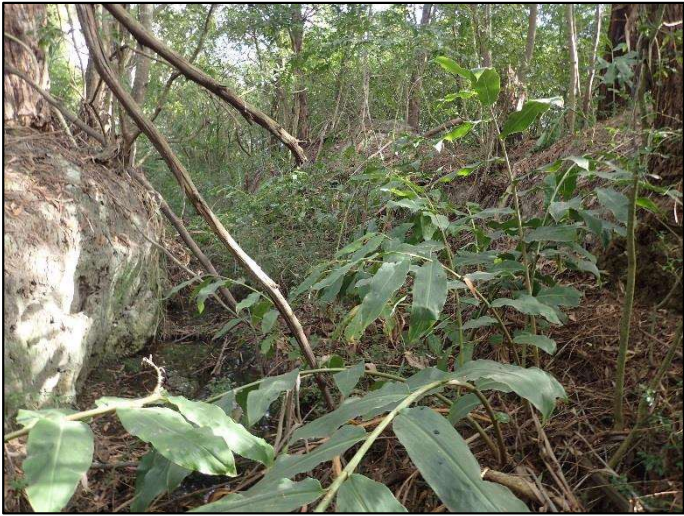
**Plate 3:** Dense exotic and native vegetation near northern portion of creek reach, view to west.

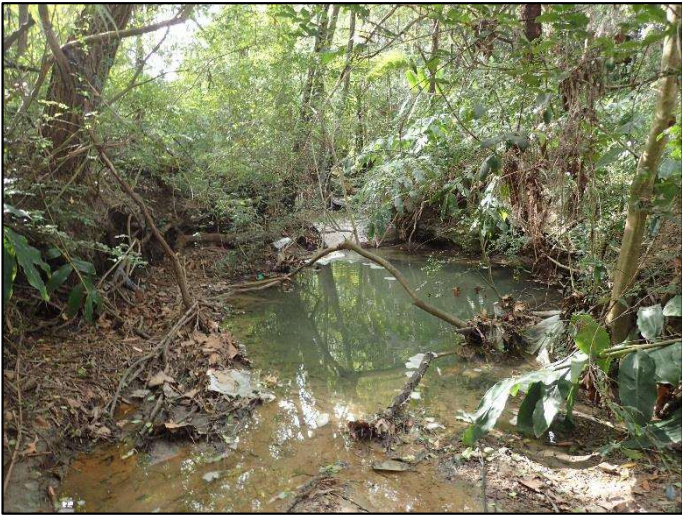
- The watercourse appears modified from its natural state. Stormwater discharges from upslope properties have incised the channel and in some sections the banks are greater than 3 m in height with near vertical drops. The erosion has led to a high degree of undercutting resulting in unstable banks.

- Erosional features, such as undercutting and scour pools were noted within the creek.
- Creek water quality is impacted by sedimentation and gross pollutants.

**Plate 4:** View east of disturbed creek, from northern portion of creek reach.

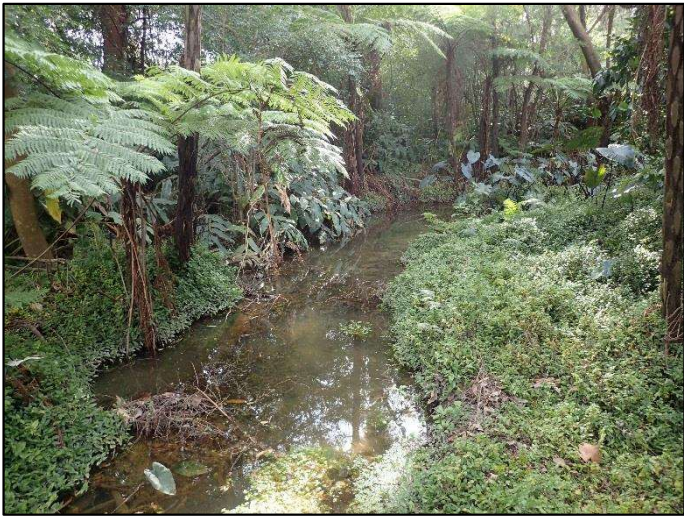
**Plate 5:** Riparian vegetation onsite and creek channel, view to west of central portion of creek reach.

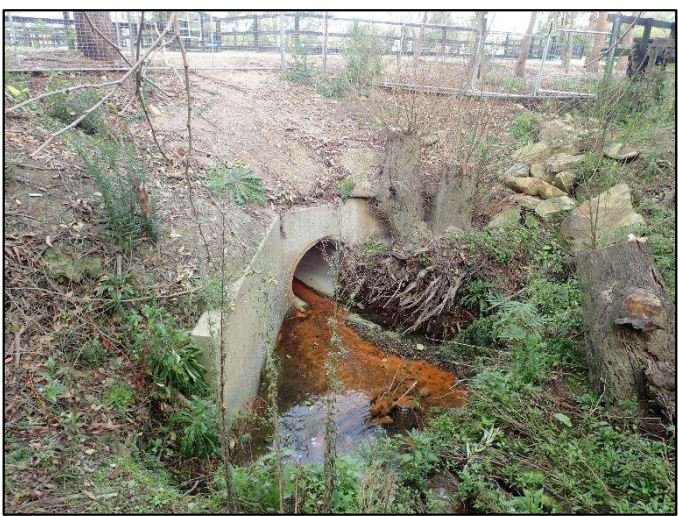
- The lower portion of the watercourse has had its banks widened likely due to the creation of the headwall and piped easement in conjunction with filling at the overland flow path by up to 1 m on the southern property being 35 Laitoki Road. The restriction of flows causes backing up of stormwater flows and flooding at the southern portion of the site during large rain events.

**Plate 6:** View of headwall and filling at southern site boundary to adjacent property to south.
