Playoust Churcher Architects

Desktop Geotechnical Assessment:  
25 Laitoki Road, Terrey Hills, NSW

P1806682JR01V01  
January 2019

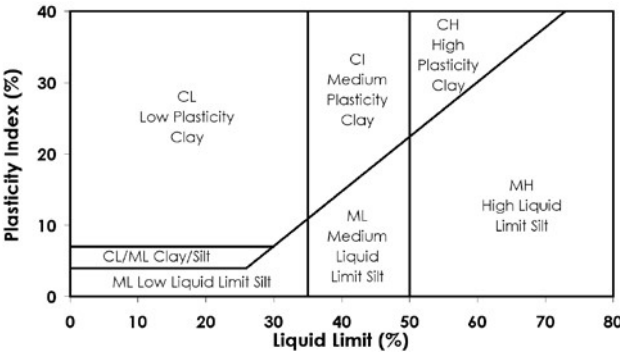
Plasticity Properties

Plasticity properties of cohesive soils can be assessed in the field by tactile properties or by laboratory procedures.
