**UPDATED REPORT**

**'DUE DILIGENCE' GEOTECHNICAL INVESTIGATION**

**PROPOSED ILU & RACF DEVELOPMENT**

**BLACKTOWN WORKERS SPORTS CLUB**  
**170 RESERVOIR ROAD, ARNDELL PARK, NSW**

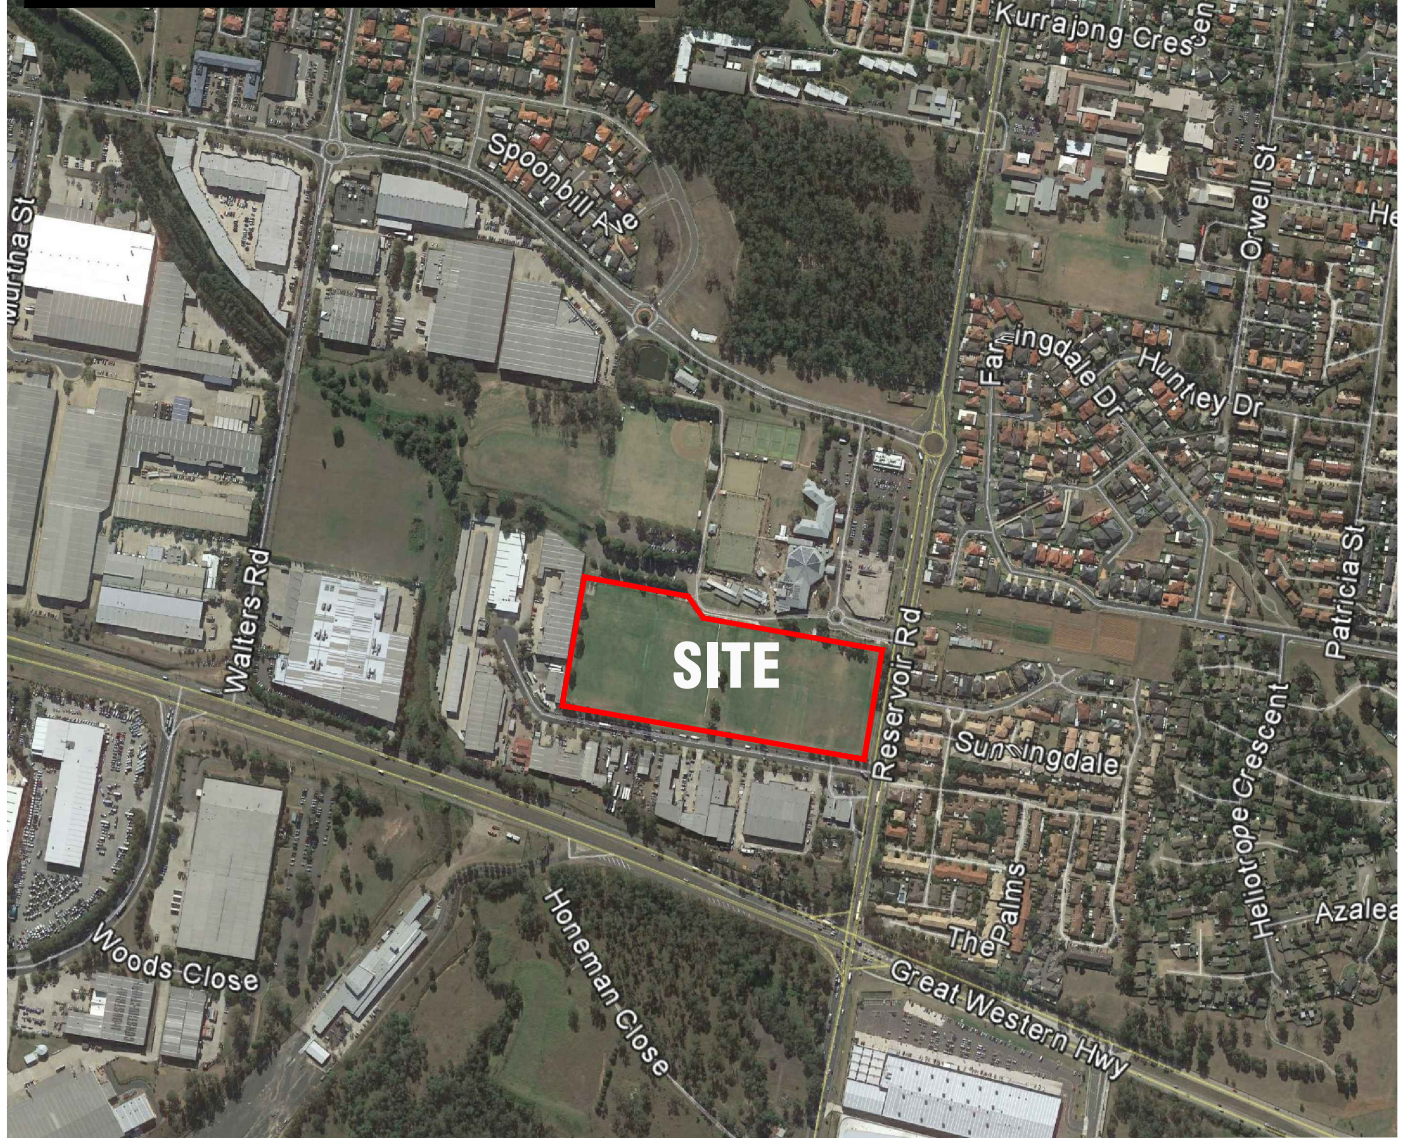
AERIAL IMAGE SOURCE: GOOGLE EARTH PRO 7.1.5.1557  
AERIAL IMAGE ©: 2015 GOOGLE INC.

This plan should be read in conjunction with the JK Geotechnics report.

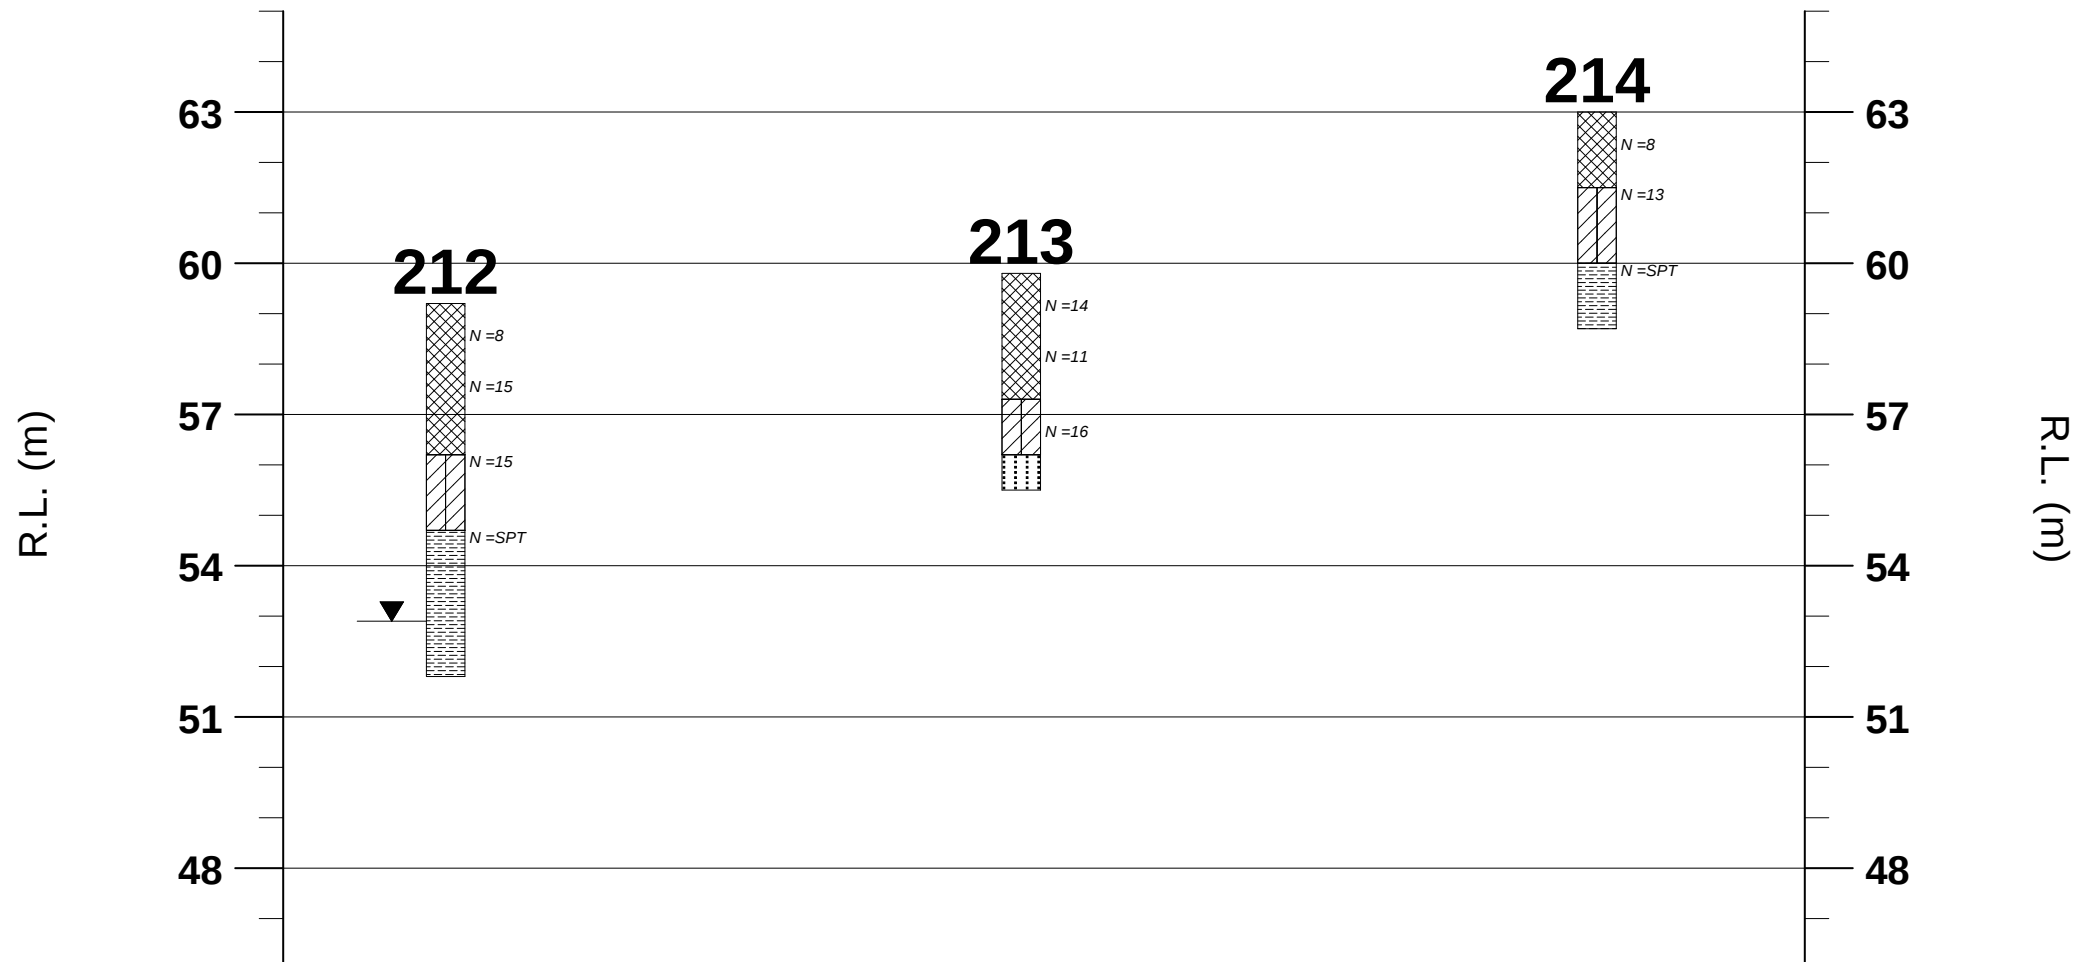
# GRAPHICAL BOREHOLE SUMMARY

| | Fill | | Sandstone/<br>Greywacke | Nc | SOLID CONE<br>BLOW<br>COUNTS<br>PER 150mm |
| | Silty Clay | | Observed<br>water<br>level | | |

NOTE: REFER TO BOREHOLE LOGS

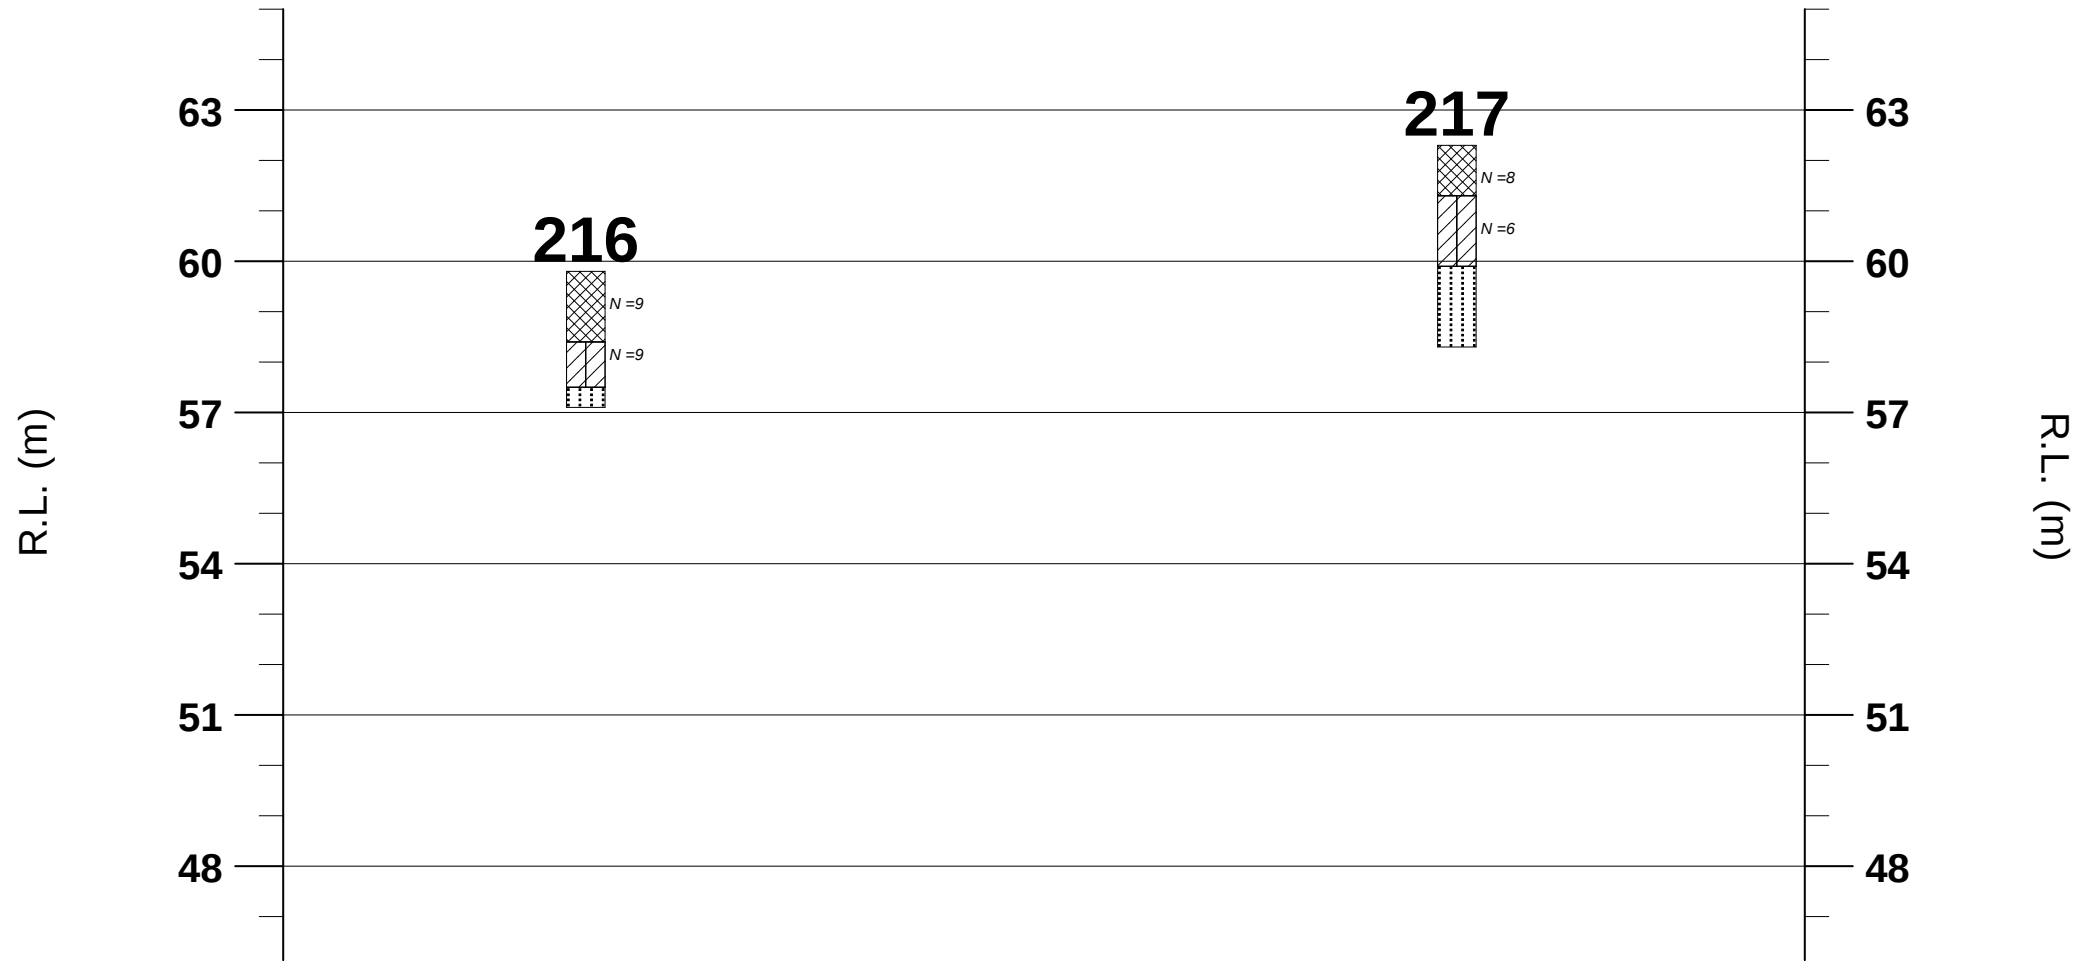
# GRAPHICAL BOREHOLE SUMMARY

| | Fill | N | SPT "N" VALUE |
| | Silty Clay | Nc | SOLID CONE BLOW COUNTS PER 150mm |

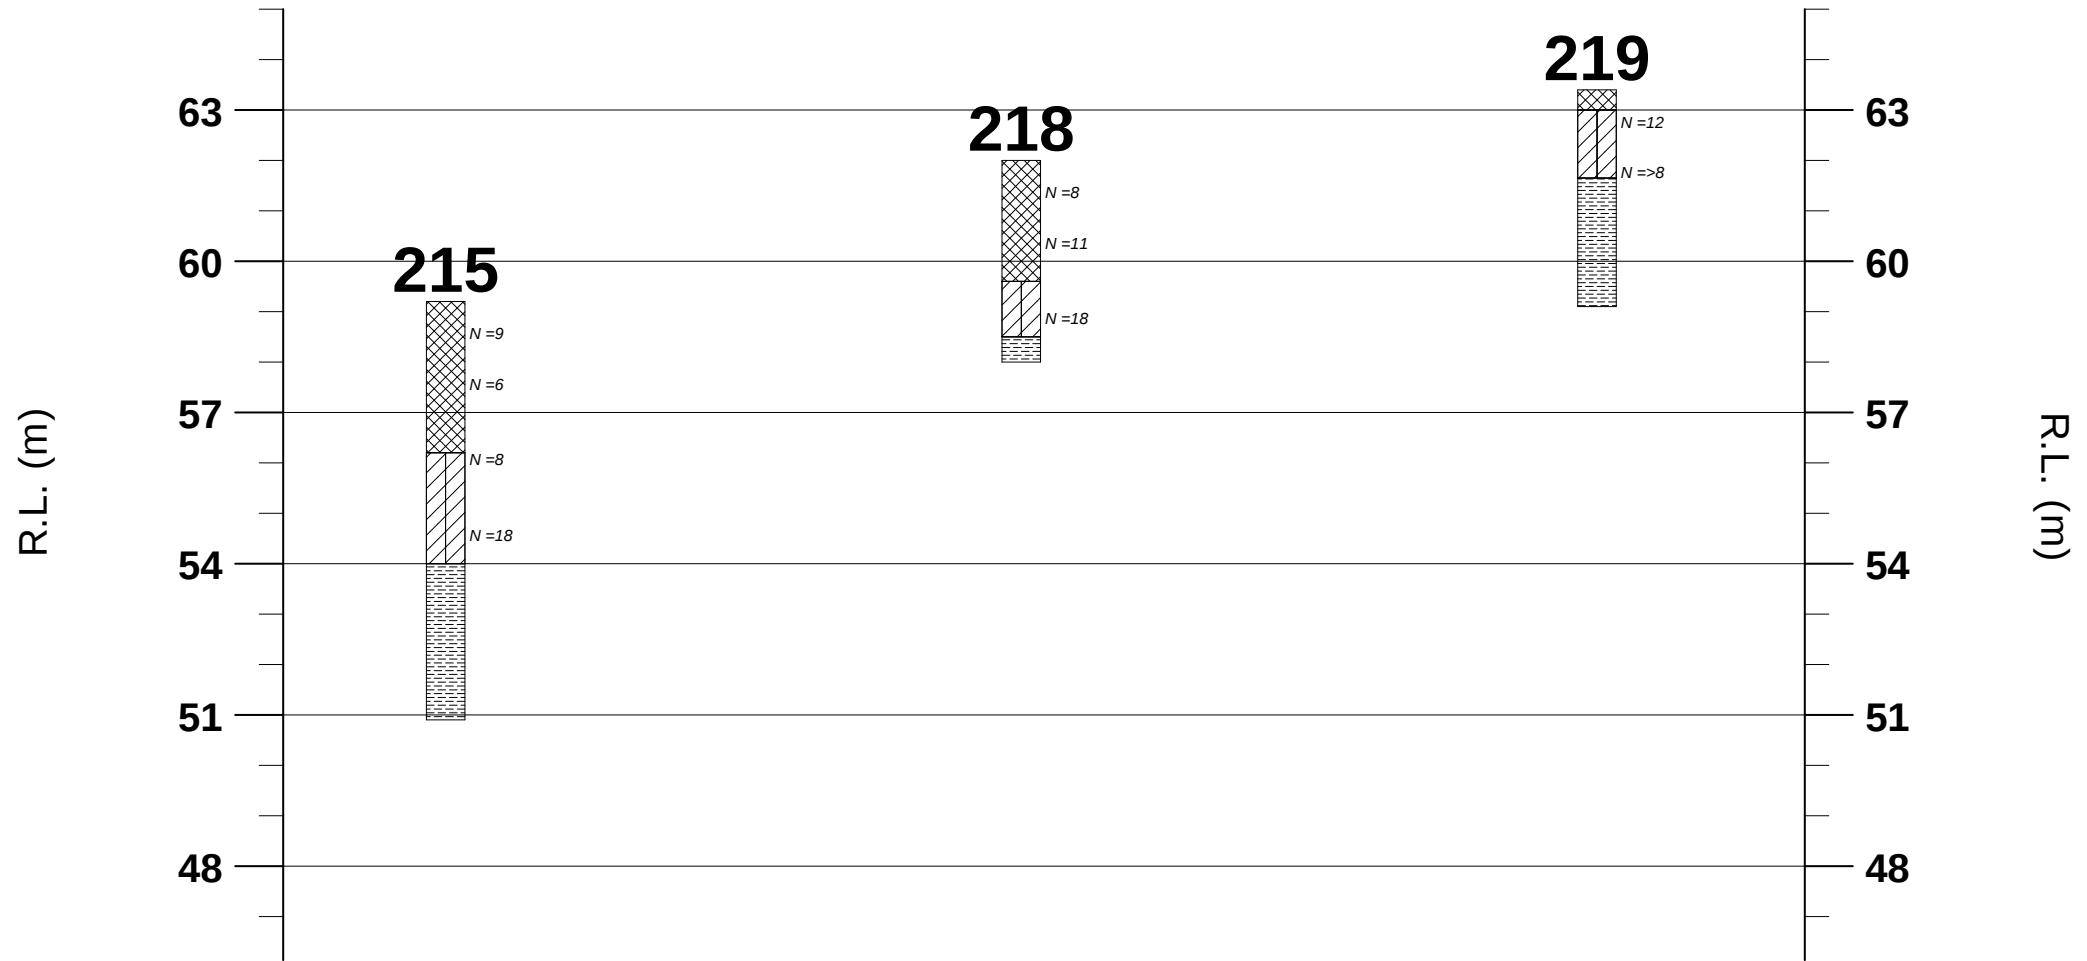
# GRAPHICAL BOREHOLE SUMMARY

Fill

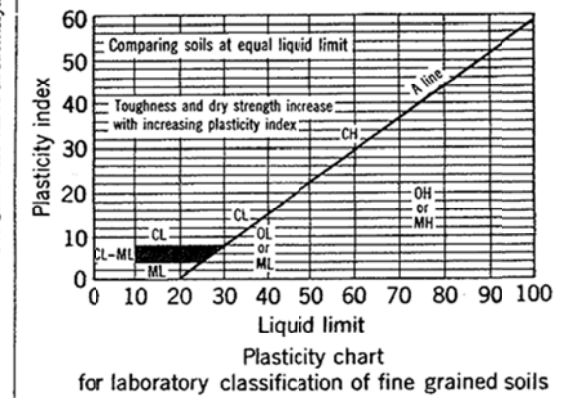
Note: 1 Soils possessing characteristics of two groups are designated by combinations of group symbols (eg. GW-GC, well graded gravel-sand mixture with clay fines).  
2 Soils with liquid limits of the order of 35 to 50 may be visually classified as being of medium plasticity.
