Asbestos and Hazardous Materials Pre-Demolition Assessment

Block B

Wyong Public Hospital

21/08/2023

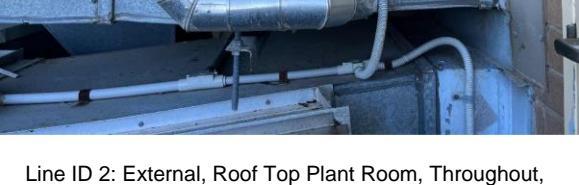
Around Heating Coils Within Ductwork, Millboard Insulation -Suspected Asbestos

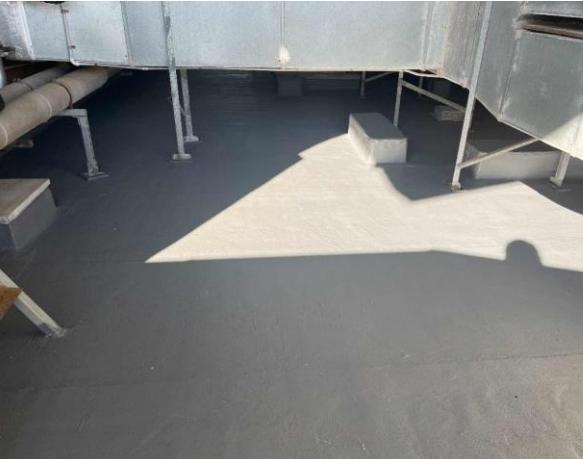
Line ID 3: External, Roof Top Plant Room, Throughout, Ductwork, Mastic Sealant - No Asbestos Detected

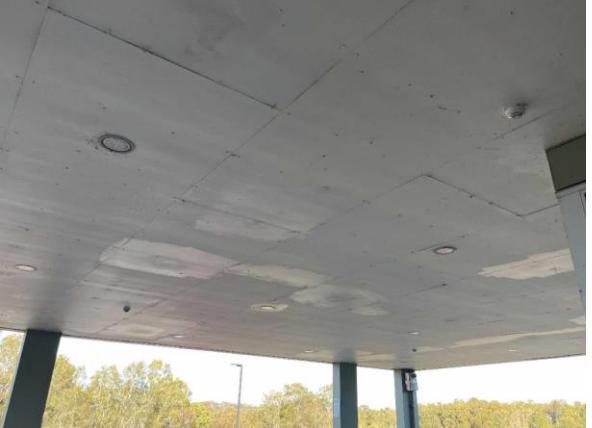
Line ID 6: External, Southern Side, Main Entrance to Building, Awning, Fibre Cement Sheet - Suspected Asbestos

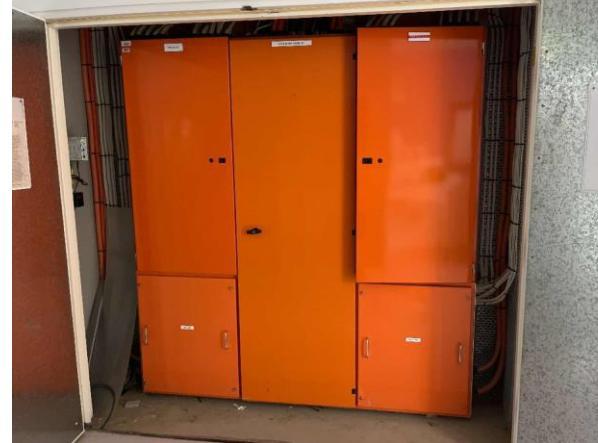
Line ID 19: Internal, House Doctor / Emergency Pediatric, EMW.C.10 Distribution Cupboards, Within Distribution Boards, HRC fuses - Suspected Asbestos

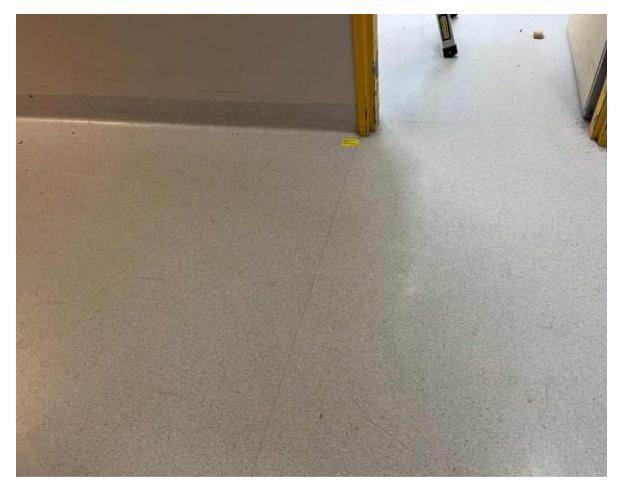
Line ID 20: Internal, House Doctor / Emergency Pediatric, EMW.C.11, Fire Door, Fire Door Core - No Asbestos Suspected

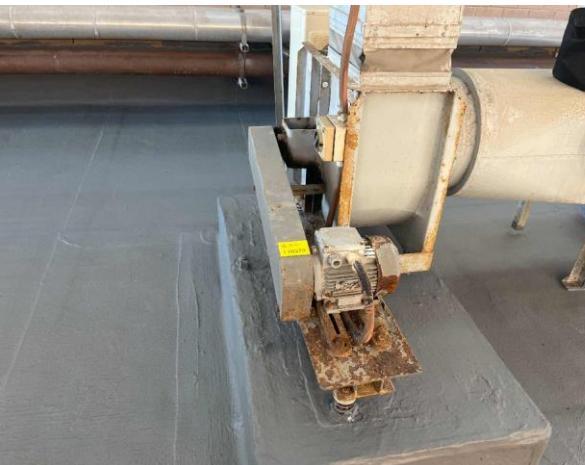
Line ID 42: External, Roof Top Plant Room, Throughout, Ductwork, Grey (Light) Paint - Lead Detected (0.02% w/w)

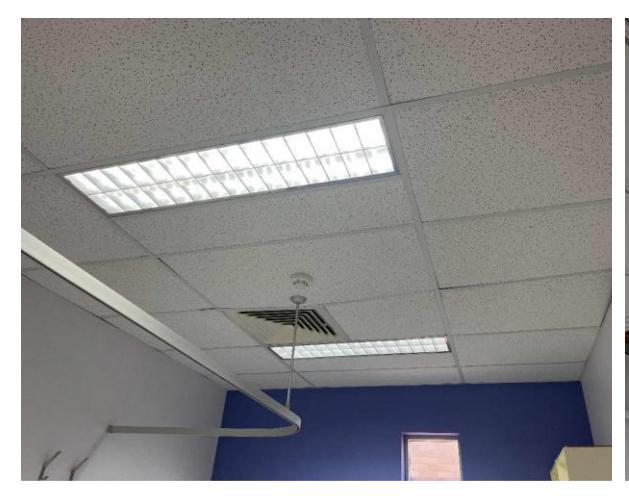
Line ID 54: Internal, Acute Emergency Unit, Throughout, Walkway Ceilings, Compressed Ceiling Tiles - Suspected SMF

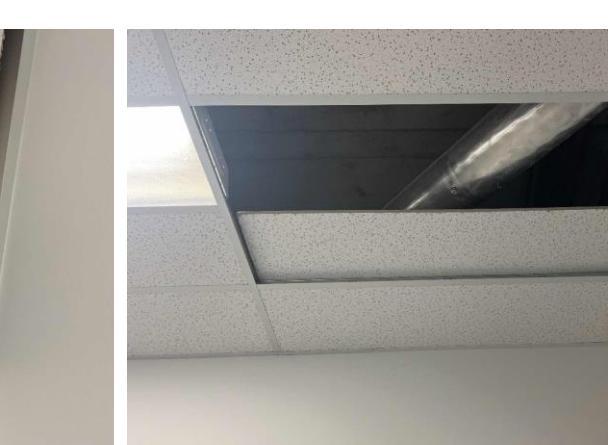
Line ID 55: Internal, House Doctor / Emergency Pediatric, Throughout, Ceiling, Compressed Ceiling Tiles - Suspected SMF

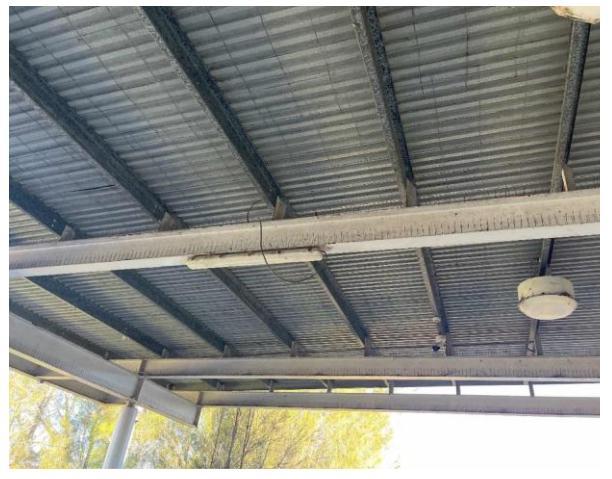
Line ID 65: Internal, Roof Top Plant Room, Throughout, Various Locations, Loose Insulation - Suspected SMF

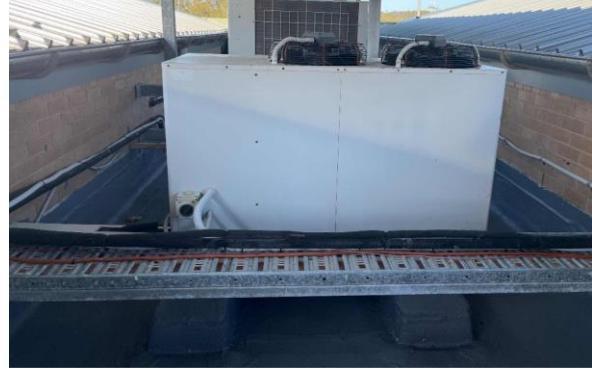
Line ID 71: External, Roof Top Plant Room, Central Area, Temperzone AC Unit, R410A Hydrofluorocarbon (HFC) - Non ODS Refrigerant

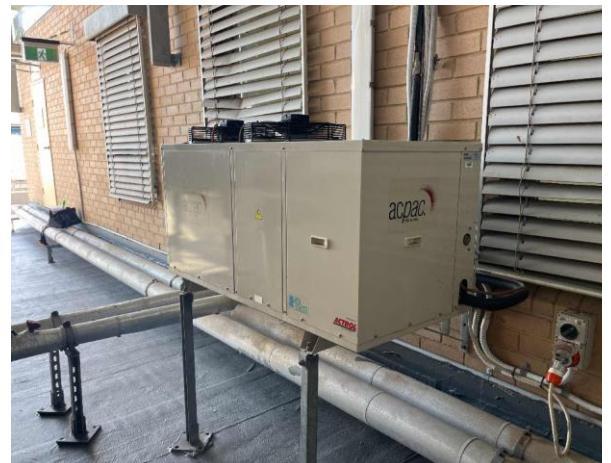
Line ID 72: External, Roof Top Plant Room, Central Area, Uni-Aire AC Unit, R22 Hydrochlorofluorocarbon (HCFC) -ODS Refrigerant

Removal of refrigerants should be undertaken prior to any future demolition, partial demolition, renovation or refurbishment, where ODS's are likely to be disturbed. A licensed contractor who will recycle and reuse the refrigerant should decommission CFC and HCFC based equipment that is being disposed of in accordance with Association of Fluorocarbon Consumers and Manufacturers, The Australian Refrigeration and Air Conditioning Code of Good Practice – 1992 and the Australian Commonwealth Government Ozone Protection Act – 1989.

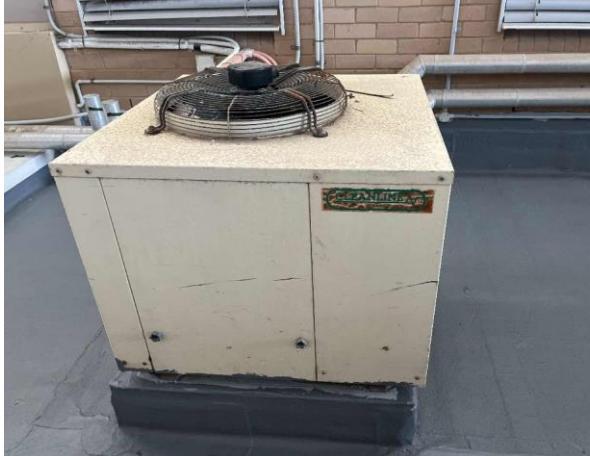
Line ID 74: External, Roof Top Plant Room, Northern Eastern Side, Apac Heat Pump, R22 Hydrochlorofluorocarbon (HCFC) - ODS Refrigerant

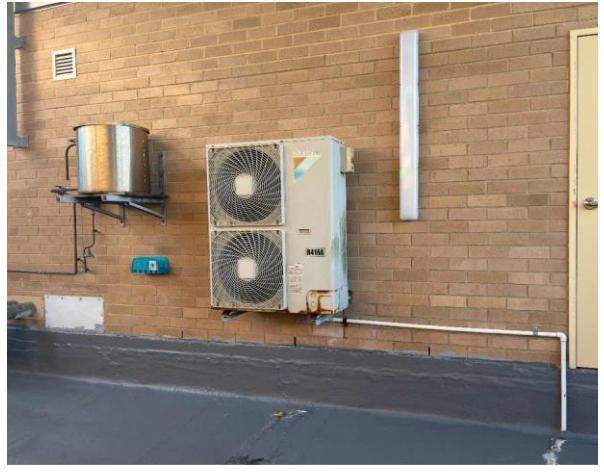
Line ID 77: External, Roof Top Plant Room, Western Side Between Ceiling 1, Central Area, Actrol Unit, R134a Refrigerant - Non ODS Refrigerant
