Asbestos and Hazardous Materials Pre-Demolition Assessment

Block C

Wyong Public Hospital

754-SYDEN329755 - Wyong Public Hospital, Block C - HMDR - 02082023

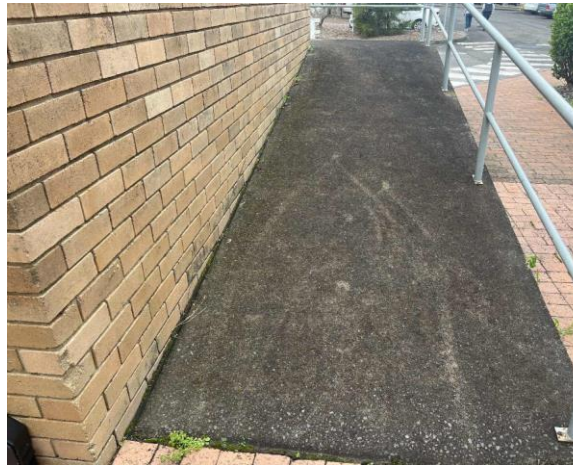
Line ID 13: External, Paediatric Unit, South Side, Ramp, Expansion Joint - No Asbestos Detected

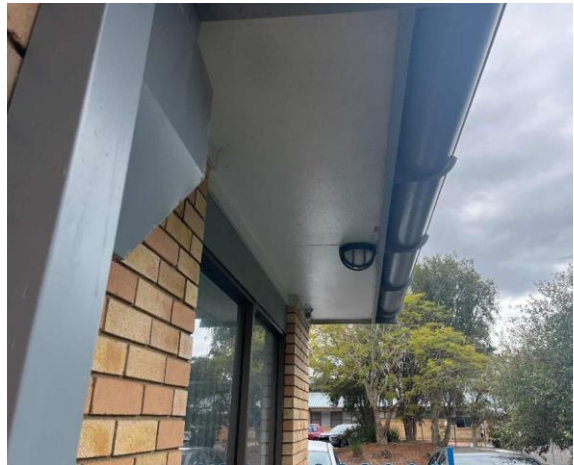
Line ID 15: External, Paediatric Unit, Throughout, Eaves, Fibre Cement Sheet - Chrysotile Asbestos Detected

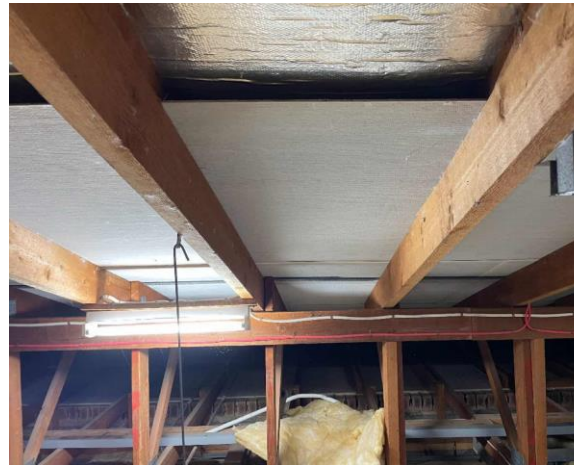
Line ID 23: Internal, Geriatric Unit, Rooftop Plant Rooms, Various Locations Throughout, Fibre Cement Sheet - No Asbestos Detected

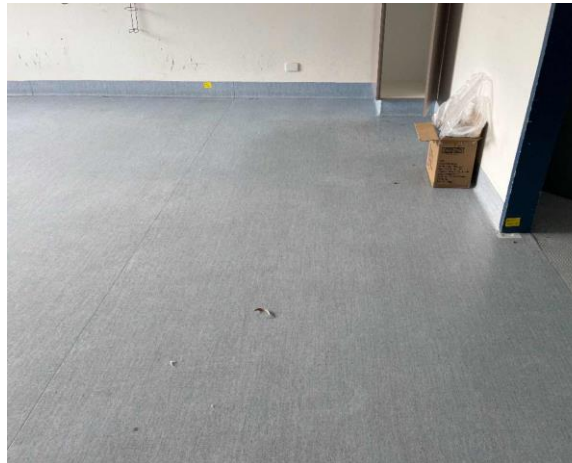
Line ID 27: Internal, Geriatric Unit Ground Level, Throughout, Below Light Blue Vinyl Sheet, Screed - No Asbestos Detected

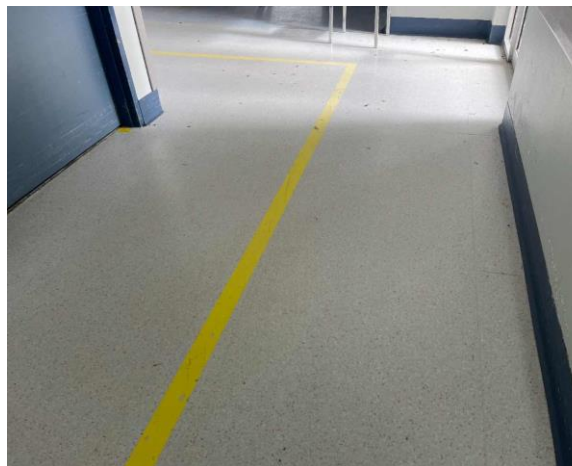
Line ID 29: Internal, Geriatric Unit Ground Level, Throughout, Floor Coverings, White Vinyl Sheet - No Asbestos Detected

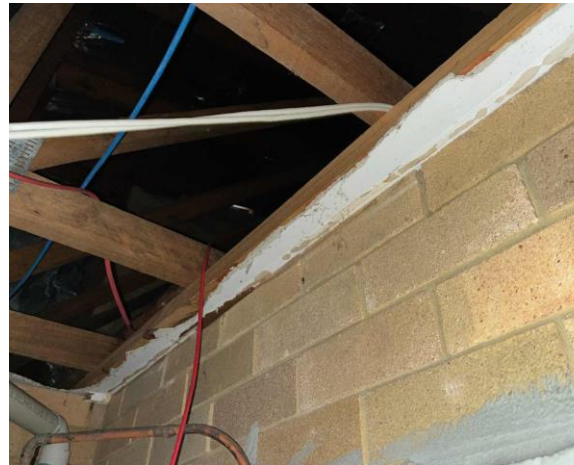
Line ID 33: Internal, Paediatric Unit, Adjacent NUM Room 30083, False Ceiling, Fibre Cement Sheet - Chrysotile Asbestos Detected

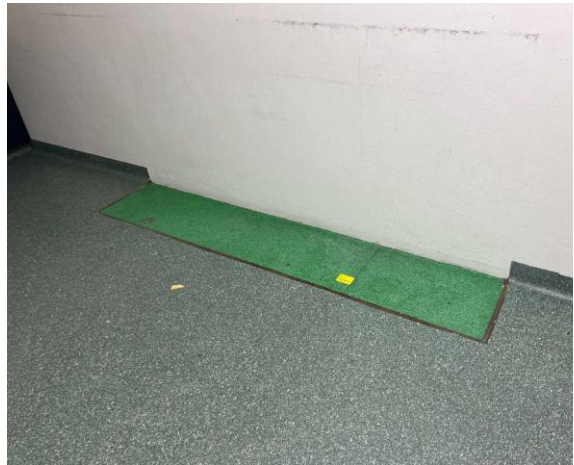
Line ID 46: Internal, Paediatric Unit, Southern Room 30089, Floor Covering, Light Green Vinyl Sheet and Paper Backing - Chrysotile Asbestos Detected

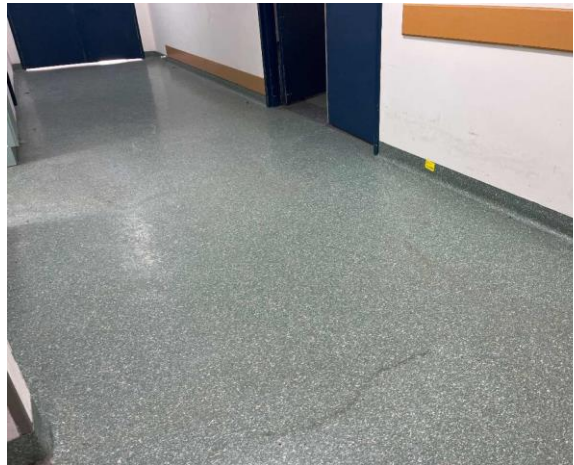
Line ID 48: Internal, Paediatric Unit, Throughout, Floor Covering, Green Vinyl Sheet - No Asbestos Detected

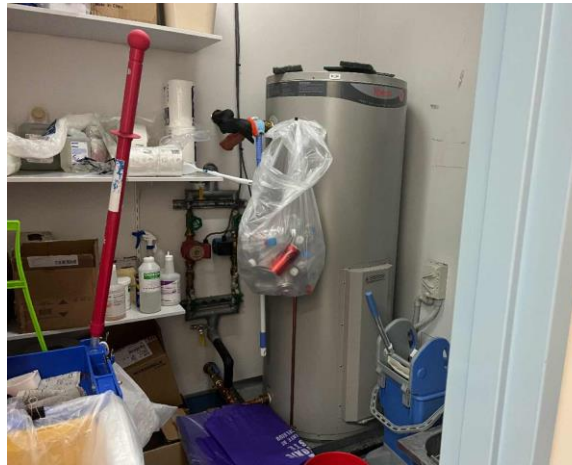
Line ID 62: Internal, Cancer Care Unit, Cleaners Room, Hot Water Heater, Internal Insulation - Suspected SMF

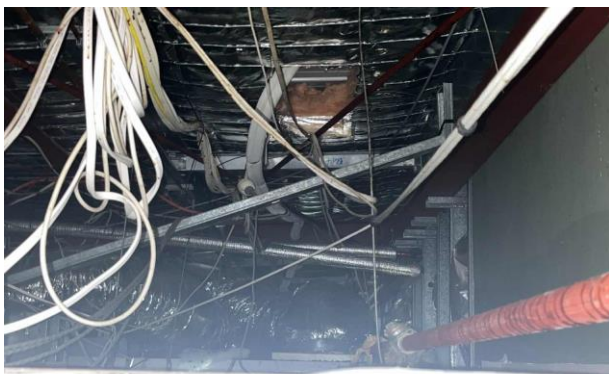
Line ID 65: Internal, Cancer Care Unit, East and West Sides, Flexible Ductwork, Internal Insulation - Suspected SMF

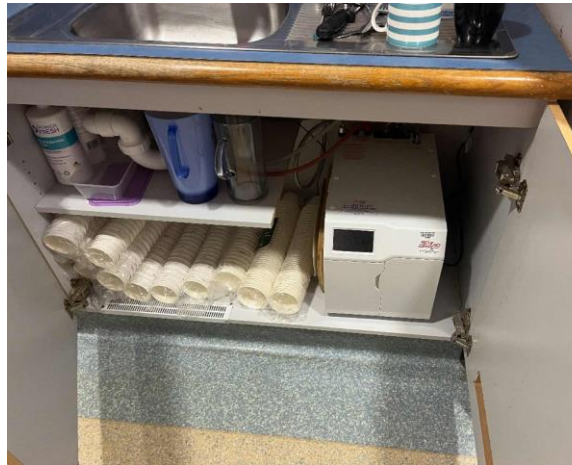
Line ID 69: Internal, Cancer Care Unit, Kitchen, Boiler Below Sink, Internal Insulation - Suspected SMF

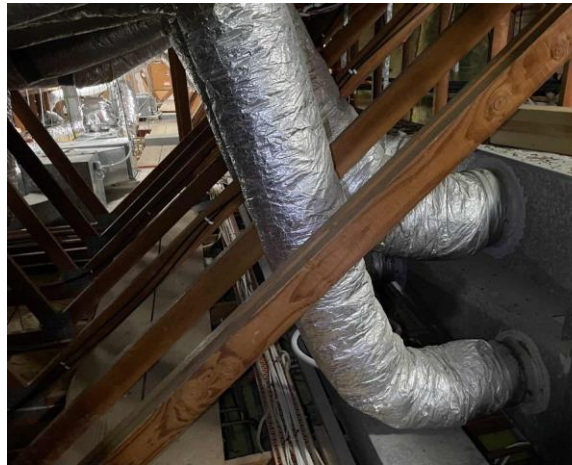
Line ID 71: Internal, Geriatric Unit, Rooftop Plant Rooms, Flexible Ductwork Throughout, Internal Insulation - Suspected SMF

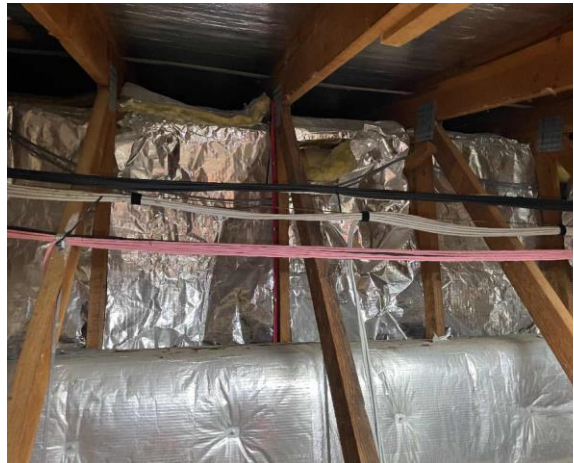
Line ID 75: Internal, Geriatric Unit, Rooftop Plant Rooms, Walls Throughout, Sarking Insulation - Suspected SMF

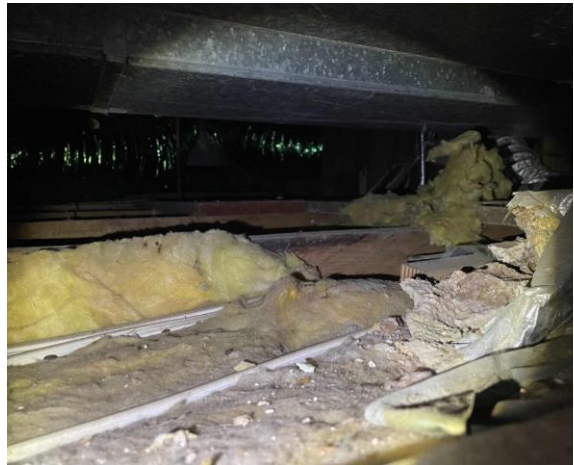
Line ID 83: Internal, Paediatric Unit, Ceiling Space, Throughout, Insulation Batts - Suspected SMF

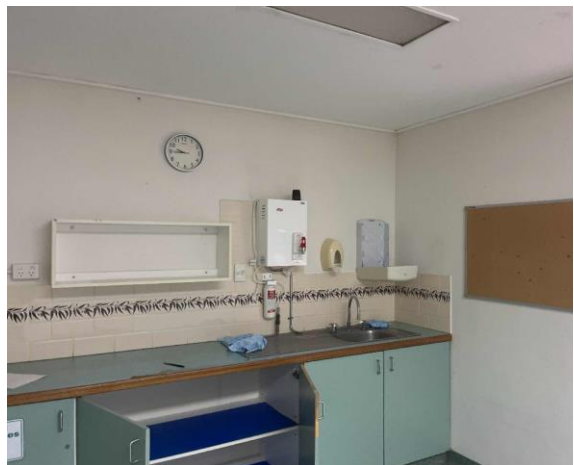
Line ID 85: Internal, Paediatric Unit, Kitchen 30074, Hot Water Heater, Above Sink, Internal Insulation - Suspected SMF

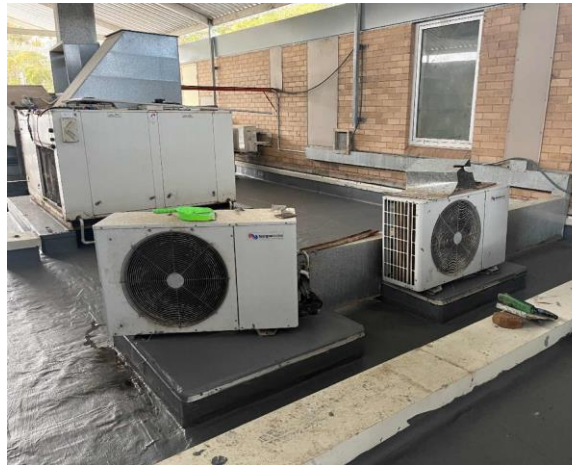
Line ID 90: External, Geriatric Unit Roof, Rooftop Plantroom, Temperzone AC Units, R410A Hydrofluorocarbon (HFC) - Non ODS Refrigerant

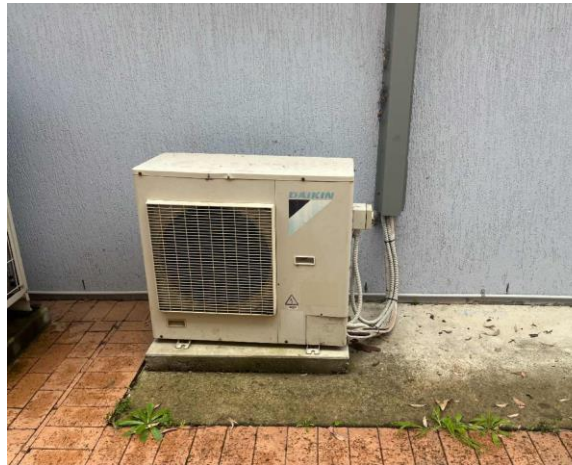
Line ID 92: External, Paediatric Unit, South Side, Daikin AC unit, Unknown Refrigerant - Suspected ODS
