Health Infrastructure
Pre-Demolition Hazardous Building Materials Survey

Wentworth Health Services Facility
Wentworth, NSW

20 September 2022
63097/ 147,383 (Rev 0)
JBS&G

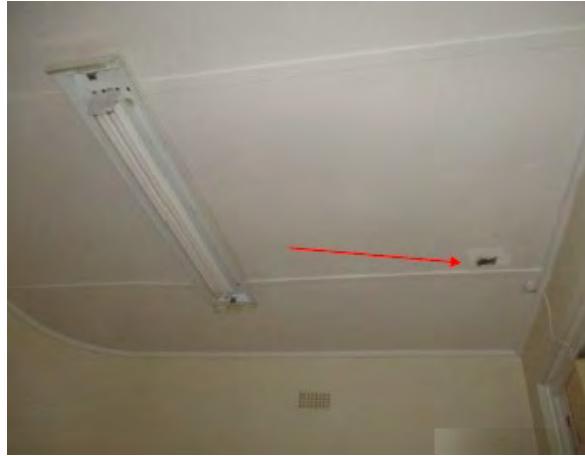
Photo 2: Wentworth Hospital Services – Asbestos containing FCS to ceiling of Former Maternity Pan RoomFormer Maternity Bathroom Ceiling Lining

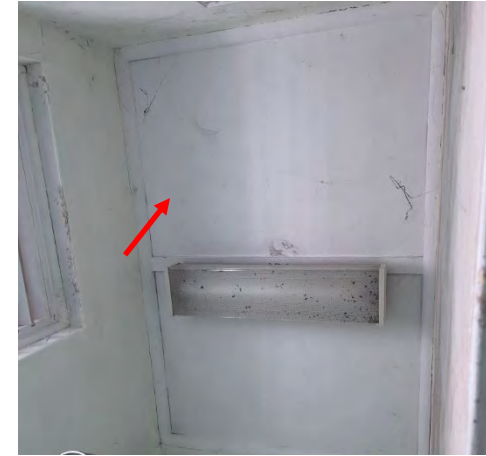
Photo 3: Wentworth Hospital Services - Former Maternity Bathroom Asbestos Ceiling Lining

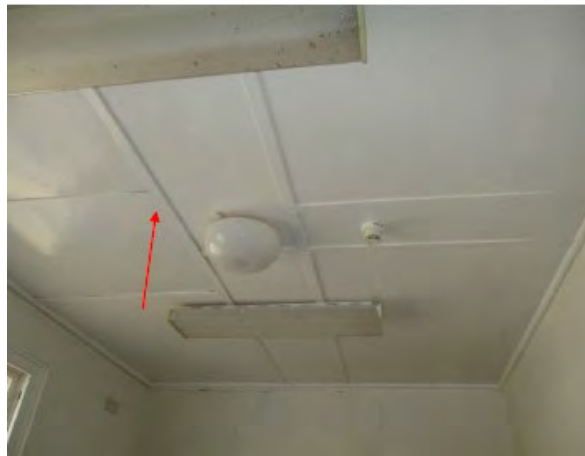
Photo 5: Wentworth Hospital Services – Former Surgical sterile room asbestos ceiling lining

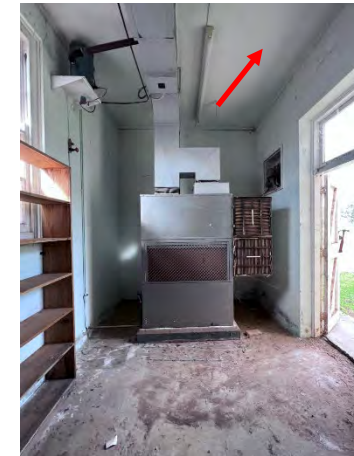
Photo 6: Wentworth Hospital Services – Old Records Room asbestos ceiling lining

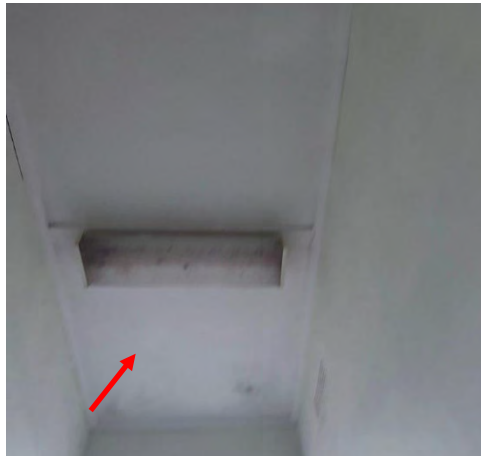
Photo 7: Wentworth Hospital Services - North-western staff bathroom asbestos ceiling lining

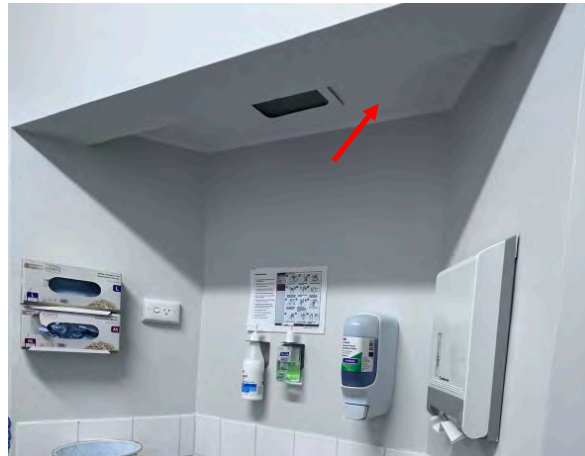
Photo 8: Wentworth Hospital Services - North-western staff bathroom alcove asbestos ceiling lining

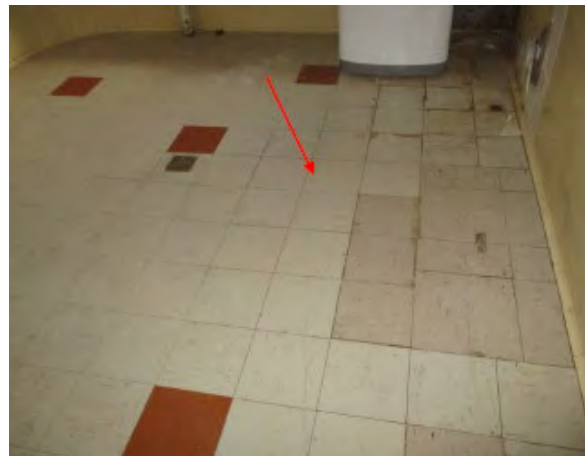
Photo 11: Wentworth Hospital Services - Former Maternity Pan Room asbestos flooring

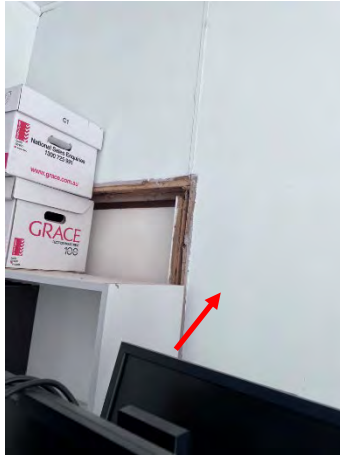
Photo 13: : Wentworth Hospital Services – Internal former maternity west veranda asbestos wall lining

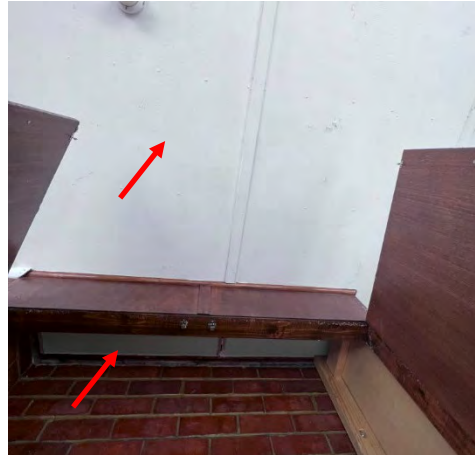
Photo 14: Wentworth Hospital Services - Internal former maternity veranda–asbestos cupboard ceiling lining

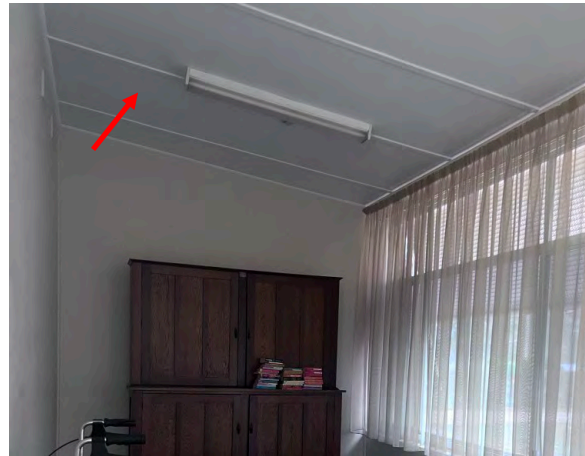
Photo 17: Wentworth Hospital Services – Internal northern 'mental health' asbestos ceiling lining

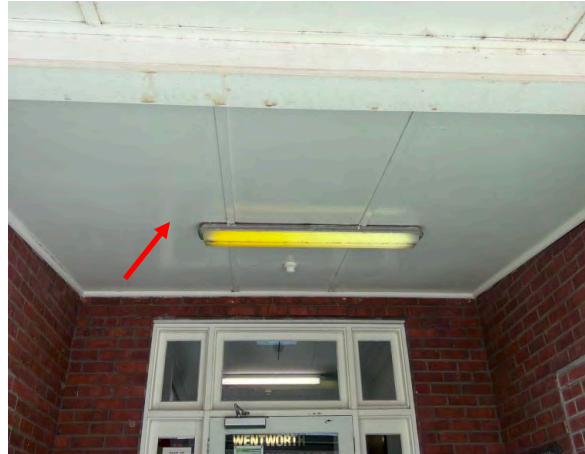
Photo 20: Wentworth Hospital Services - External northern entrance porch asbestos ceiling lining

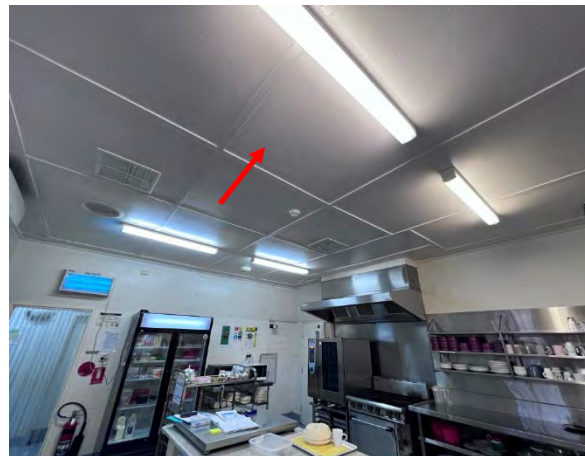
Photo 23: Wentworth Hospital Services - Internal Hotel Services kitchen – asbestos ceiling lining

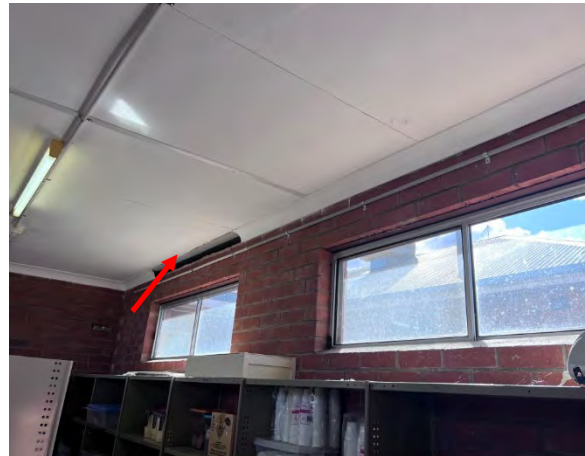
Photo 26: Wentworth Hospital Services - Hotel Services Storeroom asbestos ceiling lining

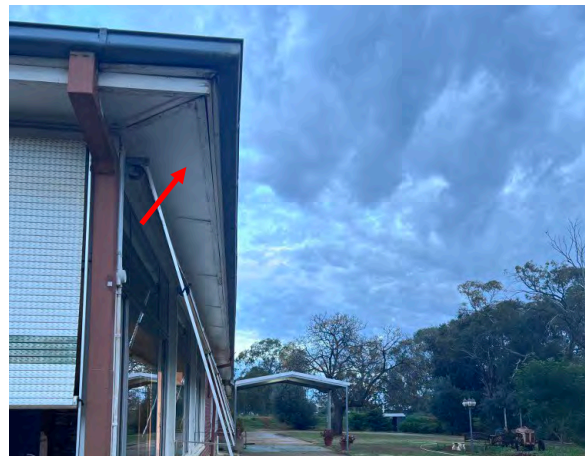
Photo 29: Wentworth Hospital Services - External flat sheet asbestos eaves

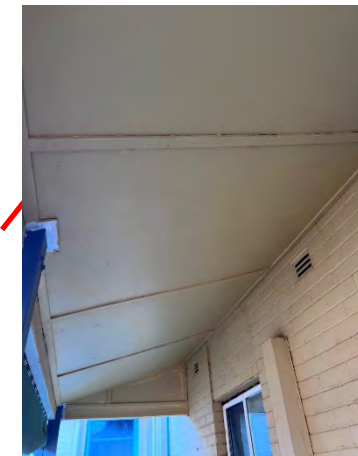
Photo 30: Wentworth Hospital Services - External flat sheet asbestos eaves – Internal courtyard

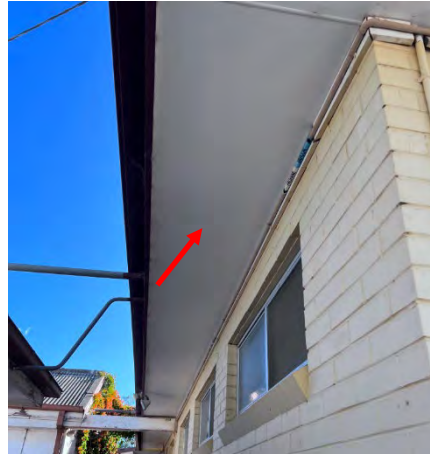
Photo 32: Wentworth Hospital Services - External flat sheet asbestos eaves

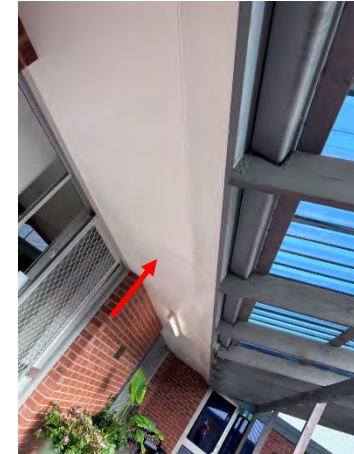
Photo 33: Wentworth Hospital Services - External flat sheet asbestos eaves - Internal Courtyard

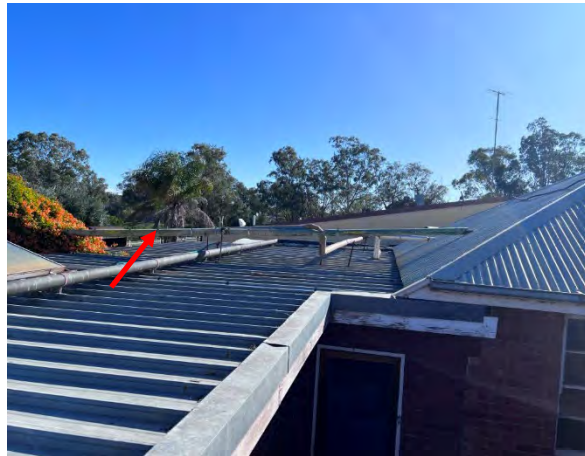
Photo 35: Wentworth Hospital Services - External south-eastern roof assumed asbestos containing lagged pipe

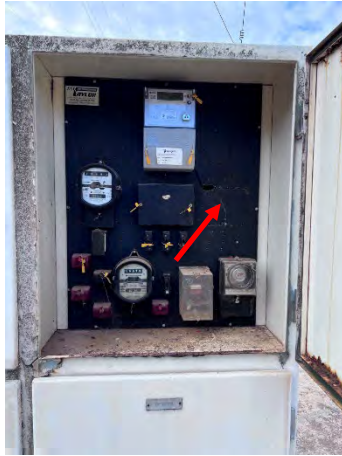
Photo 37: External eastern Wentworth Hospital Services electrical box – Black Backed Electrical Board

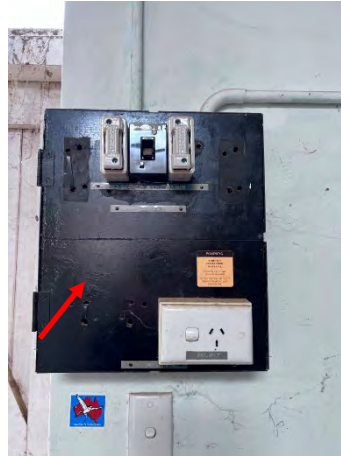
Photo 38: Wentworth Hospital Services - Old Records Room – southern wall – assumed asbestos electrical backing board

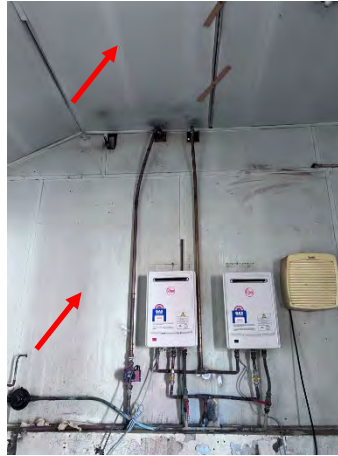
Photo 44: Old Boiler House - Internal asbestos wall and ceiling lining

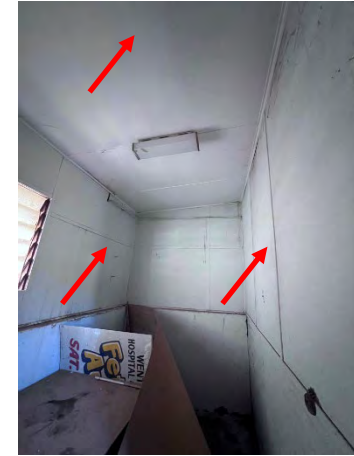
Photo 45: Old Boiler House - Internal asbestos wall, ceiling lining & joining battens

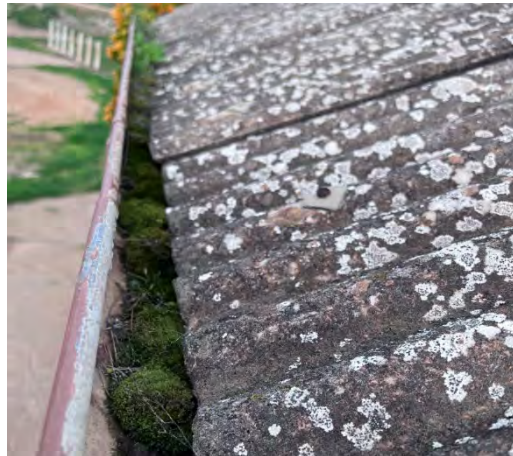
Photo 47: Old Boiler House – Asbestos super 6 Roofing and Gutter Debris

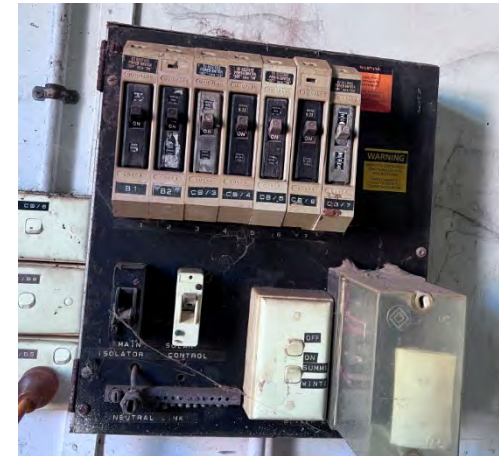
Photo 48: Old Boiler House – Assumed asbestos black backed electrical board

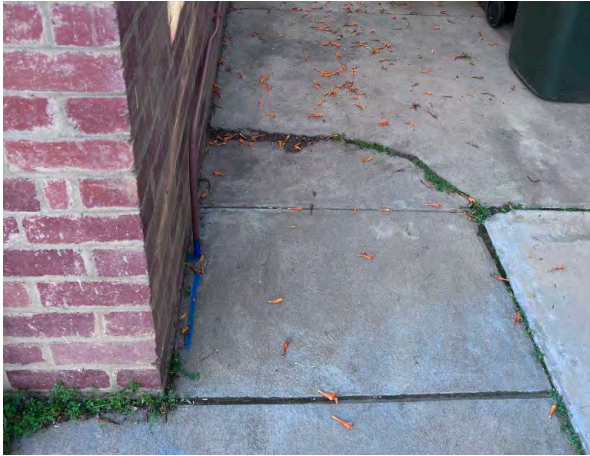
Photo 49: Non-asbestos mastic between buildings 1 & 2

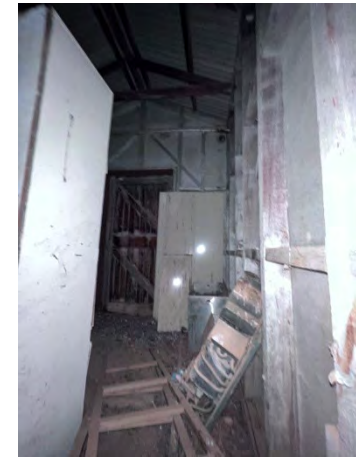
Photo 54: Pump Shed – Inaccessible Internal space

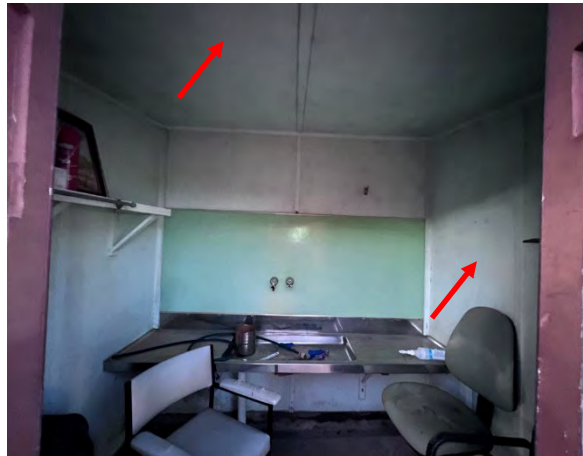
Photo 56: Dirty Linen – Internal asbestos wall and ceiling lining fibre cement sheeting

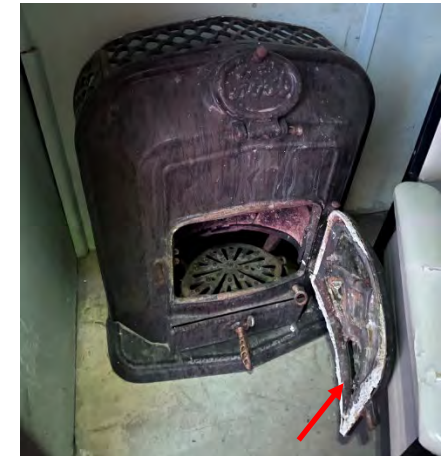
Photo 57: Dirty Linen – Friable asbestos fireplace rope

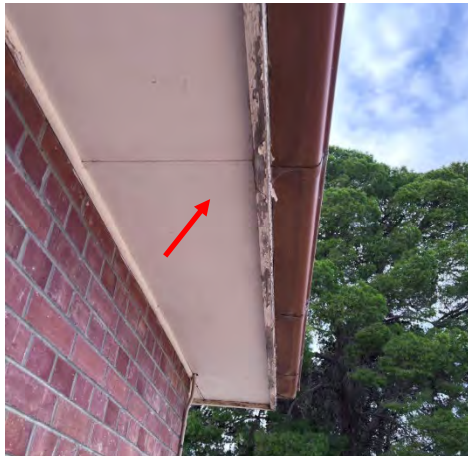
Photo 61: Staff Amenities – Asbestos fibre Cement Sheet eaves

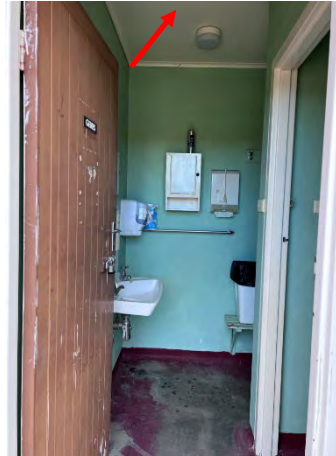
Photo 62: Staff Amenities – Assumed asbestos ceiling linings ceiling and brown lead based paint

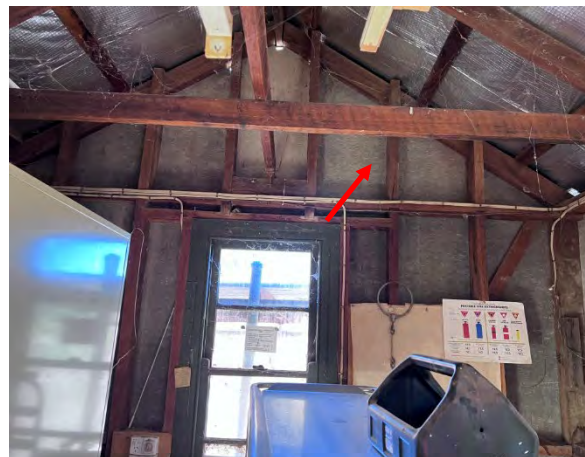
Photo 65: Maintenance Storage Shed – External asbestos cladding and silver sarked roof

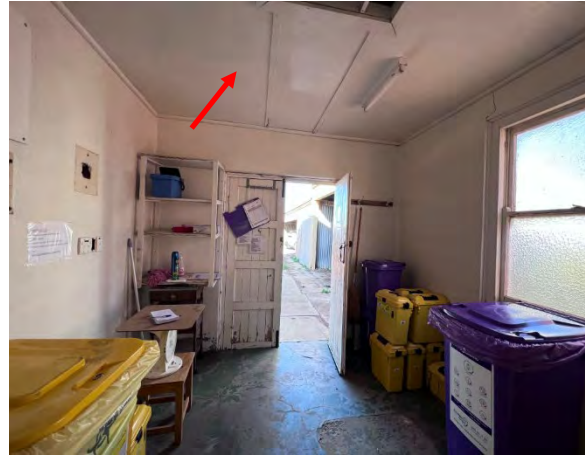
Photo 68: Old Morgue – Internal assumed asbestos fibre cement ceiling lining

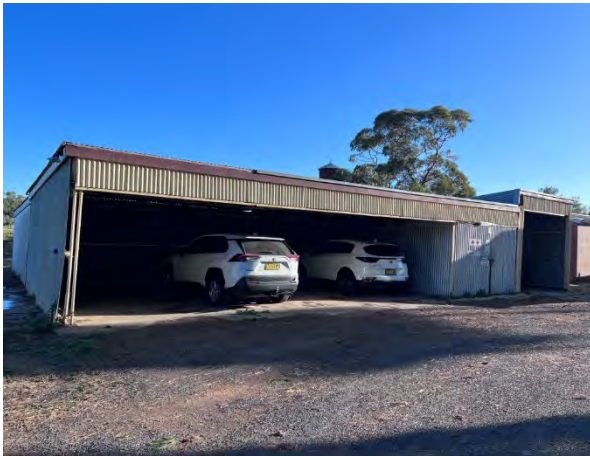
Photo 75: Emergency Generator Shed – Generator Machinery, assumed asbestos gaskets

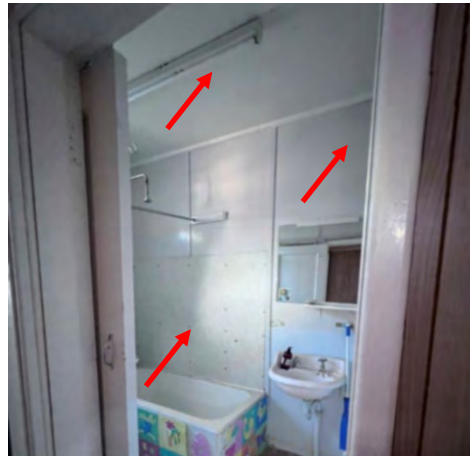
Photo 83: Old Nurses Home – Asbestos fibre cement internal bathroom wall & ceiling lining

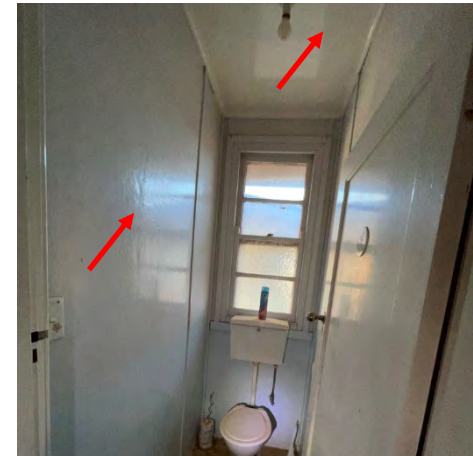
Photo 84: Old Nurses Home – Asbestos fibre cement internal toilet wall & ceiling lining

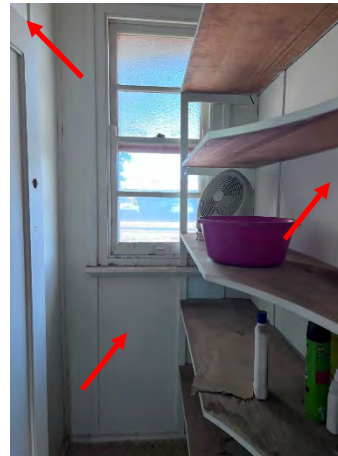
Photo 86: Old Nurses Home – Asbestos fibre cement internal pantry wall lining

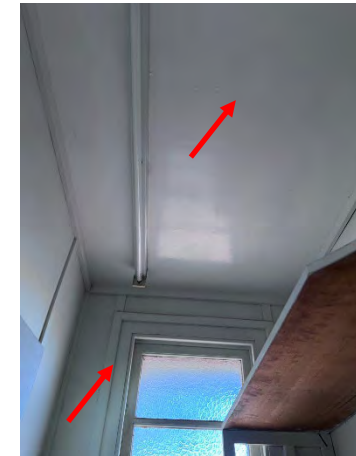
Photo 87: Old Nurses Home – Asbestos fibre cement internal pantry wall & ceiling lining

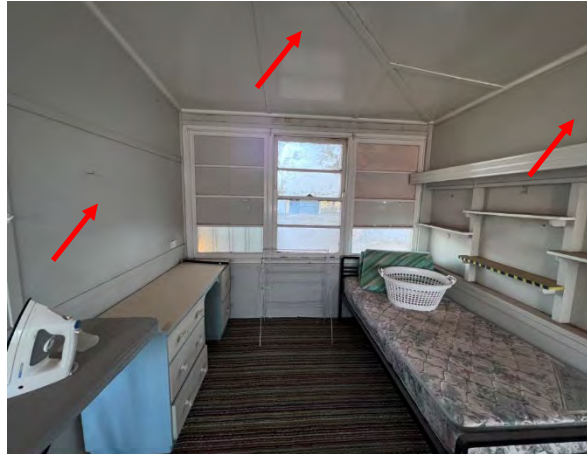
Photo 92: Old Nurses Home – Internal western room asbestos wall and ceiling lining

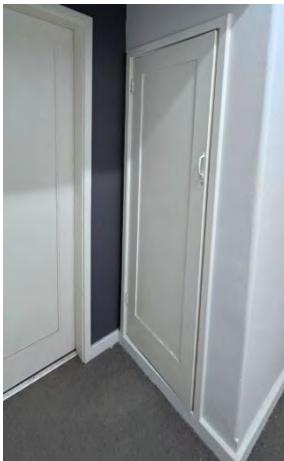
Photo 100: Senior Centre – Internal western corridor asbestos cupboard lining

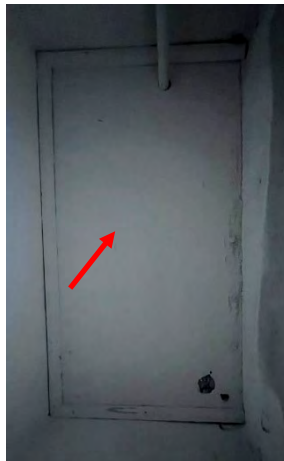
Photo 101: Senior Centre – Internal western corridor communications asbestos cupboard lining

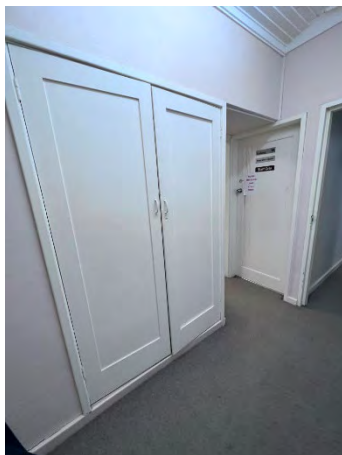
Photo 103: Senior Centre – Internal western corridor storage asbestos cupboard lining

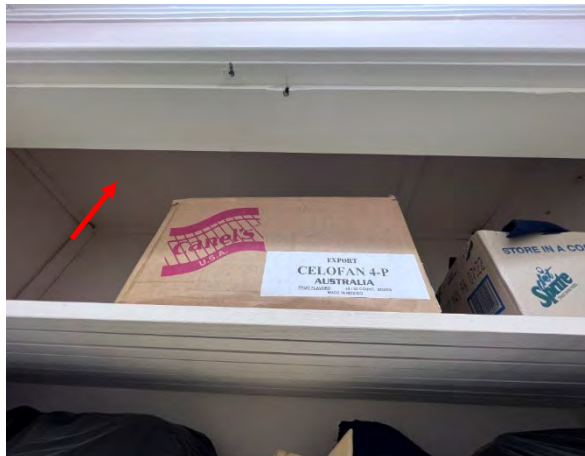
Photo 104: Senior Centre – Internal western corridor storage asbestos cupboard lining

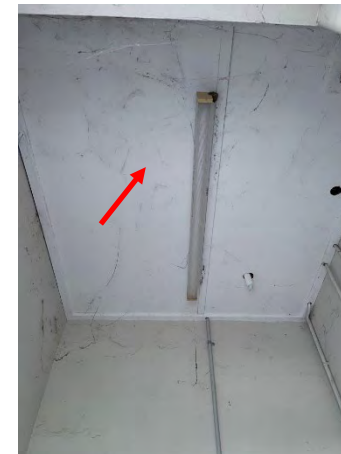
Photo 105: Senior Centre – South-western storeroom asbestos ceiling lining

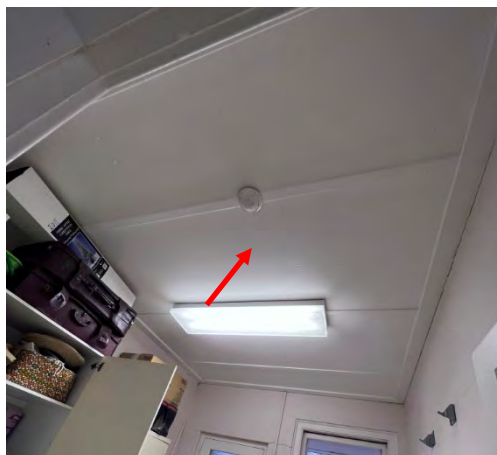
Photo 107: Senior Centre – Laundry asbestos ceiling lining

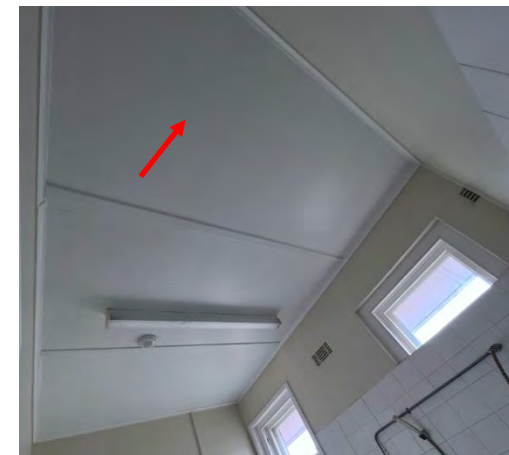
Photo 108: Senior Centre – North-eastern bathroom asbestos ceiling lining

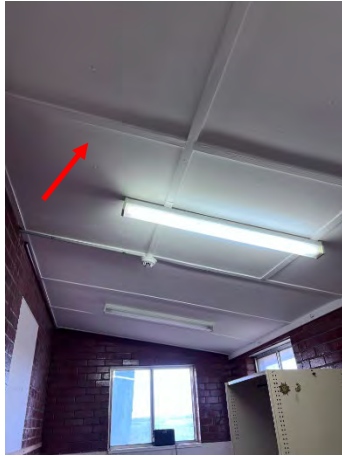
Photo 109: Senior Centre – Eastern storage room asbestos ceiling lining

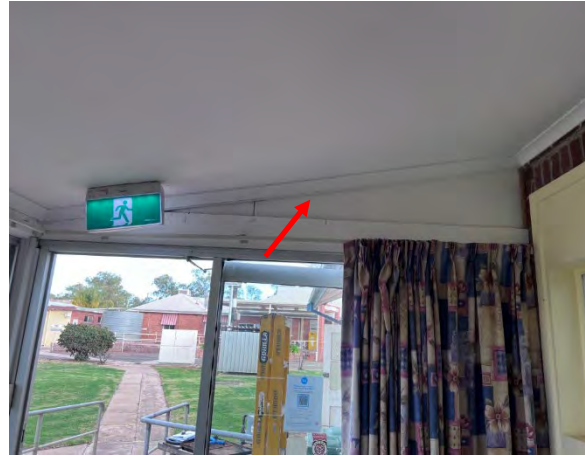
Photo 110: Senior Centre – south-western wall lining above glass door asbestos wall lining

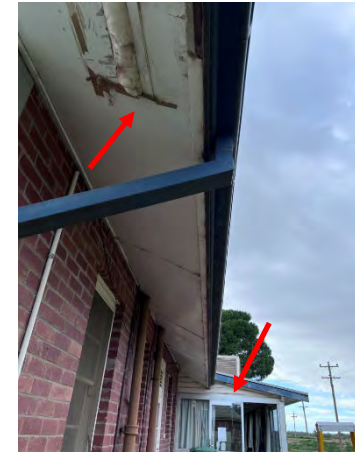
Photo 111: Senior Centre – Asbestos fibre cement eave lining
