Hazardous Materials Survey of Tamworth Base Hospital Johnston and Dean Streets Tamworth NSW 2340

30 April 2009

Document No.: E257043_Rpt_30APR09.doc

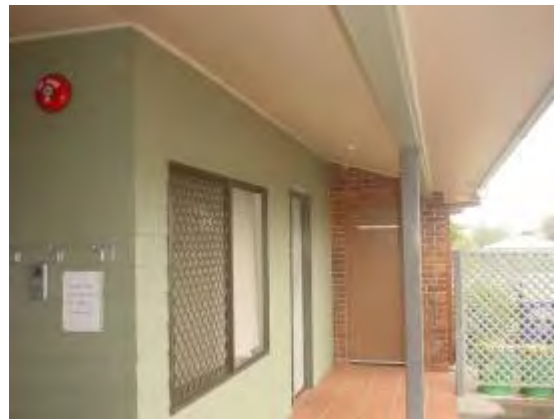
Plate P2: Building TA01 - typical eaves, porch ceiling and wall linings which do not contain asbestos.

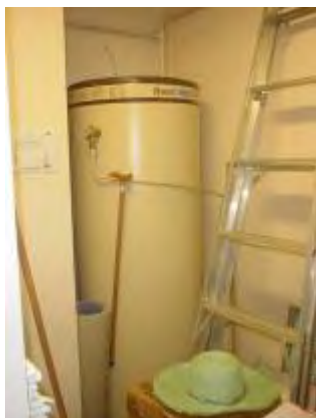
Plate P3: Building TA01 - hot water unit to Cleaners Linen/Store which is insulated with SMF.

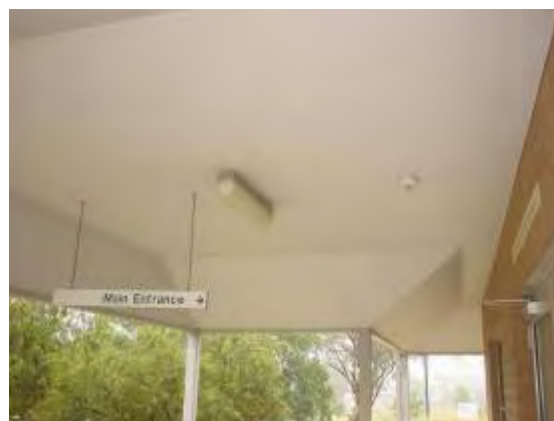
Plate P6: Building TA03 - typical eaves and porch ceiling linings which do not contain asbestos

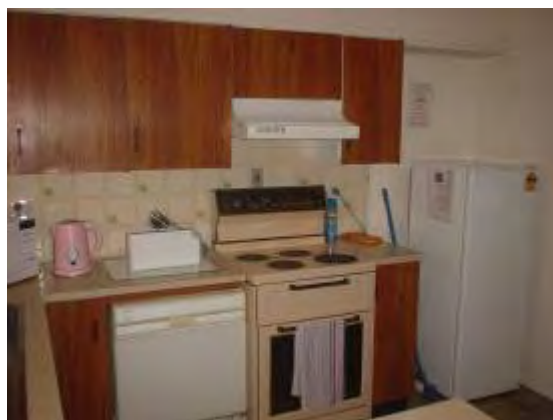
Plate P10: Building TA05 - asbestos cement wall linings behind wall tiles and cupboards to kitchen

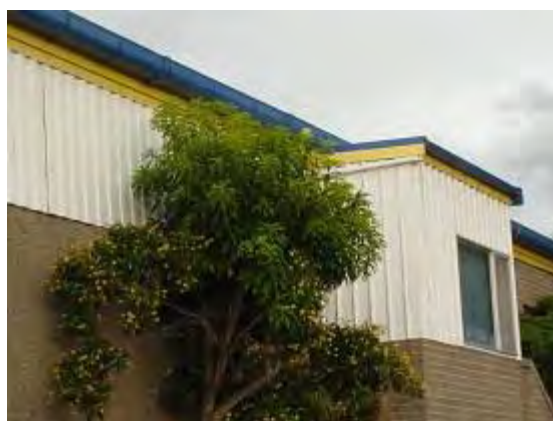
Plate P12: Building TA06 - typical asbestos cement wall linings and eaves gutters

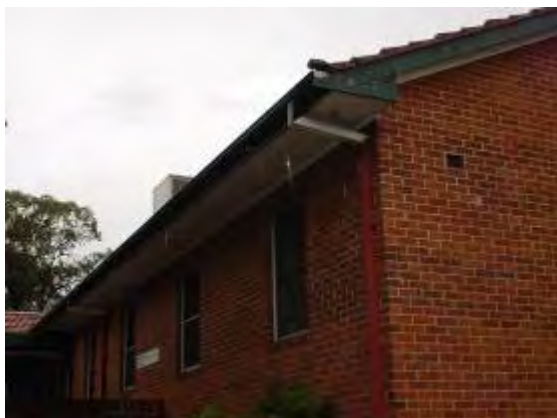
Plate P15: Building TA07 - typical asbestos cement linings to eaves and gable overhangs

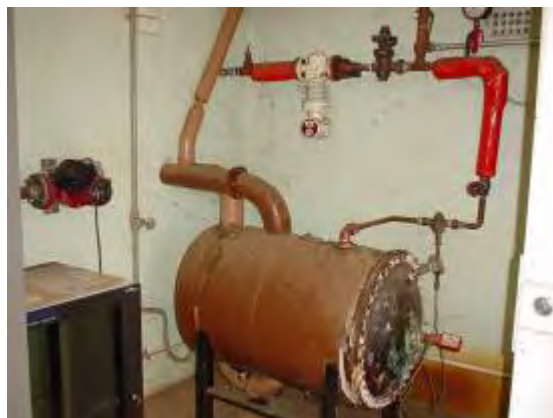
Plate P16: Building TA07 - boiler and pipework to south west boiler room which are insulated with SMF. Note: asbestos gaskets to flanged joints presumed.

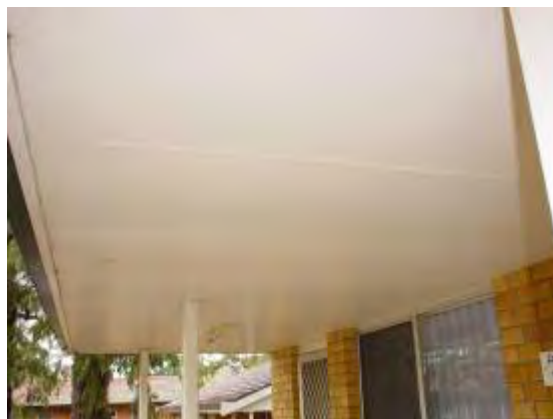
Plate P20: Building TA09 - asbestos cement ceiling linings to south side verandah

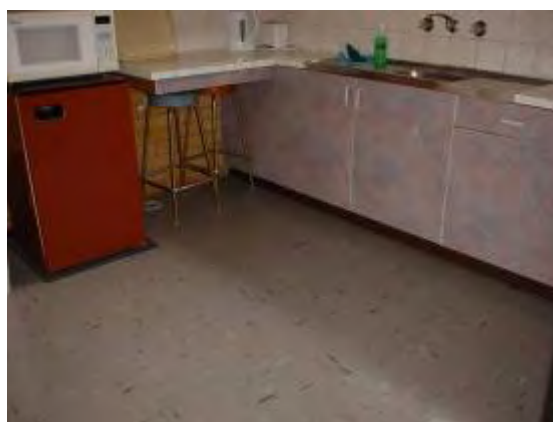
Plate P22: Building TA09 - vinyl floor tiles to kitchen which do not contain asbestos

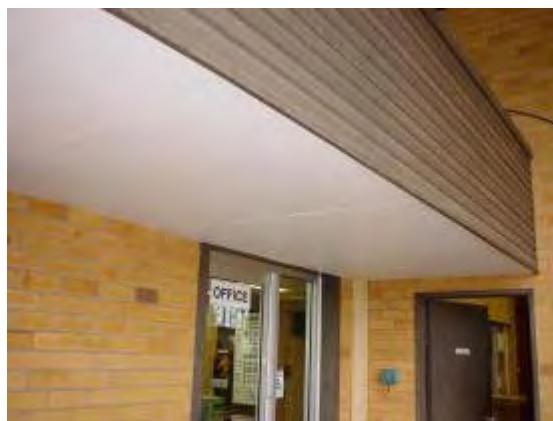
Plate P24: Building TA10 - asbestos cement fascia soffit linings to covered way

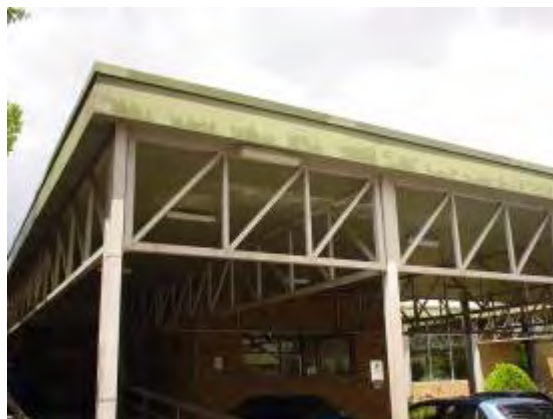
Plate P26: Building TA11 - fibrous cement ceiling linings to large north west parking area which do not contain asbestos

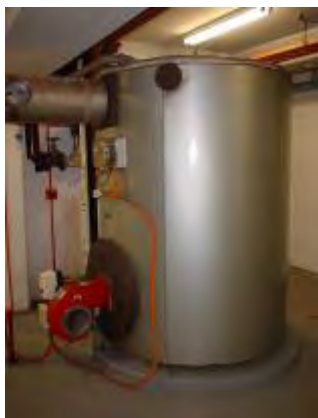
Plate P27: Building TA11 - boiler to basement level boiler room which is insulated with SMF

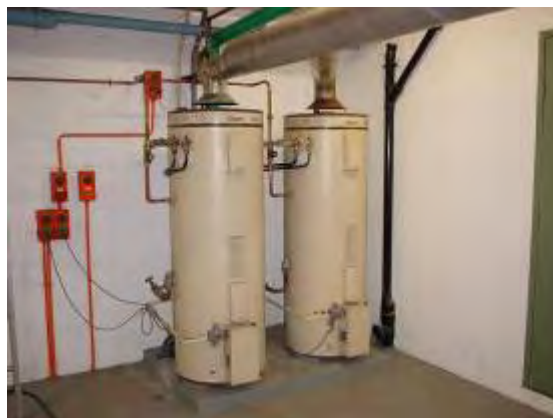
Plate P28: Building TA11 - hot water units to basement level boiler room which are insulated with SMF

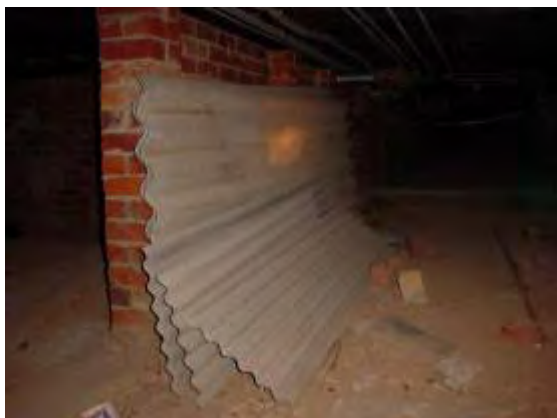
Plate P33: Building TA12 - stored asbestos cement sheeting in foundation space

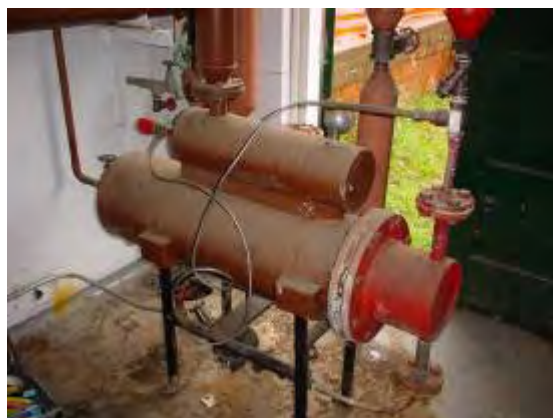
Plate P36: Building TA12 - calorifier to south east boiler room which is insulated with either asbestos or SMF

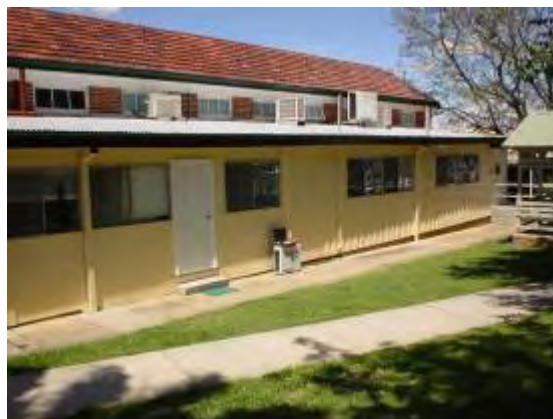
Plate P38: Building TA13 - profiled asbestos cement wall linings at north west corner and flat wall linings which do not contain asbestos

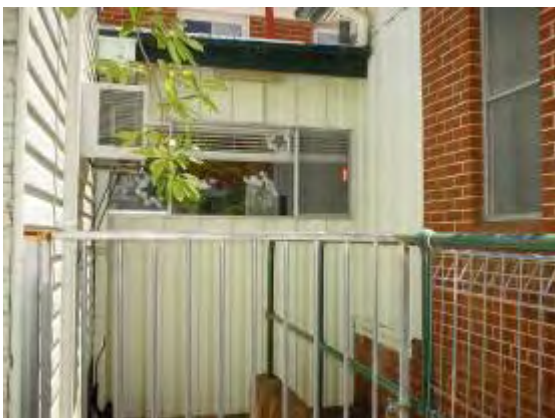
Plate P39: Building TA13 - asbestos cement wall linings to south side recess

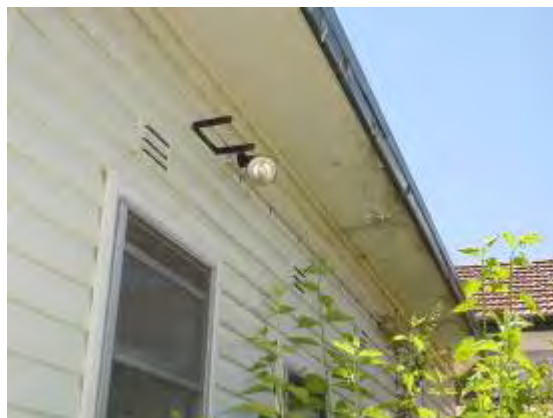
Plate P40: Building TA13 - asbestos cement eaves linings to south side of west wing

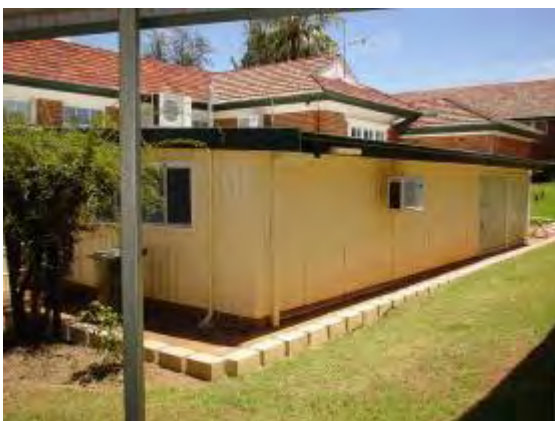
Plate P41: Building TA13 - asbestos cement wall linings to east side extension

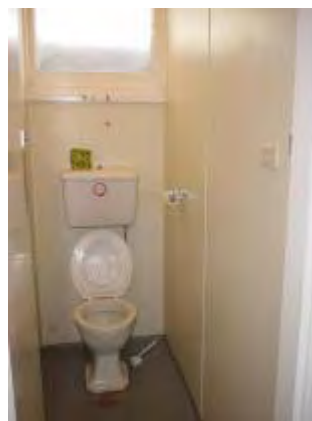
Plate P42: Building TA13 - asbestos cement wall linings to south end toilet

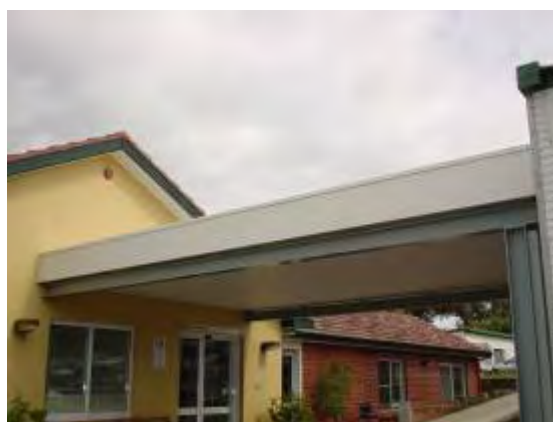
Plate P46: Building TA14 - fibrous cement fascia and ceiling linings to entry porte cochere which do not contain asbestos

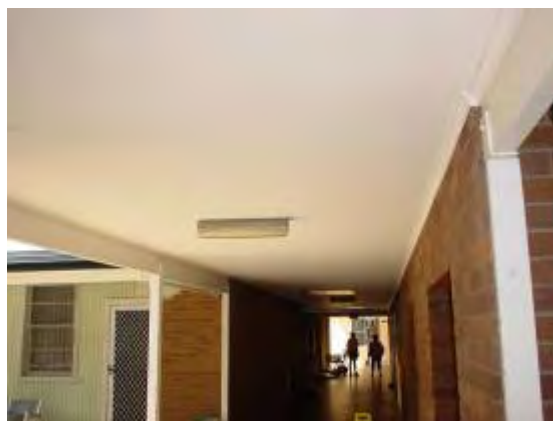
Plate P48: Building TA15 - ceiling linings to east side covered way which do not contain asbestos

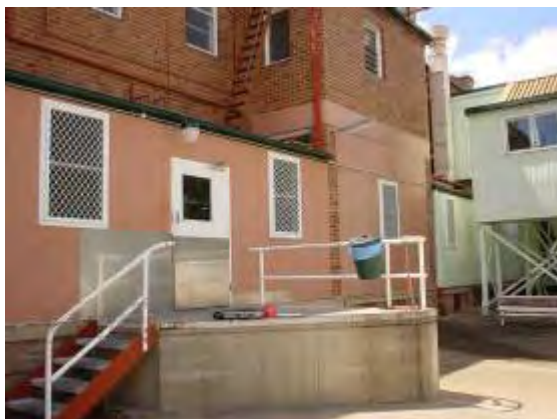
Plate P49: Building TA15 - flat fibrous cement walling (pink and green) to west side which does not contain asbestos

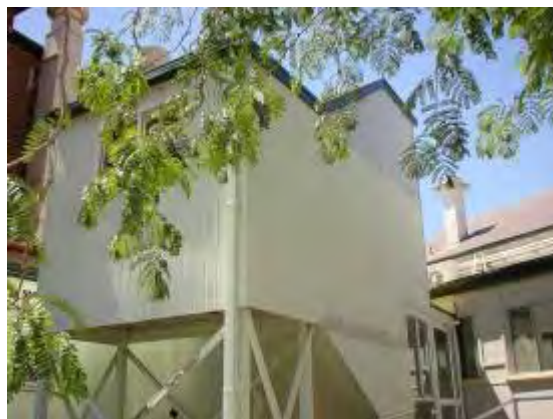
Plate P50: Building TA15 - asbestos cement walling to south west access stair

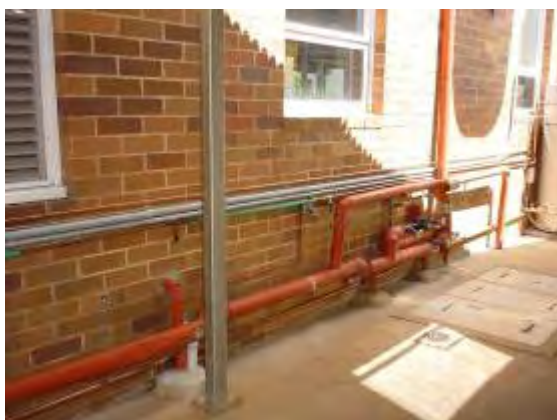
Plate P51: Building TA15 - hot water pipework along east side wall which is insulated with SMF

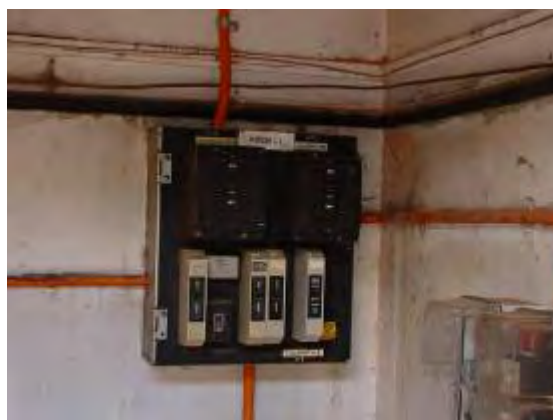
Plate P52: Building TA15 - asbestos containing electrical backing board to east side Compressor Enclosure

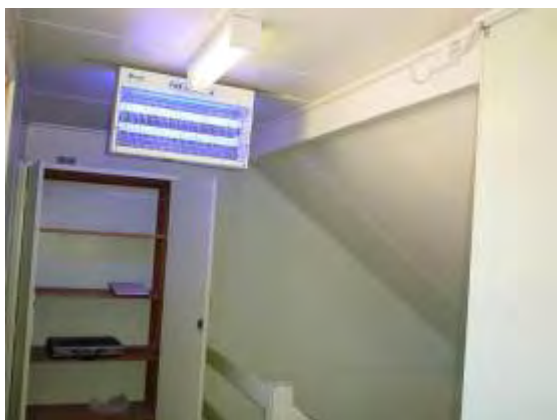
Plate P53: Building TA15 - asbestos cement internal wall and ceiling linings to south west access stair

The asbestos cement (AC) sheet materials should be regularly maintained and painted and should not be sawn, drilled or abraded. Any work involving the disturbance or penetration of these materials must be undertaken under controlled conditions.

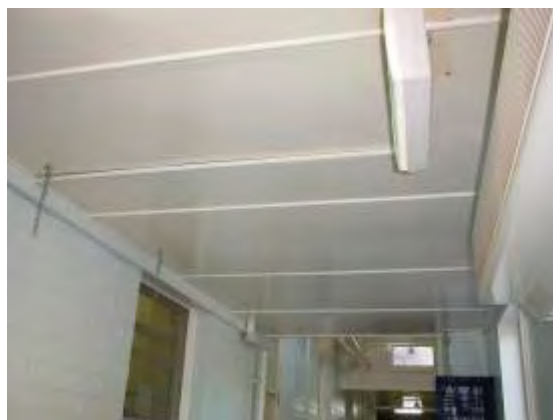
Plate P54: Building TA15 - asbestos cement ceiling linings to west side passage

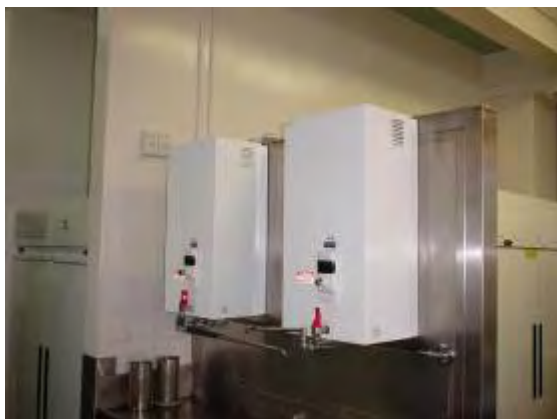
Plate P55: Building TA15 - boiling water units to main kitchen area which are insulated with SMF

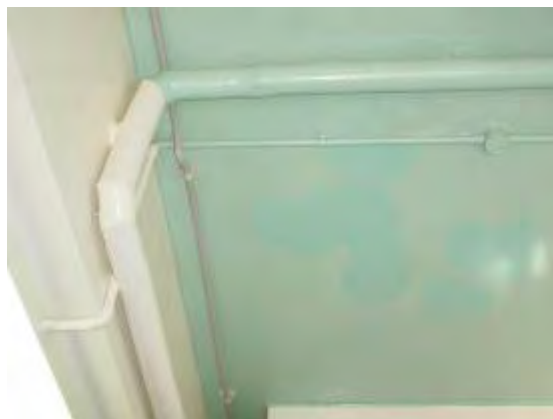
Plate P56: Building TA15 - asbestos lagged pipework to main kitchen area

These ACM will need to be removed by an AS1 Licensed Asbestos Removal Contractor under controlled asbestos conditions.

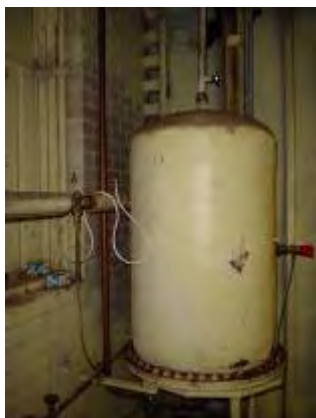
Plate P57: Building TA15 - hot water unit to south end hot water cupboard which is insulated with SMF

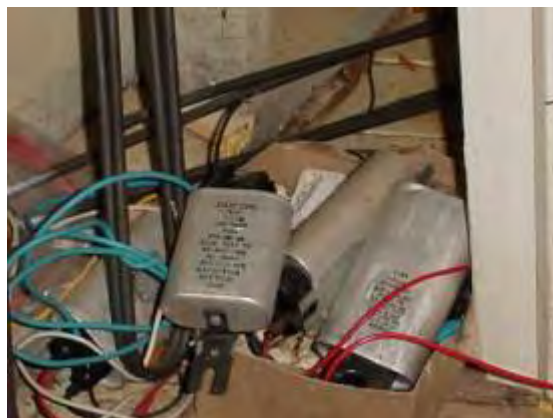
Plate P58: Building TA15 - redundant PCB containing fluorescent light capacitors to floor of south end hot water cupboard

During the survey fluorescent light fittings were identified that may contain capacitors that may with PCBs. Light fittings should be inspected as they are removed or replaced and those containing metal capacitors should be treated as containing PCB unless proven otherwise.

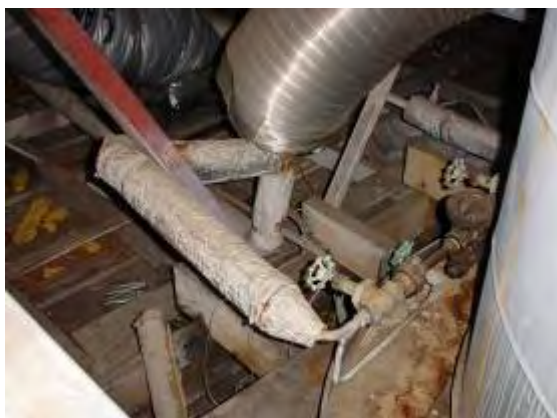
Plate P59: Building TA15- hot water pipes in roof space which are insulated with SMF

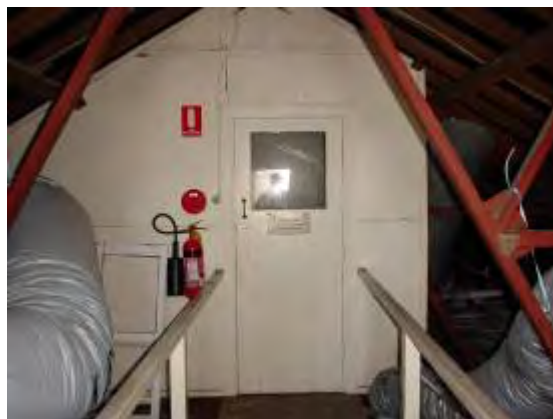
Plate P62: Building TA15 - lift motor room in roof space which is likely to contain asbestos backing boards/materials

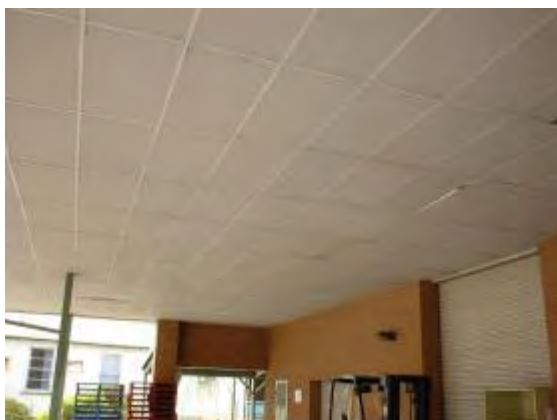
Plate P65: Building TA16 - ceiling linings to main south side dock which do not contain asbestos

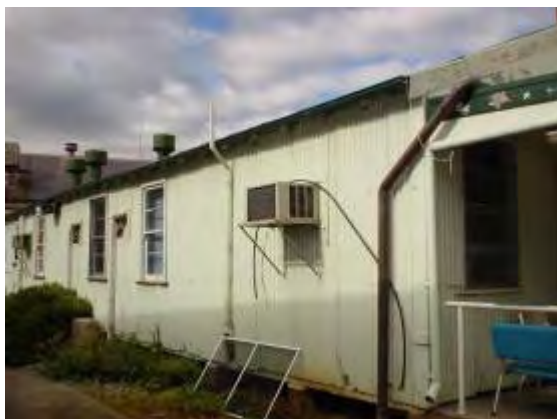
Plate P67: Building TA17 - asbestos cement wall linings to east side of building

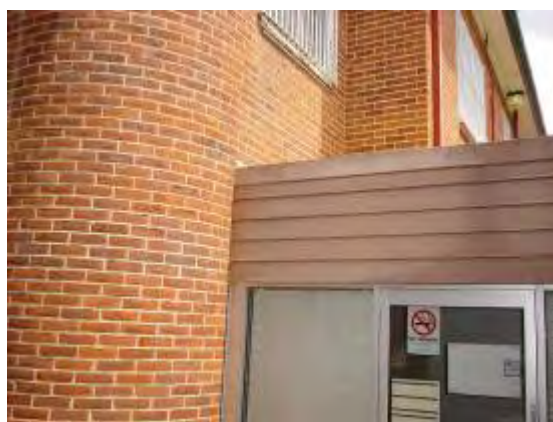
Plate P70: Building TA18 - hardboard head linings to north side doors which do not contain asbestos

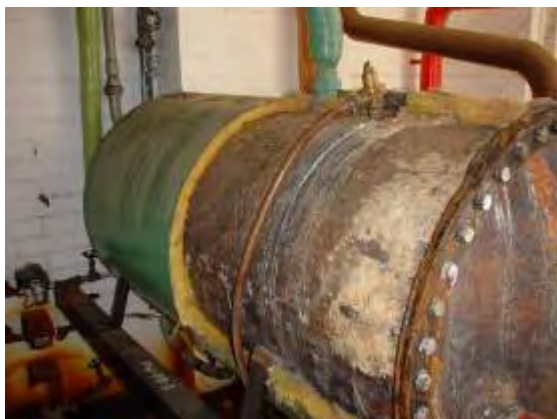
Plate P73: Building TA18 - boilers to south side boiler room which are insulated with SMF

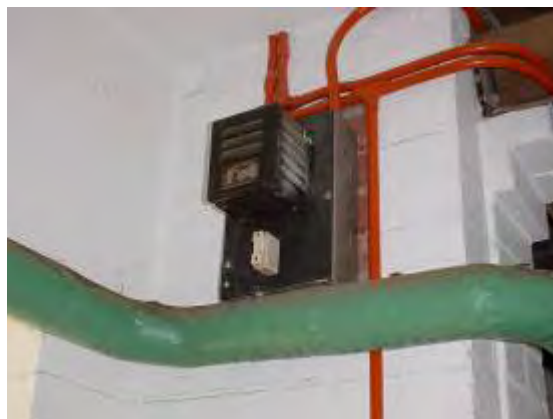
Plate P74: Building TA18 - asbestos containing electrical board to south side boiler room

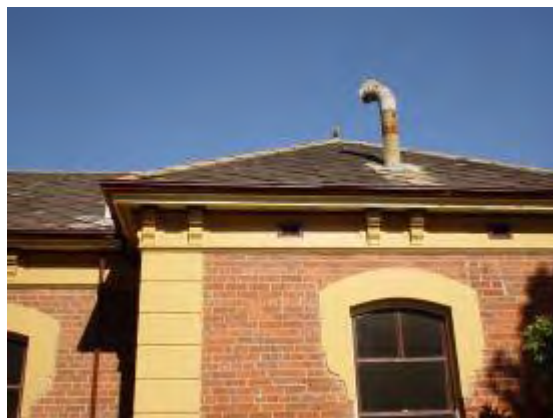
Plate P76: Building TA19 - asbestos cement shingle tiles to south east projecting wing

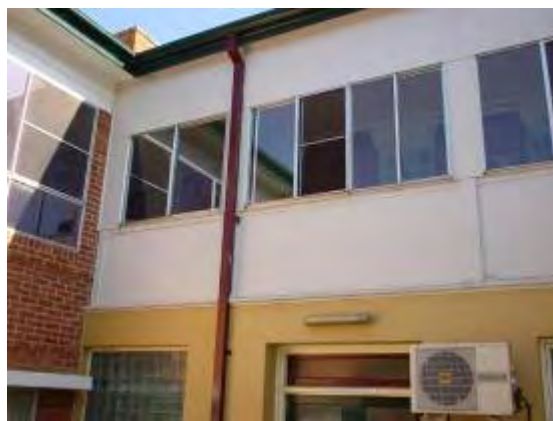
Plate P78: Building TA19 - asbestos cement upper and lower walling to verandah, south side, west end

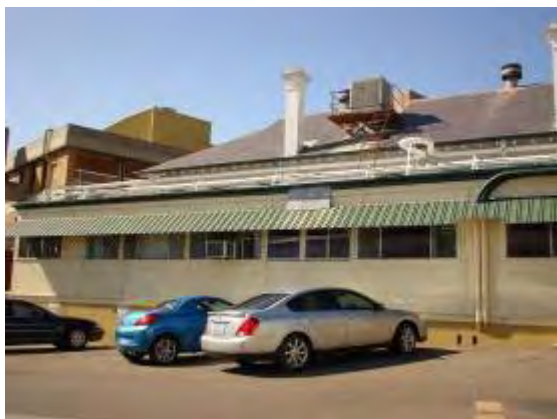
Plate P79: Building TA19 - asbestos cement walling to verandah, north side east end

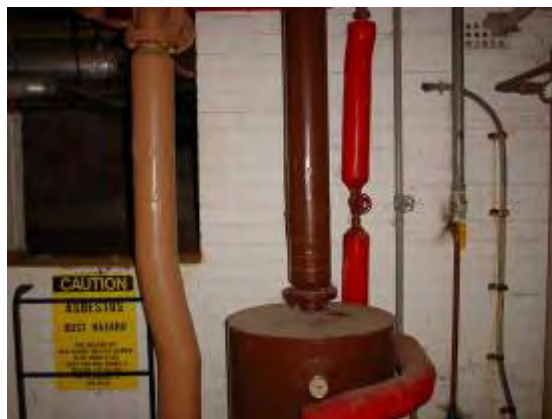
Plate P80: Building TA19 - boiler and pipework to east end boiler room which are insulated with asbestos lagging

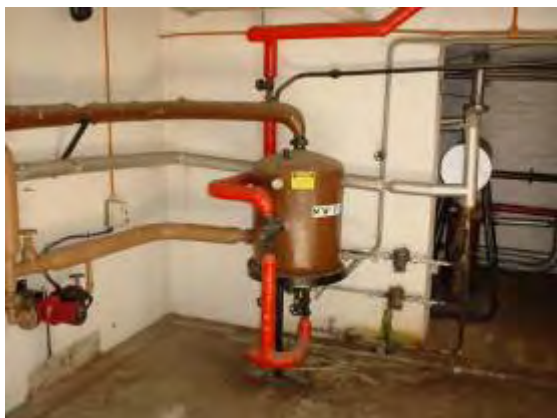
Plate P81: Building TA19 - calorifier and pipework to east end boiler room which are insulated with asbestos lagging

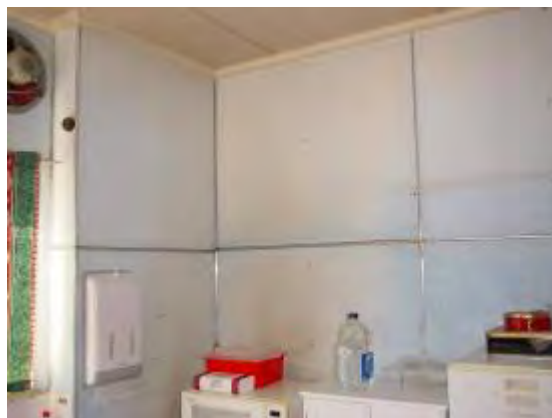
Plate P82: Building TA19 - asbestos cement wall and ceiling linings to north east kitchen/lunchroom

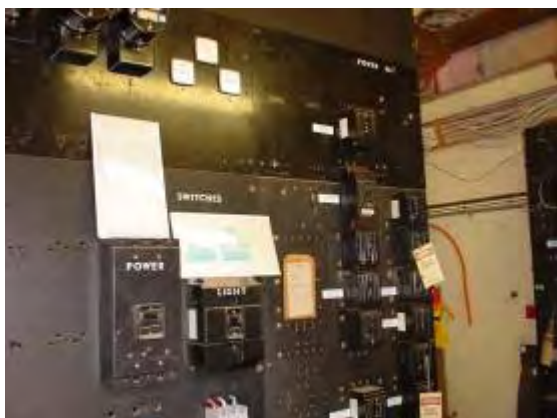
Plate P83: Building TA19 - asbestos containing backing boards to main electrical room

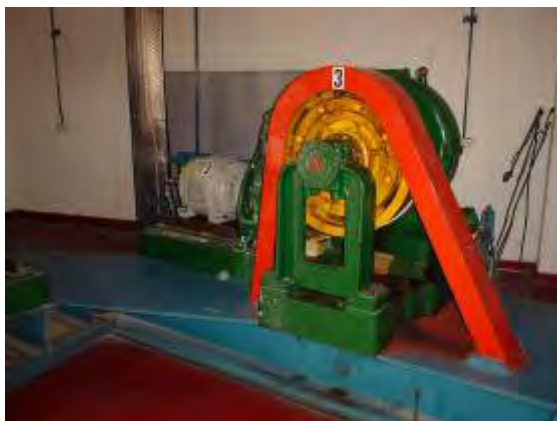
Plate P85: Building TA20 - lift motor to main roof level lift motor room which is likely to contain asbestos brake shoes

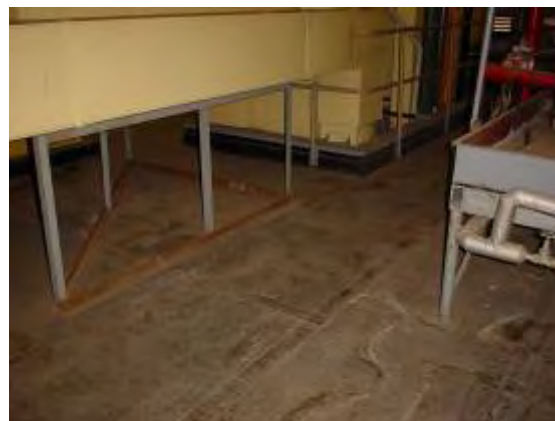
Plate P86: Building TA20 - asbestos containing membrane to floor of main roof level plantroom

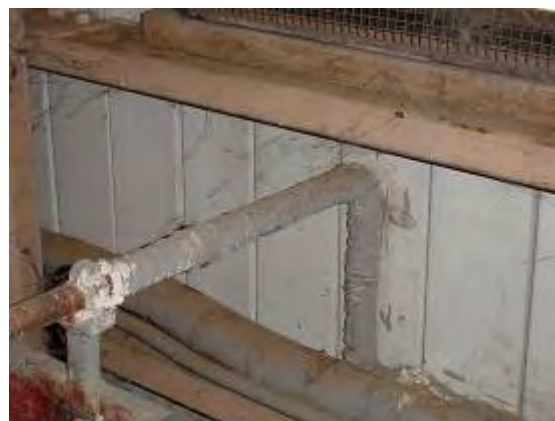
Plate P88: Building TA20 - asbestos rope insulation to pipework at rear of hot water tanks

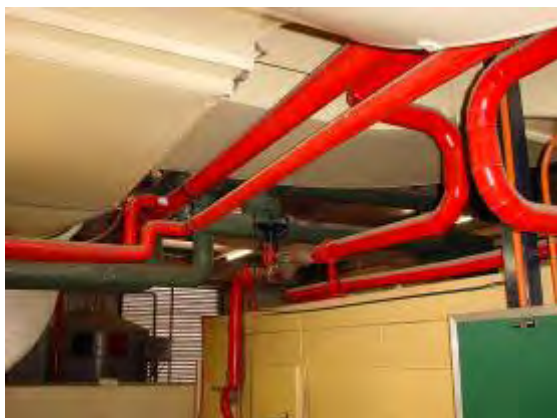
Plate P89: Building TA20 - typical asbestos lagged pipework to main roof level plantroom

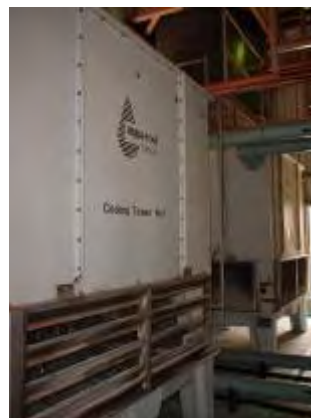
Plate P90: Building TA20 - fibreglass cooling tower to main roof level plantroom which contain SMF

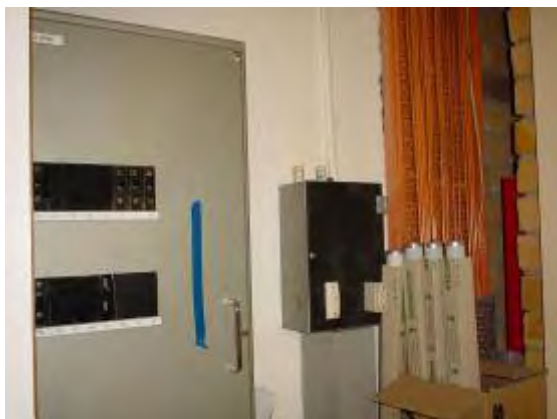
Plate P91: Building TA20 - asbestos containing backing board to typical electrical cupboard

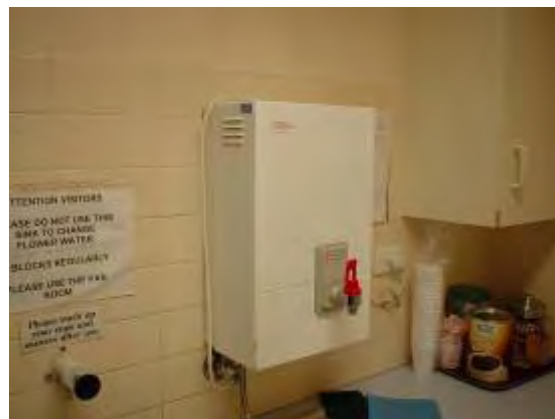
Plate P92: Building TA20 - typical boiling water unit which is insulated with SMF

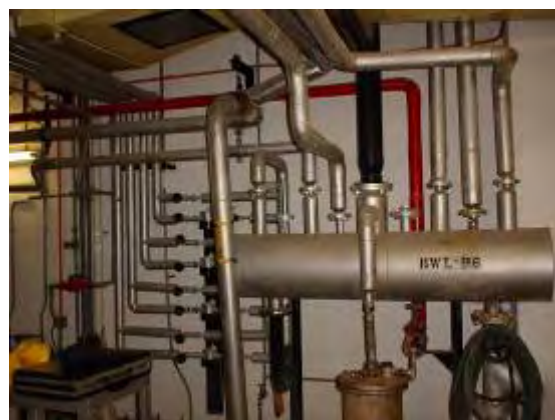
Plate P96: Building TA20 - typical asbestos lagged pipework and manifold to lower ground floor plant area

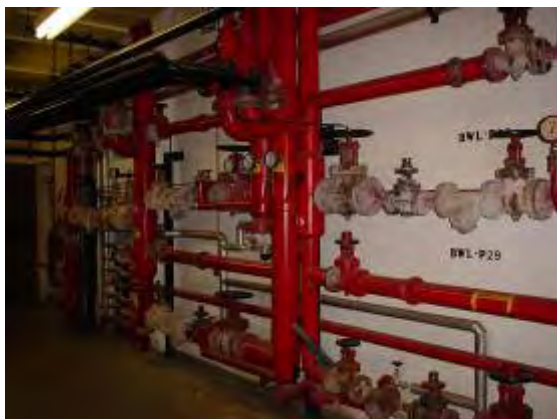
Plate P97: Building TA20 - typical asbestos lagged pipework to lower ground floor plant area

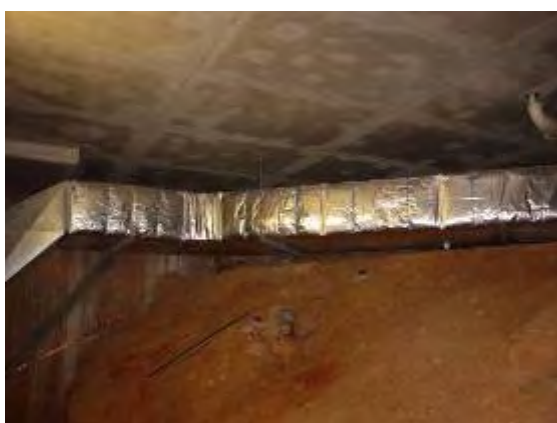
Plate P101: Building TA20 - air conditioning ductwork to foundation space which is insulated with SMF

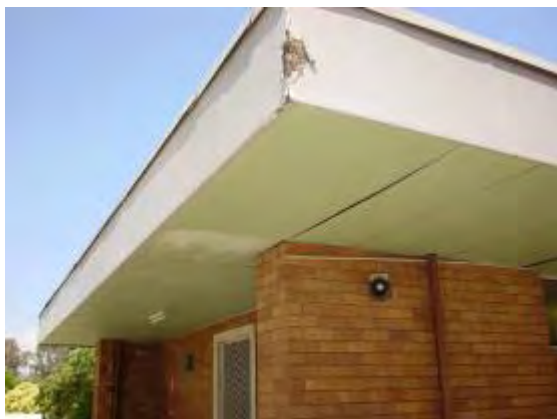
Plate P103: Building TA21 – asbestos cement fascia soffit linings to southern workshop wing

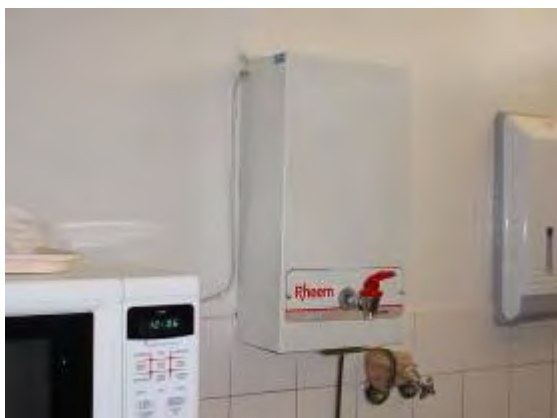
Plate P107: Building TA21 - boiling water unit to staff lunchroom which is insulated with SMF

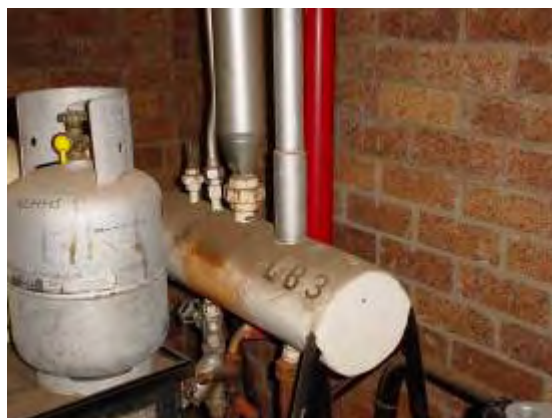
Plate P108: Building TA21 - asbestos lagged manifold to west end storeroom, Engineering Workshop area

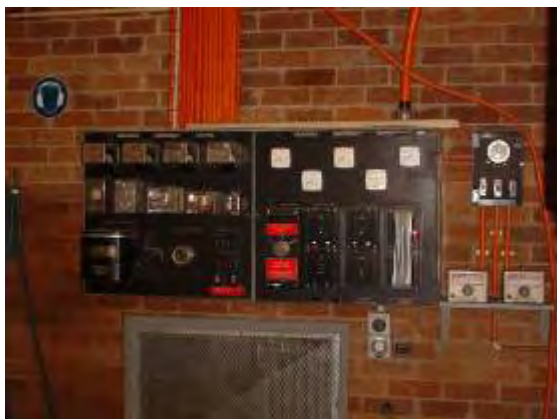
Plate P109: Building TA21 - asbestos containing electrical boards to Engineering Workshop area

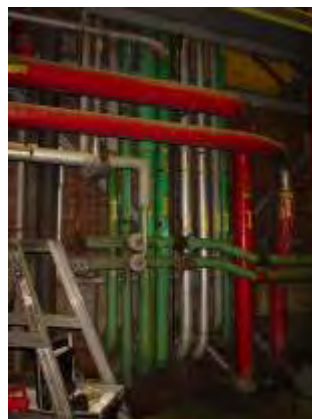
Plate P110: Building TA21 - typical asbestos lagged pipework to main Boiler Room

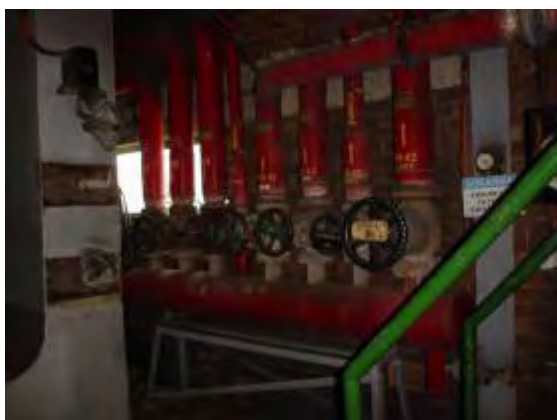
Plate P111: Building TA21 - asbestos lagged manifold and pipework to main Boiler Room

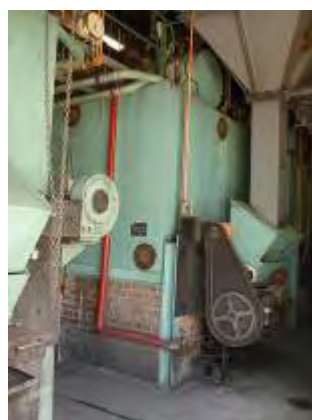
Plate P112: Building TA21 - typical boiler which is insulated with SMF. Note: brick support walls contain asbestos rope caulking

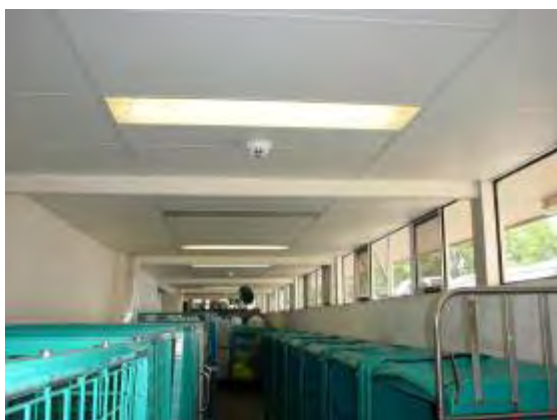
Plate P113: Building TA21 - ceiling tiles to Clean Store which do not contain asbestos

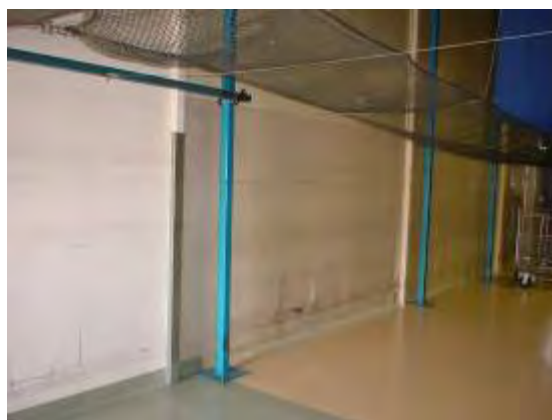
Plate P114: Building TA21 - fibrous cement walling to Sorting Dock (outer portion) which does not contain asbestos

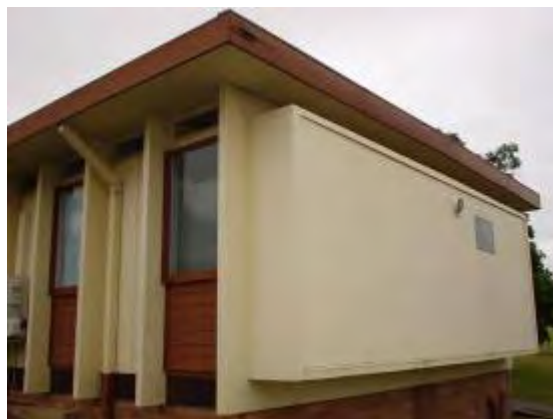
Plate P116: Building TA22 - fibrous cement wall and eaves linings which do not contain asbestos

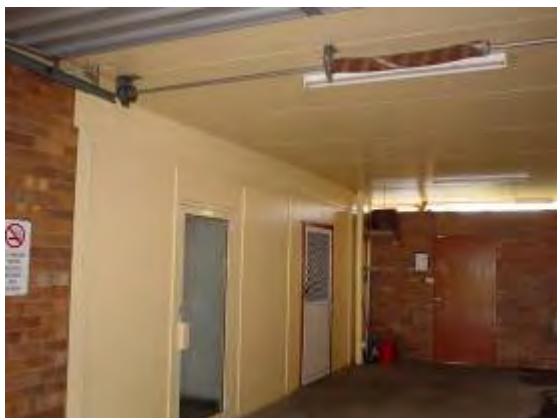
Plate P117: Building TA22 - asbestos cement walling to vehicle dock. Note: ceiling does not contain asbestos

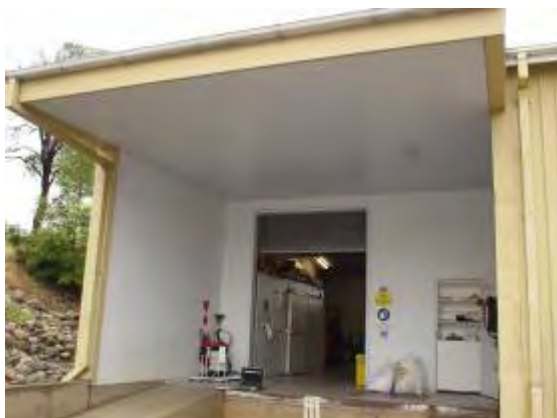
Plate P119: Building TA23 - fibrous cement wall and ceiling linings to contaminated waste dock which do not contain asbestos

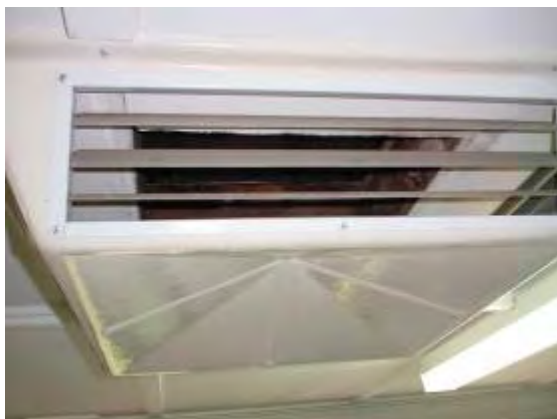
Plate P121: Building TA24 - exposed edges to asbestos cement ceiling linings to north side verandah at vent

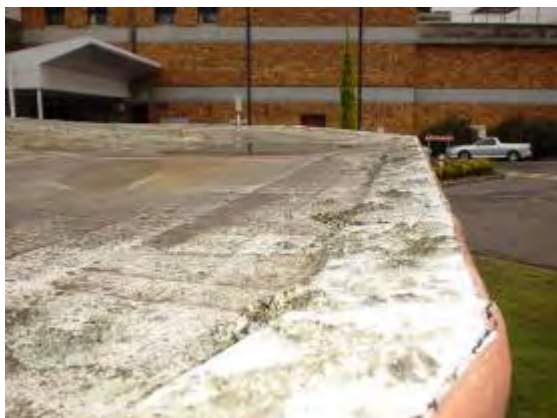
Plate P123: Building TA25 - asbestos containing bituminous membrane to roof of original western portion of building

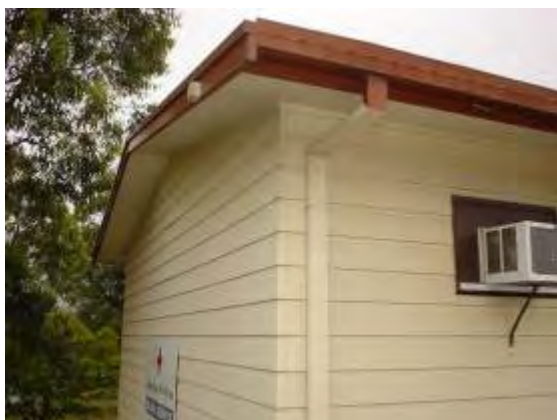
Plate P125: Building TA25 - fibrous cement walling and eaves to eastern portion which do not contain asbestos

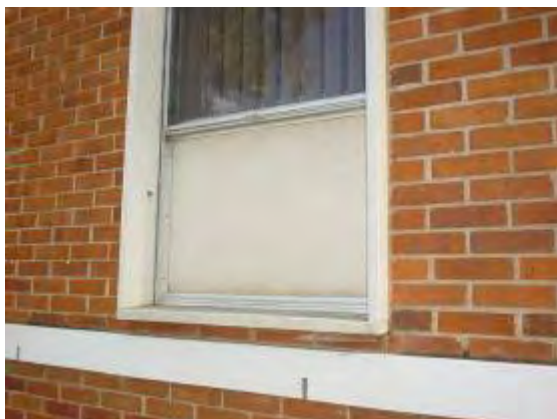
Plate P127: Building TA26 - typical asbestos cement window spandrel panel. Note: putty to window frames also contains asbestos

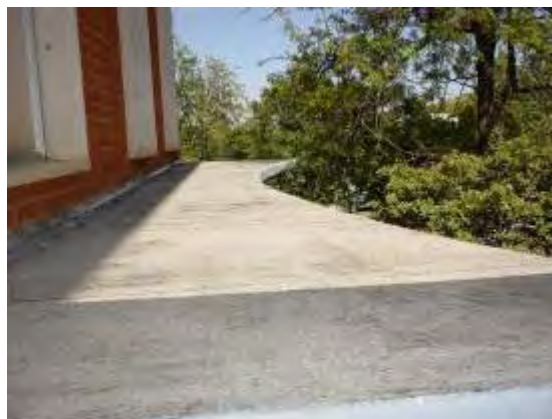
Plate P128: Building TA26 - typical bituminous roofing membrane to concrete awning which contains asbestos

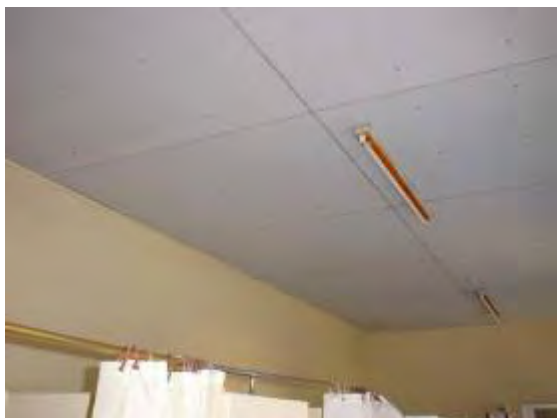
Plate P129: Building TA26 - typical asbestos cement ceiling lining to bathrooms

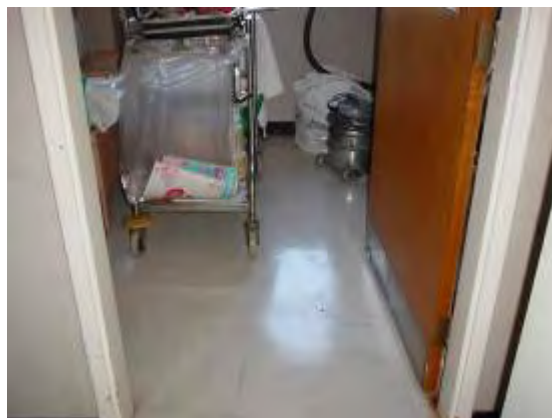
Plate P130: Building TA26 - asbestos containing vinyl floor tiles to second floor utility room

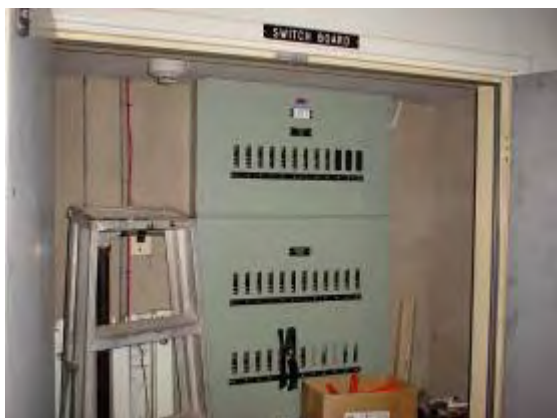
Plate P131: Building TA26 - electrical cabinet which is likely to contain asbestos backing boards or mounting strips

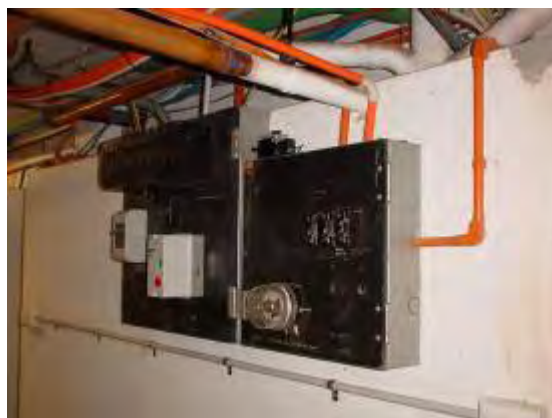
Plate P132: Building TA26 - typical asbestos containing electrical backing boards

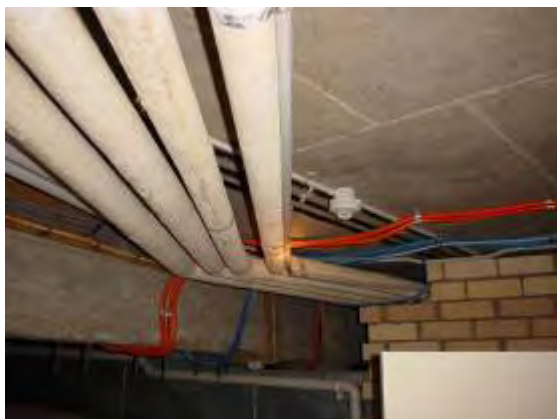
Plate P133: Building TA26 - asbestos lagged pipework in foundation space

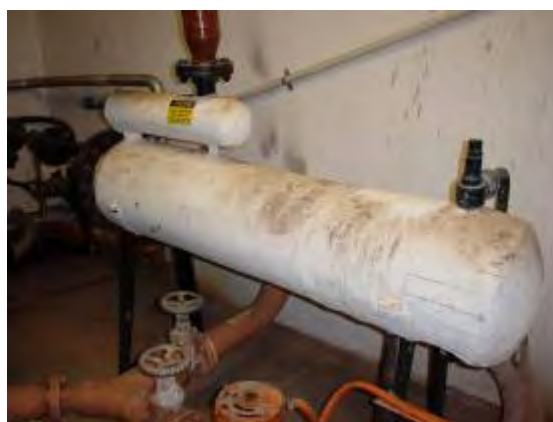
Plate P136: Building TA26 - asbestos lagged calorifier to plant/boiler room

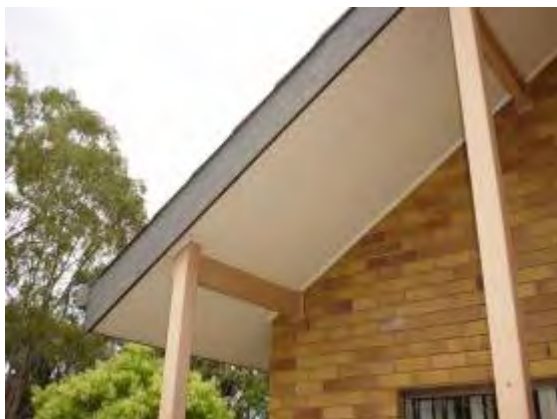
Plate P139: Building TA27 - fibrous cement eaves and porch ceiling linings which do not contain asbestos

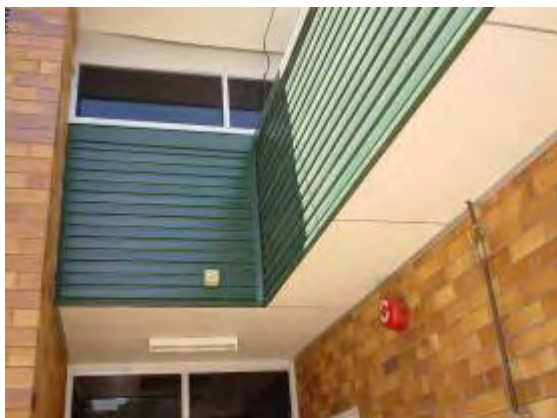
Plate P141: Building TA28 - typical asbestos cement fascia soffit linings

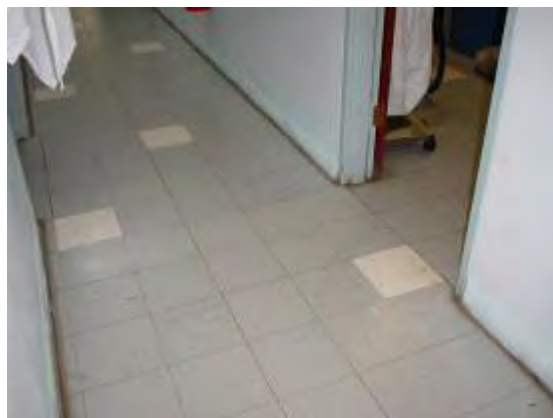
Plate P142: Building TA28 - typical vinyl floor tiles which do not contain asbestos

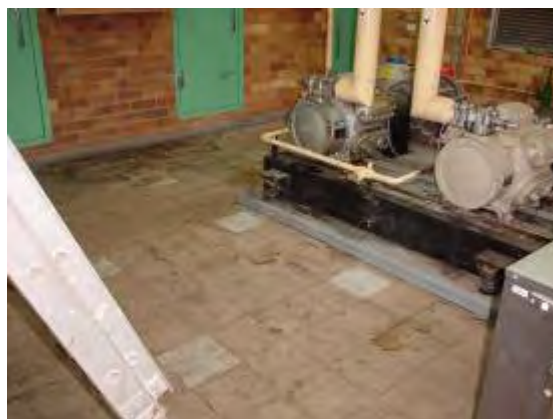
Plate P144: Building TA29 - typical vinyl floor tiles which do not contain asbestos

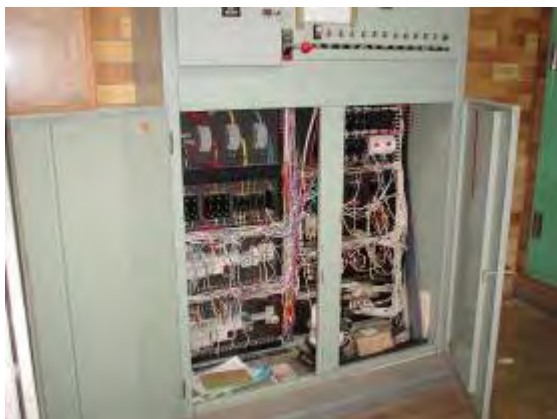
Plate P145: Building TA29 - asbestos containing backing boards to main electrical control cabinets

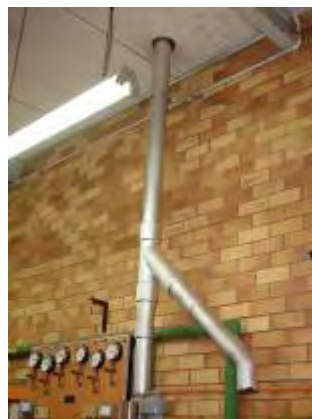
Plate P146: Building TA29 - asbestos cement flue to gas hot water unit. Note: asbestos cement ceiling linings

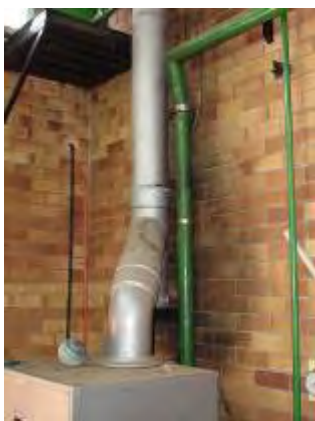
Plate P147: Building TA29 - asbestos cement flue to boiler

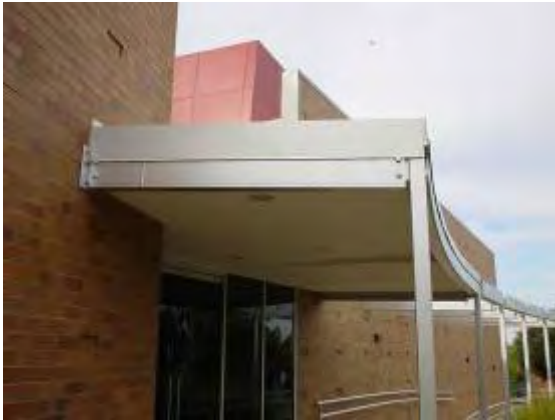
Plate P156: Building TA35 - fibrous cement walling at north end which does not contain asbestos
