L070 Hazardous Materials Advice, REF6, RPA Hospital Rev A

Hazardous Materials Summary and Advice – REF6, Royal Prince Alfred Hospital Redevelopment, Camperdown, NSW

CPB Contractors Pty Ltd Hazardous Building Materials Survey

Main Works Package, Royal Prince Alfred Hospital Redevelopment Missenden Road, Camperdown, NSW

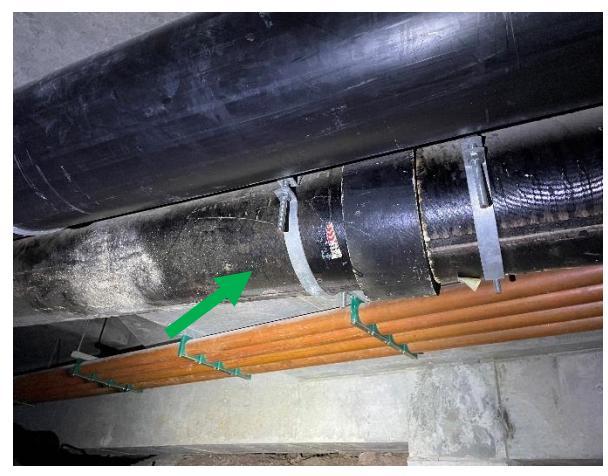
Photo 2: Level 1 – Southeast undercroft, Non asbestos containing fibre cement pipe

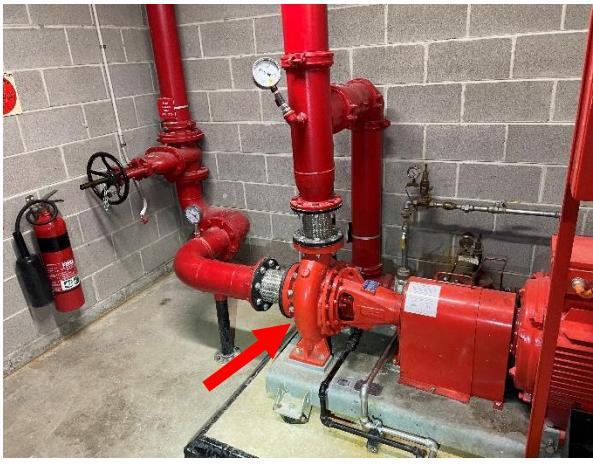
Photo 5: Level 1 – Fire pump room, Lead based red paint to pumps

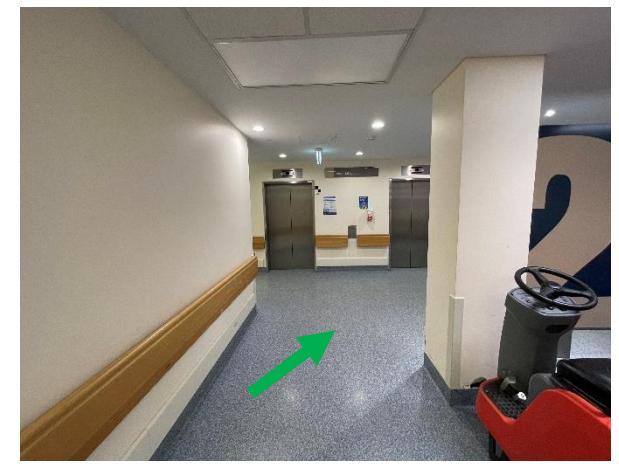
Photo 7: Level 2 – North lift foyer and corridor, Non asbestos containing blue vinyl sheeting to floor

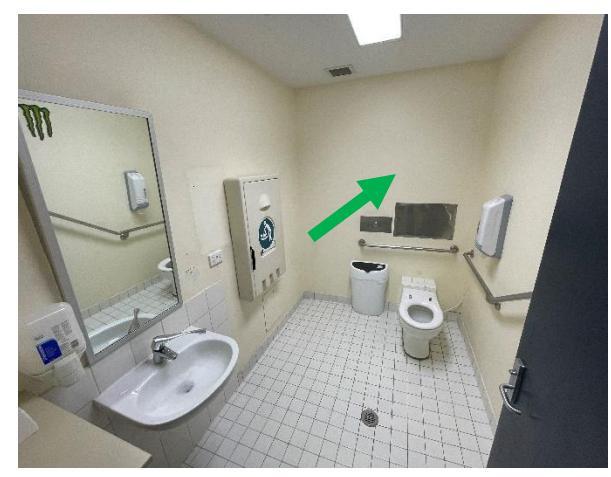
Photo 8: Level 2 - Toilets, Non asbestos containing fibre cement sheeting to walls

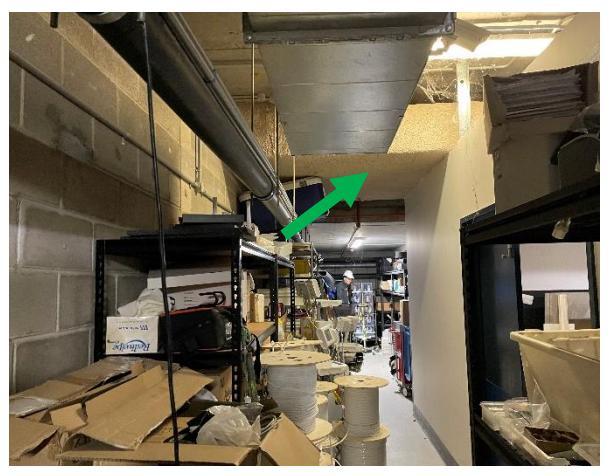
Photo 9: Level 2 – Carpark storerooms, Non asbestos containing vermiculite insulation to pipework and air con ducting

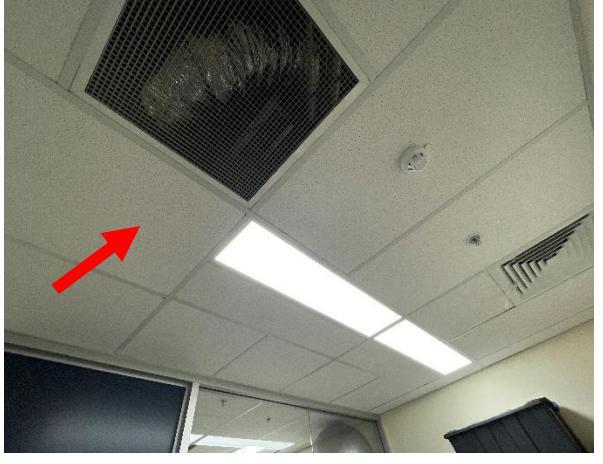
Photo 11: Level 2 - Assumed SMF insulation to the ceiling tiles throughout

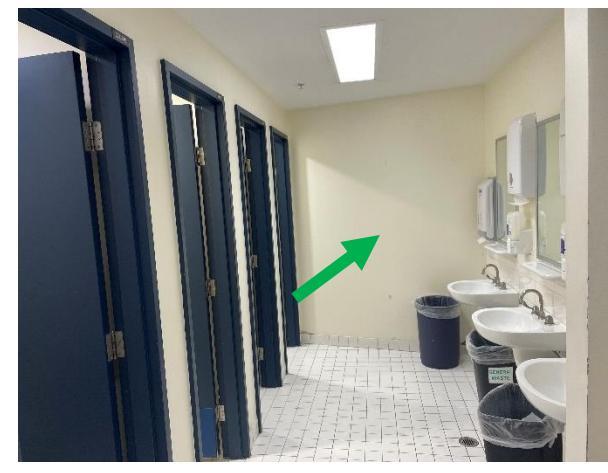
Photo 14: Level 3 – B89, ICU toilets, Non asbestos containing fibre cement sheeting to walls

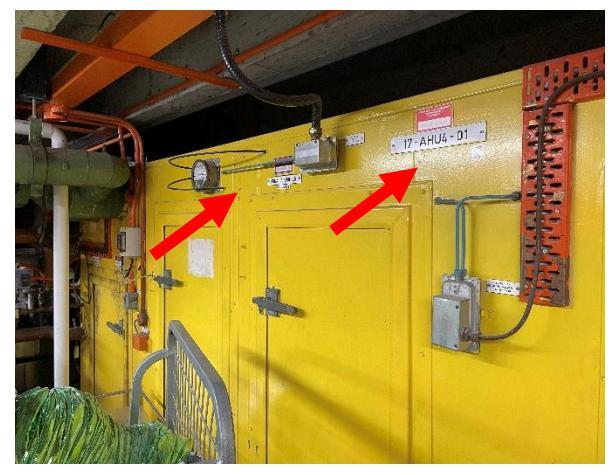
Photo 17: Level 4 – B75 plant room, Asbestos containing mastic to yellow AHU

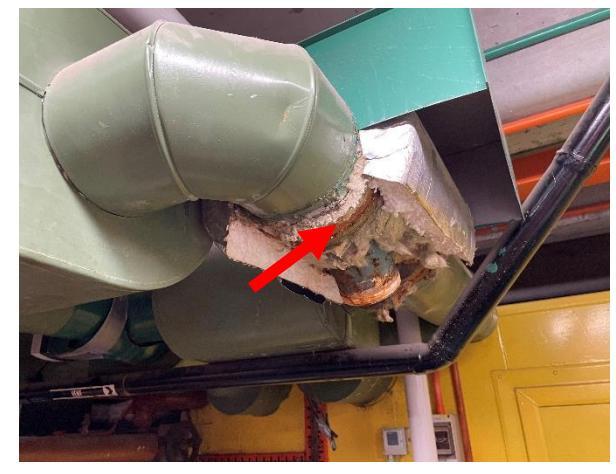
Photo 19: Level 4 - B75 plant room, Asbestos containing gasket to chilled water pipework

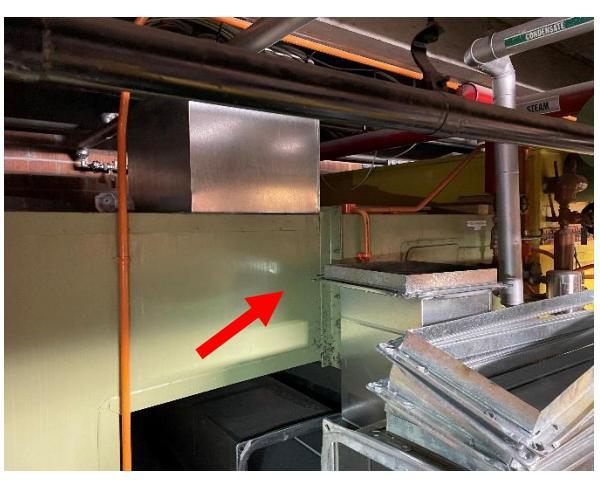
Photo 29: Level 4 - B75 plant room, Lead based green paint to the air plenum

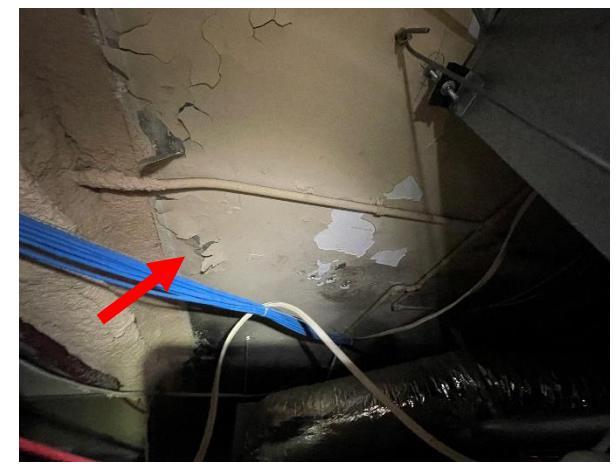
Photo 31: Level 4 – B63, storerooms, Lead based white paint to the concrete ceiling within ceiling cavity

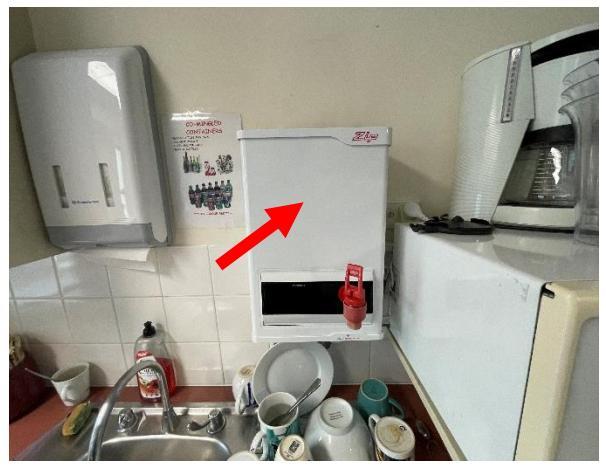
Photo 32: Level 4 – Assumed SMF insulation to the hot water units throughout

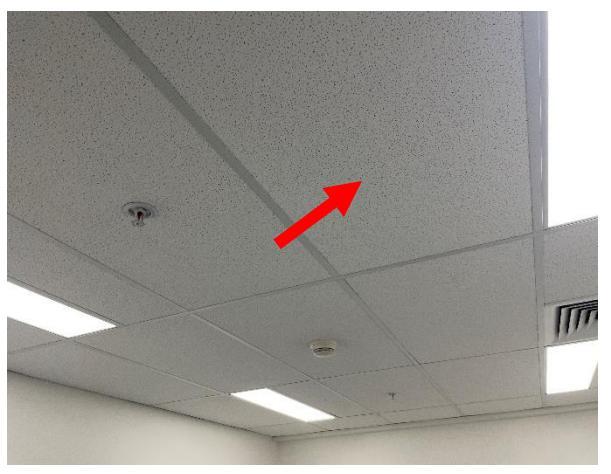
Photo 33: Level 4 – Assumed SMF insulation to the ceiling tiles throughout

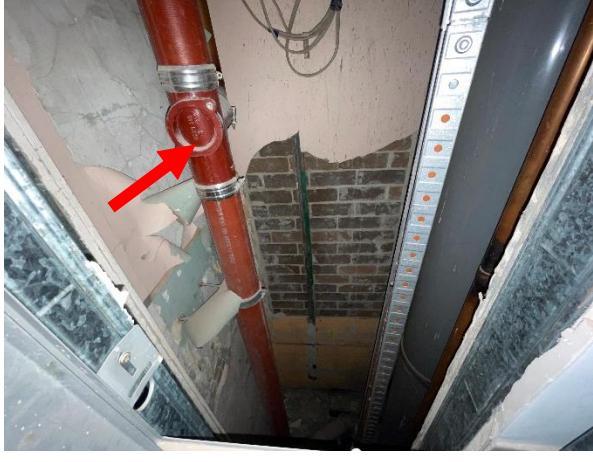
Photo 35: Level 5 – B63 Emergency Department, Lead based red paint to hydrant and door/frames

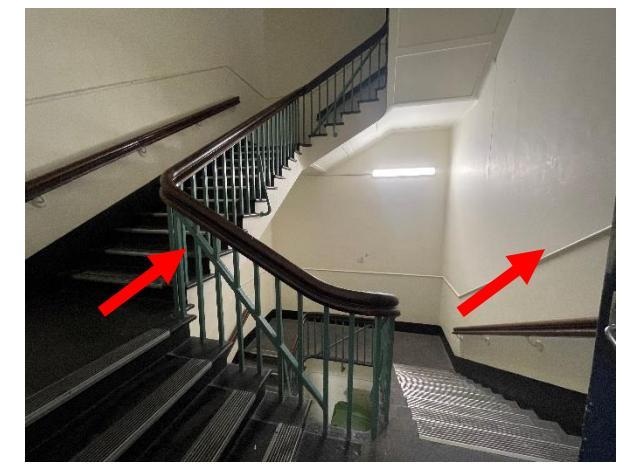
Photo 37: Level 5 - B63, Lead based cream and green paint to the cement rendered walls and the railings to stairwell

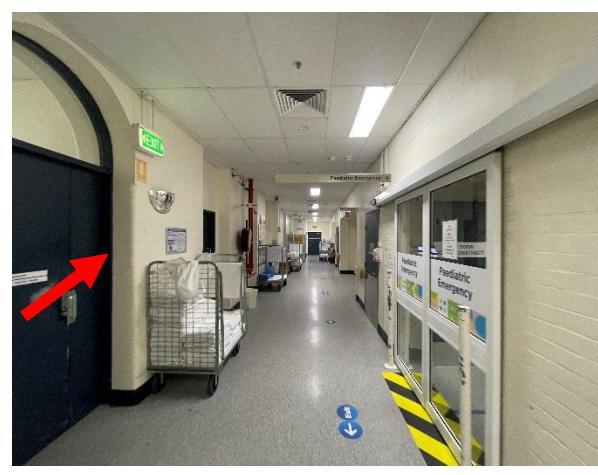
Photo 38: Level 5 - B63 Emergency Department, Lead based dark blue paint to the arches throughout the main corridor and staff rooms

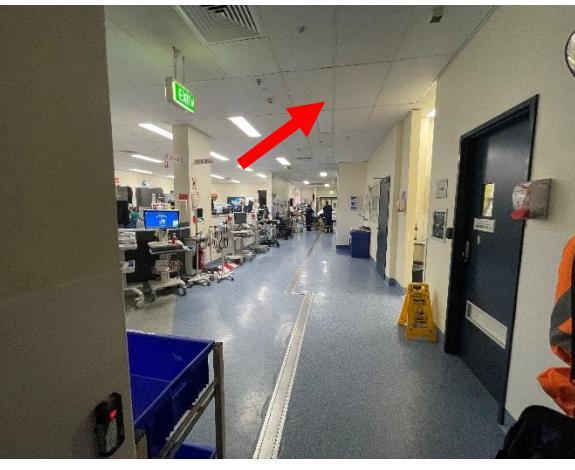
Photo 41: Level 5 - Assumed SMF internal insulation to the ceiling tiles throughout

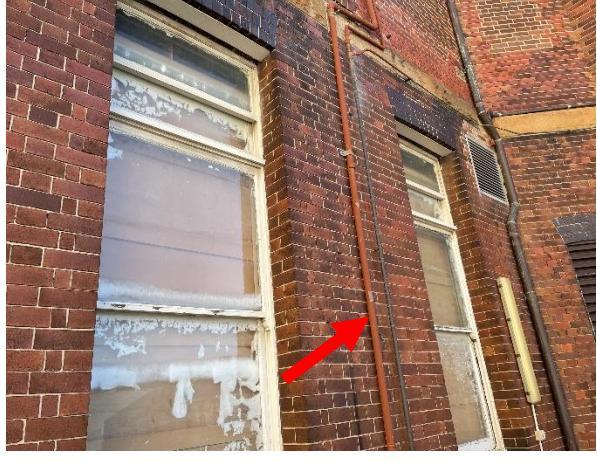
Photo 47: Level 6 – B63, Lead based orange paint to the external vent pipes

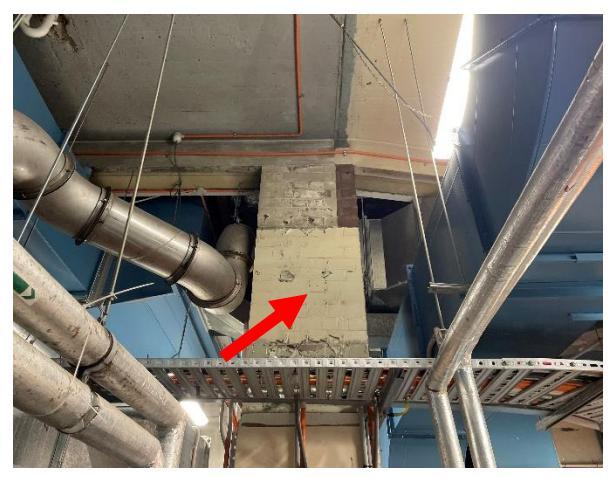
Photo 50: Level 6 - B63 Mechanical Plant Room, Lead based green/cream paint to the masonry walls

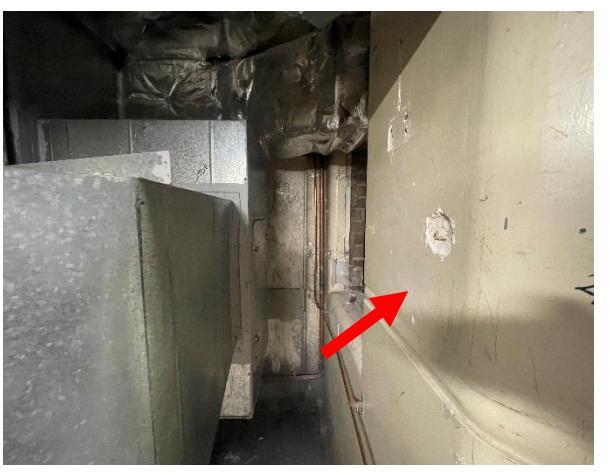
Photo 51: Level 6 - B63 Plant Room, Lead based cream paint to the double brick walls

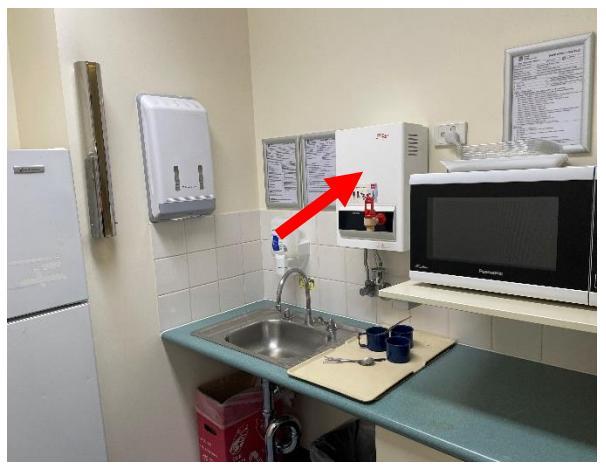
Photo 53: Level 6 - Assumed SMF internal insulation to the hot water units throughout

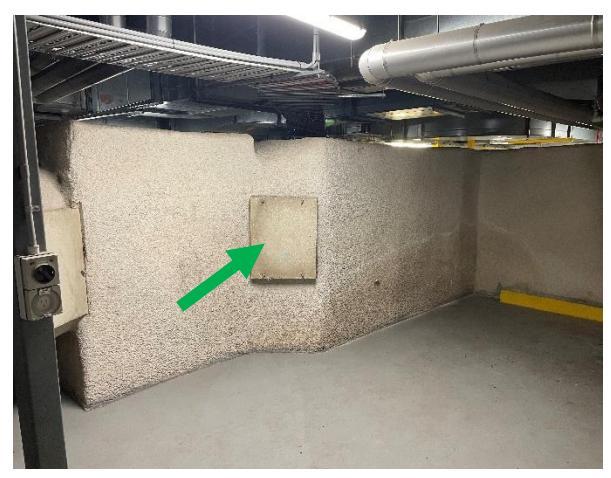
Photo 56: Level 7 – Plant Room, Non asbestos containing millboard insulation

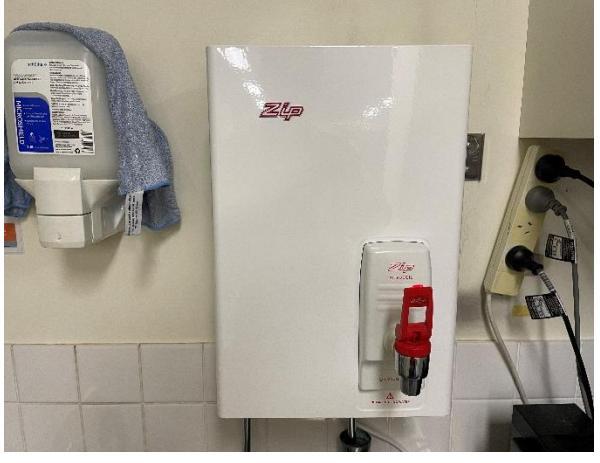
Photo 59: Level 7 – Assumed SMF internal insulation the hot water units throughout

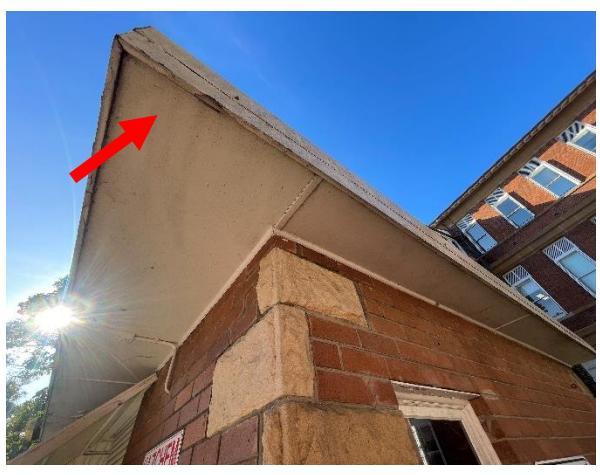
Photo 62: Gate House – Asbestos containing fibre cement sheeting to the eaves
