DILAPIDATION REPORT

Council Assets surrounding
Lot 27, 17 Mae Crescent,
Panania

Fairmont Homes

Prepared By: Sidarth Rajkumar
Date: June 2022
Ref: 220453-001-DR
Revision: A

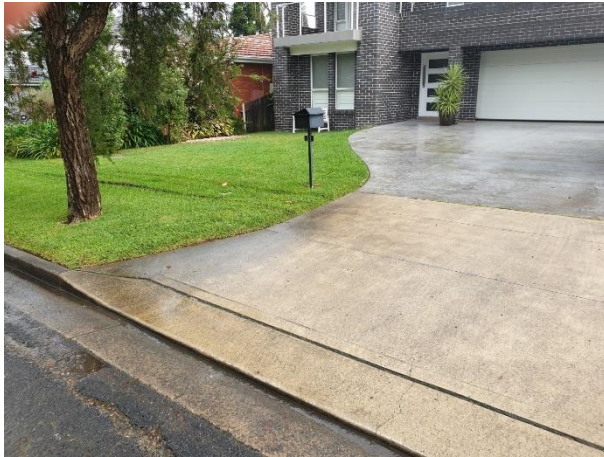
Photo 2.1-1
General Photo – Driveway to No. 21

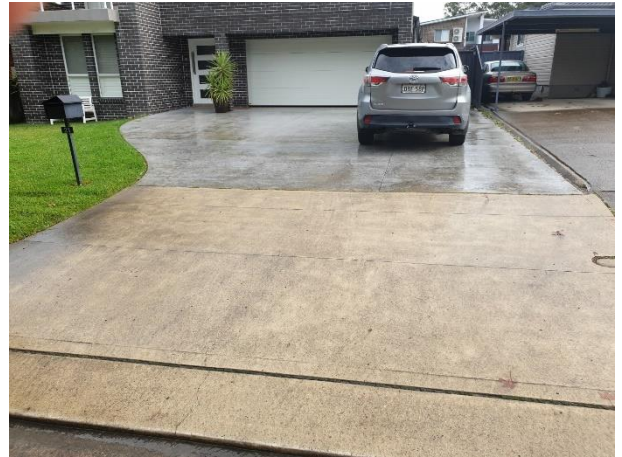
Photo 2.1-2
General Photo – Driveway to No. 21

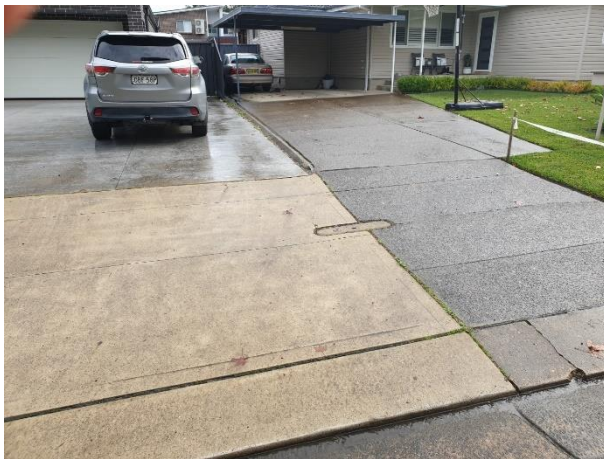
Photo 2.1-3
General Photo – Driveway to No. 21 and joint driveway to No. 19

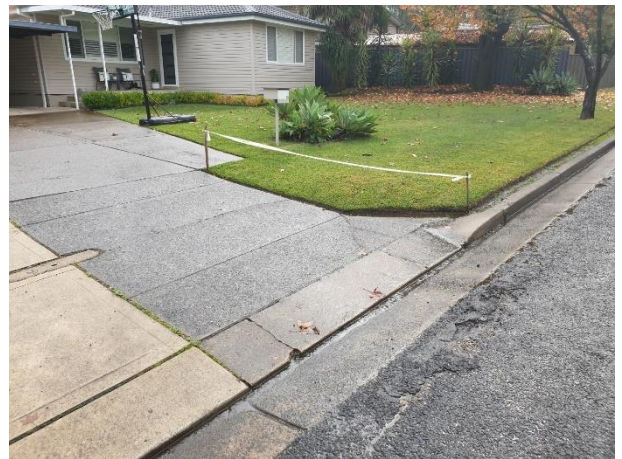
Photo 2.1-4
General Photo – Driveway to No. 21 and joint driveway to No. 19

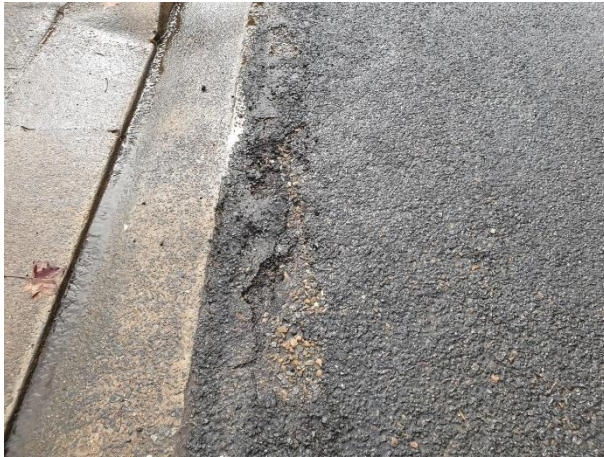
Photo 2.1-7
Deteriorated road surface adjacent driveway to No. 21

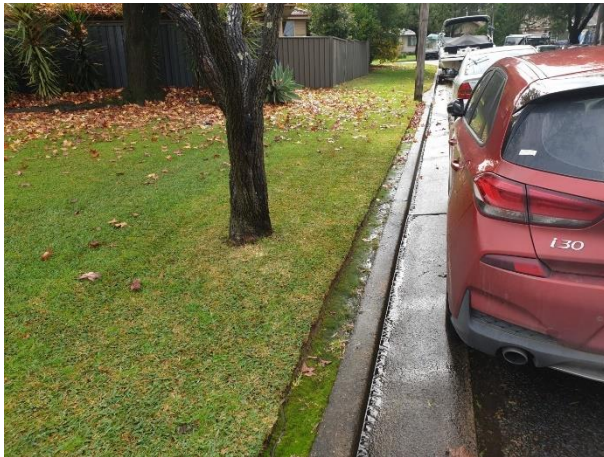
Photo 2.1-9
Existing condition of kerb and gutter (facing north)

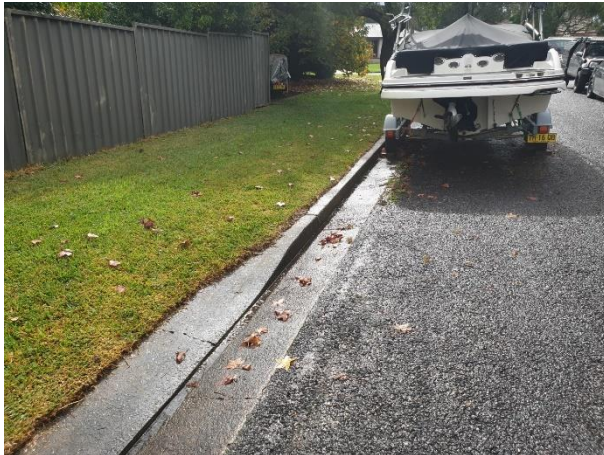
Photo 2.1-13
Existing condition of layback and kerb & gutter (facing north-west)

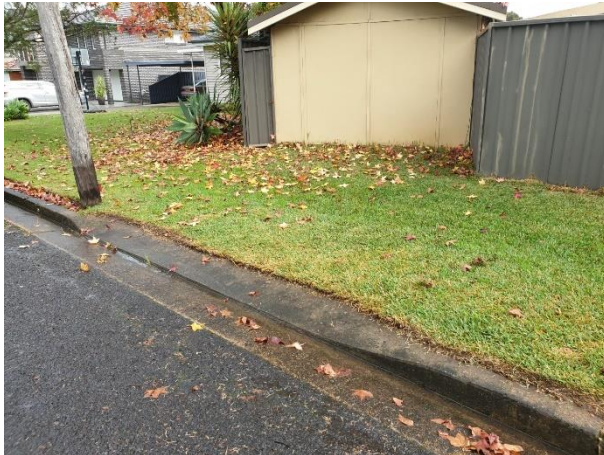
Photo 2.1-19
Existing condition of the layback and kerb & gutter (facing south-west)

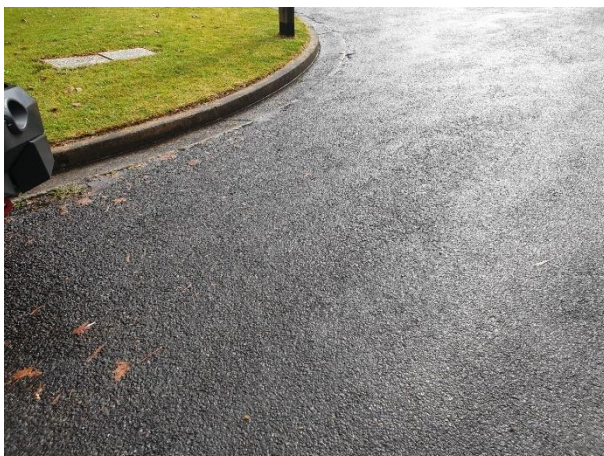
Photo 2.1-23
Existing condition of road surface adjacent No. 17 (facing north-west)

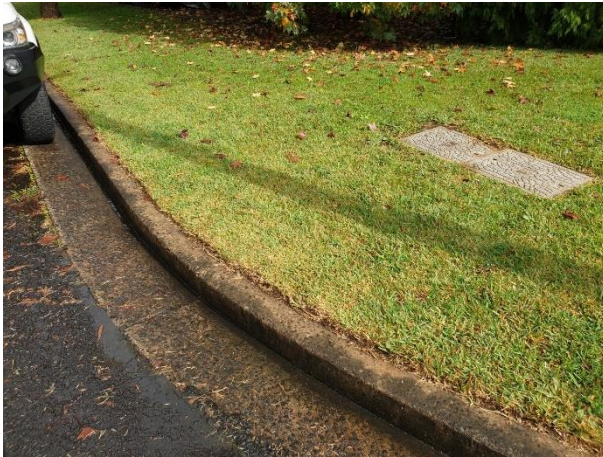
Photo 2.1-25
Existing condition of kerb & gutter adjacent No. 17 (facing south)

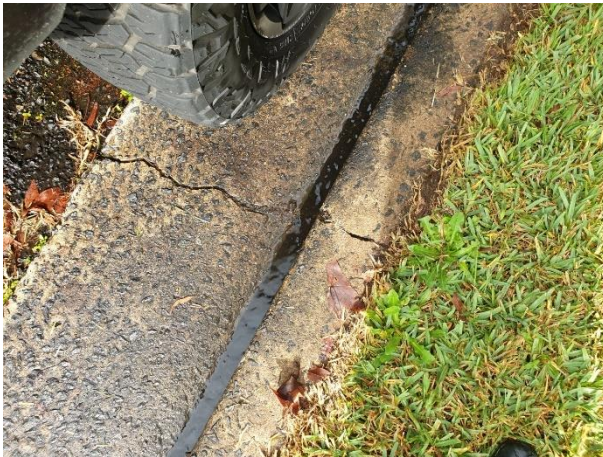
Photo 2.1-27
Cracking observed in kerb & gutter adjacent No. 17

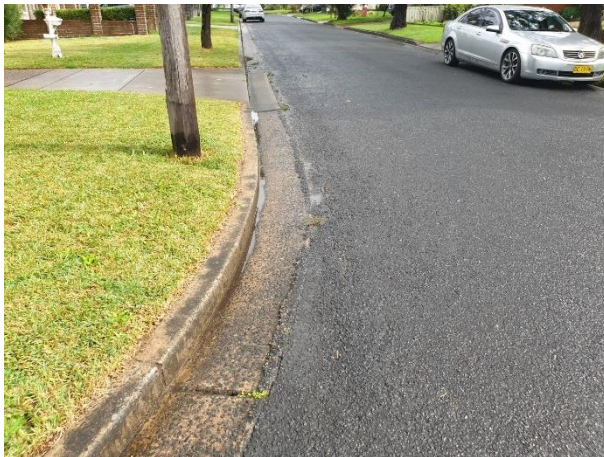
Photo 2.1-31
Existing condition of kerb & gutter adjacent No. 17 (facing west)

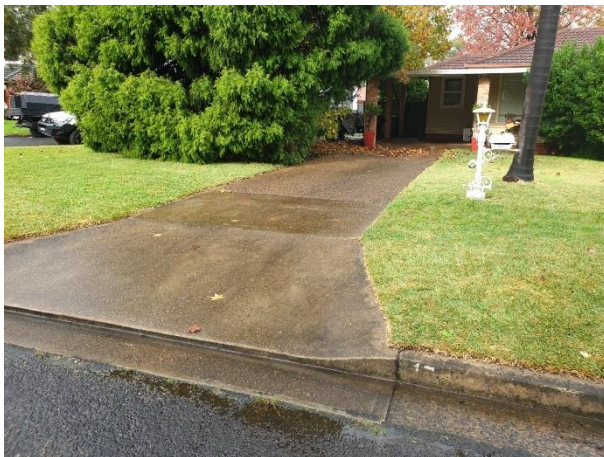
Photo 2.1-33
Existing condition of driveway, kerb and gutter and road surface adjacent No. 17 (facing south)

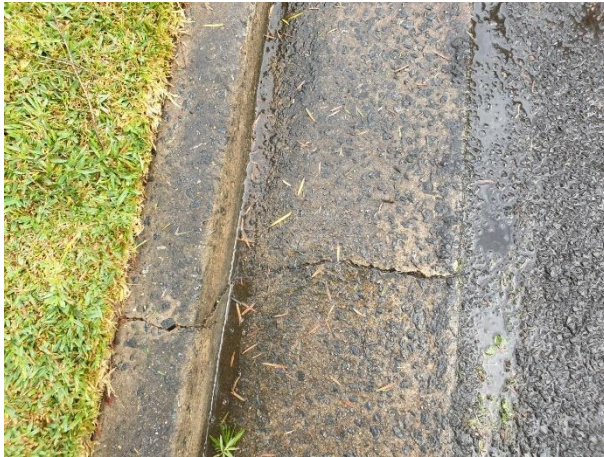
Photo 2.1-37

Cracking observed in kerb & gutter adjacent No. 17

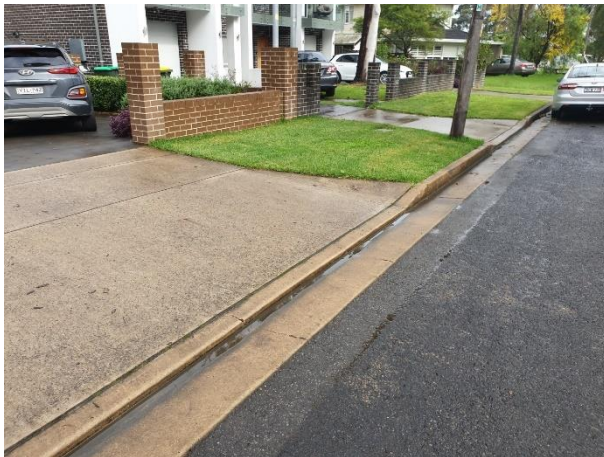
Photo 2.1-43
Existing condition of driveway to No. 15 (facing west)

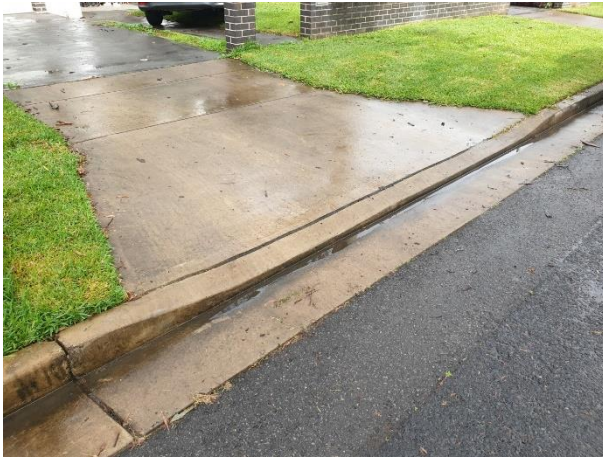
Photo 2.1-49
Existing condition of driveway to No. 13A (facing west)

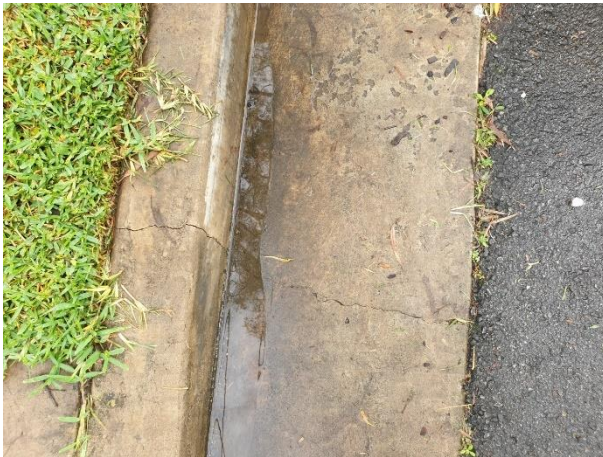
Photo 2.1-51
Cracking observed in kerb & gutter adjacent No. 13A

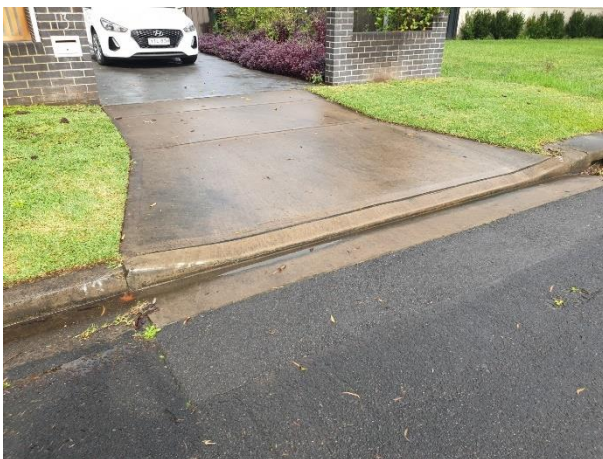
Photo 2.1-53
Existing condition of driveway to No. 13

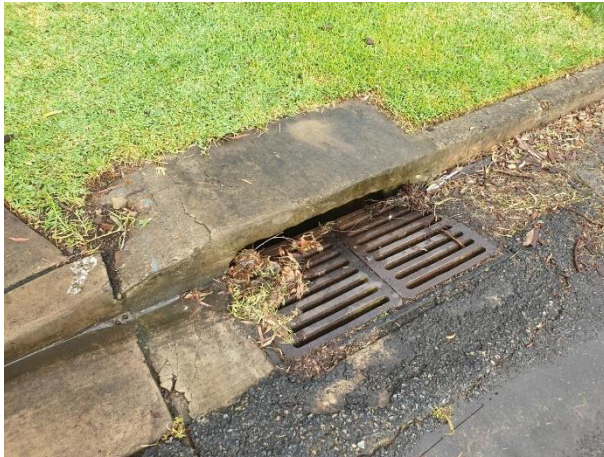
Photo 2.1-55
Existing condition of kerb inlet pit adjacent No. 13A (facing north)

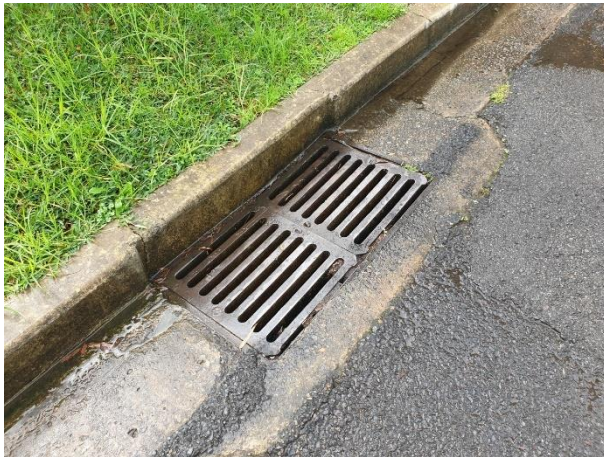
Photo 2.1-57
Existing condition of kerb inlet pit adjacent No. 14

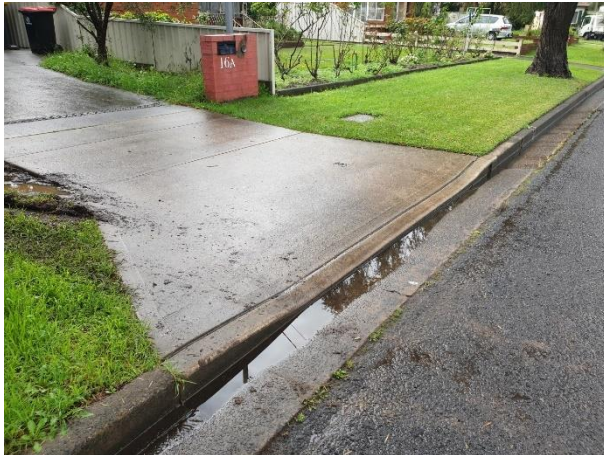
Photo 2.1-61

Existing condition of driveway to No. 16A (facing north-east)

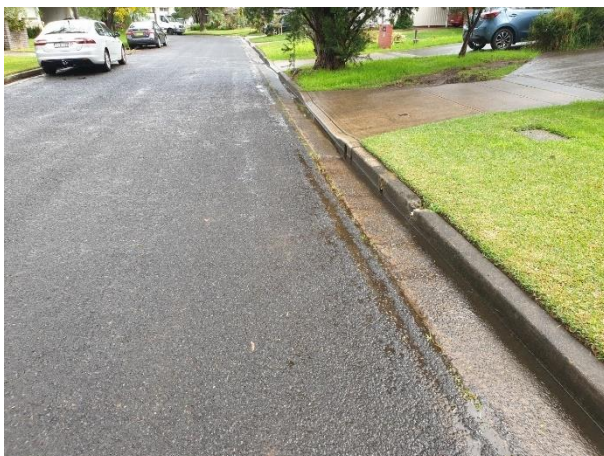
Photo 2.1-65

Existing condition of verge, kerb & gutter and road surface adjacent No. 16A (facing west)

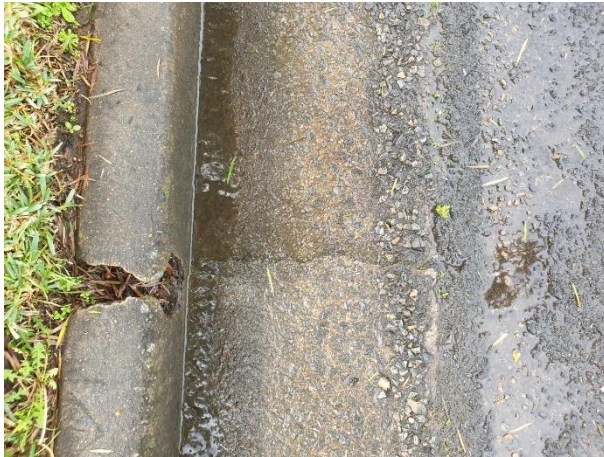
Photo 2.1-67

Cracking observed in kerb & gutter adjacent No. 16A

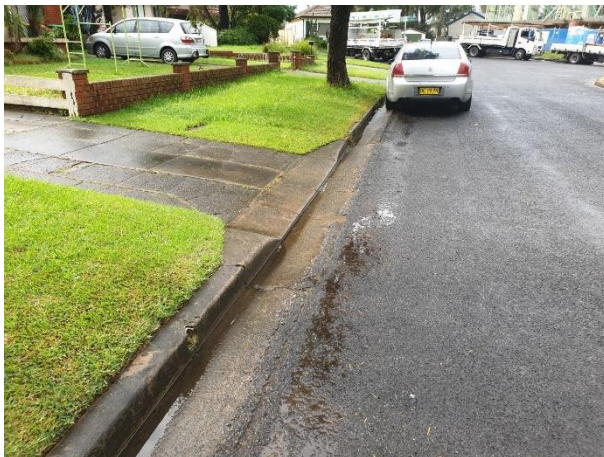
Photo 2.1-69

Existing condition of verge, kerb & gutter and road surface adjacent No. 18 (facing east)

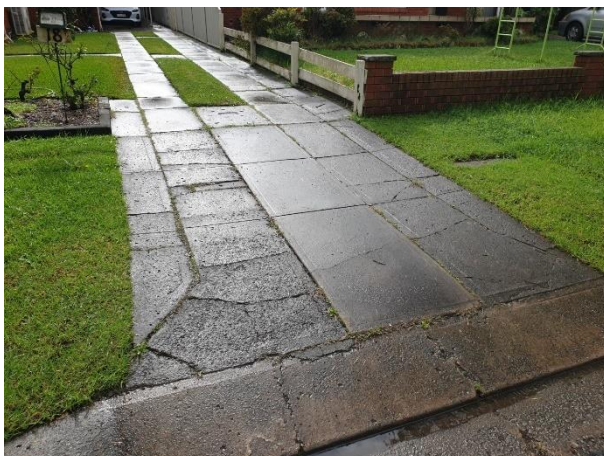
Photo 2.1-71

Existing condition of driveway to No. 18 (facing north)

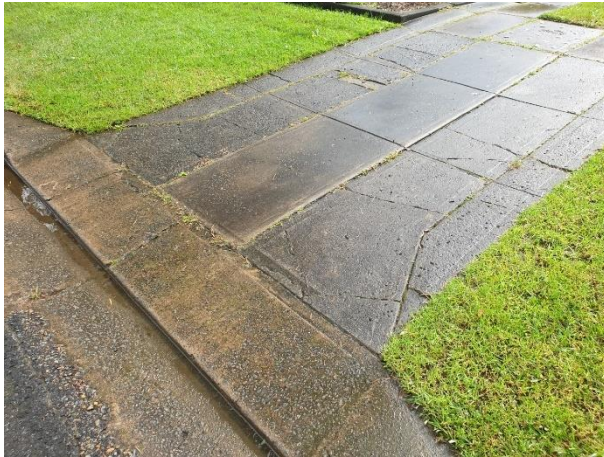
Photo 2.1-73
Existing condition of driveway and layback to No. 18
(facing north)

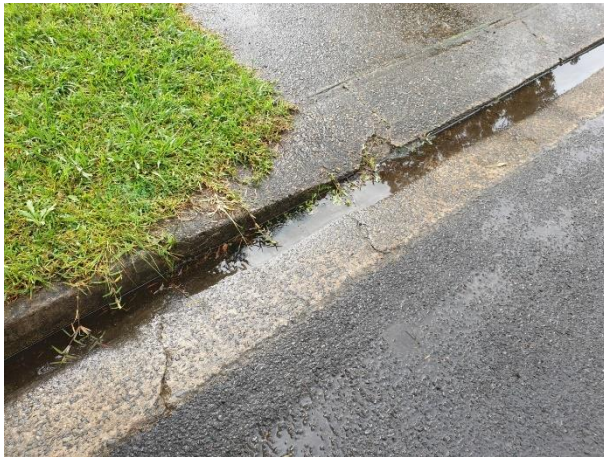
Photo 2.1-75
Existing condition of layback adjacent No. 20 (facing north)

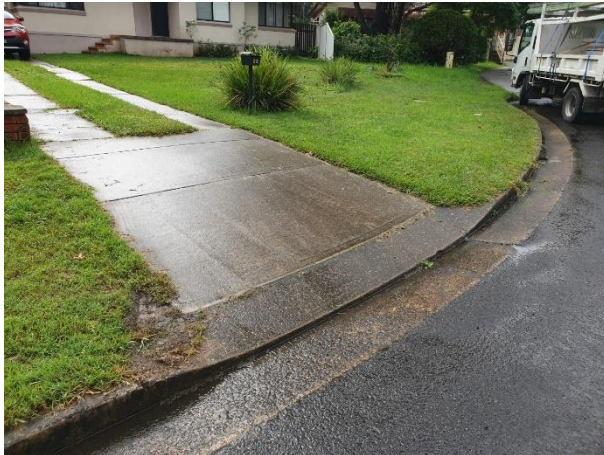
Photo 2.1-79
Existing condition of driveway to No. 22 (facing north)

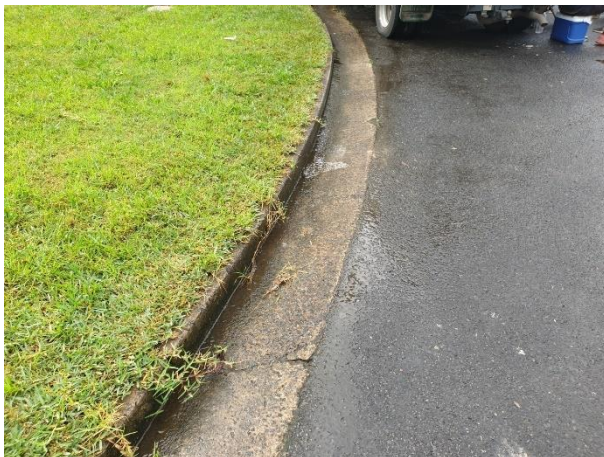
Photo 2.1-81
Existing condition of kerb & gutter adjacent No. 22 (facing north)

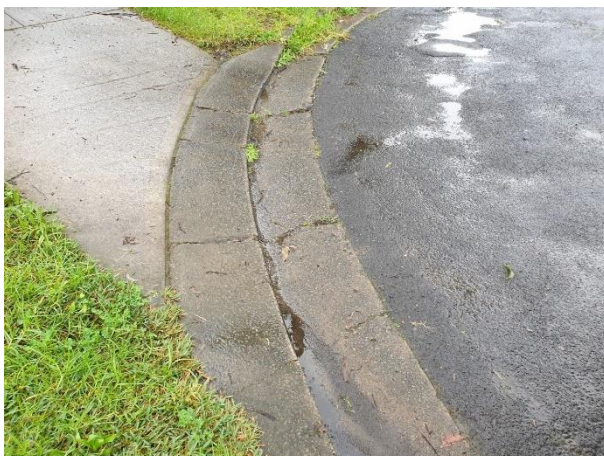
Photo 2.1-83
Existing condition of driveway to No. 24 (facing east)

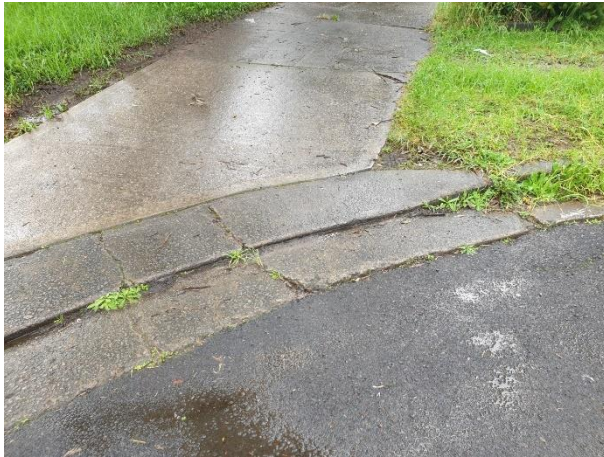
Photo 2.1-85
Cracking observed in layback to No. 24 (facing north)

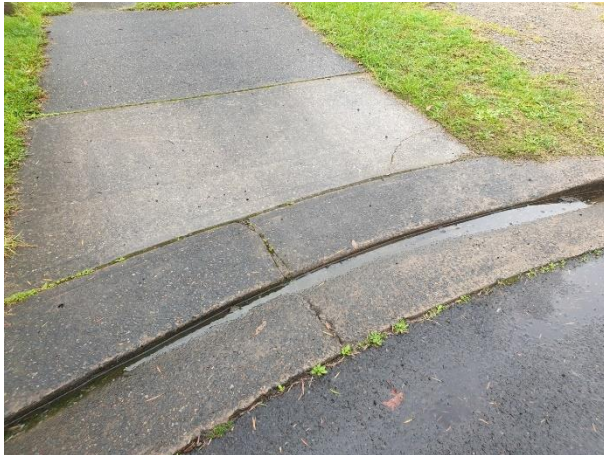
Photo 2.1-91
Existing condition of driveway to No. 26 (facing east)

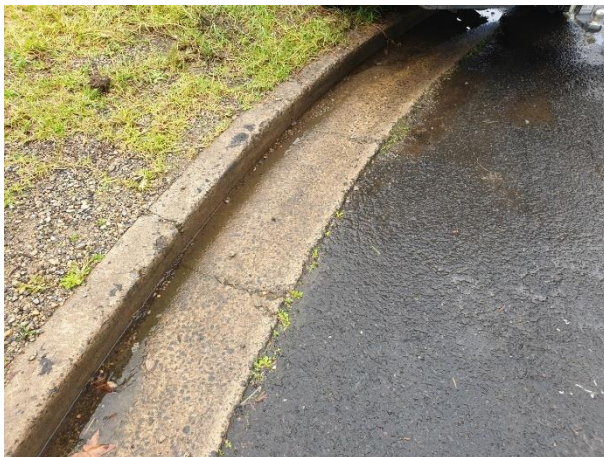
Photo 2.1-93
Existing condition of kerb and gutter adjacent No. 26 (facing east)

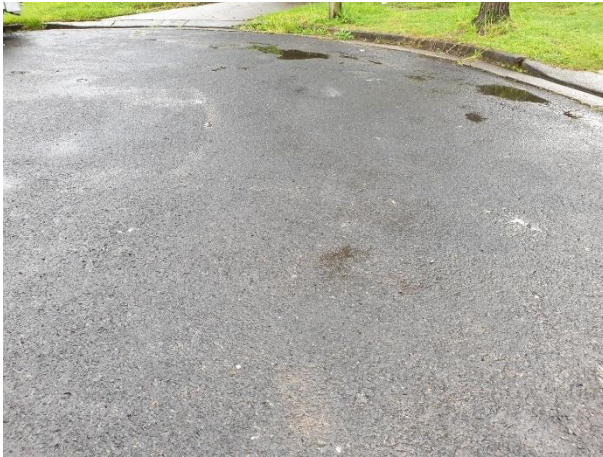
Photo 2.1-97
Existing condition of road surface adjacent No. 28 (facing north)

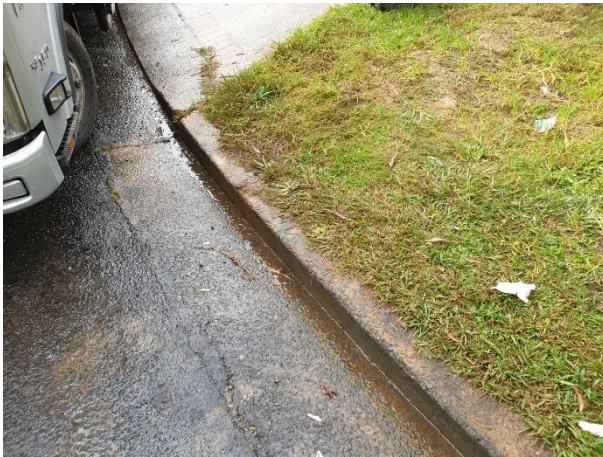
Photo 2.1-99
Existing condition of kerb and gutter adjacent No. 28 (facing north)

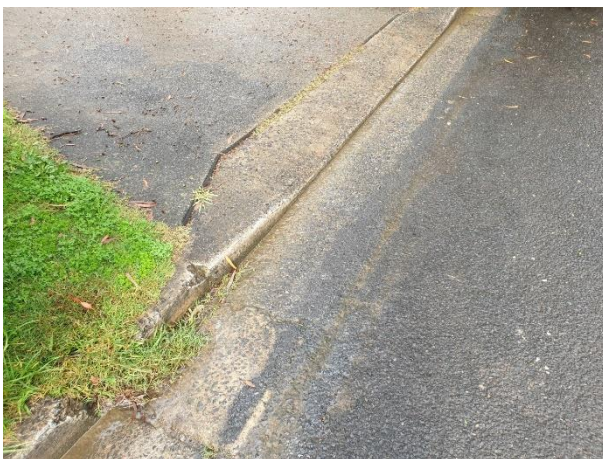
Photo 2.1-101
Existing condition of layback to No. 30 (facing south)

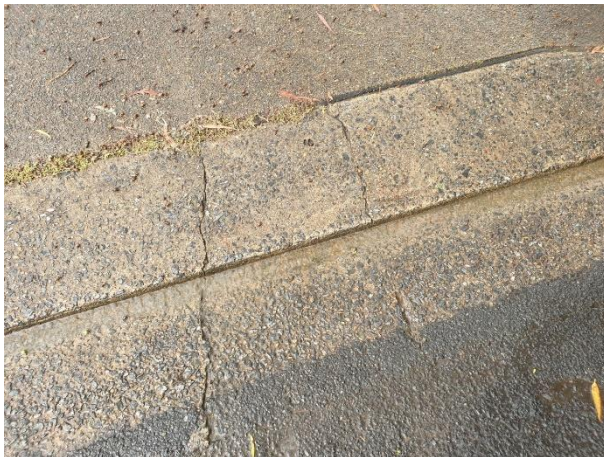
Photo 2.1-103

Cracking observed in layback to No. 30

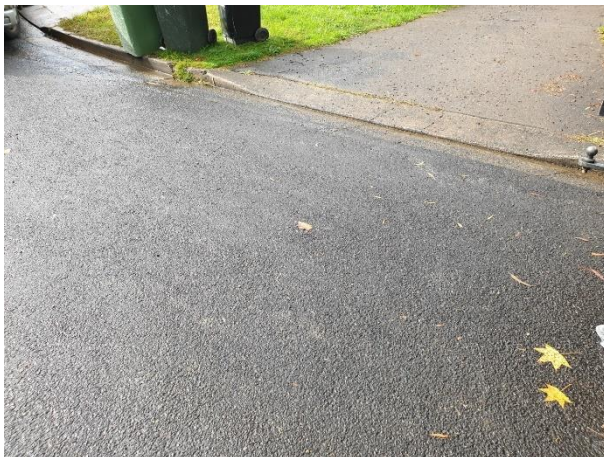
Photo 2.1-105

Existing condition of road surface adjacent No. 30 (facing east)

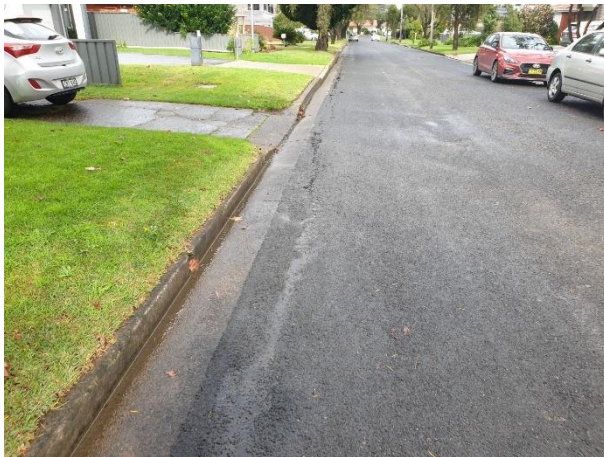
Photo 2.1-109
Existing condition of verge, kerb & gutter and road surface adjacent No. 30 (facing south)

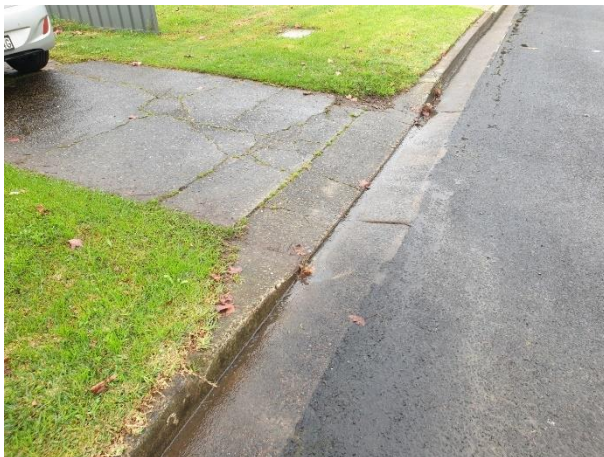
Photo 2.1-111
Existing condition of driveway to No. 32 (facing south)

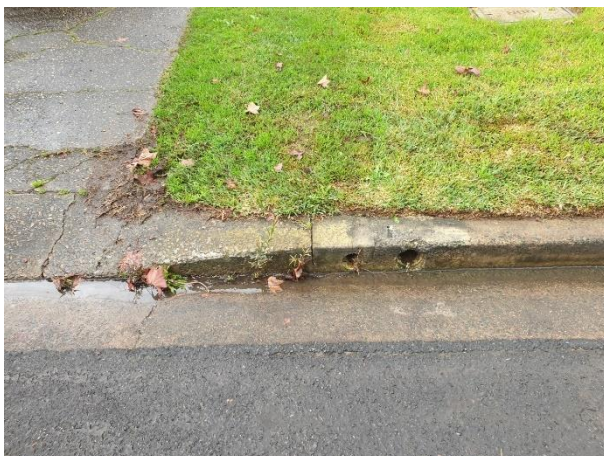
Photo 2.1-113
Existing condition of kerb and gutter and road surface adjacent No. 32 (facing east)

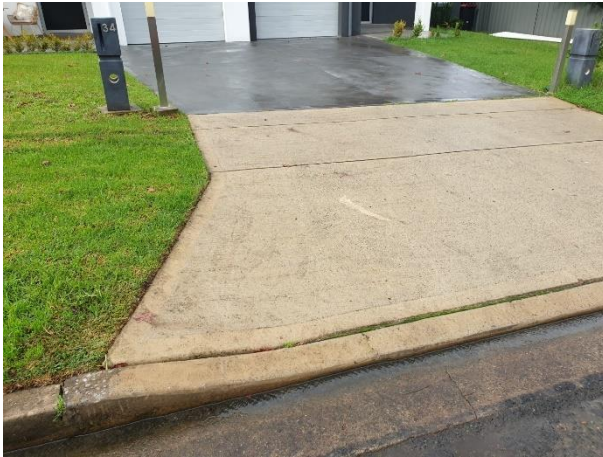
Photo 2.1-115

Existing condition of driveway, kerb and gutter, road surface adjacent No. 34 (facing east)

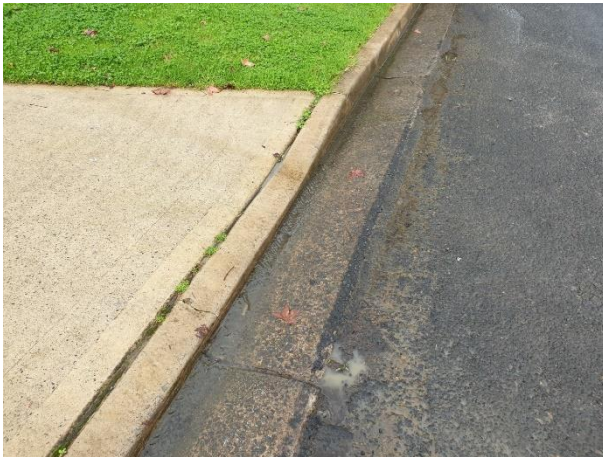
Photo 2.1-117

Existing condition of layback / driveway to No. 34 (facing south)
