## **Preliminary Site Investigation**

427 Burwood Road

Belmore NSW 2192

E21260-1

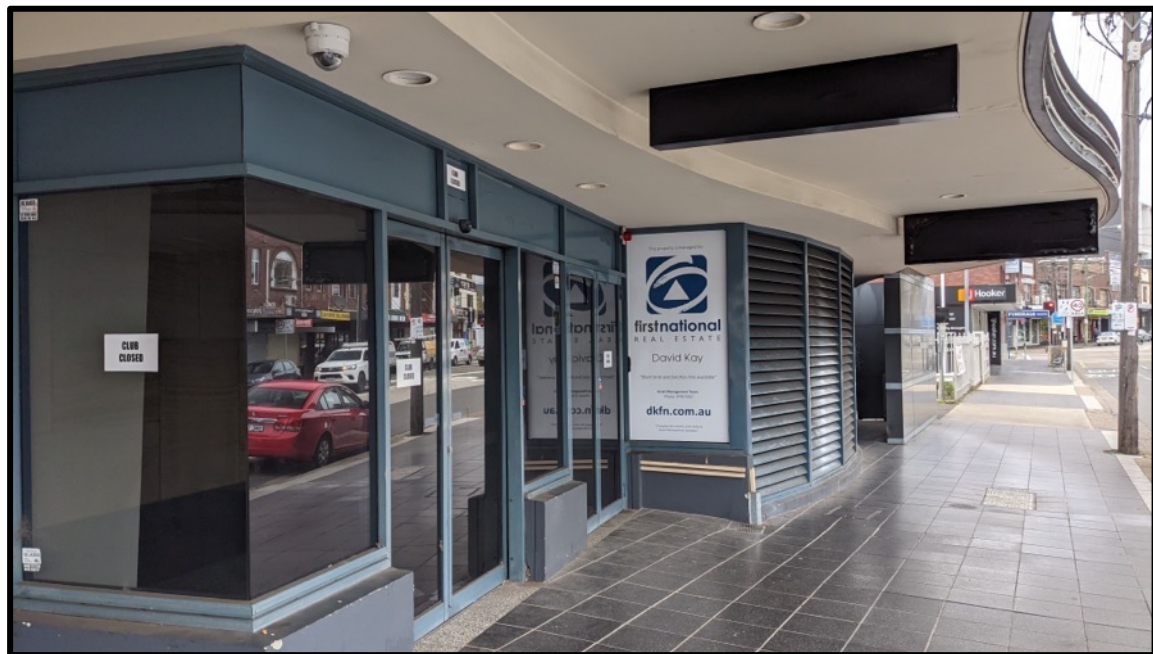
Figure 11. The entrance to the site was tiled and sealed.

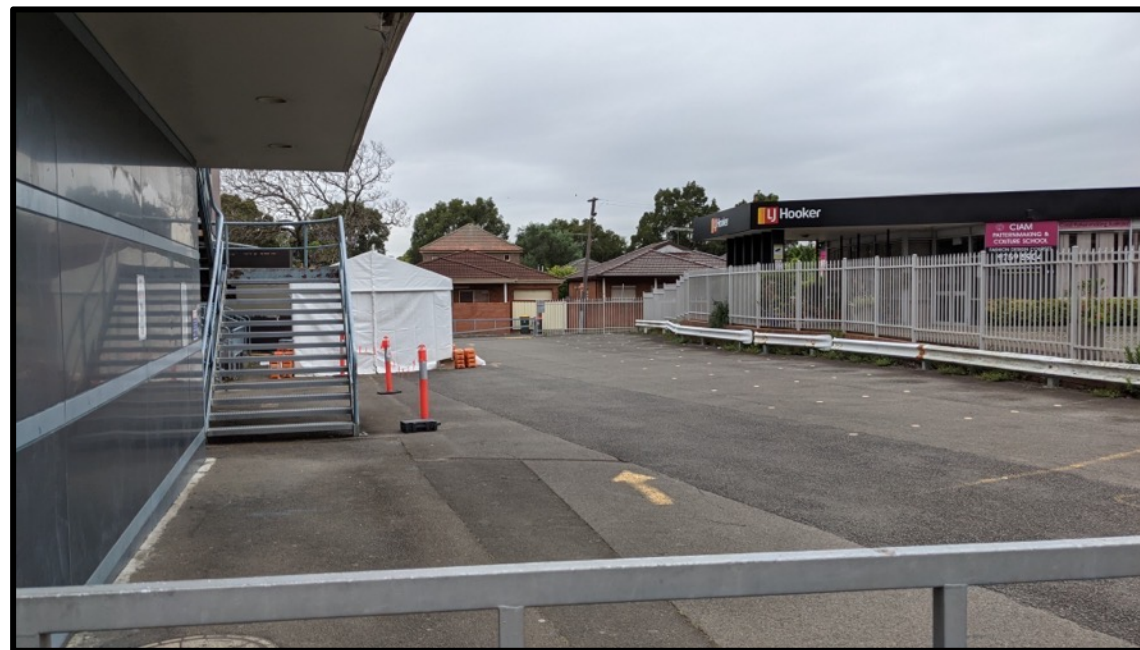
Figure 12. Burwood Road view of the site entrance.

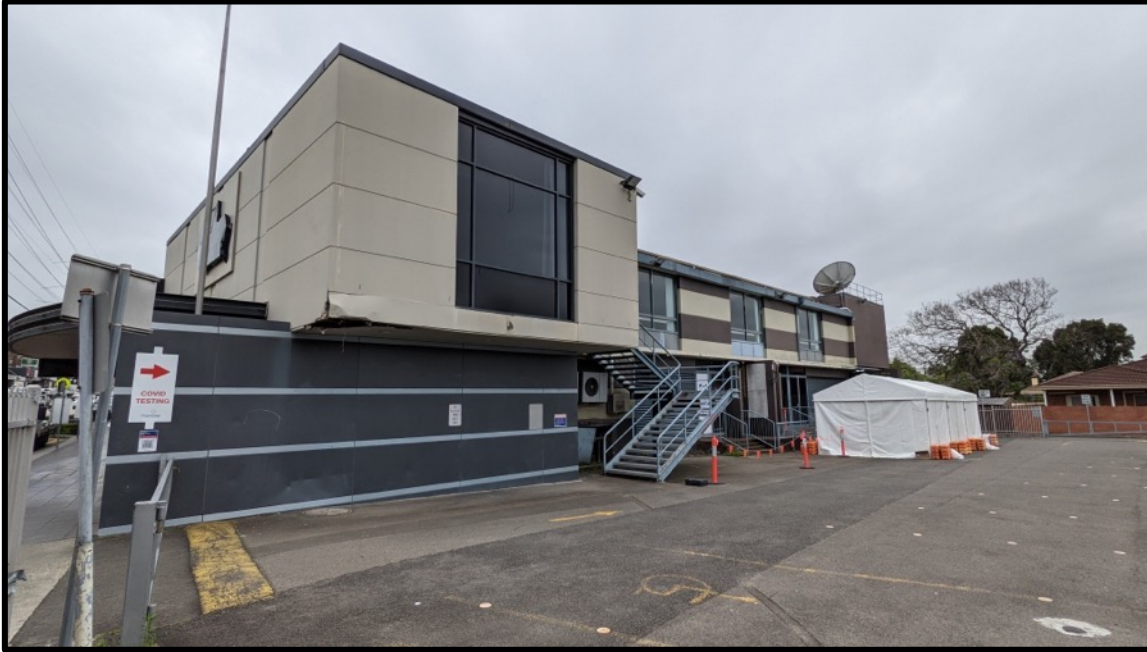
Figure 13. Rear of the site. The site building exit had metal stairs that led to an asphalt covered area.

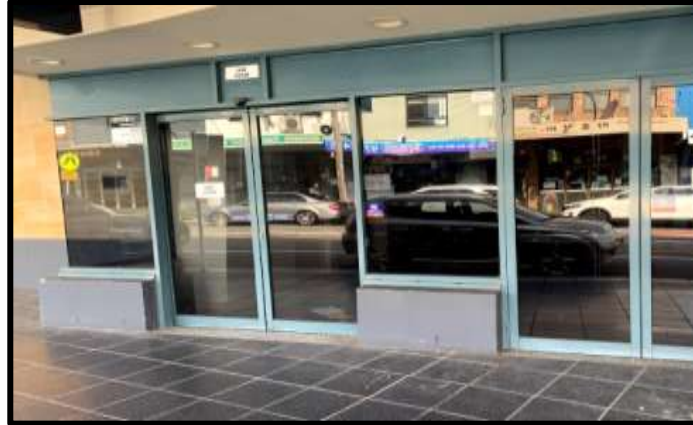
Image 1: Depicts the front view of the site. The site is a two-level structural dwelling used for commercial purposes. There is a vent coming out of the structure. In addition, there is an area which is eroding (seen from circle).

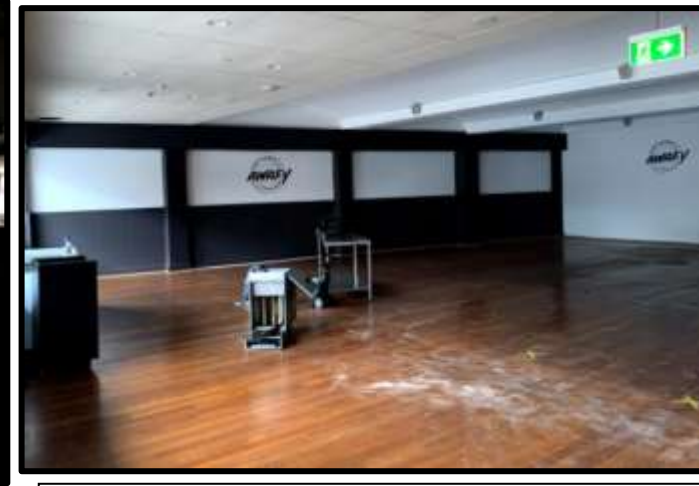
Image 5: Depicts an overview of the main hall of the site found within the ground floor of the un-named storefront.
