# Structural Condition Assessment

Norbrick Dr. and Old Windsor Rd. Pedestrian Bridge - Sign Structures

Prepared for: Mulpha Norwest Pty Ltd

Ref No: 2311081

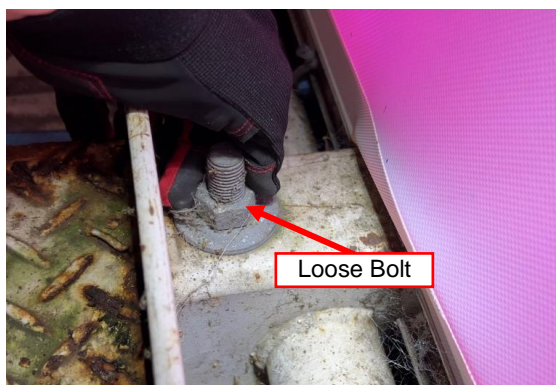
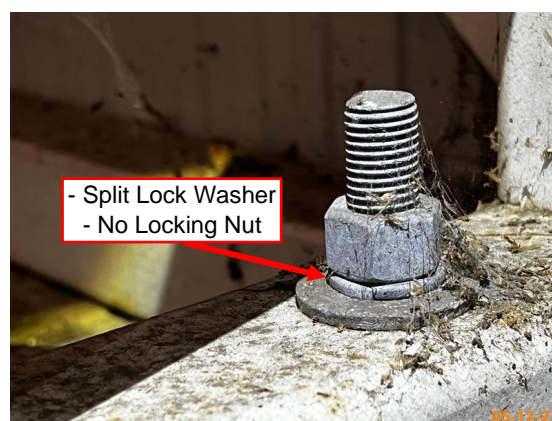
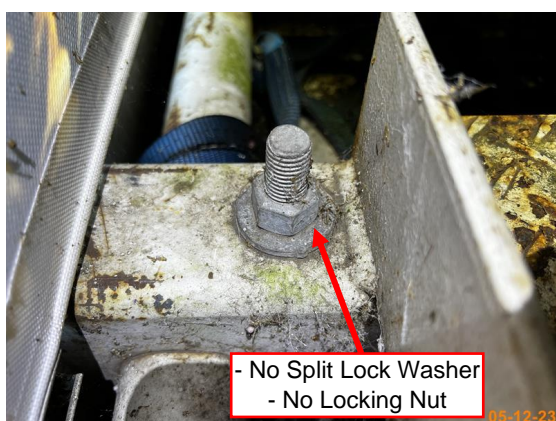
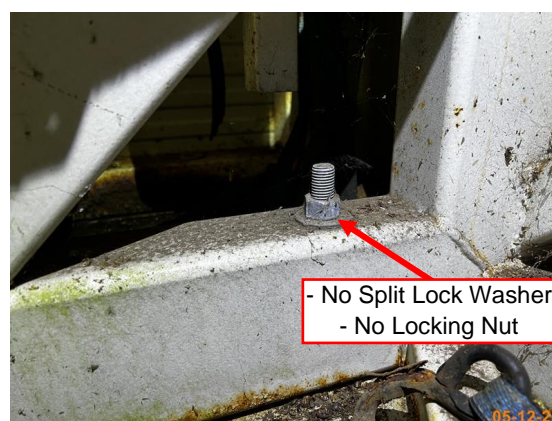
- The top and bottom chords of the frame were connected to BEAMS 1 and 2 using bolts, nuts, and washers. (Refer to **Figures 1 and 3 - Photographs 72**)
- All readily accessible bolts from the walkway within the sign boxes were hand-tested for looseness. One loose nut was identified (in Sign 2) and hand-tightened by our engineer as a safety precaution. (Refer to **Photograph 76**)
- There was no lock nut installed on Bolts B1, B2, T1 and T2. (Refer to **Photographs 72-73-74-75**)
- Split lock washers were installed on some of the Bolts. (Refer to **Photograph 73**)
- Some bolts lacked both lock nuts and split lock washers. (Refer to **Photograph 74-75-76-77**)
- Surface corrosion (rust stains) was observed on a number of Bolts T1 and T2 (on the bolt head, washer and nuts). (Refer to **Photograph 66-70-77**)

Corroded bolts, nuts and washer to be replaced like-for-like.

All bolts shall be hand-tested and loose nuts to be tightened using a standard wrench to a 'snug-tight' condition as per the approved structural drawings.

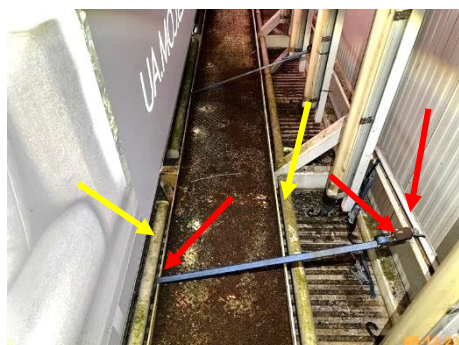
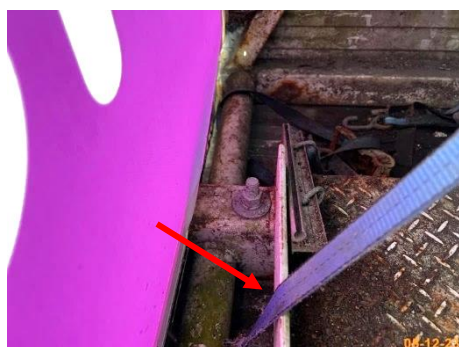
- Both sign boxes have two tensioning bars (CHS 60x3.6) welded between the bottom chords (indicated by the yellow arrows above). (Refer to **Figure 1** and **Photograph 78**)
- The sign banner was tensioned with ratchet straps attached to its edge at one end and tied around the non-structural horizontal Light Rod supports at the other end. (Refer to **Photographs 78-79-80-81-83-84**)
- Due to the way the straps were installed, the straps rub against the edge of the walkway checker plate. (Refer to **Photographs 81-85**)
- Surface corrosion was observed on several rachets. Broken and faulty rachets and torn straps were found on the floor of the sign boxes. (Refer to **Photograph 79**)

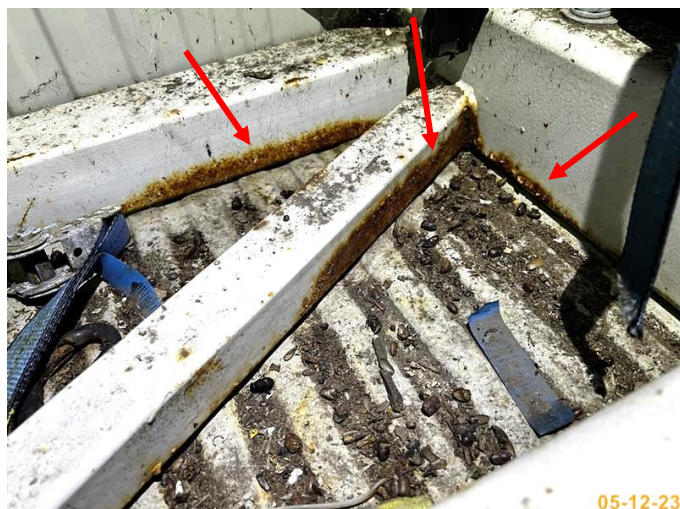
**Photograph 4**

Sign 1 – Defect 6.1

- Paint degradation and surface corrosion of structural members

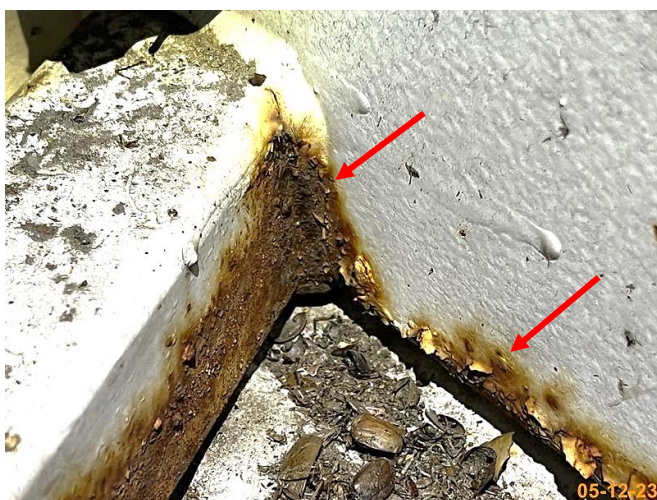
**Photograph 5**

Sign 1 – Defect 6.1

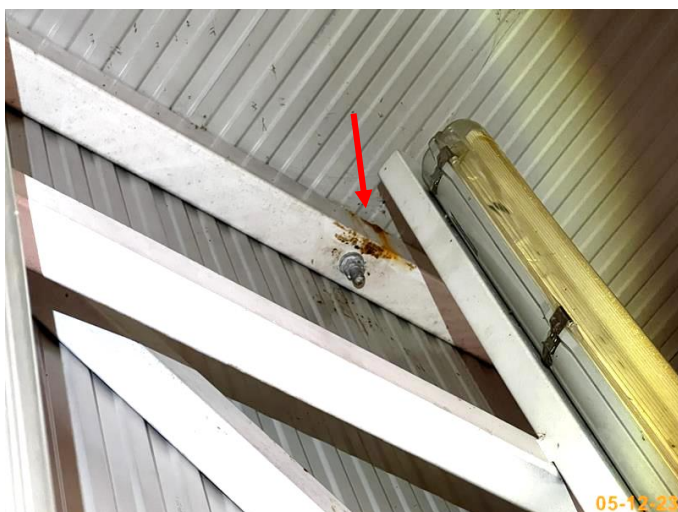
**Photograph 17**

Sign 1 – Defect 6.1

- Localised corrosion of structural members

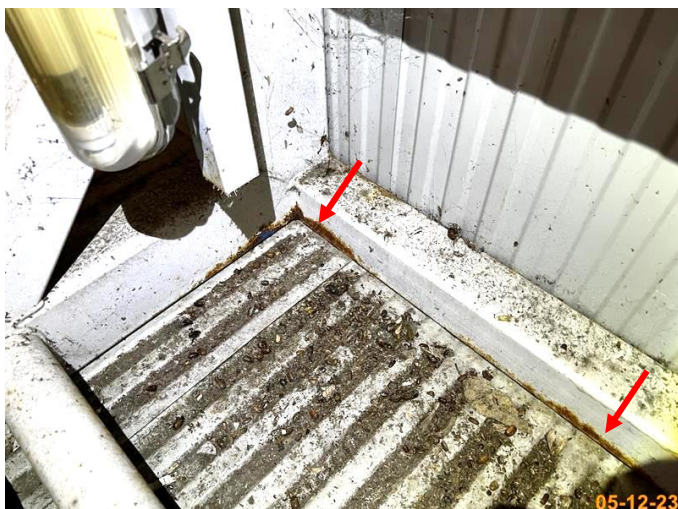
**Photograph 18**

Sign 1 – Defect 6.1

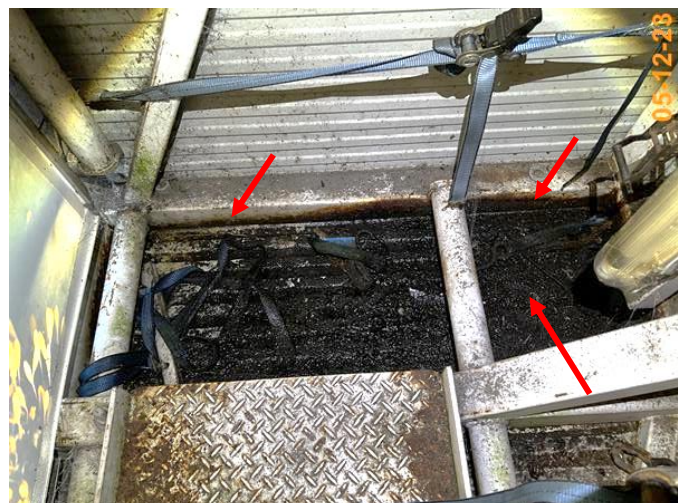
**Photograph 21**

Sign 1 – Defect 6.1

Close-up view of **Photograph 20**.

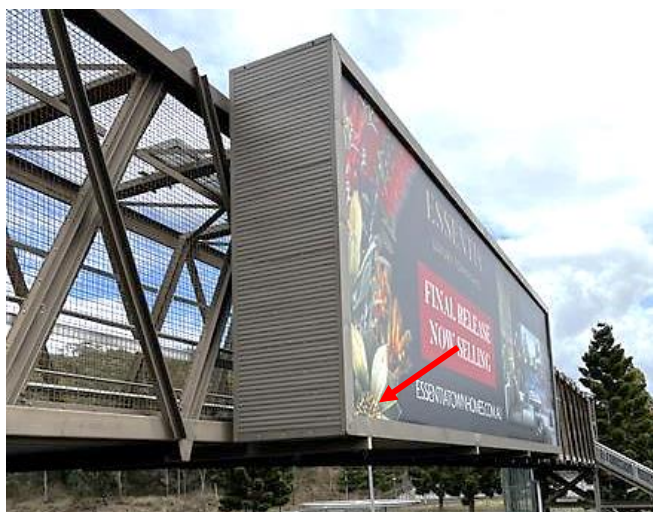
**Photograph 25**  
Sign 1 – Defect 6.1  
 - Gap between the banner and the cladding.

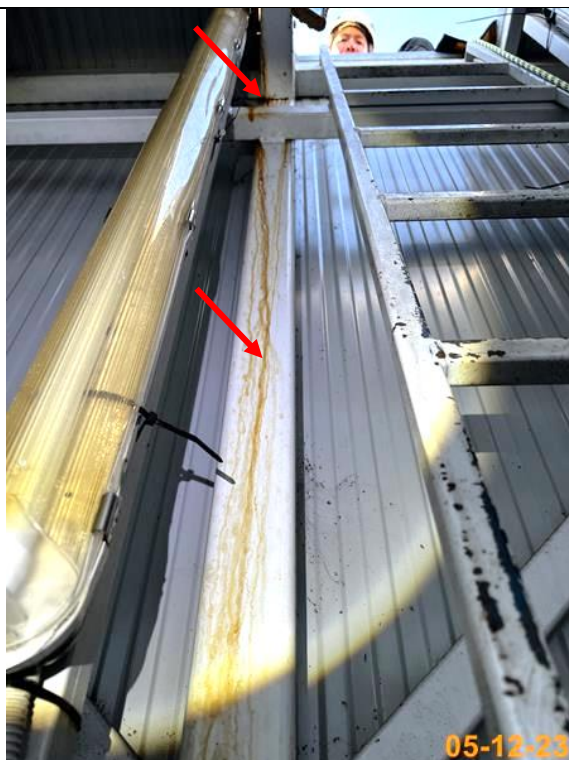
**Photograph 29**

Sign 1 – Defect 6.1

- Rust staining near the western access hatch.

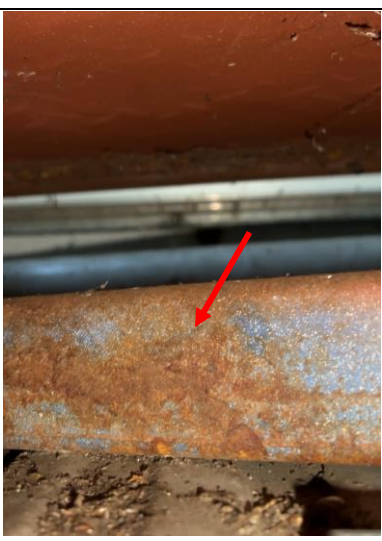
- Surface corrosion was observed on the bottom members of the sign frame under the walkway checker plate. (Refer to **Photograph 30**)
- Localised surface corrosion and rust stains were noted on the various members of the sign structure.

<p><b>Photograph 30</b>  <u>Sign 1 – Defect 6.1</u>          - Surface corrosion of structural members under the walkway plate.</p>

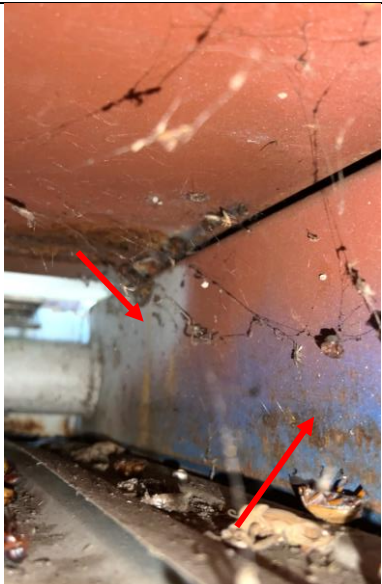
<p><b>Photograph 31</b>  <u>Sign 1 – Defect 6.1</u>          - Two paint layers on the structural members (blue and white)</p>

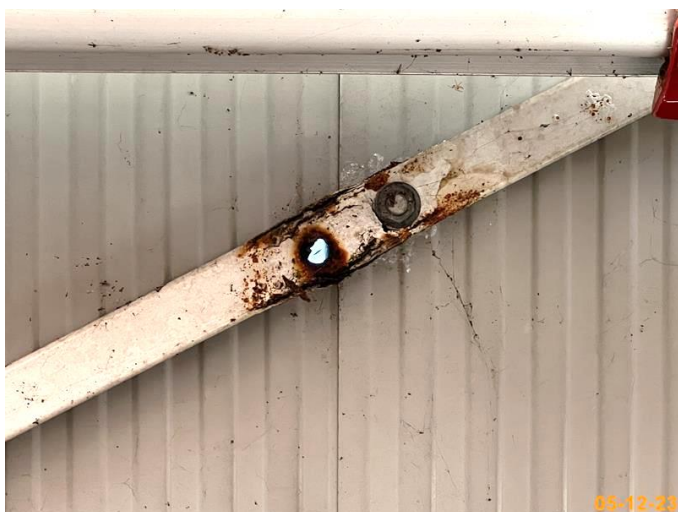
**Photograph 42**

Sign 2 – Defect 6.1

- Closed up view of **Photograph 41**.
- Open bolt hole.

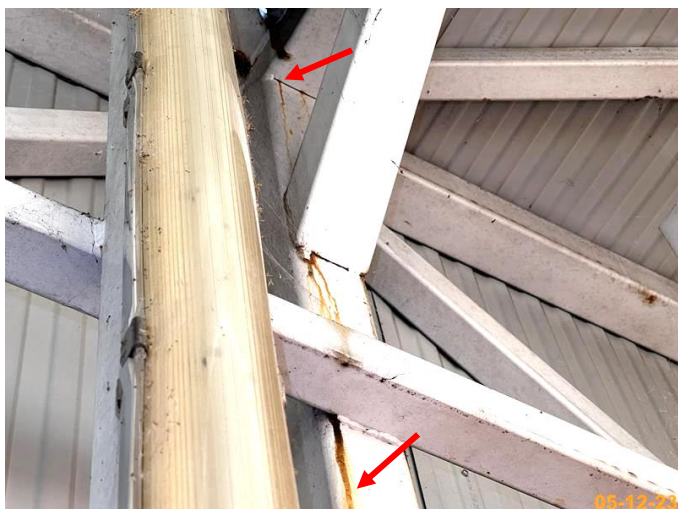
**Photograph 43**

Sign 2 – Defect 6.1

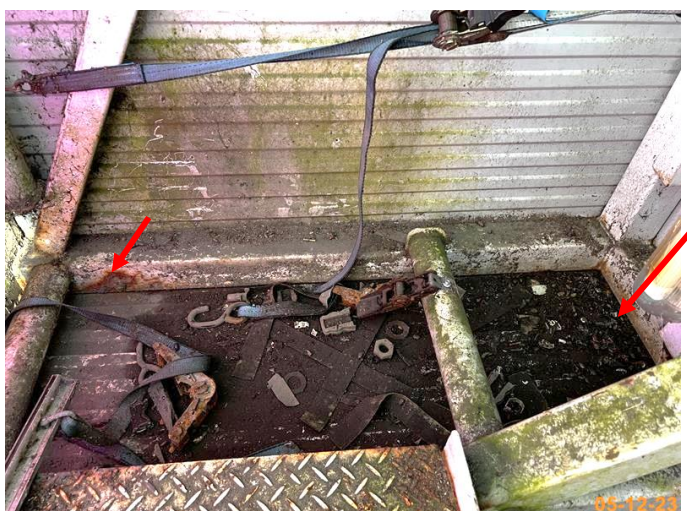
**Photograph 55**

- Minor to moderate corrosion was observed on the bottom members of the sign frame. (Refer to **Photographs 2-4-5-7-19-54-56**)
- Moderate localised paint flaking was noted on the bottom members of the sign frame in the areas where the corrugated metal sheet lining of the sign comes into contact with the bottom members of the frame. (Refer to **Photographs 19-54-56**)
- Waterponding was noted at the east end of Sign 1 and the west end of Sign 2. Moderate-severe corrosion was observed on the bottom member of the frame where water was ponds. (Refer to **Photographs 20-25-55-56**)

Sign 2 – Defect 6.1

- Waterponding (west end of Sign 2)
- Localised corrosion and mild section loss in the bottom chord of the frame.

It is worth noting that because of how the PVC/vinyl banner is installed, gaps exist at its perimeter, this allows wind-driven rain to penetrate the sign boxes and contribute to corrosion, mould growth, and other issues. Therefore, we recommend installing drainage holes in the bottom sheets where water has been

observed to pool. Additionally, the bottom members should be coated with a more durable coating system that complies with AS2312.1 standards.

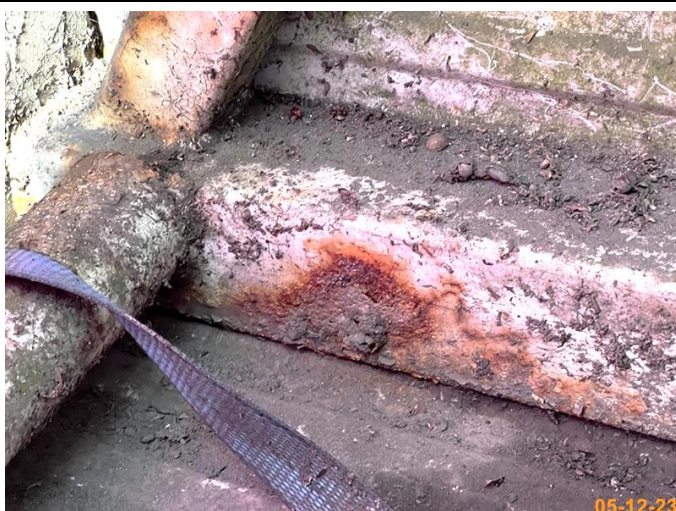
**Photograph 56**

Sign 2 – Defect 6.1

- Closed up view of **Photograph 55**.

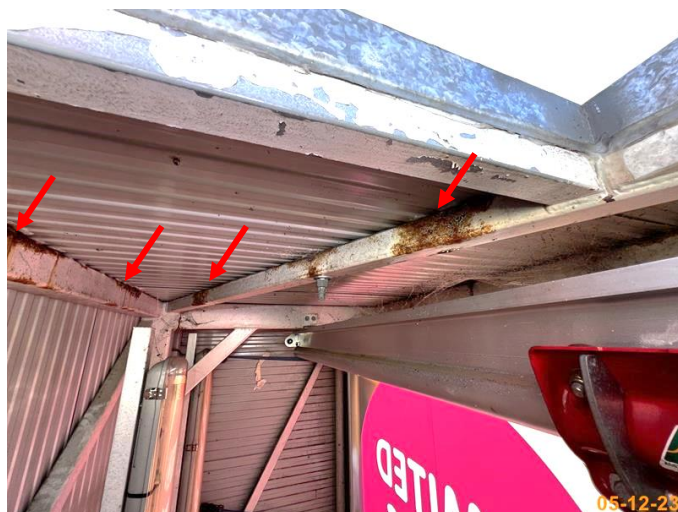
**Photograph 57**

Sign 2 – Defect 6.1

- Localised corrosion of structural members and cladding sheet linings

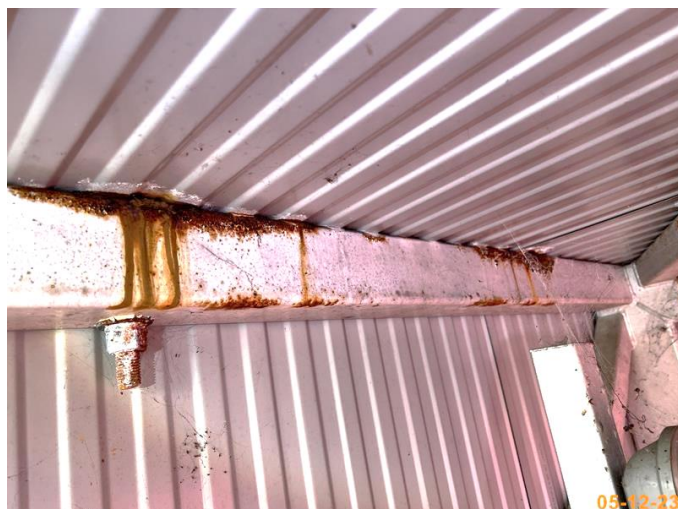
**Photograph 58**

Sign 2 – Defect 6.1

- Closed up view of **Photograph 57**.

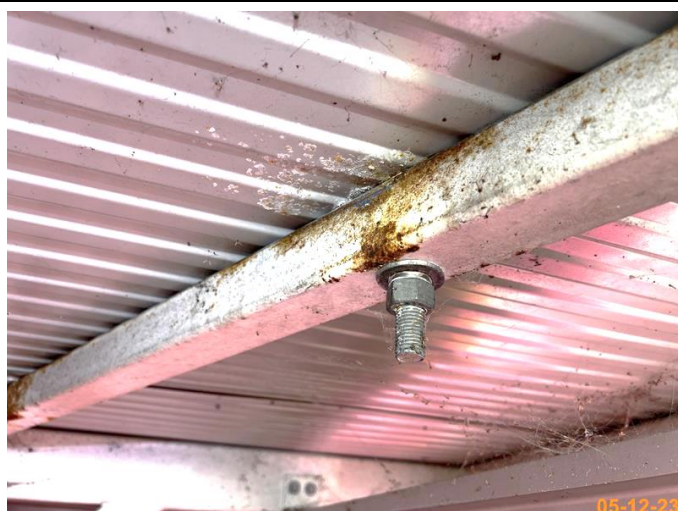
**Photograph 59**

Sign 2 – Defect 6.1

- Closed up view of **Photograph 58**.

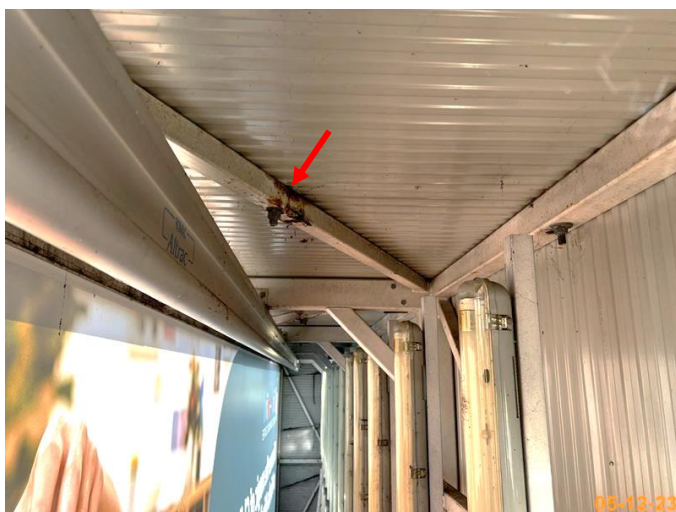
**Photograph 60**

Sign 2 – Defect 6.1

- Localised corrosion of structural members (Refer to Photograph 61 for the view of the connection from above)

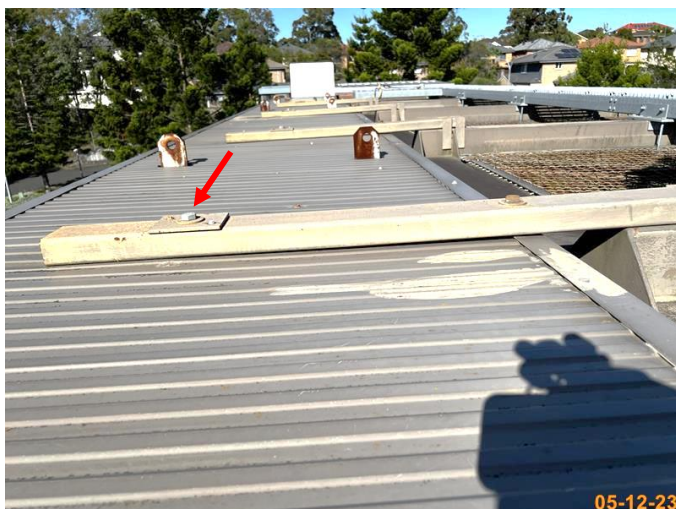
**Photograph 61**

Sign 2 – Defect 6.1

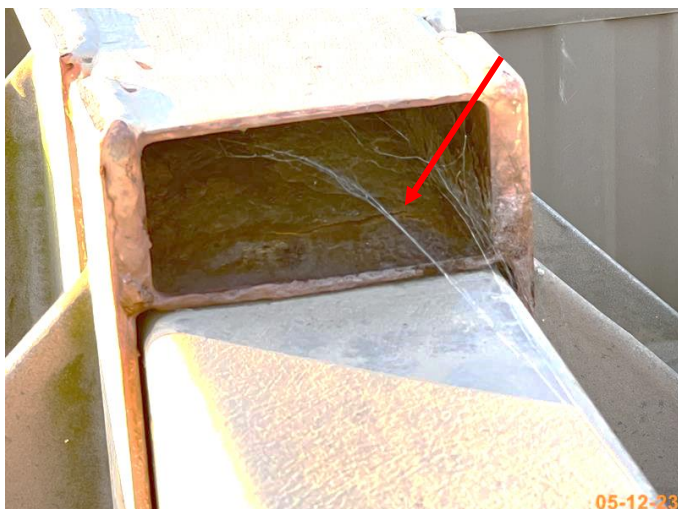
**Photograph 69**

Sign 2 – Defect 6.1

- Closed up view of **Photograph 68**.

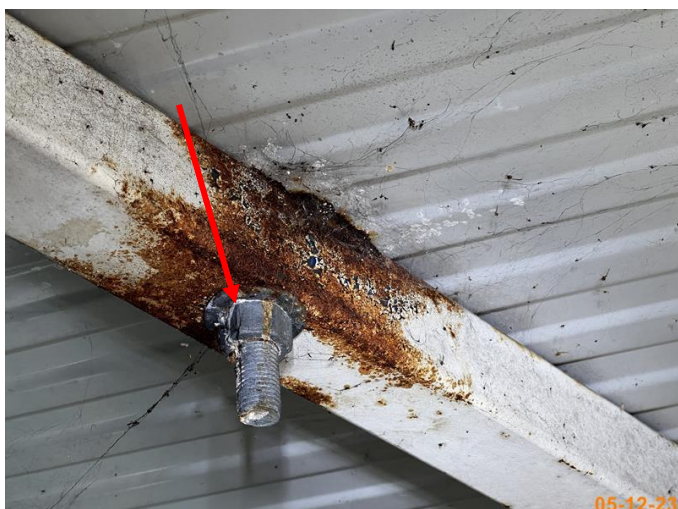
**Photograph 77**  
Sign 2 – Defect 6.2  
- No locking nut  
- No split washer

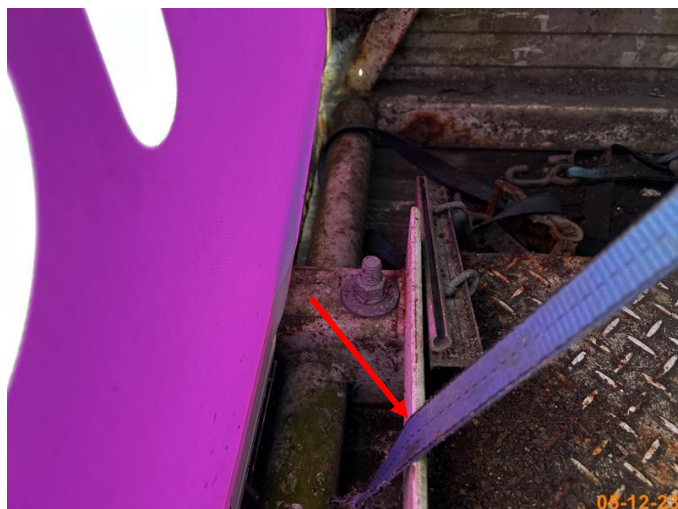
**Photograph 85**

Sign 2 – Defect 6.3

- Closed up view of **Photograph 83**.

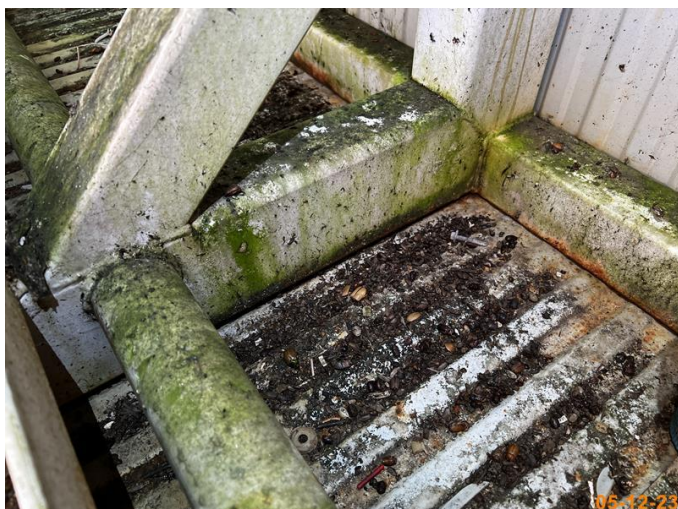
**Photograph 88**  
Sign 2 – Defect 6.4  
As above.

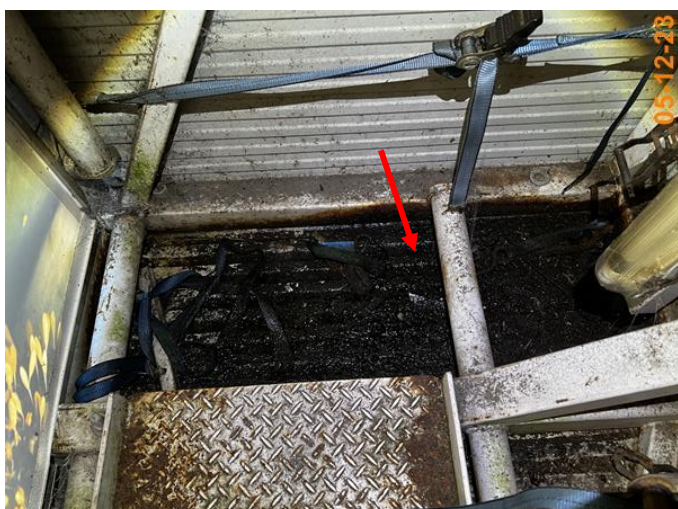
**Photograph 89**  
Sign 1 – Defect 6.5  
- Waterponding (east end of Sign 1)

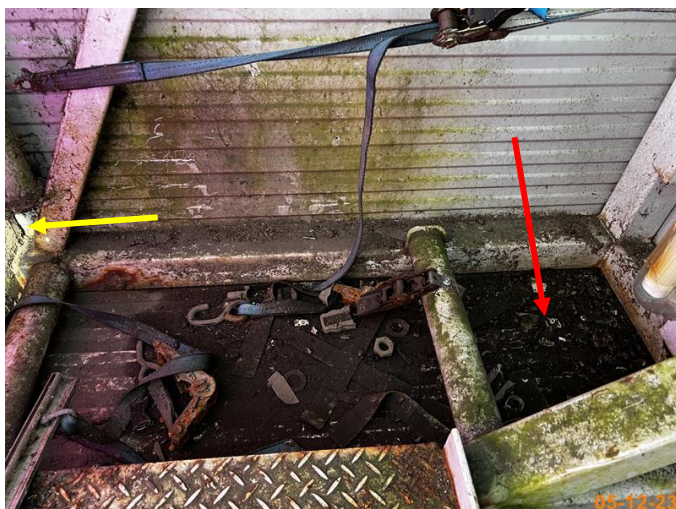
**Photograph 91**

<ul style="list-style-type: none"> <li>- A gap was noted between the edge flashings and the sheet linings (indicated by the yellow arrows above). (Refer to <b>Photograph 24</b>)</li> <li>- Sunlight beams were passing through the gap along the perimeter of the banner. (Refer to <b>Photograph 91</b>)</li> </ul>	
<p><b>Comments and Recommendations:</b></p> <p>We are of the opinion that the waterponding observed at the East end of Sign 1 and west end of Sign 2 has primarily occurred due to the following factors (or a combination of them):</p> <ul style="list-style-type: none"> <li>a) Gap between the banner and its surrounding structure: This allows water to directly penetrate the space below the banner.</li> <li>b) Inadequate flashing: Lack of or insufficiently sealed flashing at the edges of the sign boxes and cladding panels provides pathways for water infiltration.</li> <li>b) Unsealed gaps and bolt holes in the roof: Openings in the roof, especially unsealed bolt holes, create points of entry for water.</li> <li>c) Missing rubber sealing washers on cladding screws: The absence of these washers allows water to bypass the screws and seep into the structure.</li> </ul> <p>We recommend that the following remedial actions be undertaken to minimise the water ingress issue:</p> <ul style="list-style-type: none"> <li>- All gaps and unsealed joints between the corrugated roof sheets and flashings be fully sealed with a durable, UV-resistant silicone sealant.</li> <li>- All holes in the sign's roof sheets should also be sealed with UV-resistant sealant. All sheet lining screws shall be replaced with new fasteners with rubber sealing washers.</li> <li>- The perimeter of all the roof penetrations and openings (e.g. access hatch, sign box anchor points) shall be fully sealed.</li> <li>- Modify the banner installation and tensioning methods to minimise or, ideally, eliminate the gap between the banner and the sign frame.</li> </ul>

Sign 2 – Defect 6.5

- Waterponding (west end of Sign 2)  
- Sunlight inside the box (yellow arrow)

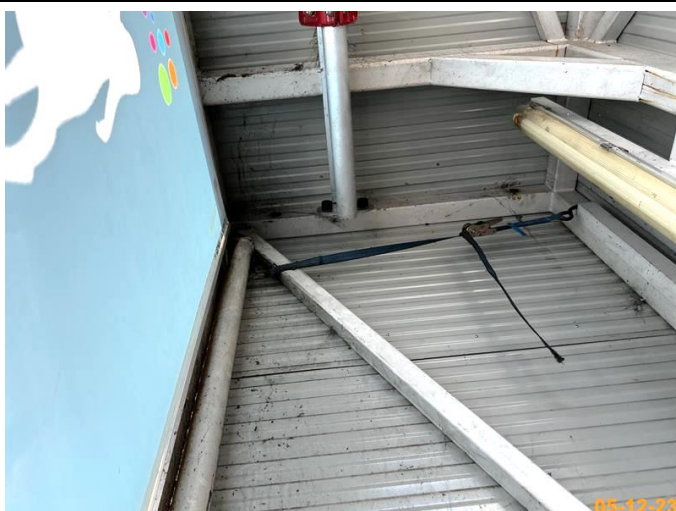
**Photograph 92**

Sign 2 – Defect 6.5

General condition of ceiling above  
(west end of Sign 2)

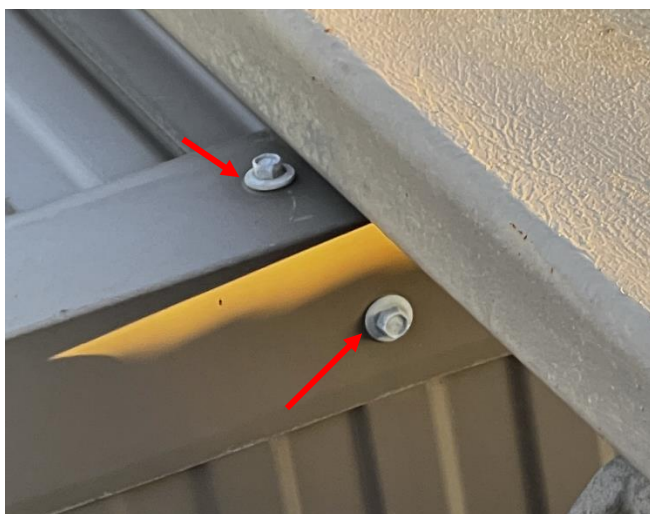
**Photograph 93**

Sign 1 – Defect 6.5
