# **Hazardous Chemicals Assessment**

**Blakebrook Public School**

3 August 2023

Project Ref: 754-SYDGE319200-1

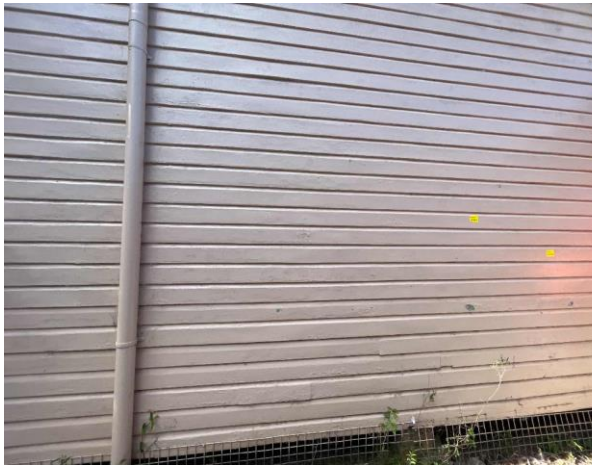
Line ID 1: External, Building A, Throughout, Walls, Beige Paint - No Asbestos Detected

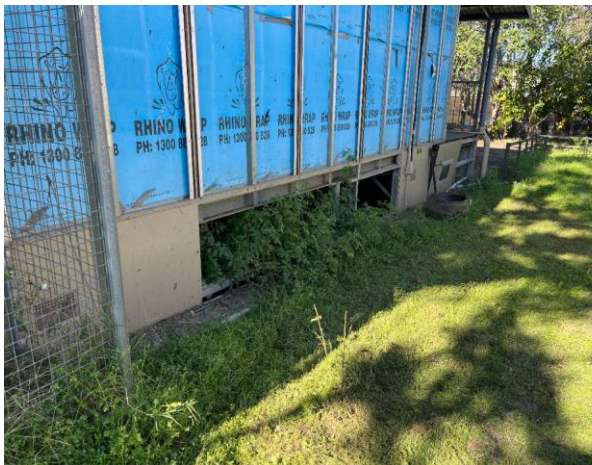
Line ID 15: External, Building I, Throughout, Walls, Compressed Cement Sheet - No Asbestos Detected

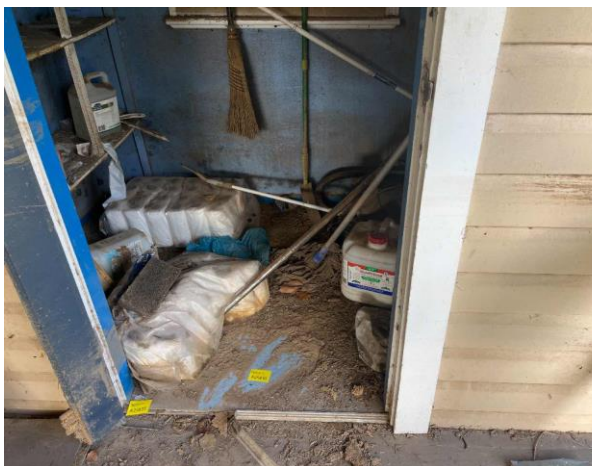
Line ID 26: Internal, Building F, Southwest Storeroom, Floor, Blue Vinyl Sheet - No Asbestos Detected

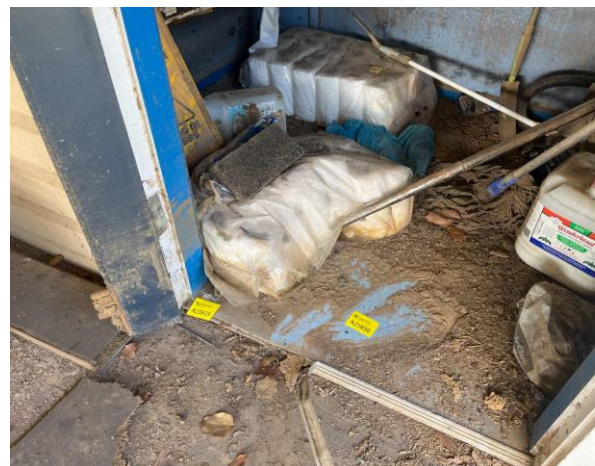
Line ID 27: Internal, Building F, Southwest Storeroom, Floor, Below Blue Vinyl Sheet, Fibre Cement Sheet - No Asbestos Detected

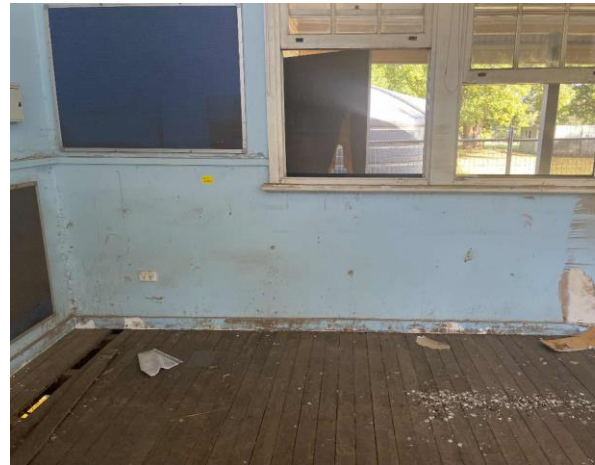
Line ID 29: Internal, Building F, Throughout, Lower 1/3 of Walls, Fibre Cement Sheet - No Asbestos Detected

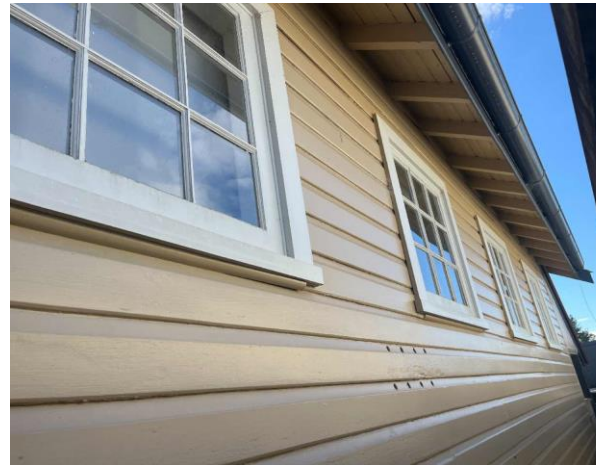
Line ID 42: External, Building F, Throughout, Window Frames, White Paint - Lead Detected (<0.005% w/w)

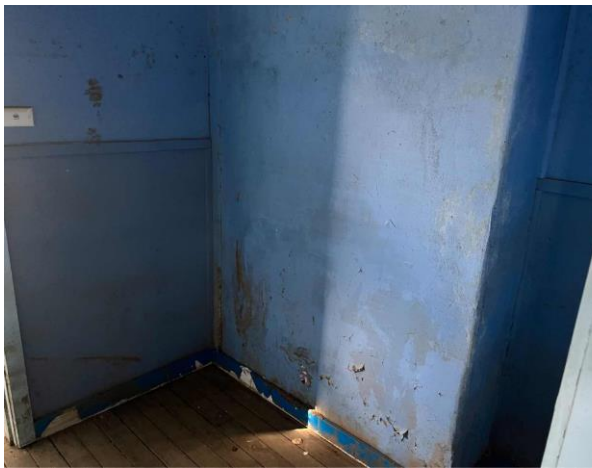
Line ID 56: Internal, Building F, Northern Room, Walls, Blue (Dark) Paint - Lead Detected (<0.005% w/w)
