## **Hazardous Building Materials (HAZMAT) Report**

**Former Shoalhaven Anglican School**

**17 Croobyar Milton NSW**

**Project 89390.08**

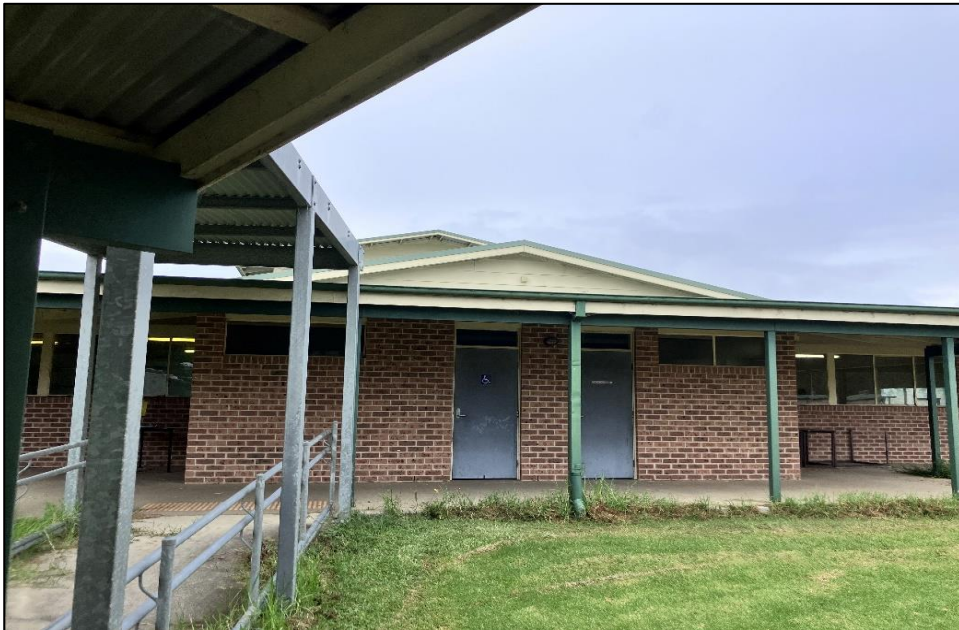
Photograph 2: B00A, exterior, upper level, wall and gables generally, weatherboard linings, suspected non-asbestos.

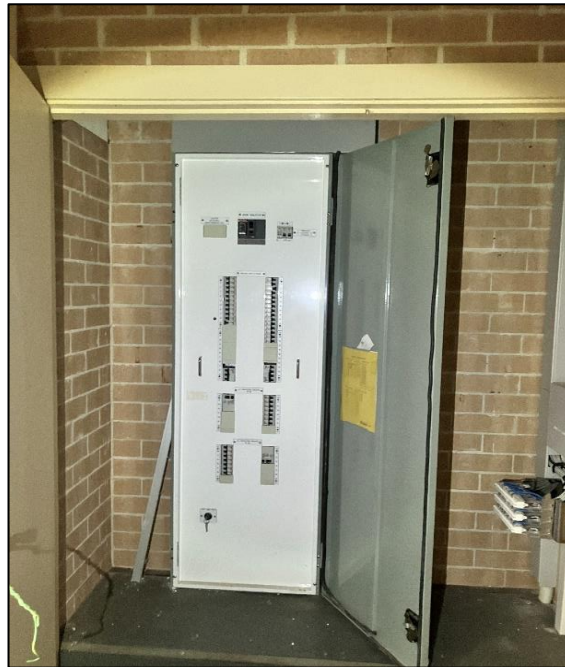
Photograph 6: B00A, AR0021, interior of electrical panel(s), materials in general, suspected non-asbestos.

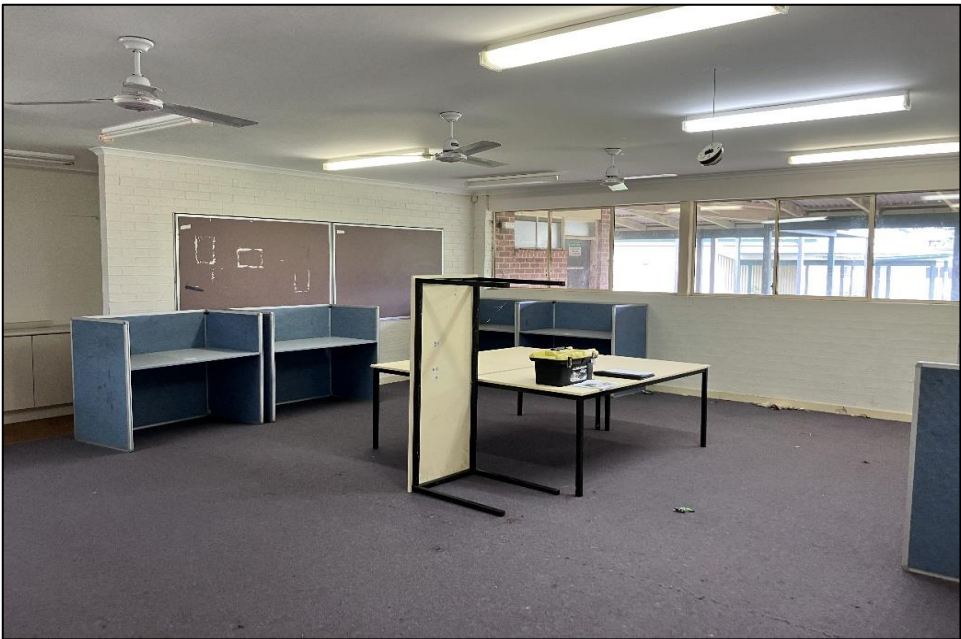
Photograph 7: B00A, AR0014, brick wall, white paint.

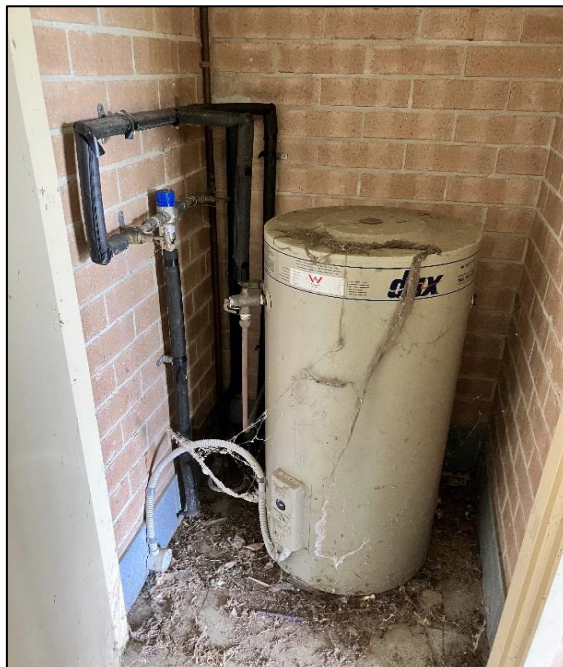
Photograph 10: B00A, AR0018, Dux hot water unit (circa 1998), insulation, SMF (suspected).

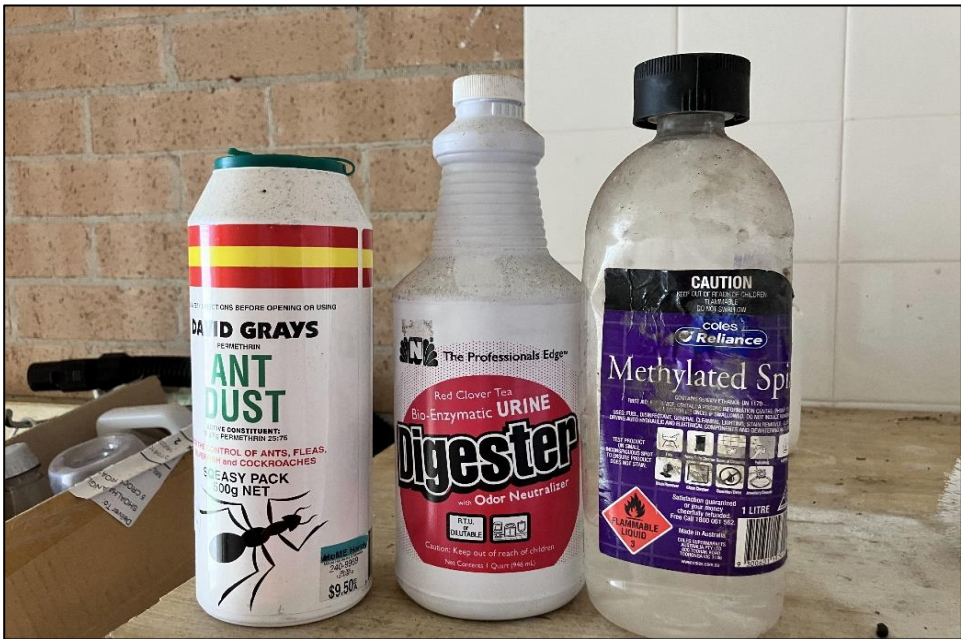
Photograph 14: B00A, AR0017, throughout, residual chemical products (e.g. methylated spirits, urine digester and ant dust).

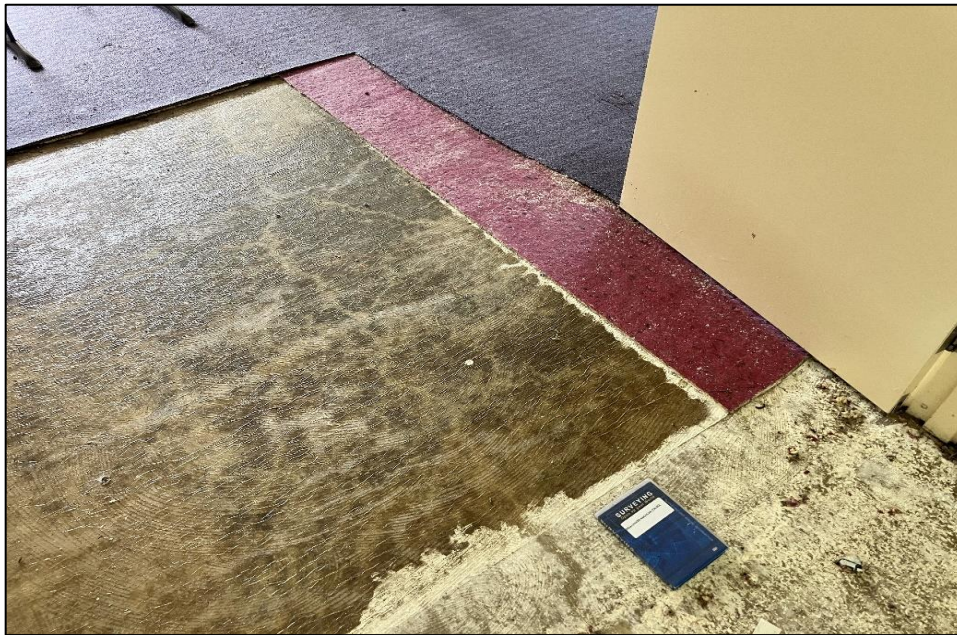
Photograph 3: B00B, BR0003, floor, below carpet/underlay, adhesive, no asbestos detected by analysis.

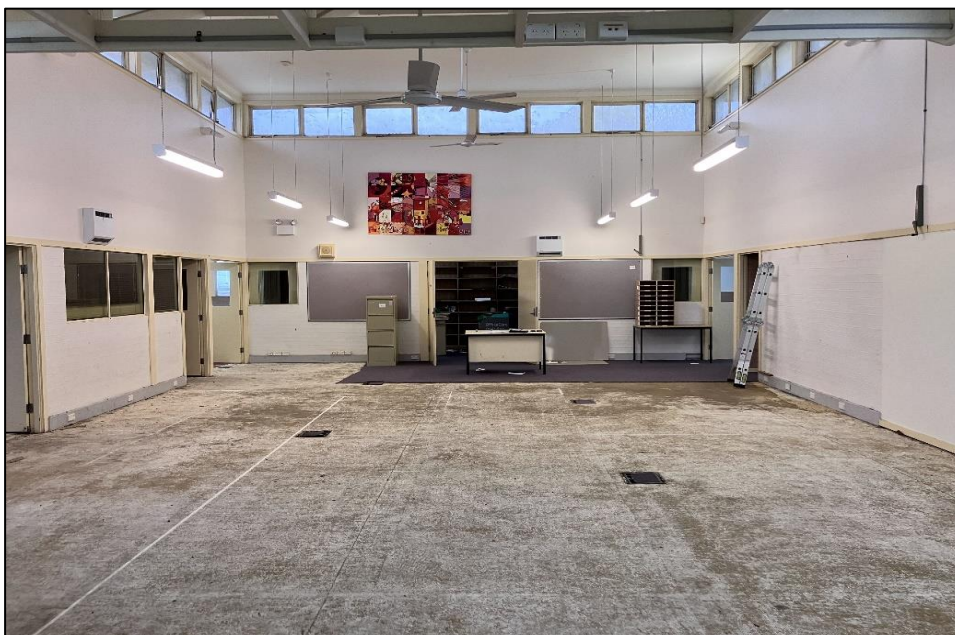
Photograph 4: B00B, BR0009, floor, below carpet/underlay, adhesive, no asbestos detected by analysis.

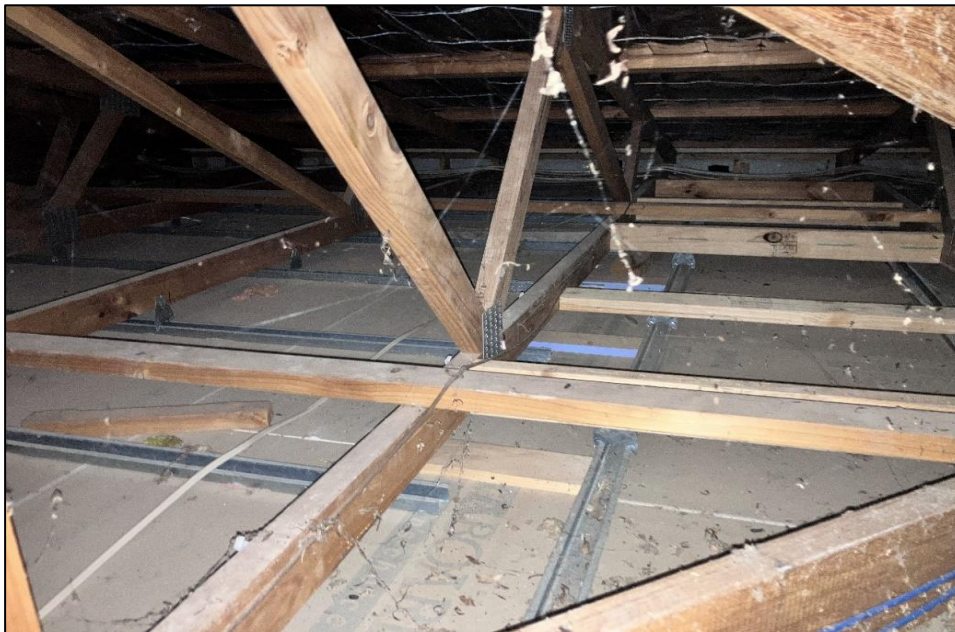
Photograph 8: B00B, ceiling cavity, settled dust / debris, elevated lead concentration detected.

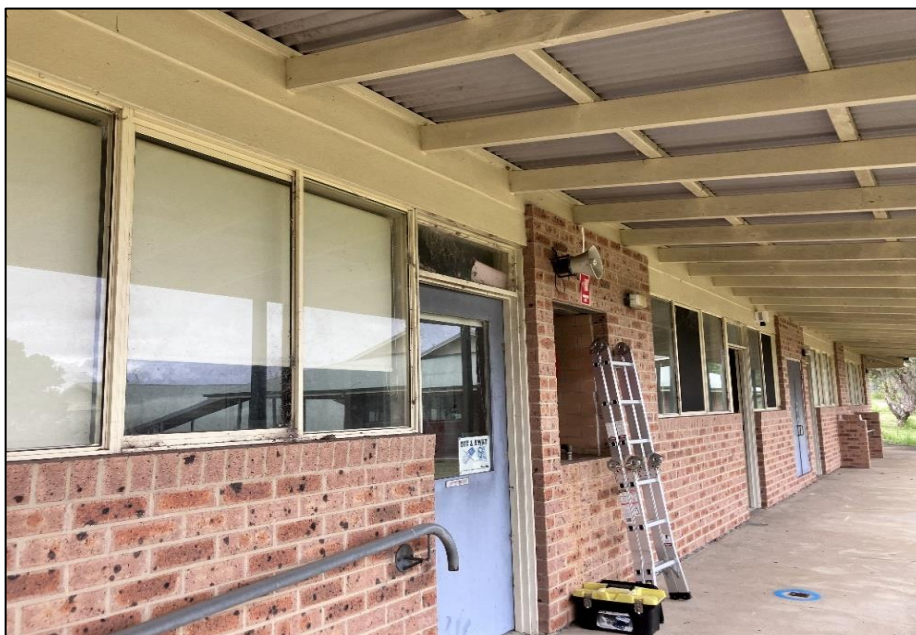
Photograph 2: B00C, exterior, walls in general, weatherboard linings, no asbestos detected by analysis.

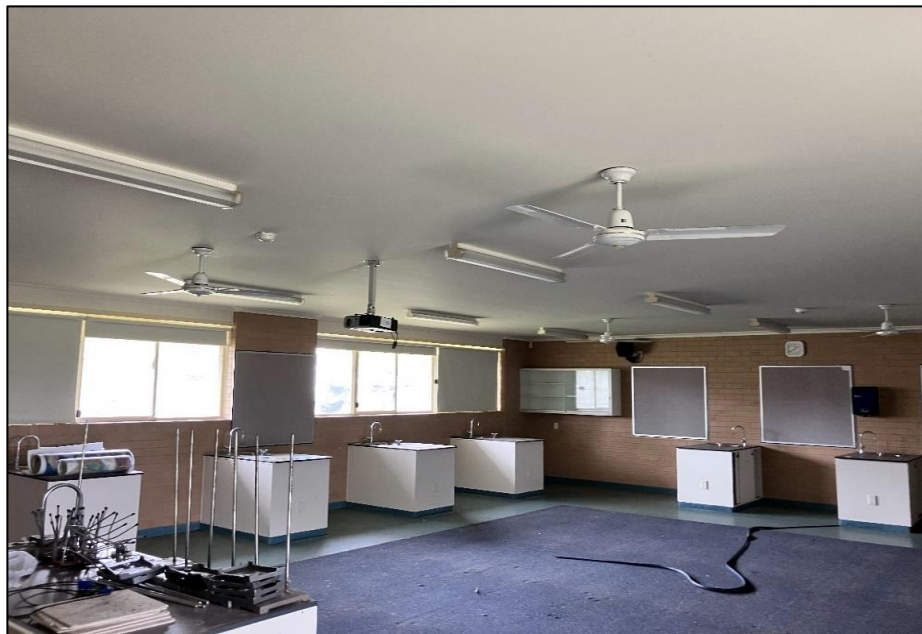
Photograph 10: B00C, rooms and areas in general, fluorescent light fittings and ceiling fans, internal components, nil PCB (suspected).

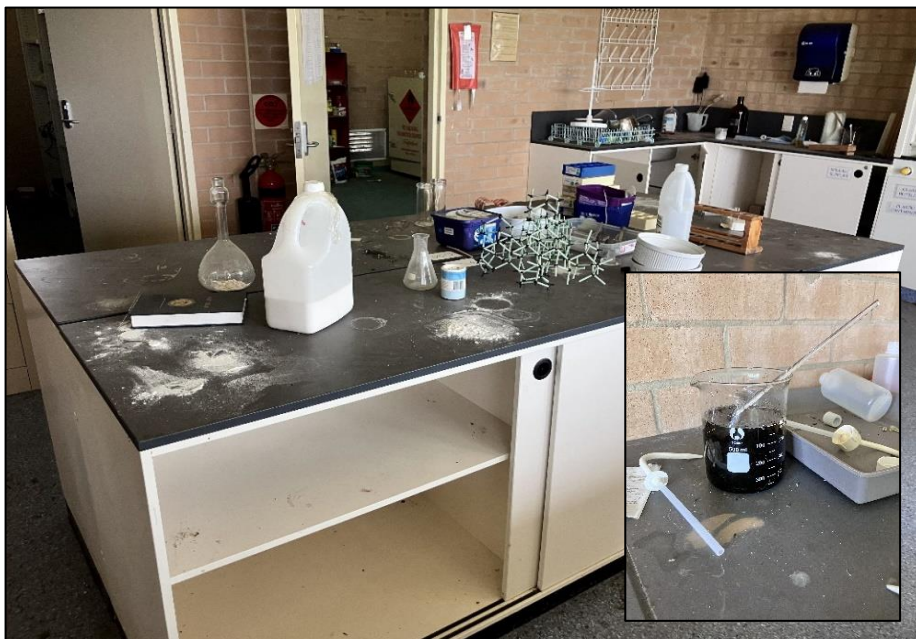
Photograph 11: B00C, CR0002, benchtops, unidentified powder and liquid residues.

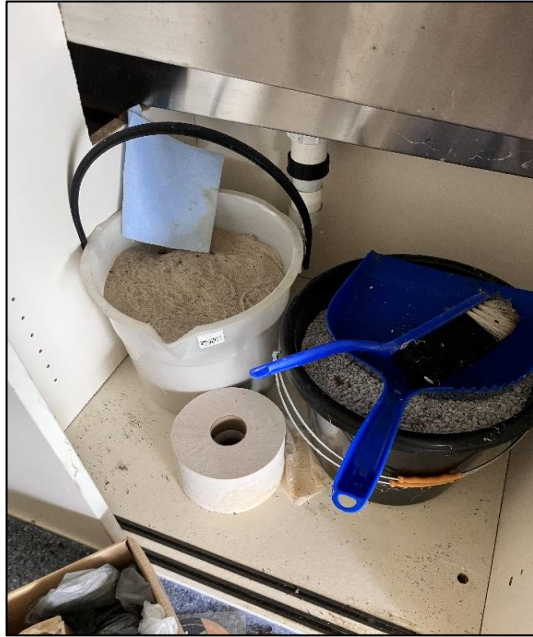
Photograph 17: B00C, CR0002, cabinetry, buckets, suspected diatomaceous earth / Perlite or similar.

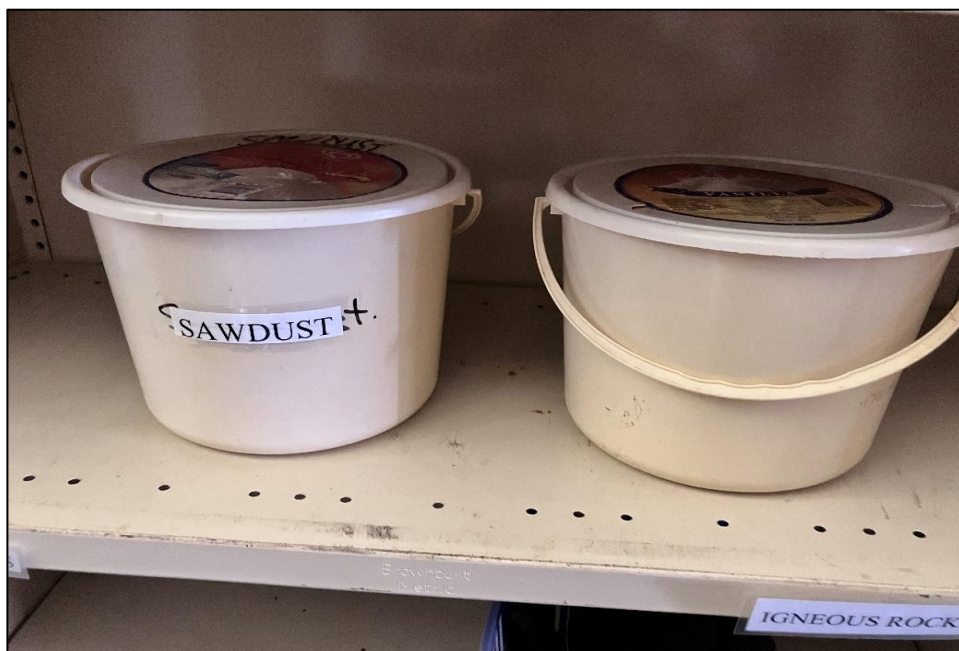
Photograph 20: B00C, CR0007, general laboratory / craft supplies (e.g. paints, diatomaceous earth (or similar) and sawdust).

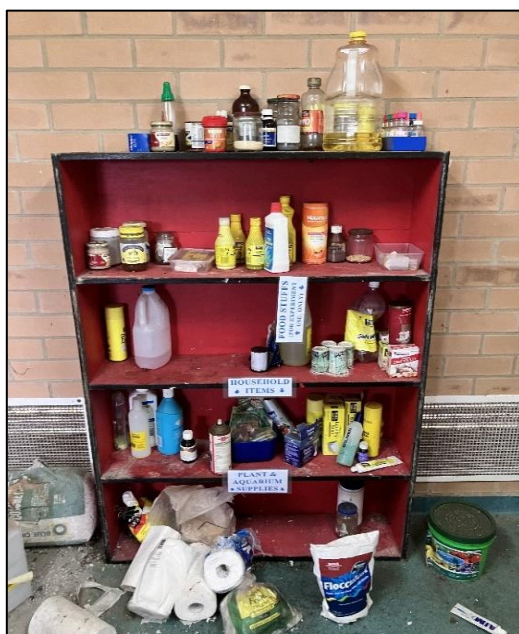
Photograph 21: B00C, CR0006, general laboratory supplies including detergent, over cleaner, Perlite, concrete, fertiliser, flocculant, aerosols etc.

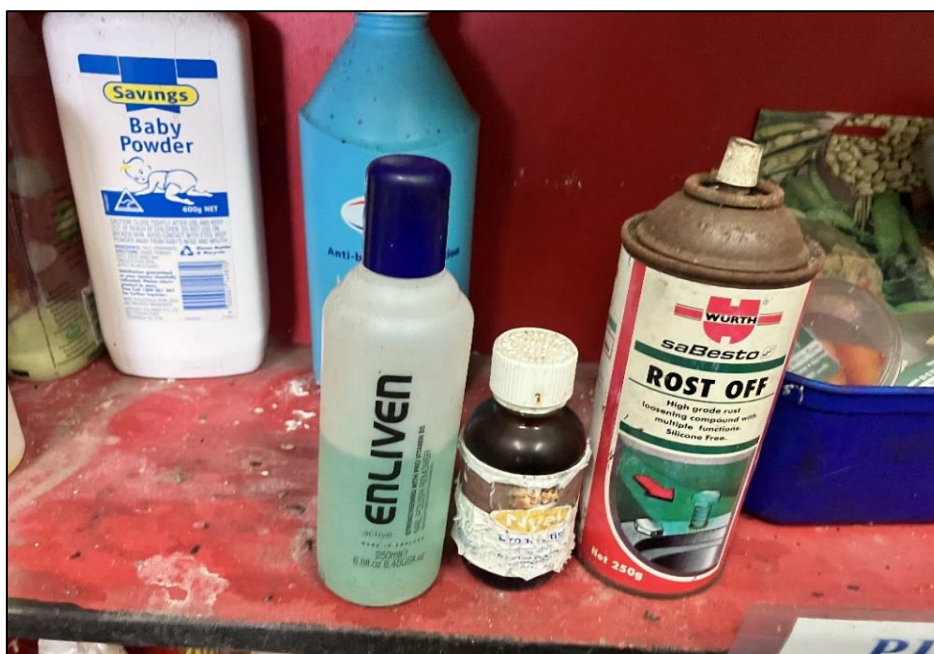
Photograph 22: B00C, CR0006, general laboratory supplies including detergent, over cleaner, Perlite, concrete, fertiliser, flocculant, aerosols etc.

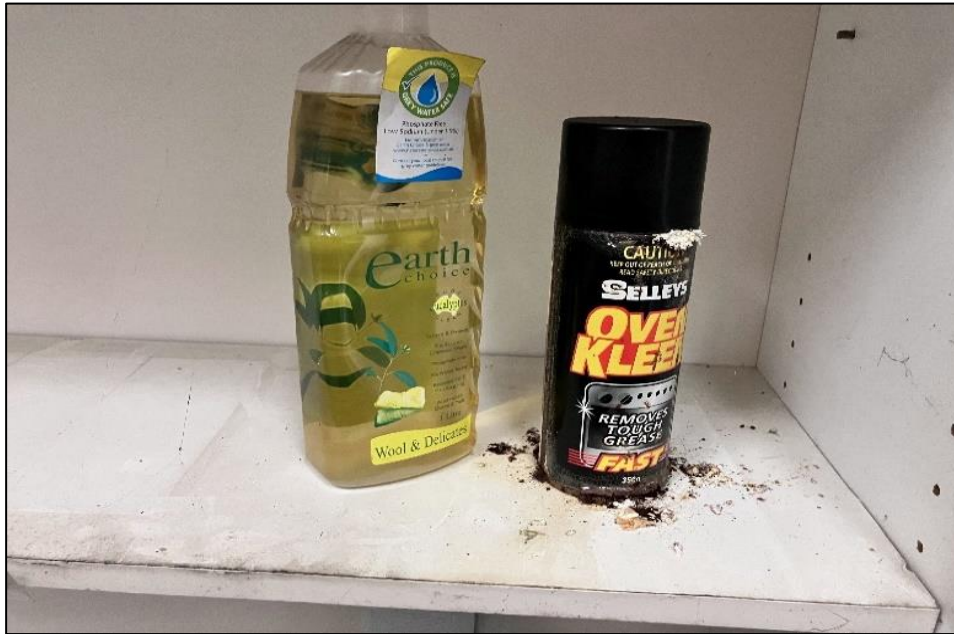
Photograph 25: B00C, CR0006, general laboratory supplies including detergent, over cleaner, Perlite, concrete, fertiliser, flocculant, aerosols etc.

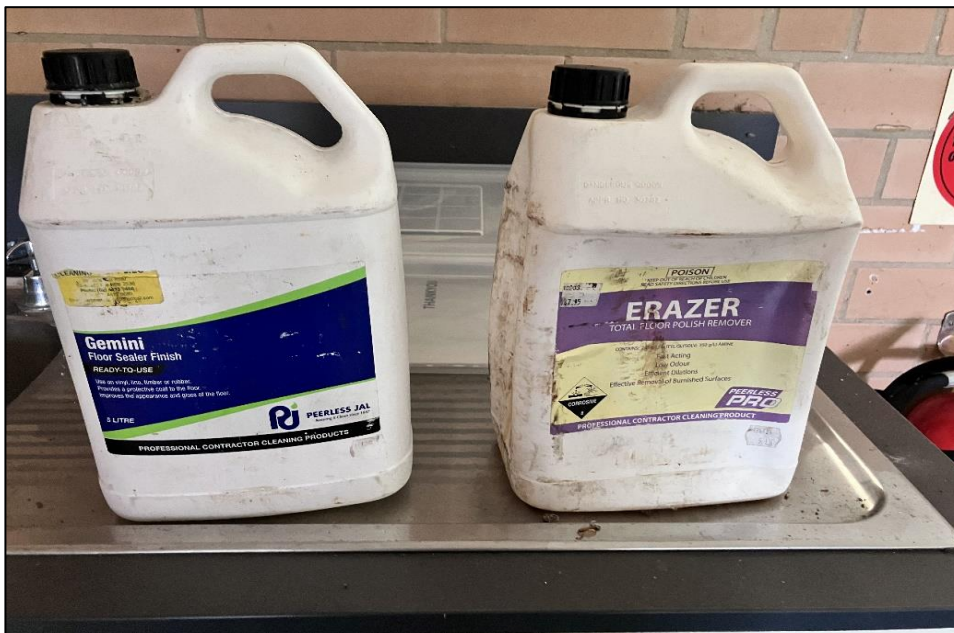
Photograph 26: B00C, CR0001, general laboratory supplies including floor sealer and floor polish remover, plus various empty storage containers.

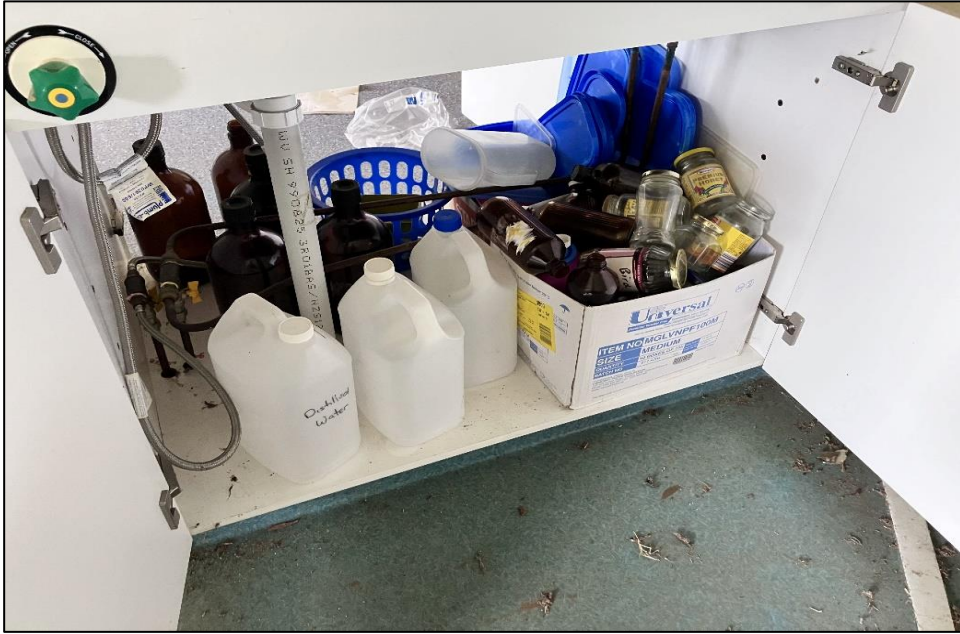
Photograph 27: B00C, CR0001, general laboratory supplies including various empty storage containers.

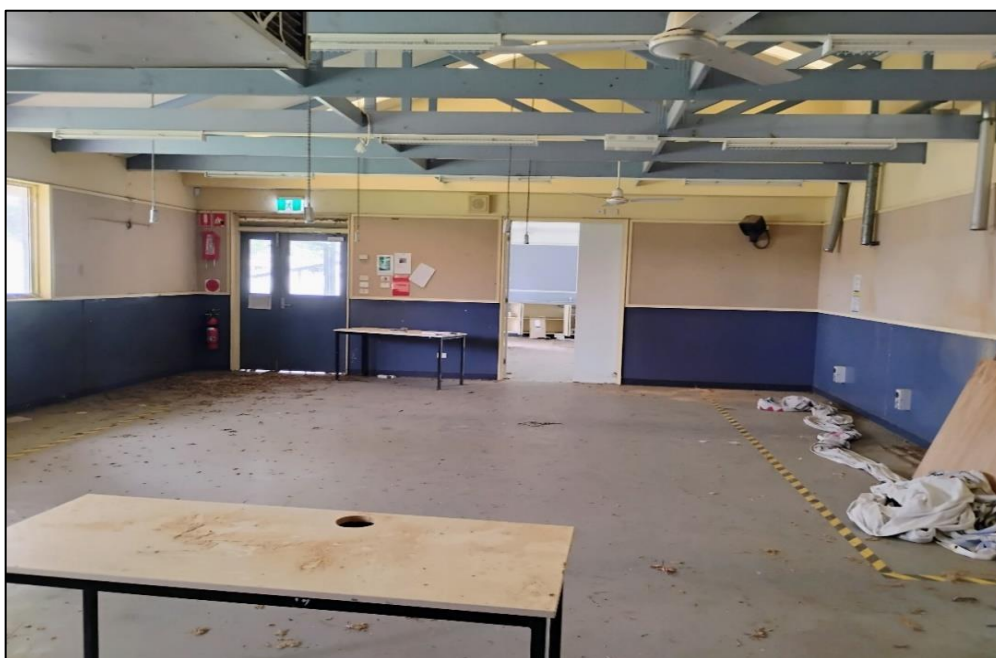
| Building | Room / Area | Material Location | Material Type | Sample No. | Material Status | Photo No. | Summary Comment/Recommendation |
|---|---|---|---|---|---|---|---|
| B00D | rooms and areas in general | ceiling fans | internal components (e.g. capacitors and ballasts) | N/A | nil PCB (suspected) | 8 | Inaccessible area/material. Nil PCB containing capacitors suspected based on apparent age of building construction (1980's onwards). As a precaution, confirm status of hazardous material(s) when safe access available and prior to any disturbance. |

Photograph 8: B00D, rooms and areas in general, ceiling fans, internal components, nil PCB (suspected).

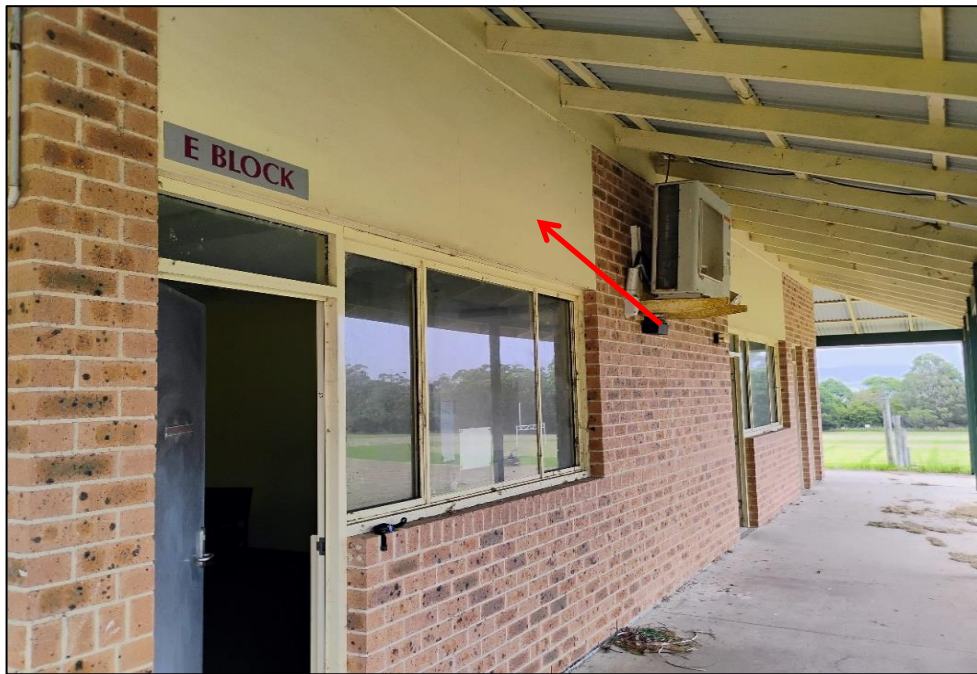
Photograph 2: B00E, exterior, north façade, infill, fibre cement sheeting, no asbestos detected by analysis.

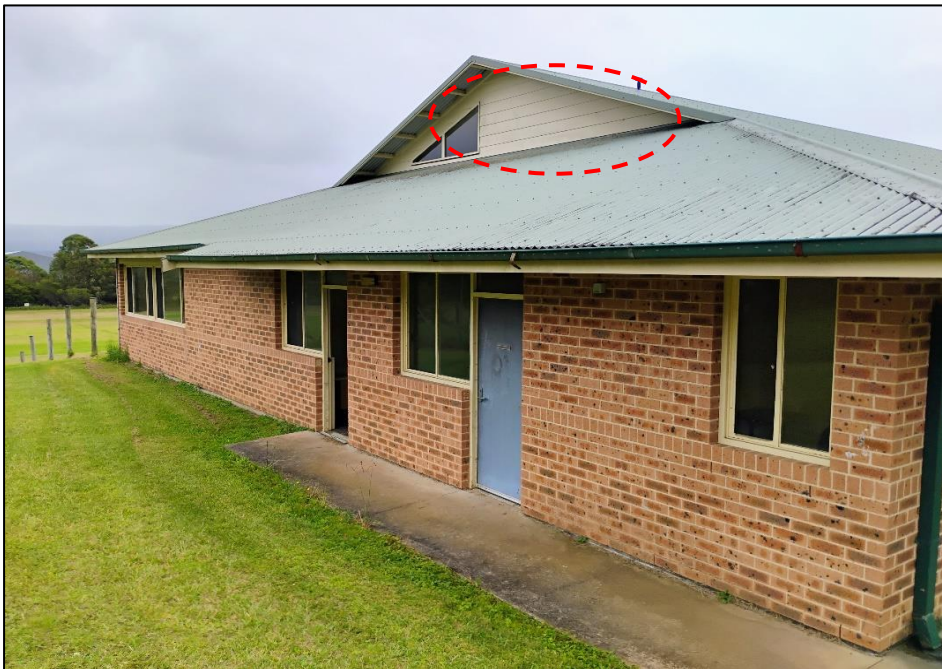
Photograph 4: B00E, exterior, north and south façade, gables, weatherboard linings, inaccessible.

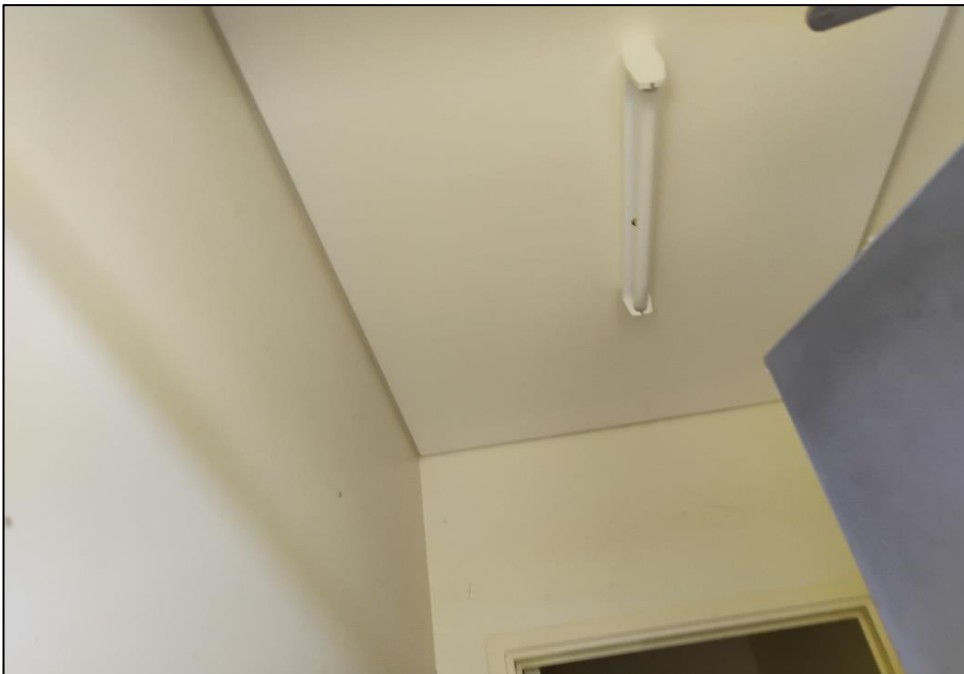
Photograph 6: B00E, interior, ER0021, linings generally, fibre cement sheeting, no asbestos detected by analysis.

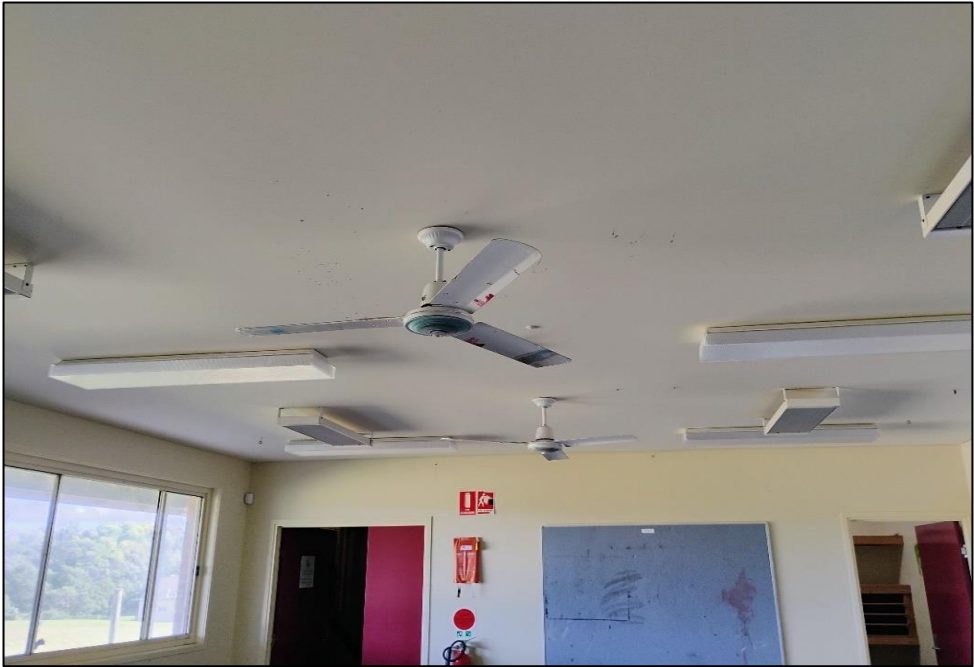
Photograph 12: B00E, rooms and areas in general, fluorescent light and fan fittings, internal components, nil PCB (suspected).

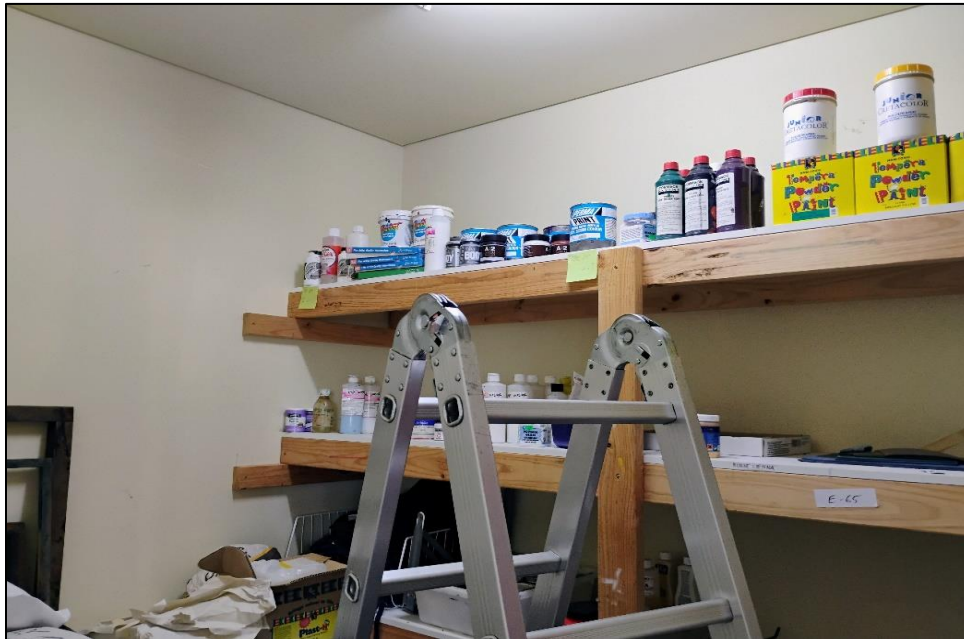
Photograph 14: B00E, ER0012, shelf, general craft supplies.

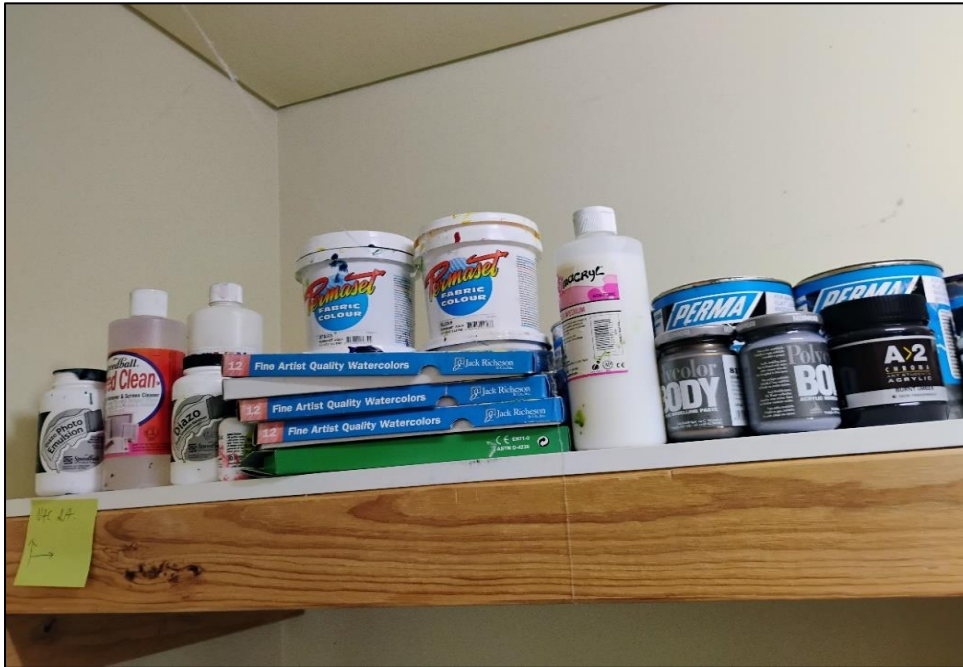
Photograph 15: B00E, ER0012, shelf, general craft supplies such as binder mediums, dyes and photo emulsion.

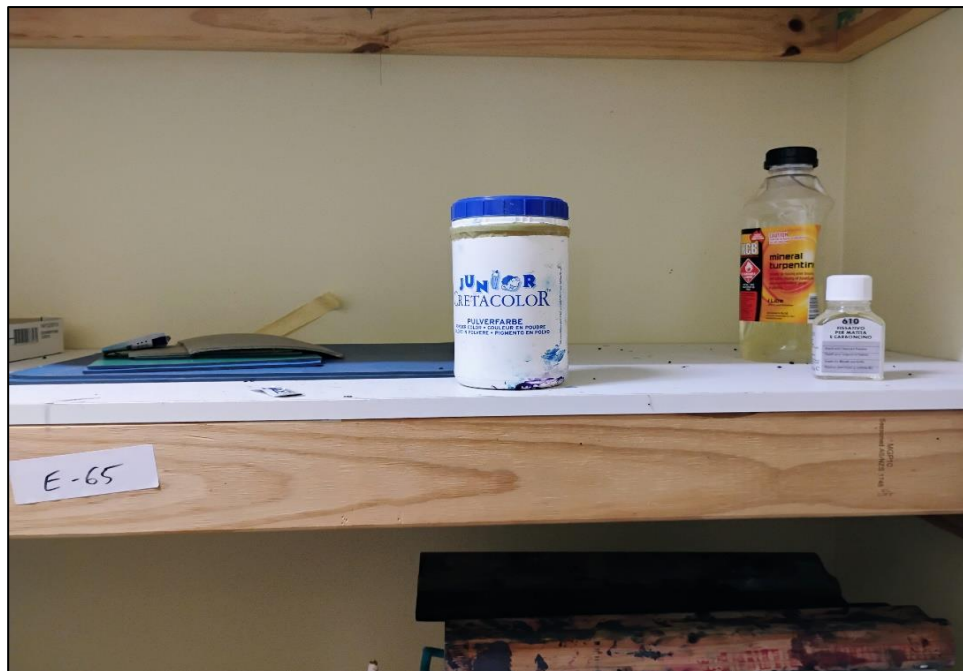
Photograph 16: B00E, ER0012, shelf, general craft supplies (e.g. powder paints and mineral turpentine).

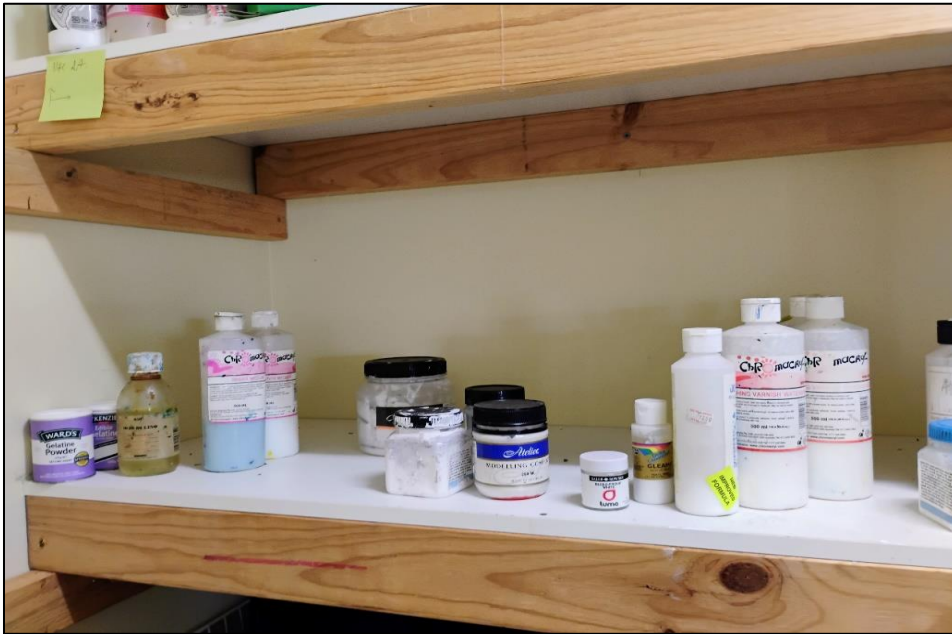
Photograph 17: B00E, ER0012, shelf, general craft supplies such as varnish and binder medium.

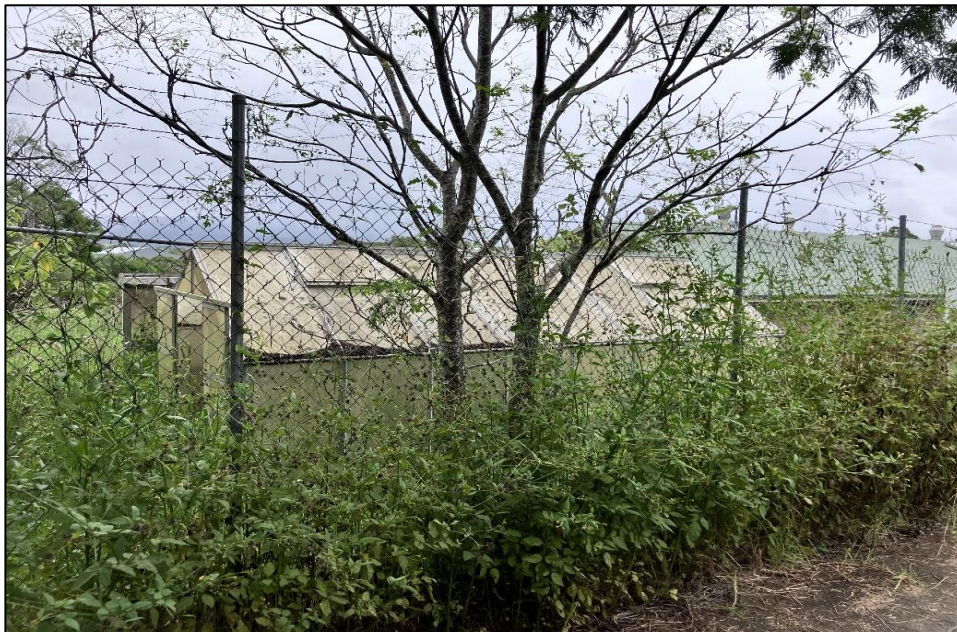
Photograph 2: B00F, inaccessible inside security (barbed wire) fencing.

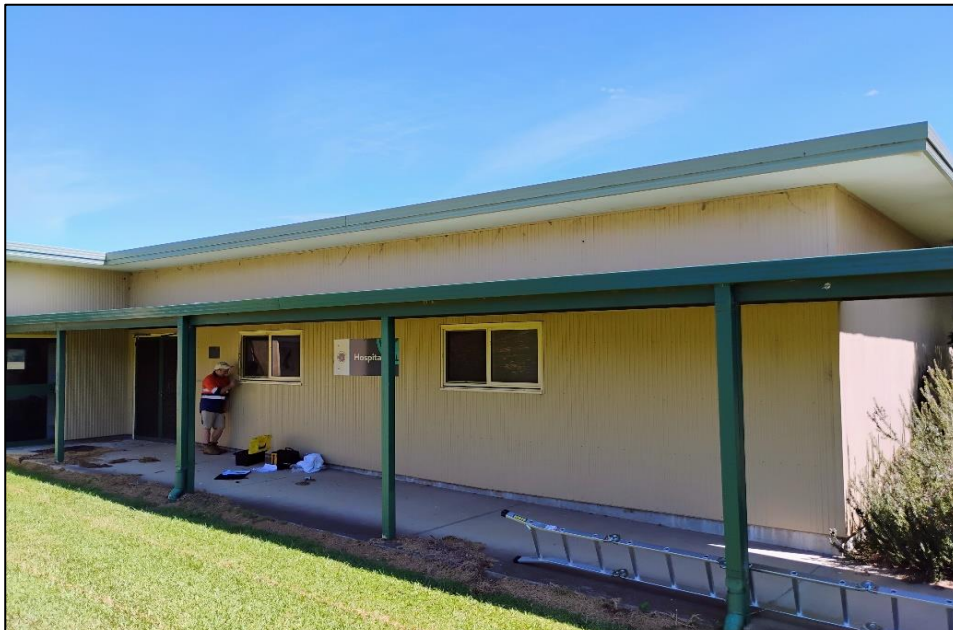
Photograph 2: B00H, exterior generally, eave linings, fibre cement sheeting, suspected non-asbestos.

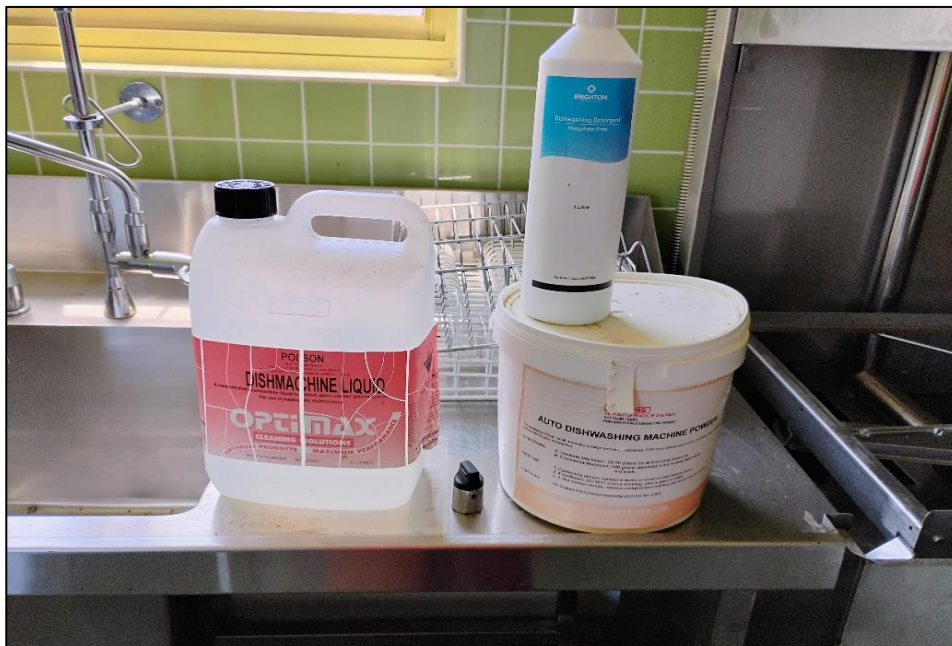
| Building | Room / Area | Material Location | Material Details | Quantity | Photo No. | Summary Comment/Recommendation |
|---|---|---|---|---|---|---|
| B00H | interior | HR0004 | dishwashing liquids / powder | Less than bulk storage (<500 L or 500 kg) | 9 | <p>Ensure chemical storage is secure and compliant.</p> <p>Ensure any unused product is safely returned to the supplier and / or taken to an approved collection point for secure recycling or destruction.</p> <p>LPG cylinders should not be placed in regular waste due to the risks associated with uncontrolled de-pressurisation and explosion.</p> |

Photograph 9: B00H, interior, HR0004, dishwashing liquids / powder.

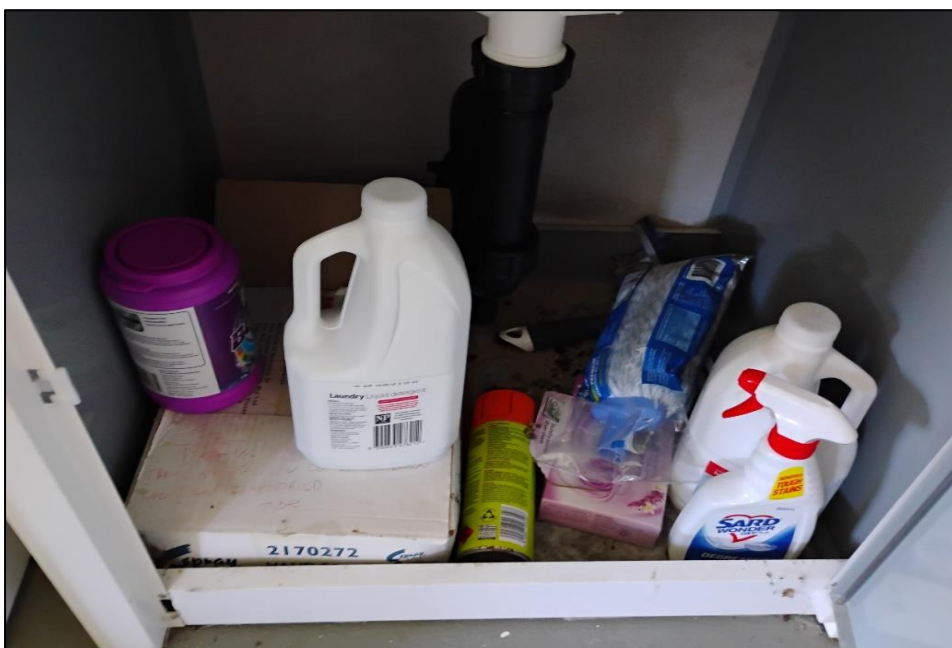
| Building | Room / Area | Material Location | Material Details | Quantity | Photo No. | Summary Comment/Recommendation |
|---|---|---|---|---|---|---|
| B00H | interior | HR0005 | household laundry products | Less than bulk storage (<500 L or 500 kg) | 10 | <p>Ensure chemical storage is secure and compliant.</p> <p>Ensure any unused product is safely returned to the supplier and / or taken to an approved collection point for secure recycling or destruction.</p> <p>LPG cylinders should not be placed in regular waste due to the risks associated with uncontrolled de-pressurisation and explosion.</p> |

Photograph 10: B00H, interior, HR0005, household laundry products.

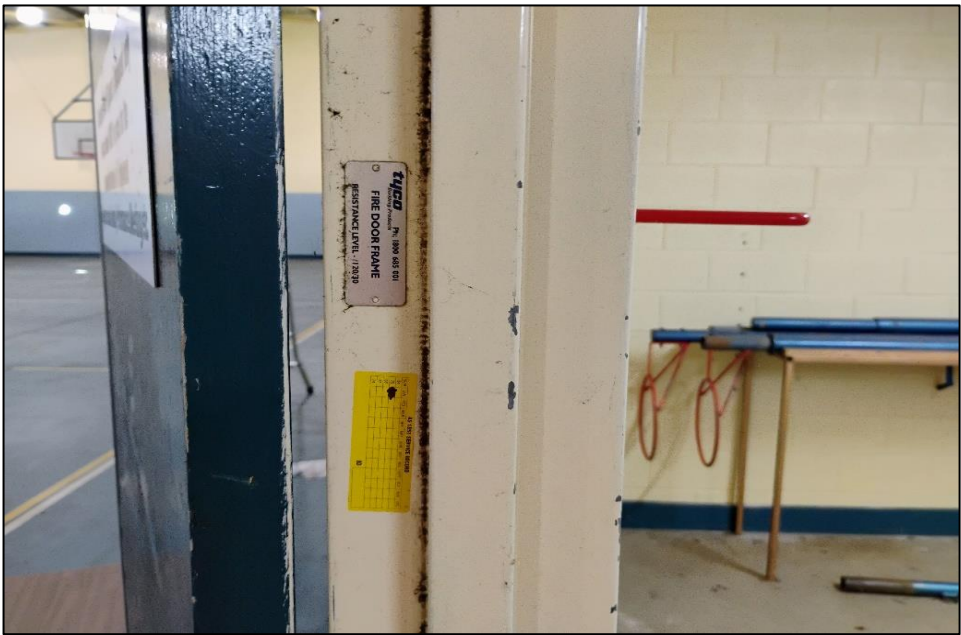
| | | | | | | Asbestos Risk Assessment | | | | | | | | Photo No. | Summary Comment/Recommendation |
|---|---|---|---|---|---|---|---|---|---|---|---|---|---|---|---|
| B00I | interior generally | fire door(s) (e.g. IR0005, IR0006) | insulating core | N/A | inaccessible | N/A | N/A | N/A | N/A | N/A | N/A | N/A | N/A | 2 | Inaccessible area/material - Confirm status of hazardous material(s) when safe access available and prior to any disturbance. |

Photograph 2: B00I, interior generally, fire door(s) (e.g. IR0005, IR0006), insulating core, inaccessible.

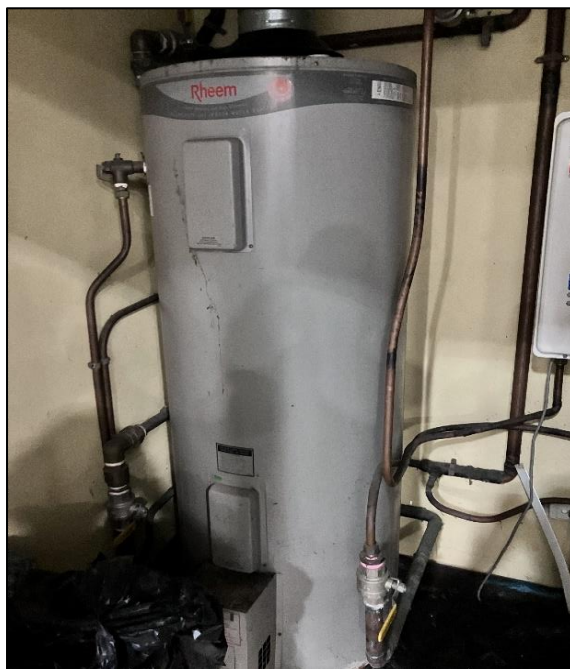
Photograph 6: B00I, interior, IR0013, hot water unit (circa 2001), bulk insulation, SMF (suspected).

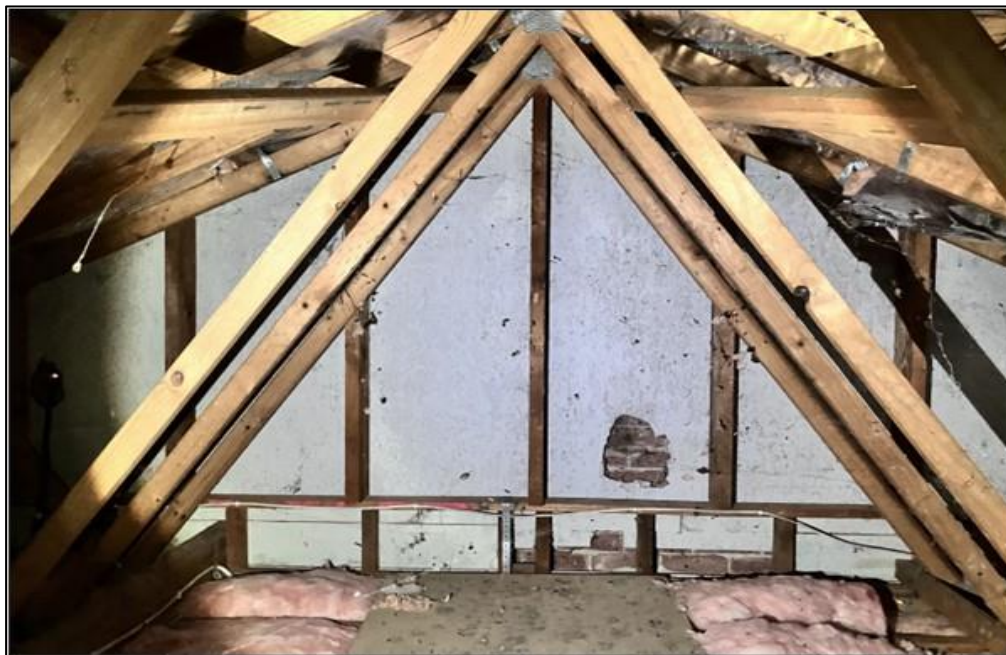
Photograph 6: B00P, ceiling cavity, gable, southern façade, fibre cement sheeting, no asbestos detected by analysis.

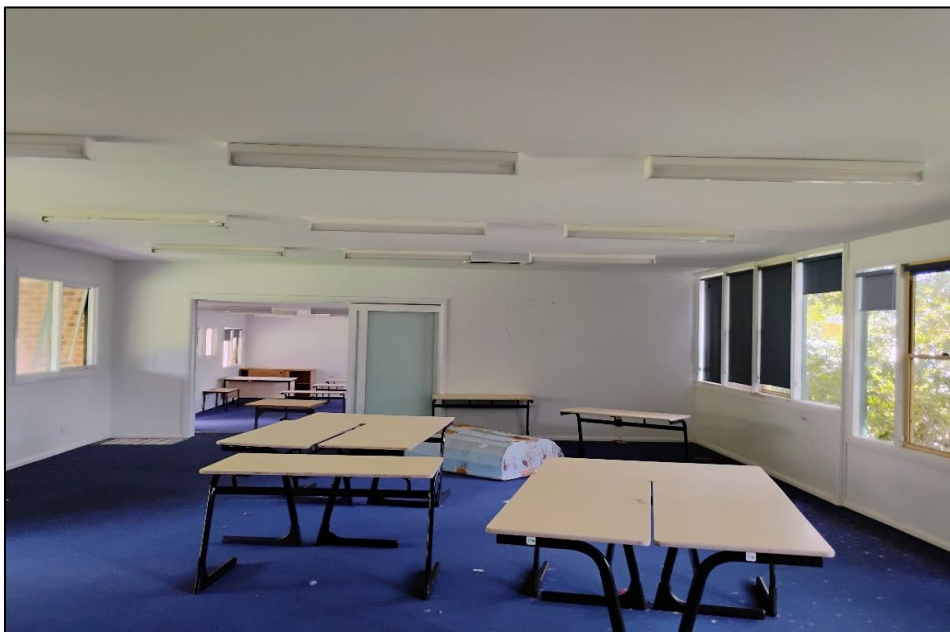
Photograph 10: B00P, rooms and areas in general, fluorescent light / fan fittings, internal components, nil PCB (suspected).

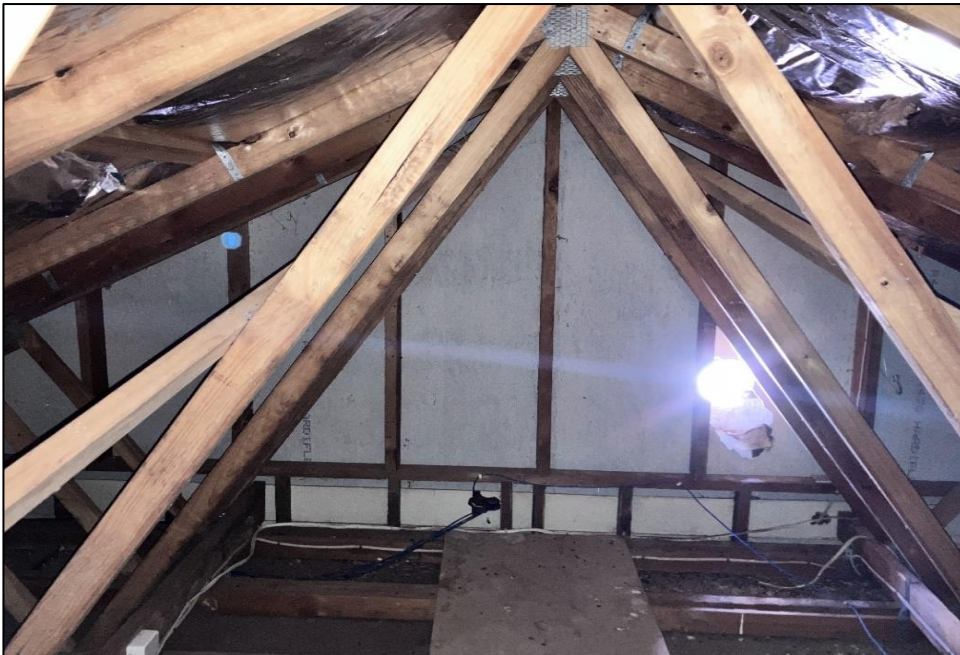
Photograph 4: B00Q, exterior, south façade, weatherboard gable / bulkhead linings, fibre cement sheeting, no asbestos detected by analysis.
