## **Hazardous Building Materials (HAZMAT) Report**

**Former Shoalhaven Anglican School**

**17 Croobyar Milton NSW**

**Project 89390.08**

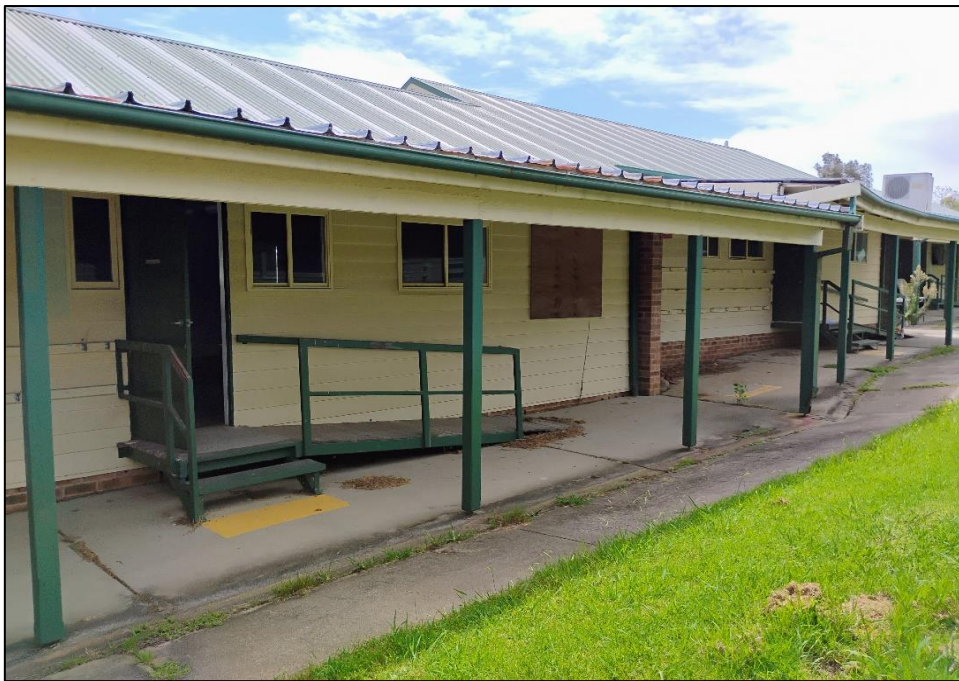
Photograph 6: B00Q, exterior, west façade, timberwork (green paint), hand rails (green paint), window frames (cream paint).

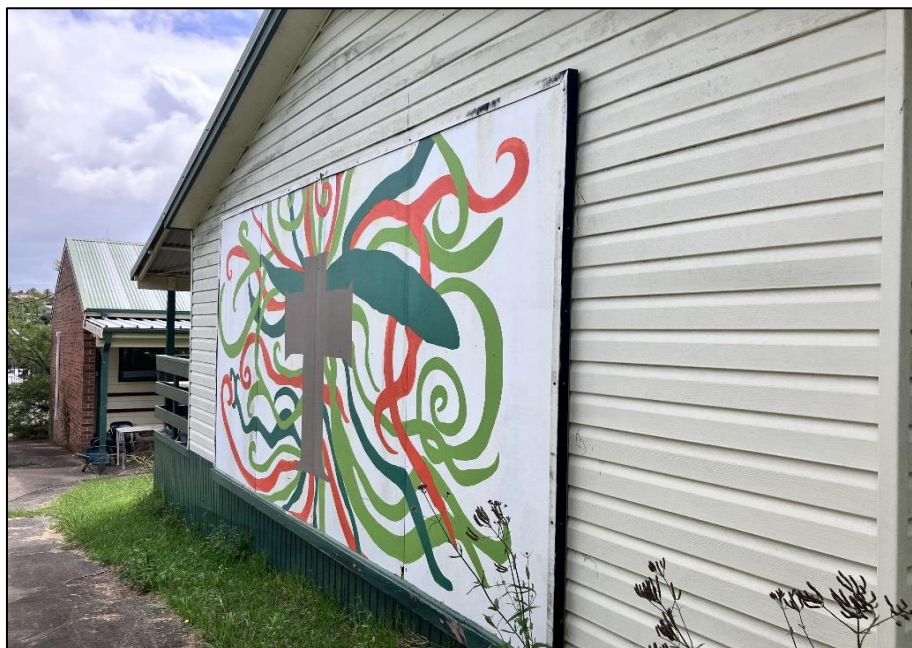
Photograph 2: B00R, exterior, southern façade, mural, fibre cement sheeting, no asbestos detected by analysis.

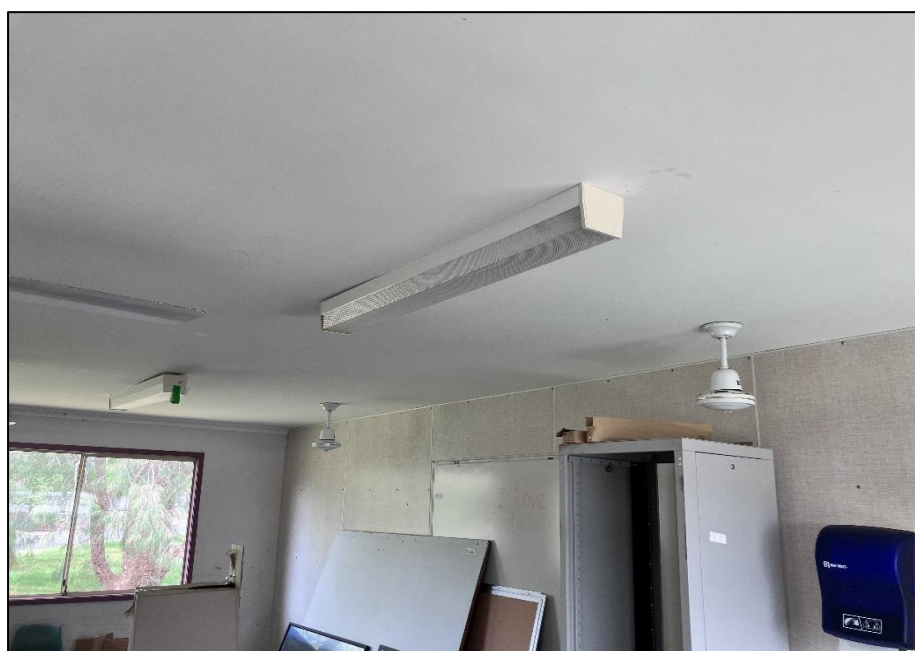
Photograph 6: B00R, rooms and areas in general, fluorescent light fittings, internal components, nil PCB (suspected).

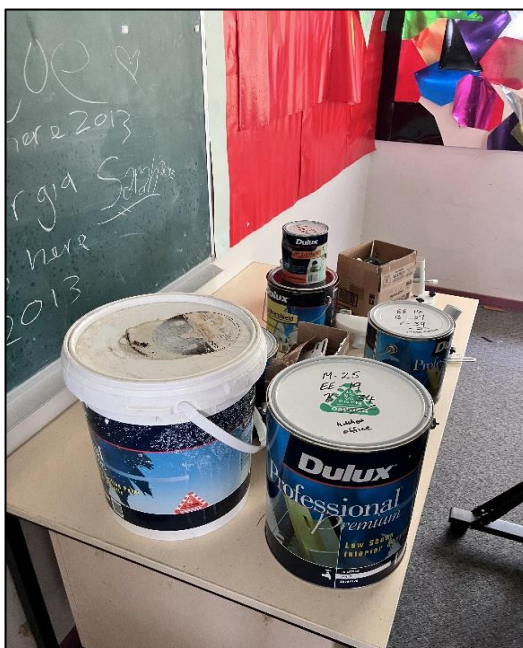
Photograph 7: B00R, RR0002, stored on desks etc., various Dulux paints or similar (approximately 30L).

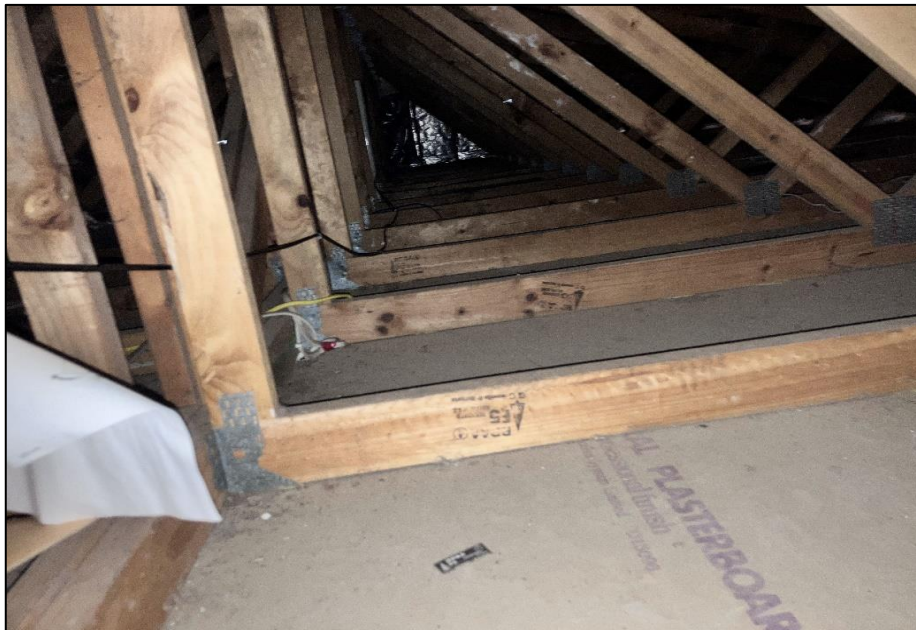
Photograph 4: B00S, interior, ceiling cavity, settled dust / debris, elevated lead concentration detected.

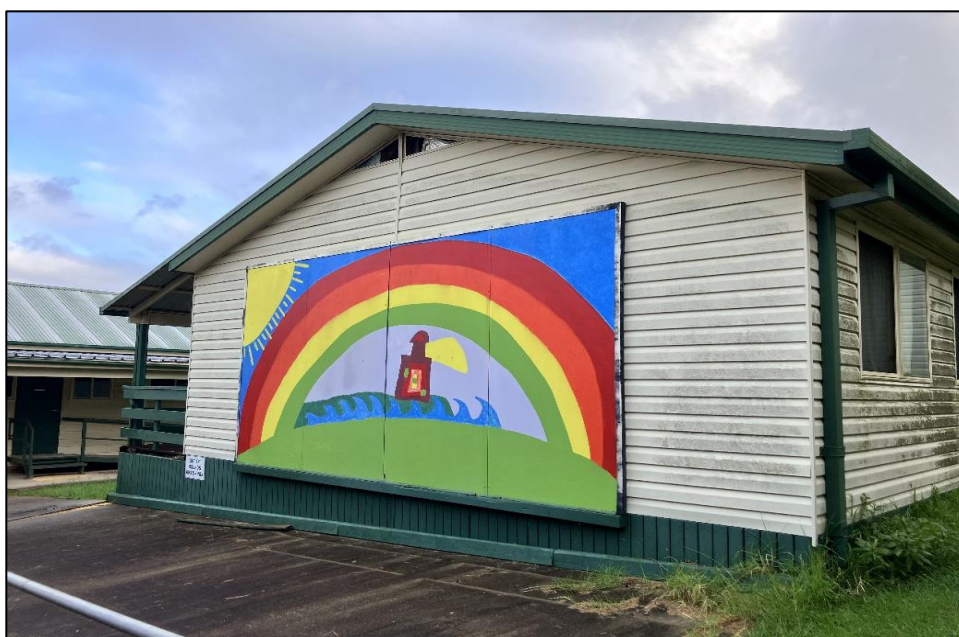
Photograph 2: B00T, exterior, mural, fibre cement sheeting, no asbestos detected by analysis.

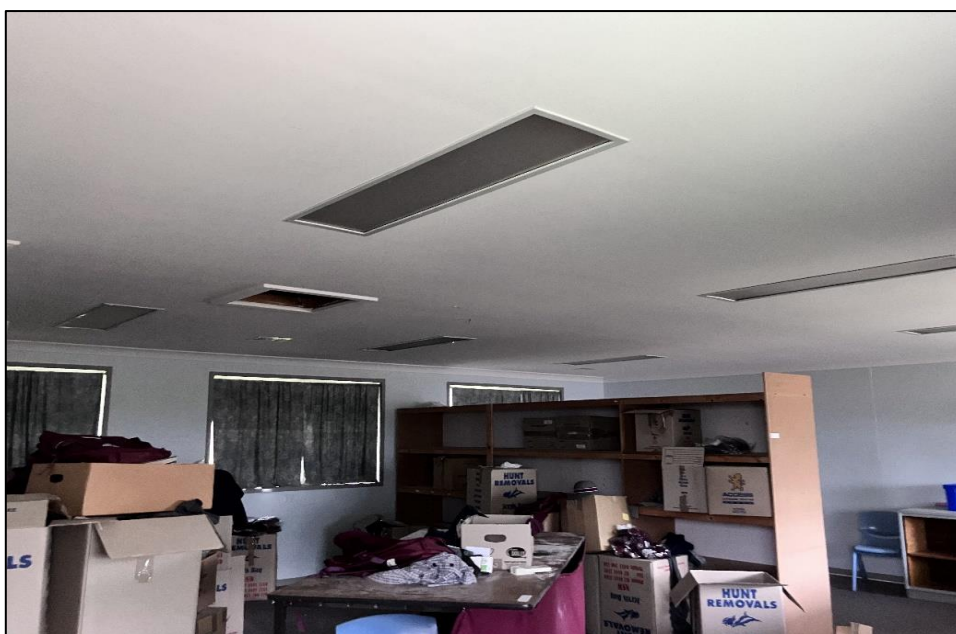
Photograph 4: B00T, rooms and areas in general, fluorescent light fittings, internal components, nil PCB (suspected).

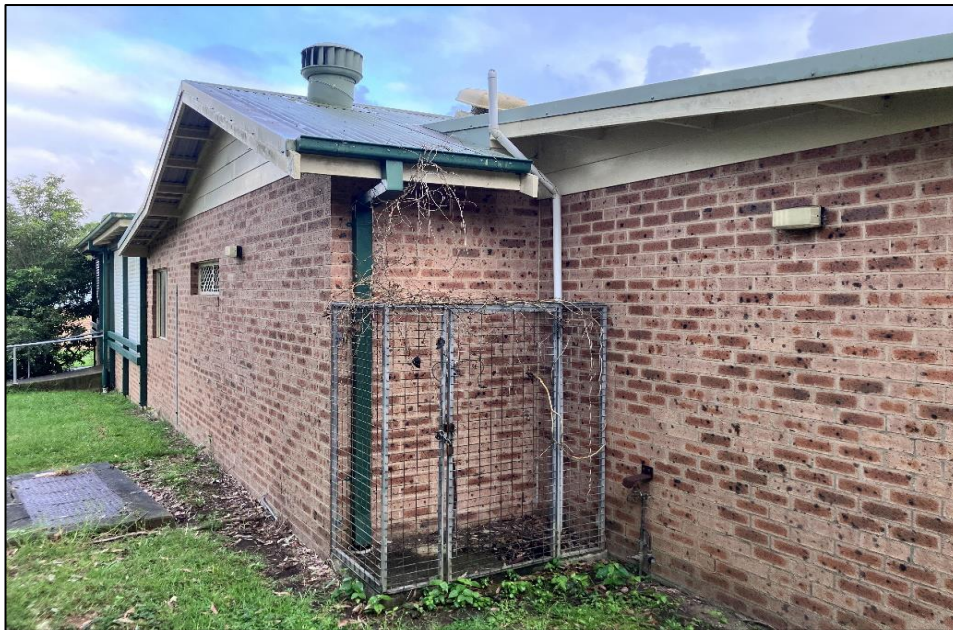
Photograph 2: B00U, exterior, weatherboard linings generally, fibre cement sheeting, suspected non-asbestos.

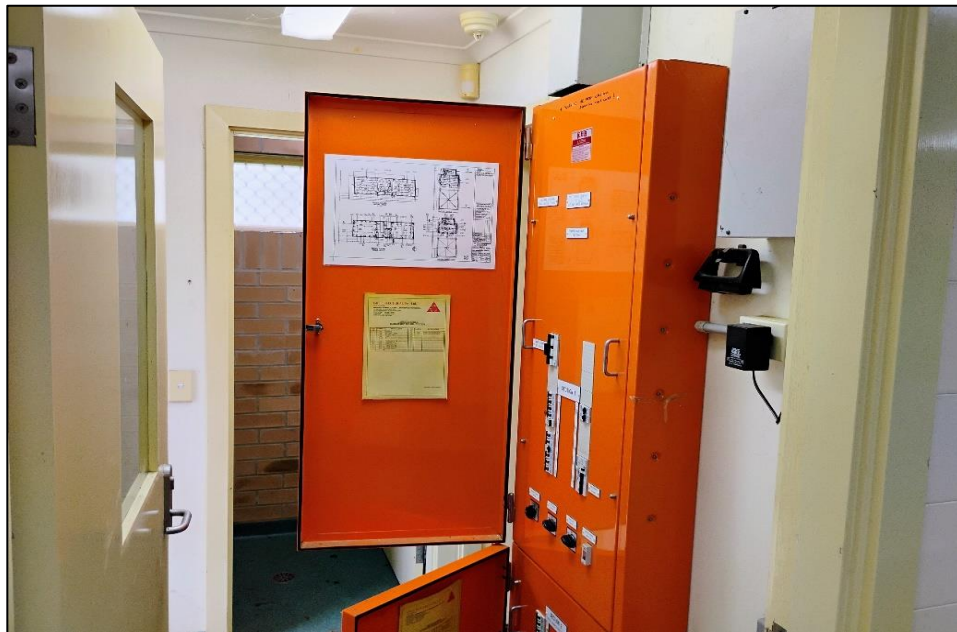
Photograph 4: B00U, UR005, electrical panel, internal components, suspected non-asbestos.

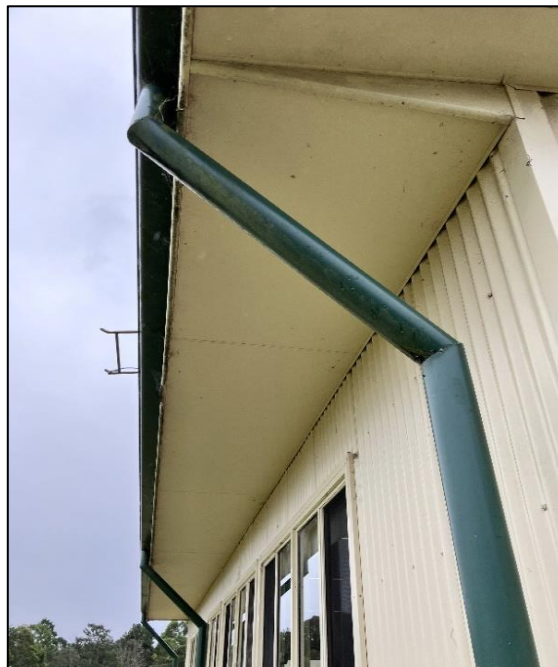
Photograph 2: B00V, exterior, western façade, centre, eave lining, no asbestos detected by analysis.

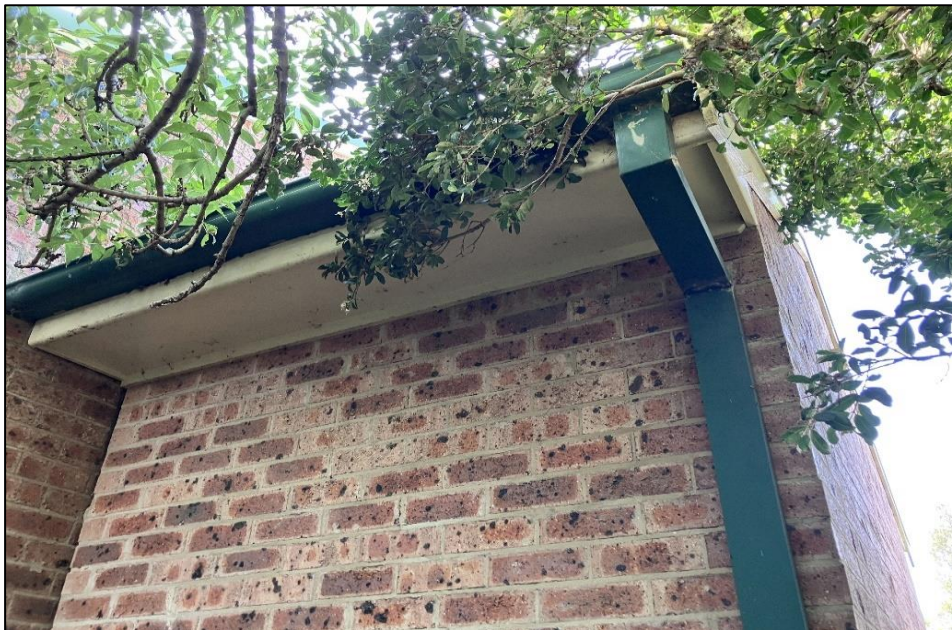
Photograph 2: B00W, exterior, WR0015, eave lining, fibre cement sheeting, no asbestos detected by analysis.

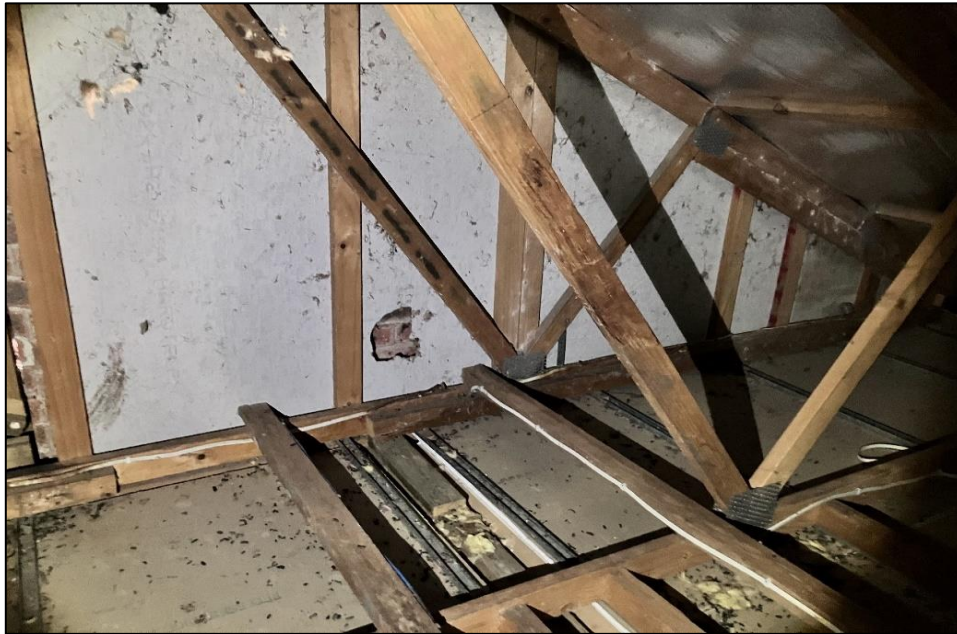
Photograph 7: B00W, interior / exterior, northeastern gable lining, fibre cement sheeting, no asbestos detected by analysis.

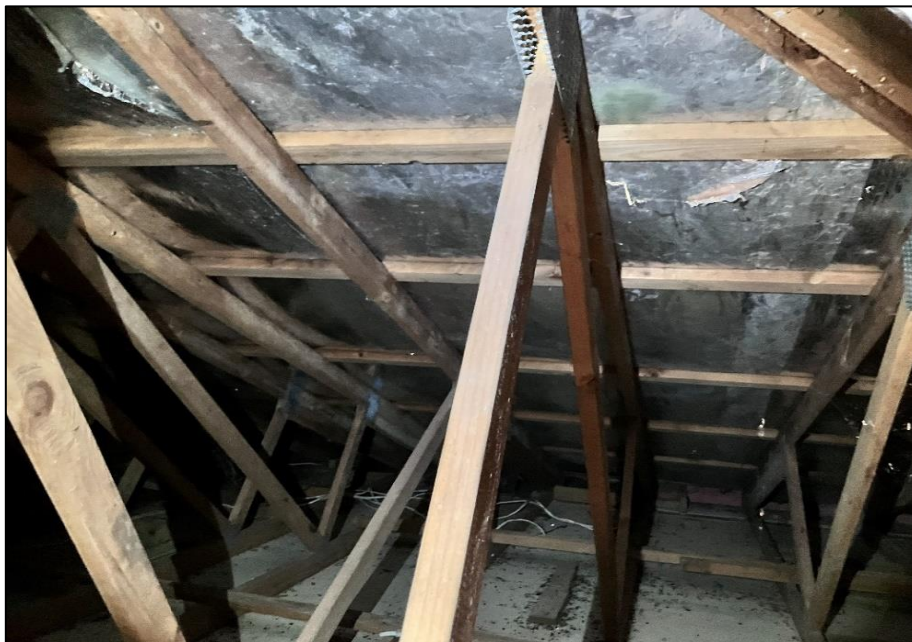
Photograph 14: B00W, ceiling cavity, underside of roof, insulation materials, SMF identified visually.
