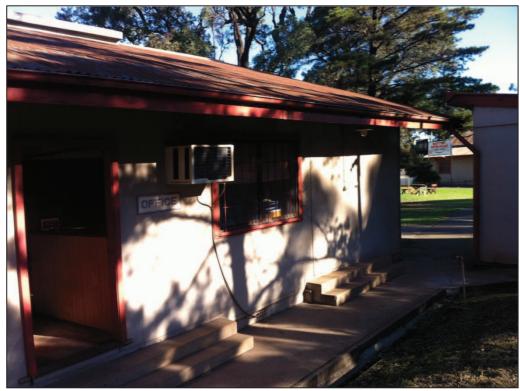
Plate 1 – Offices on the eastern portion of the site, adjacent to Christie Street.

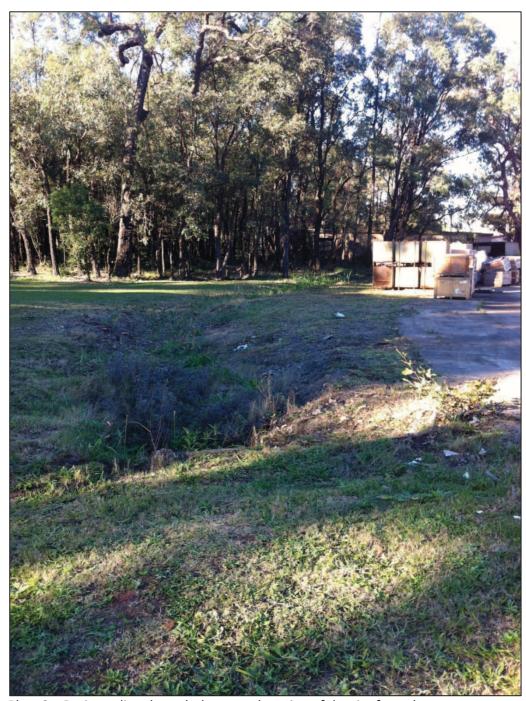
Plate 3 – Drainage line through the central portion of the site from the western boundary.

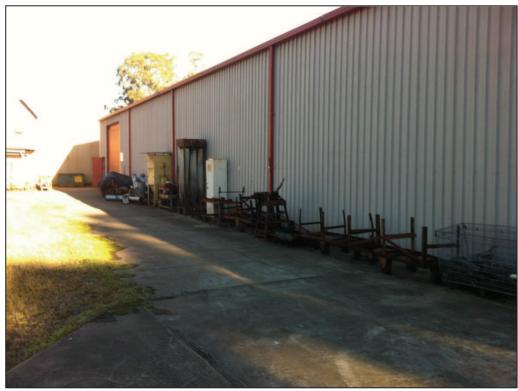
Plate 4 – Along the western boundary of the site viewed from the north.

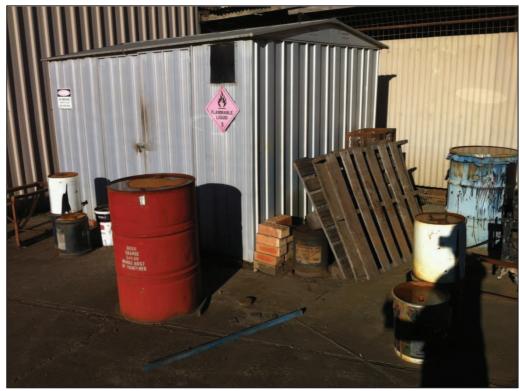
Plate 6 – Location 12, flammable shed north of the Coils Factory.

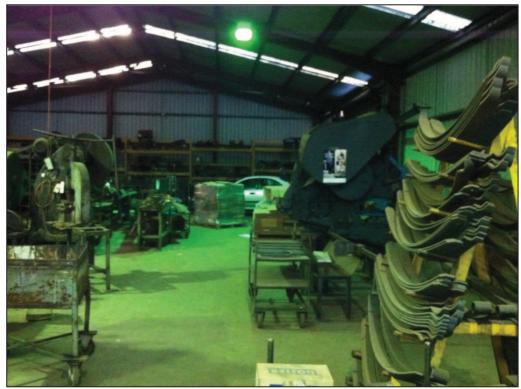
Plate 9 – Inside the Leaf Springs Shed.

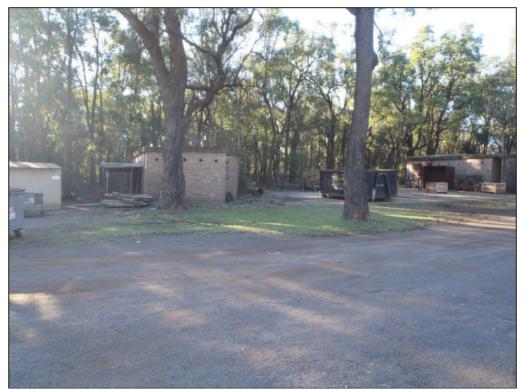
Plate 15 – The old ammunitions bunkers on the eastern portion of the site.

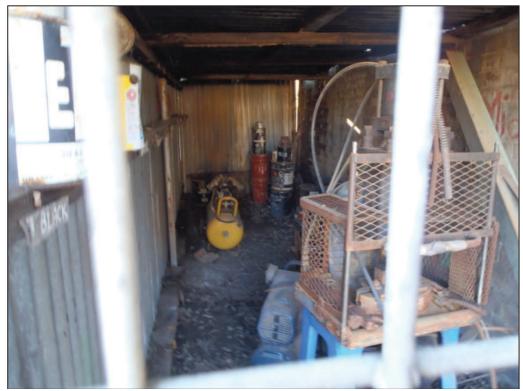
Plate 16 – The metal shed adjoining the western wall of the western bunker.

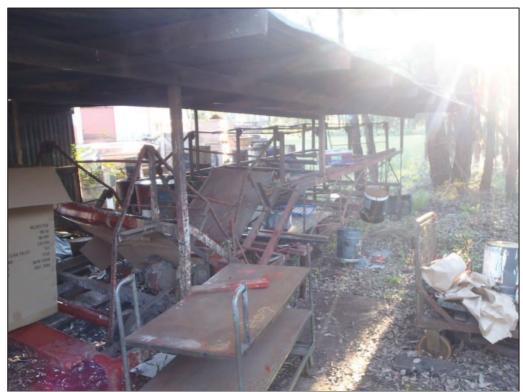
Plate 17 – Location 21, painting shed in the central portion of the site, west of the bunkers.

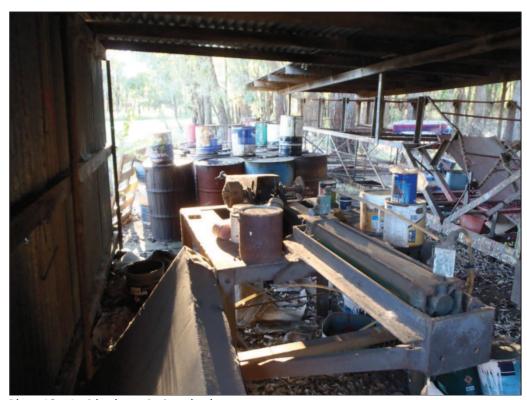
Plate 19 – Inside the painting shed.

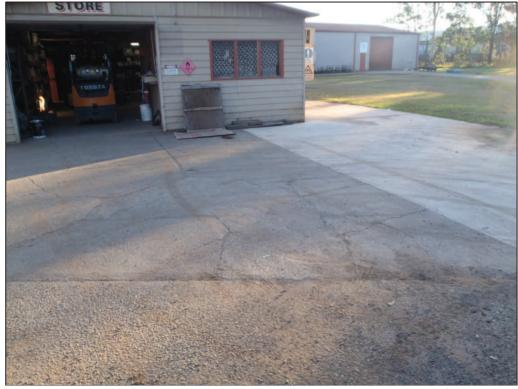
Plate 21 – The area of the decommissioned UST (UST 1) with a store shed (Location 24) beyond.

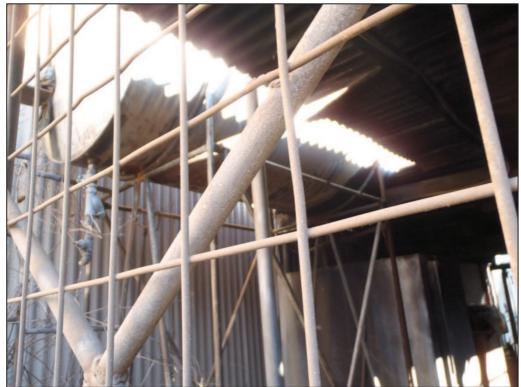
Plate 22 - 2,500L diesel AST (AST 3) adjacent north of the eastern portion of the Coils Factory (Location 27).

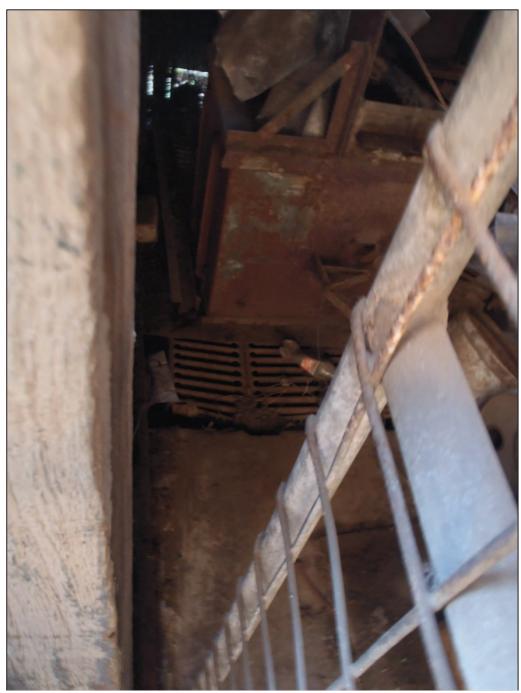
Plate 24 – Drain in Location 28 adjacent to the western wall.

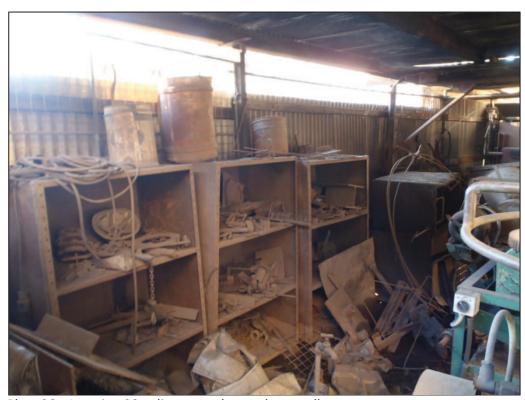
Plate 26 – Location 28, adjacent to the northern wall.

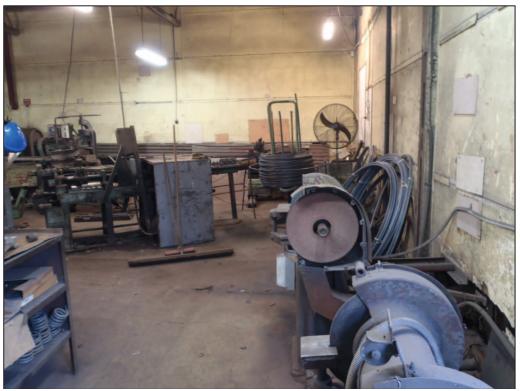
Plate 27 – The northern corner of the western half of the Coils Factory.

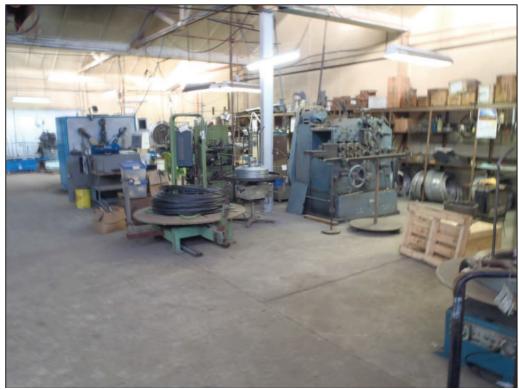
Plate 29 – The eastern half of the Coils Factory.

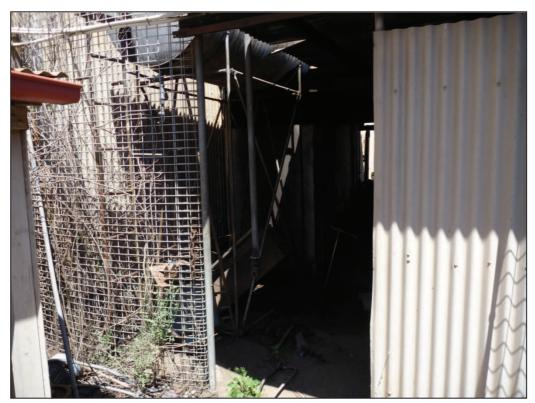
Plate 51 – Boring location B24 and diesel AST.
