Residential Subdivision of Henry Parks Drive Lot 442 DP 1201831 Kiama Downs

Report on Preliminary Geotechnical Assessment

Our Ref: TERRA19419.Rep1.Rev2

27 August 2020

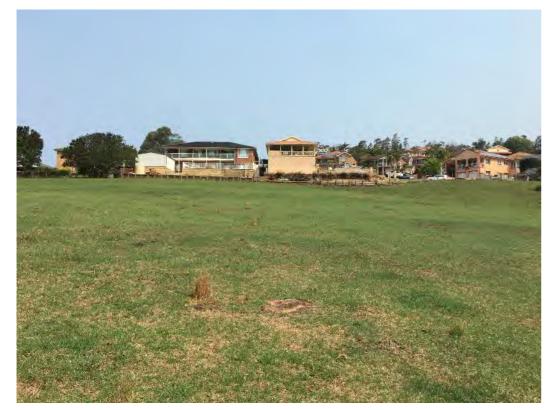
Photograph 6: View of Area 4. Area steeper than surrounding land, contains a

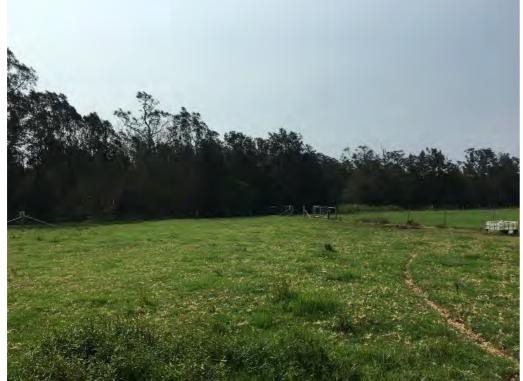
Photograph 25: Level land of Area 2, looking north.
