Residential Subdivision of No. 105 Cooby Road,  
Tullimbar NSW

Report on Preliminary Geotechnical Assessment

Our Ref: TERRA18320.Rep1.Rev1

15 August 2019

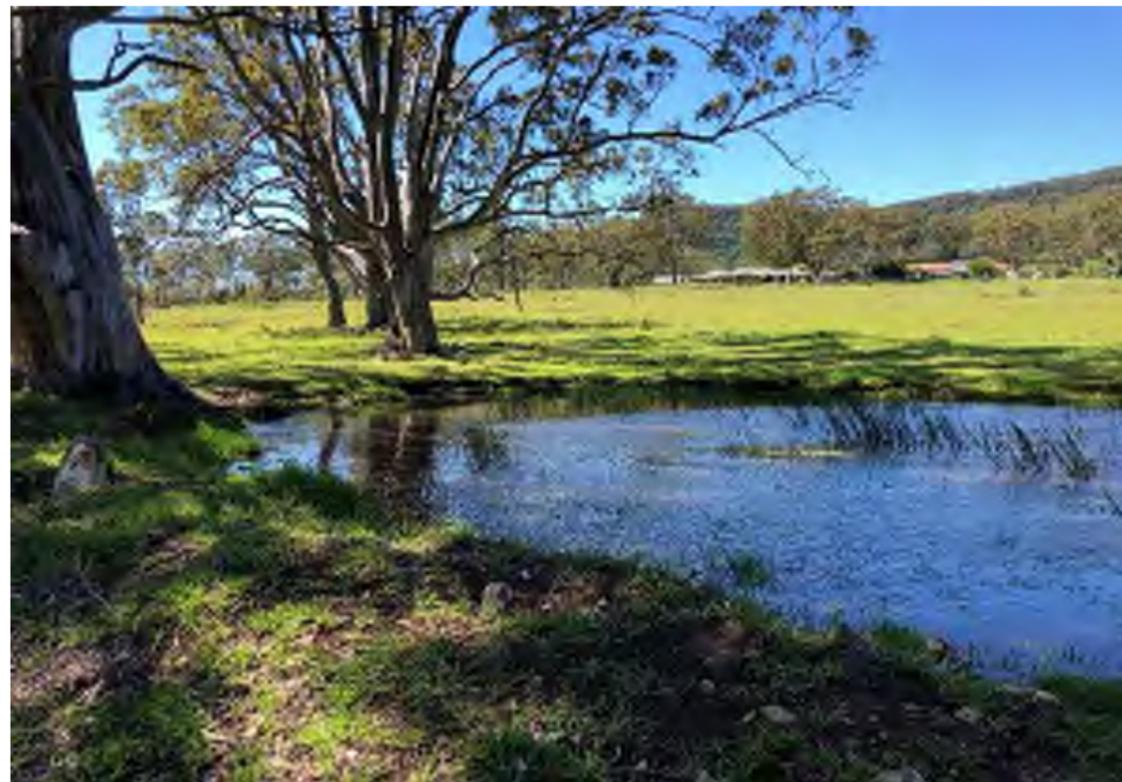
Photograph 3: View of Dam South on Terrace 1A looking south east

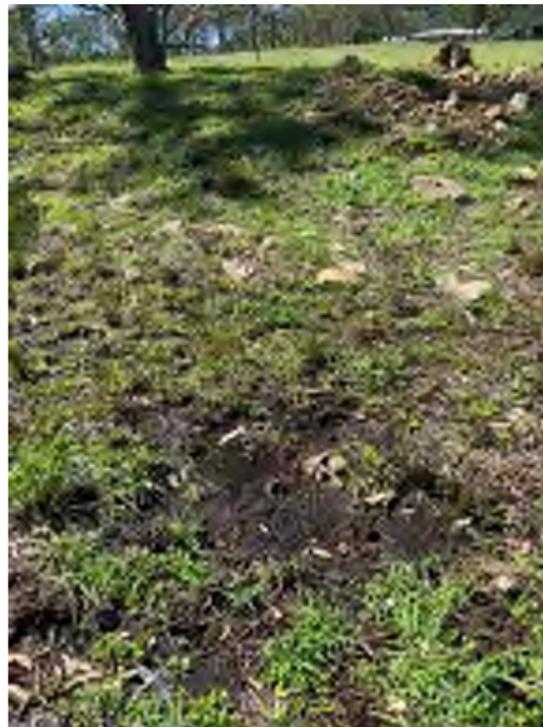
Photograph 5: View looking south east at the northern wall of Dam South showing dam seepage

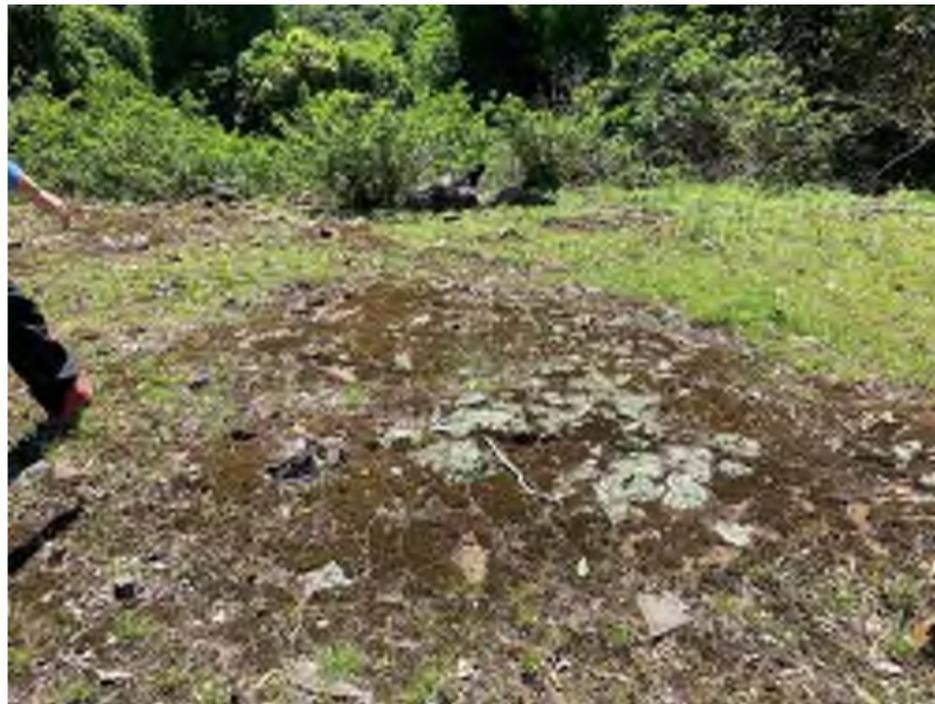
Rock outcropping (photograph 14 and 15). Steep drop off of rock along crest of slope (photograph 16)

Photograph 15: Outcropping latite in the middle section of Terrace 1B

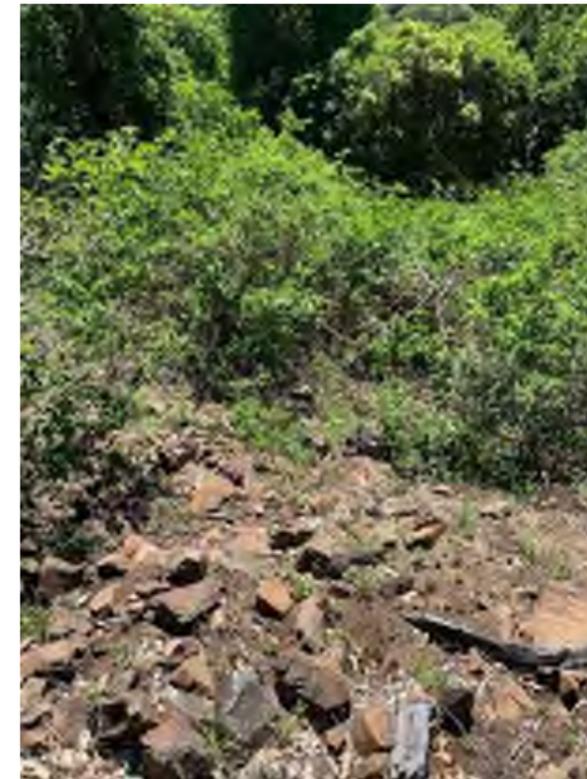
Photograph 16: View looking east down Area 2 from Terrace 1B

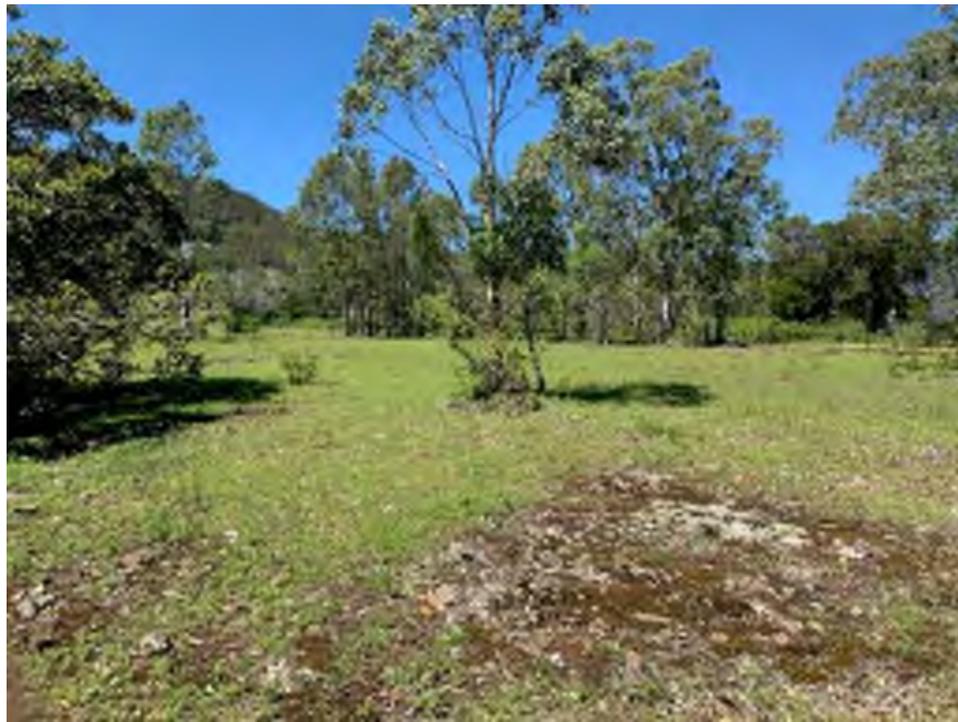
Photograph 17: View looking south west across Terrace 1B

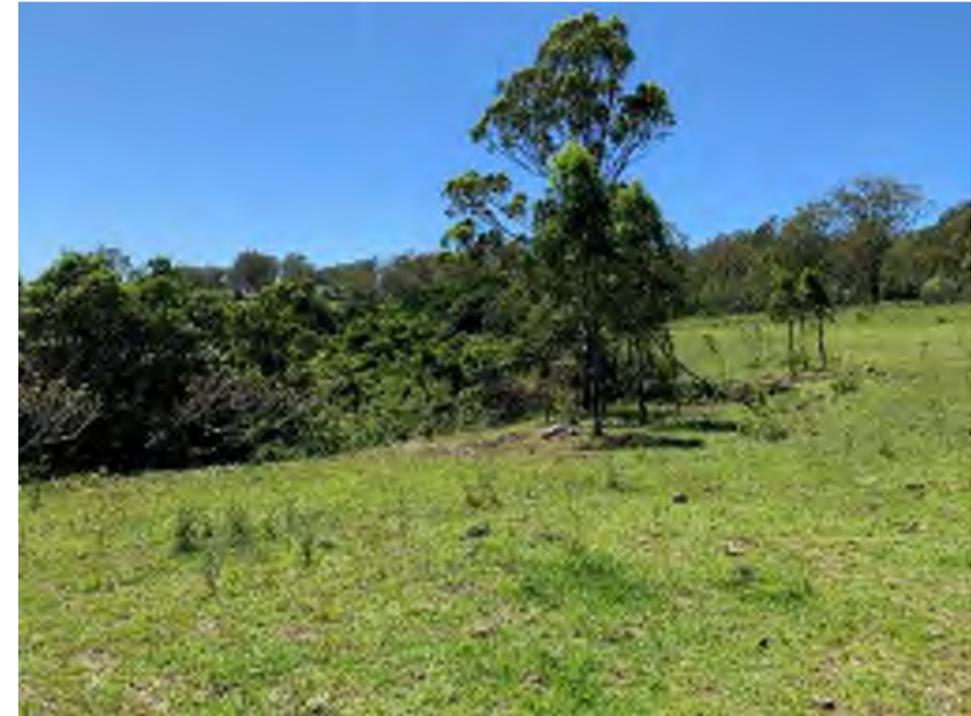
Photograph 18: View looking south east across Terrace 1B and the boundary of Area 2

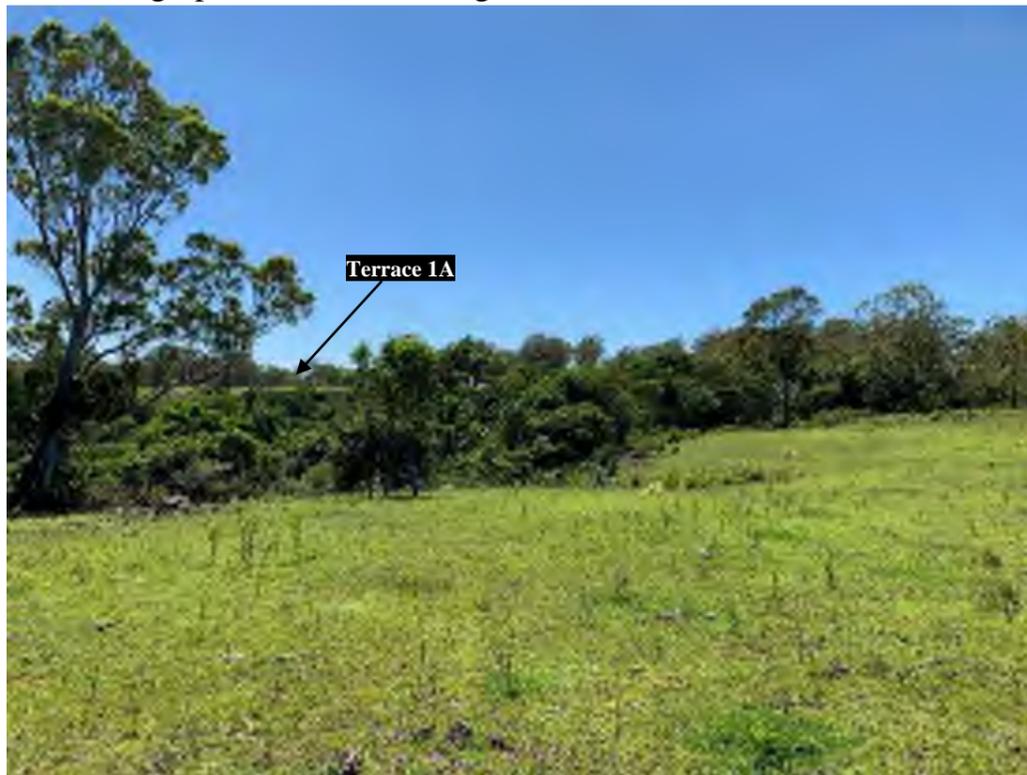
Photograph 19: View looking east from Terrace 1B over Areas 2 and 3 to Terrace 1A

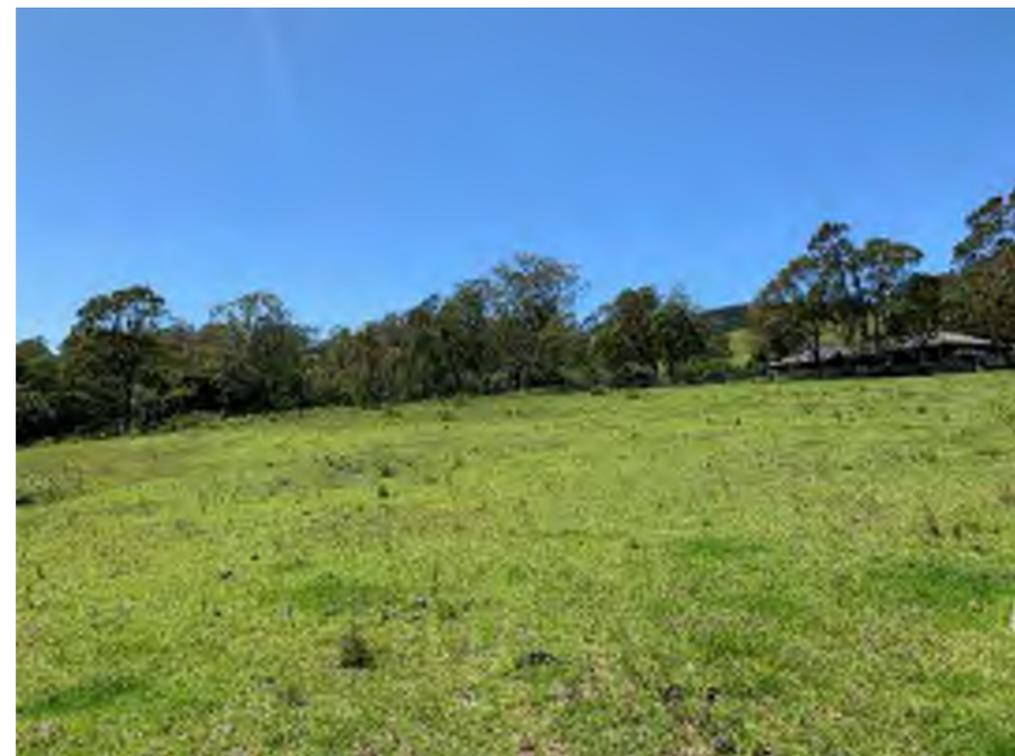
Photograph 20: View looking east over the southern section of Terrace 1B

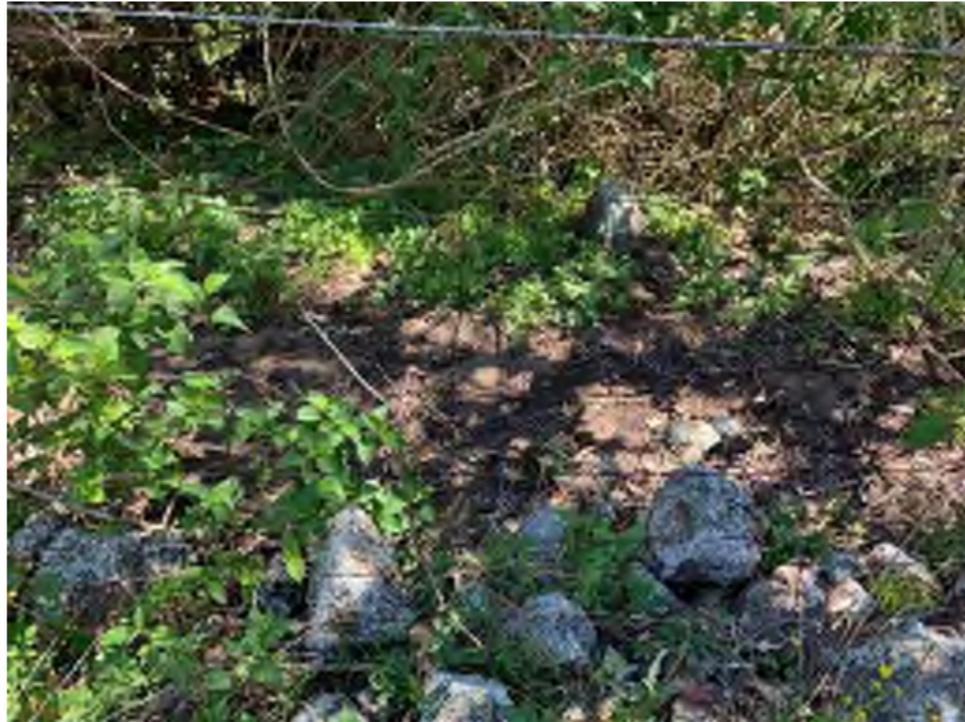
Photograph 21: Outcropping latite on the south eastern boundary between Terrace 1B and Area 2

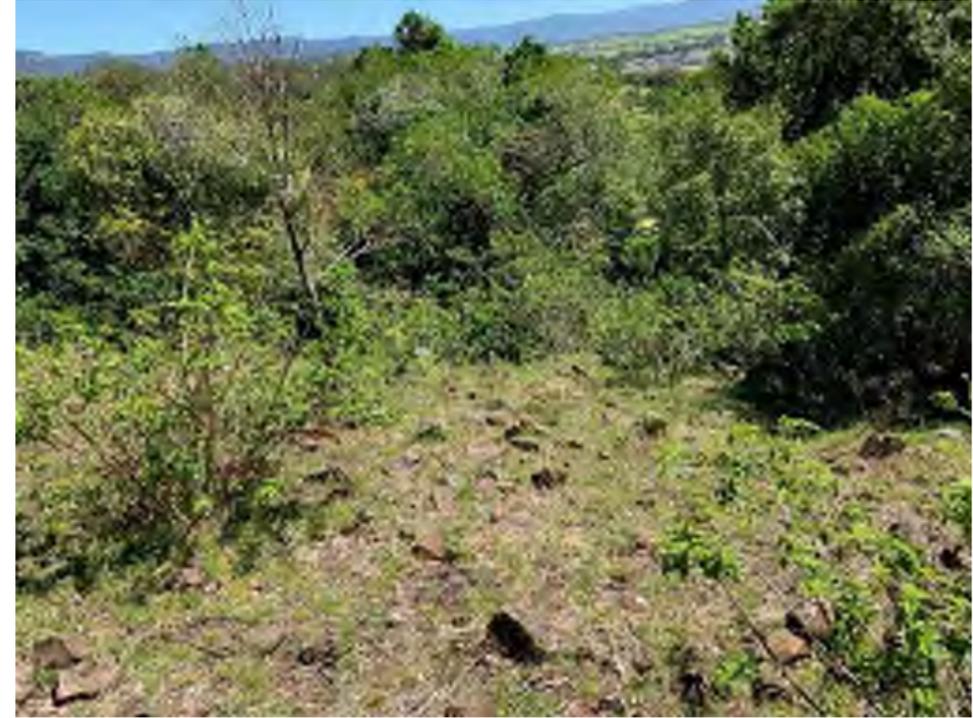
Photograph 22: Looking down area 2 from Terrace 1B north toward Area 3

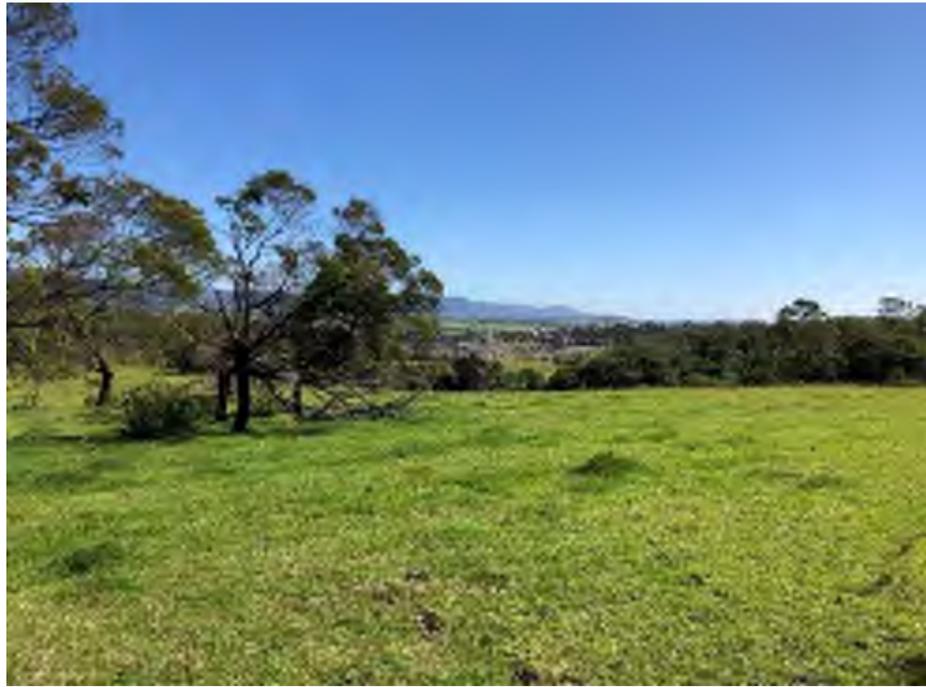
Photograph 25: View from Cooby Rd looking north over the southern area of Terrace 1B

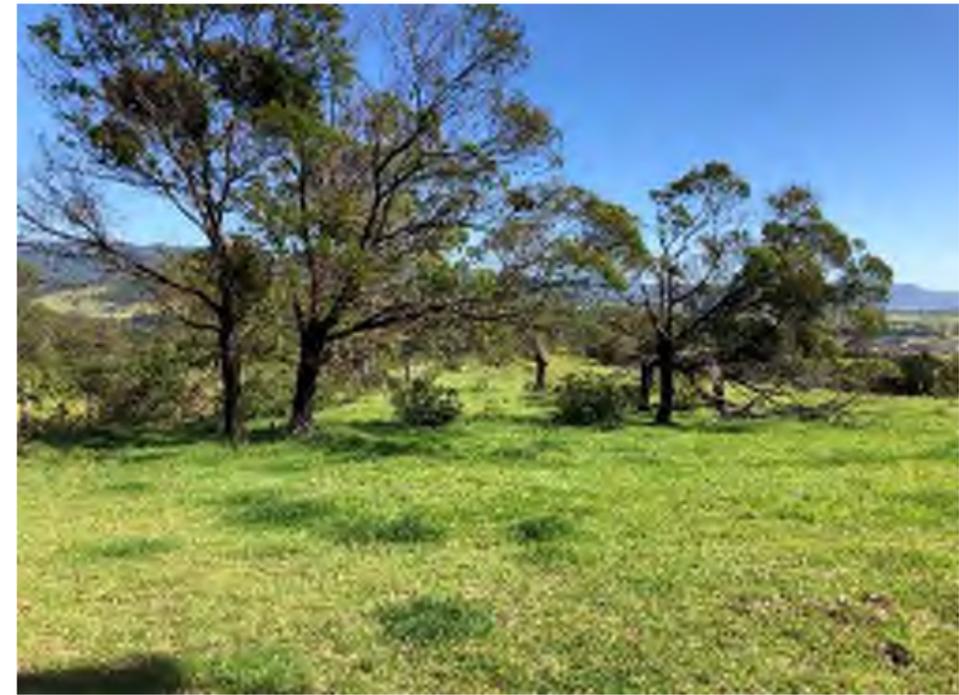
Photograph 26: View from Cooby Rd looking north west over Terrace 1B

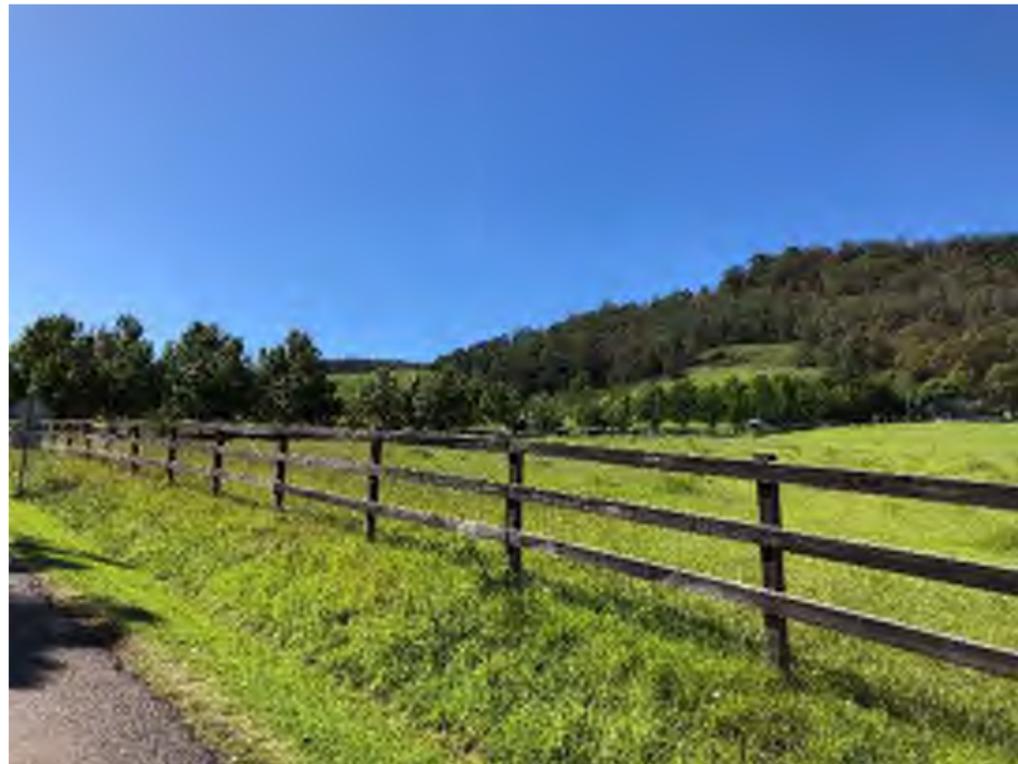
Photograph 27: View from Cooby Rd looking south east at neighbouring farm

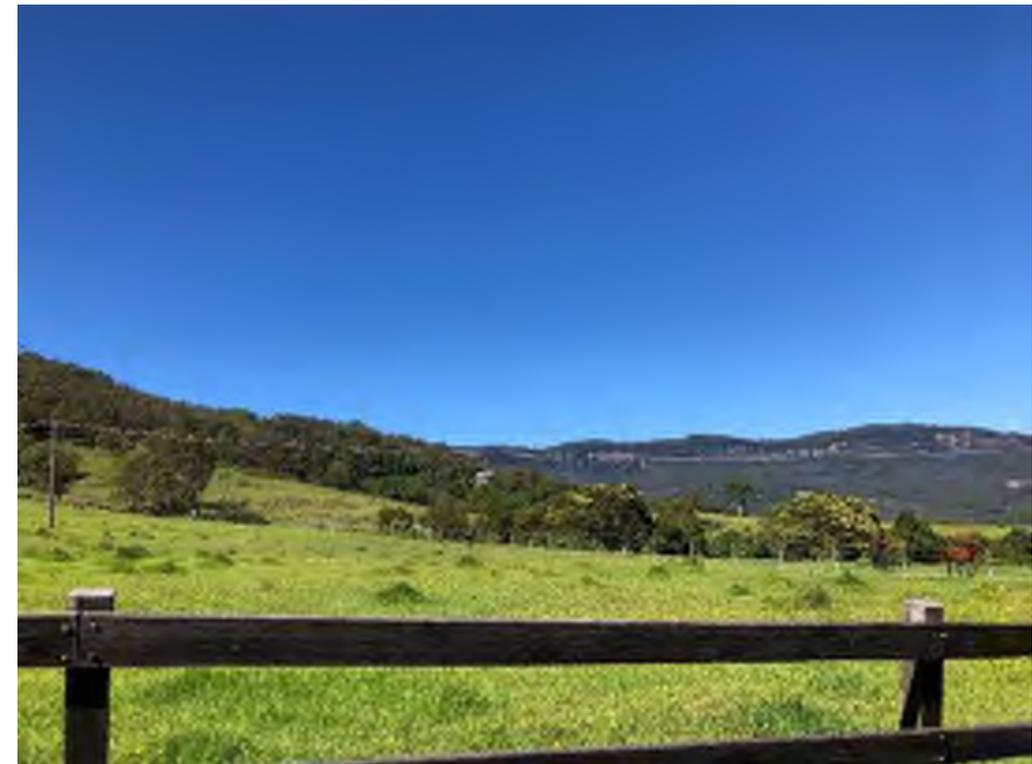
Photograph 28: View from Cooby Rd looking west to the escarpment in the distance

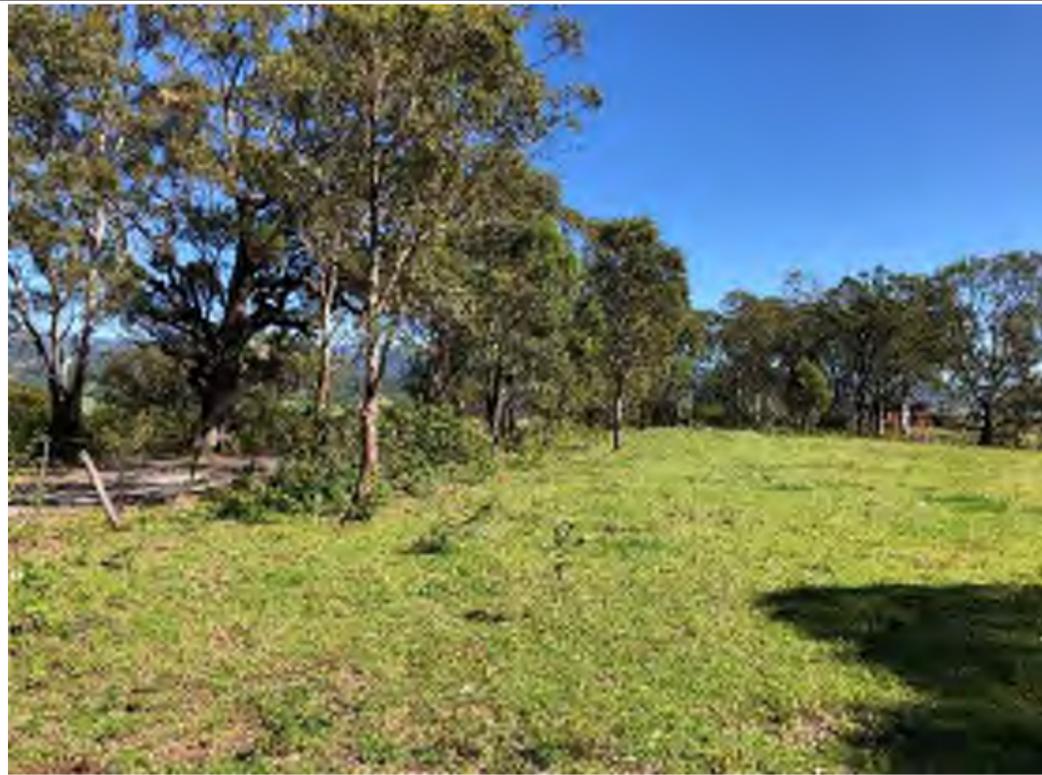
Photograph 29: View of the north western end of Terrace 1B

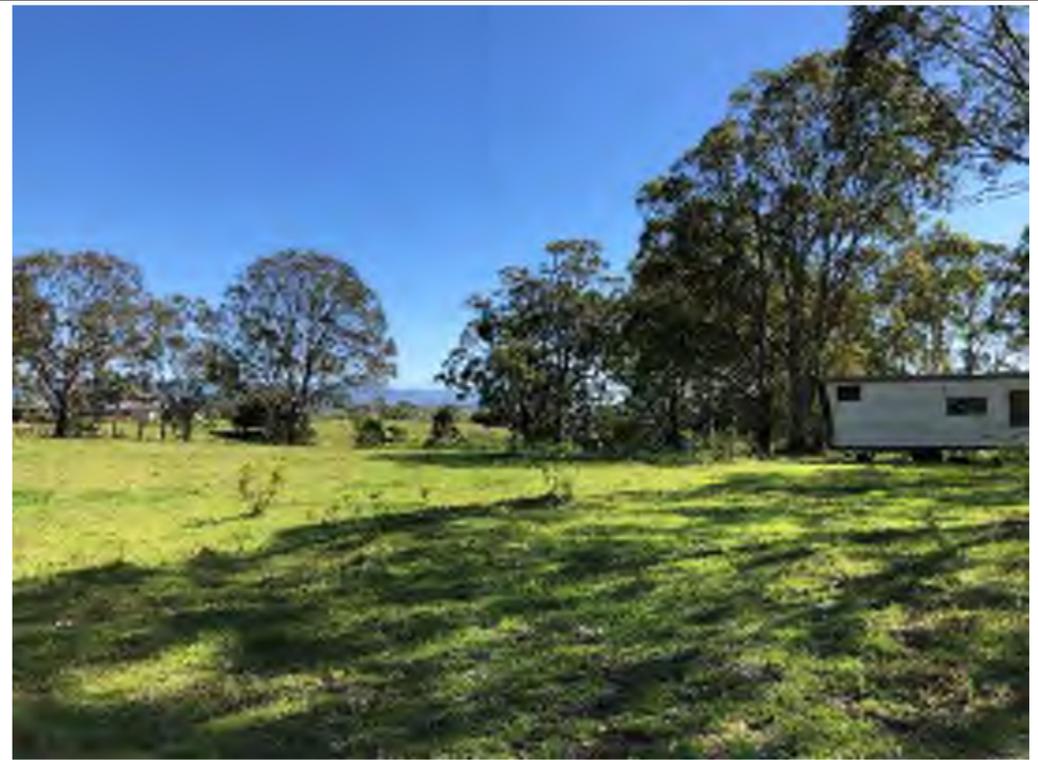
Photograph 30: View looking north east over Terrace 1B from near the road access gate

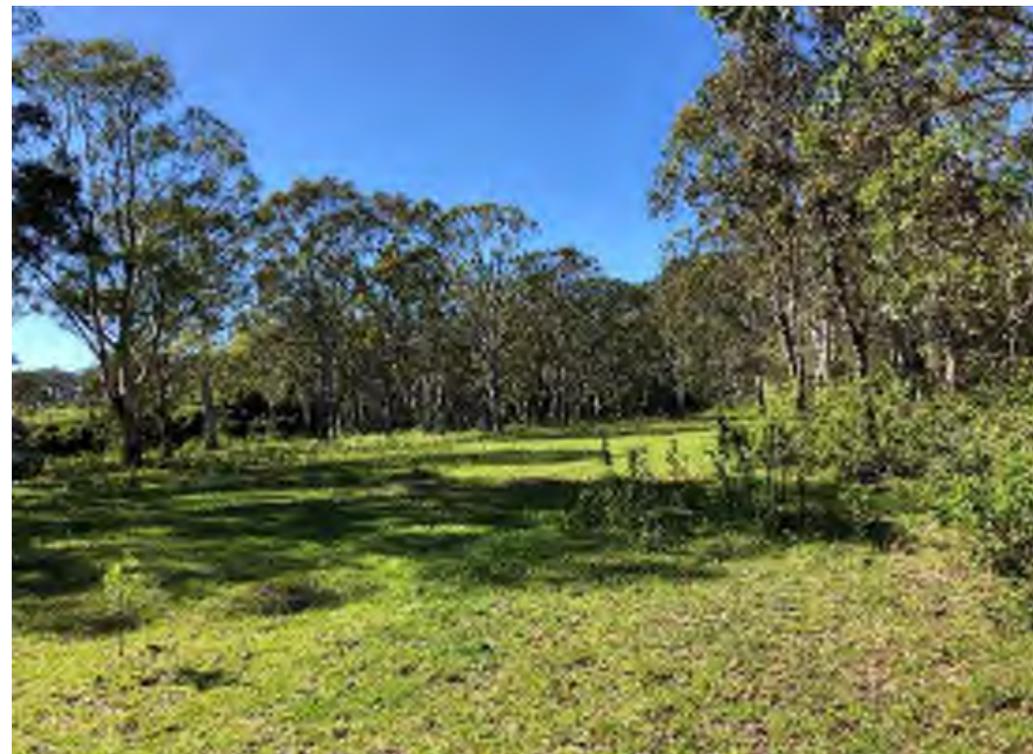
Photograph 31: View looking south down Terrace 1B from road access gate

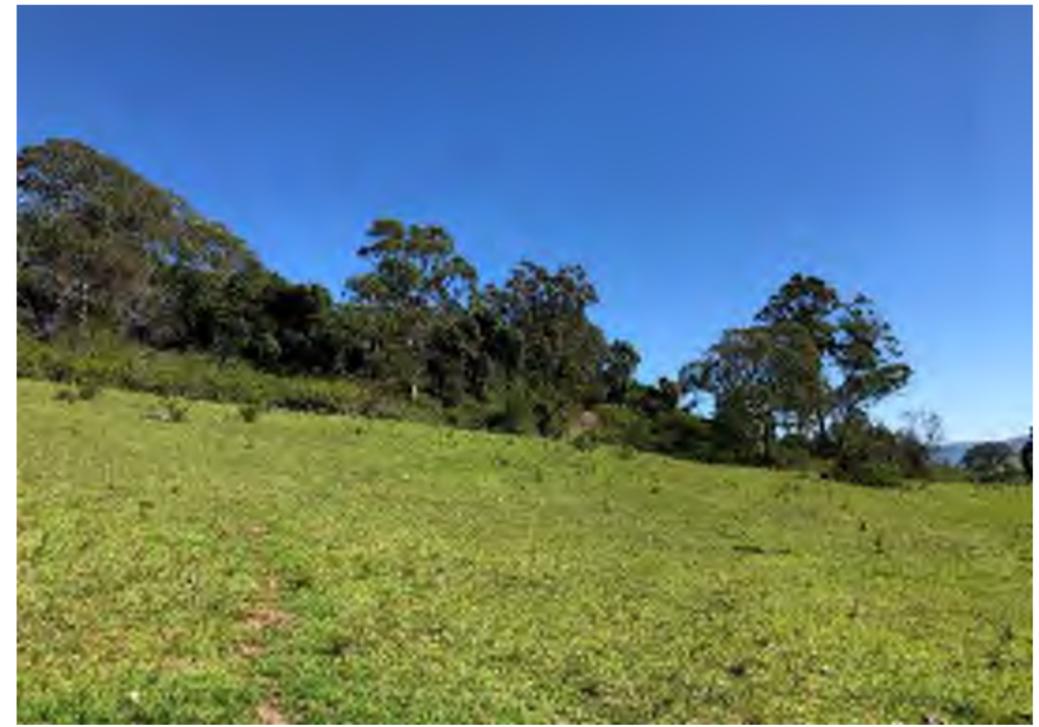
Photograph 34: View of the slope on the western side of Area 3 looking north

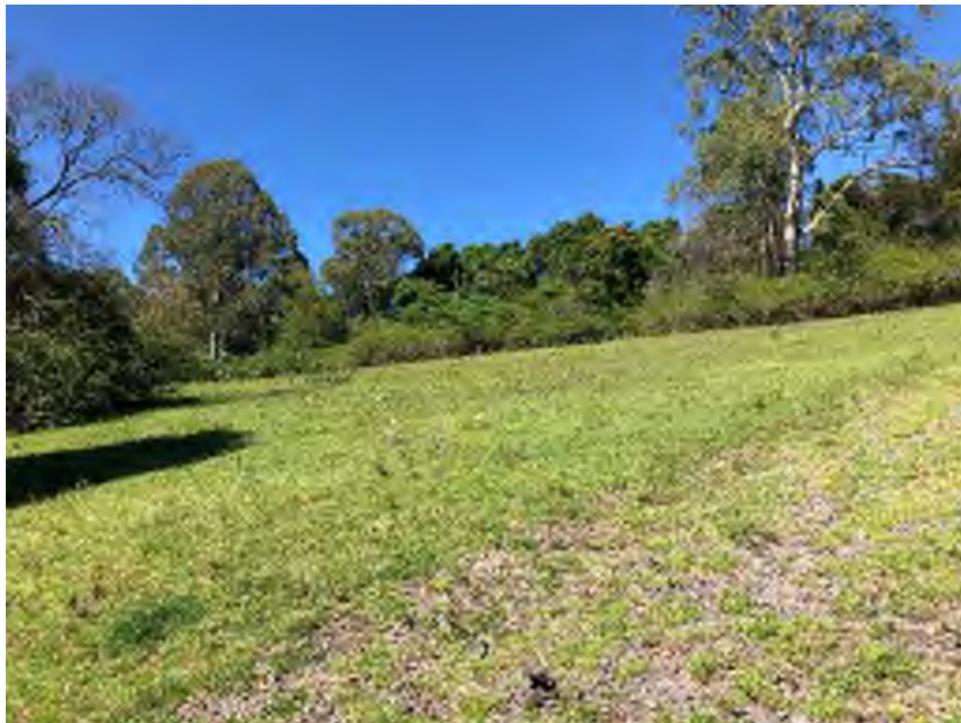
Photograph 35: Looking up the slope on the western side of area 3. Looking south west. Showing latite gravel on the surface.

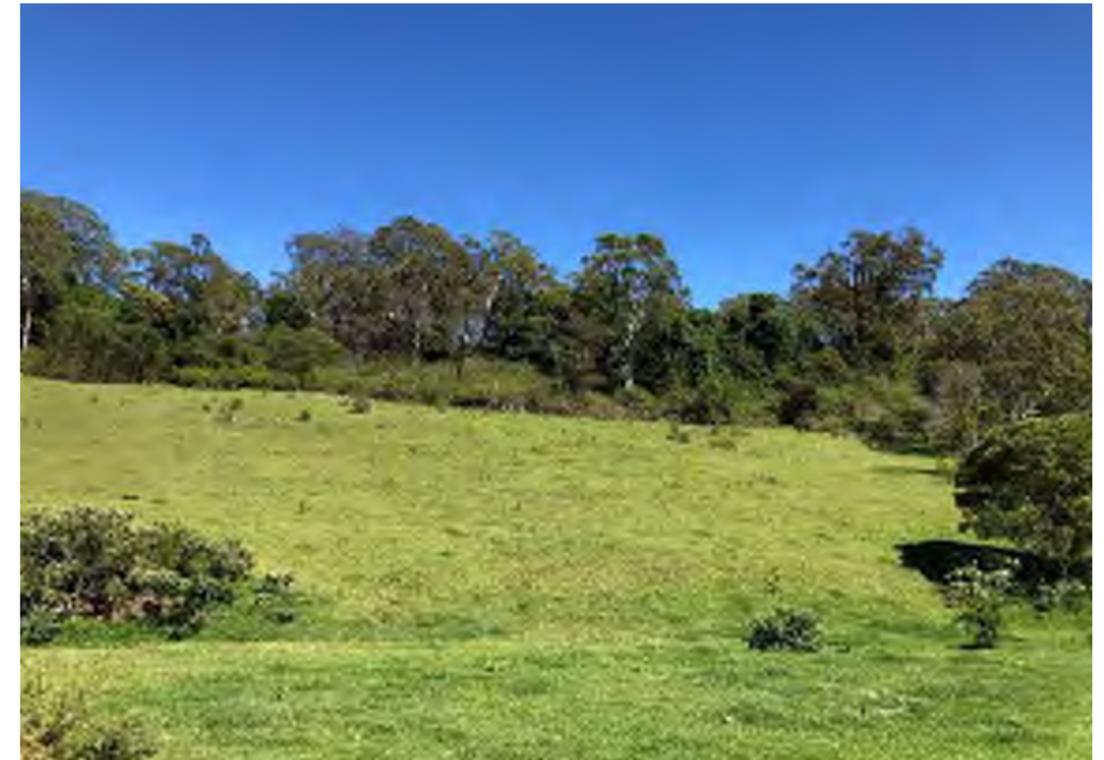
Photograph 36: Looking west at the slope of Area 3 up to Area 2 and Terrace 1B

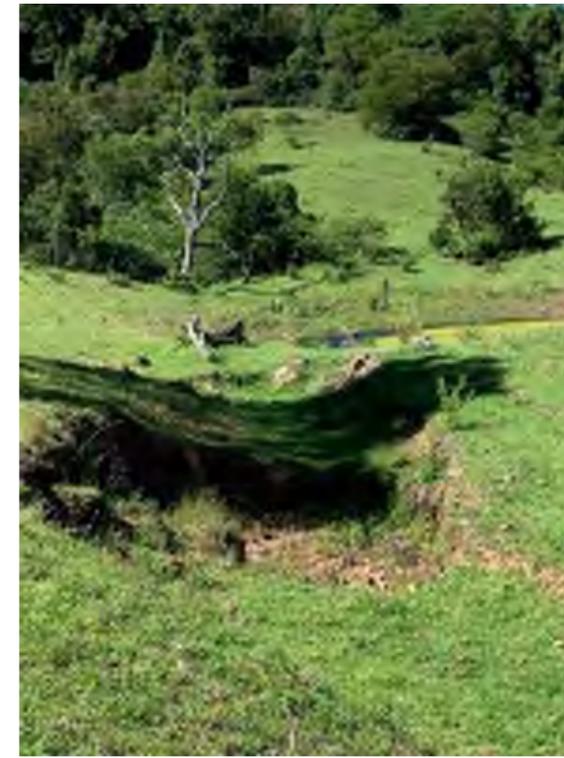
Photograph 38: View of spill way for Dam West. Located north east of Dam West in Area 3

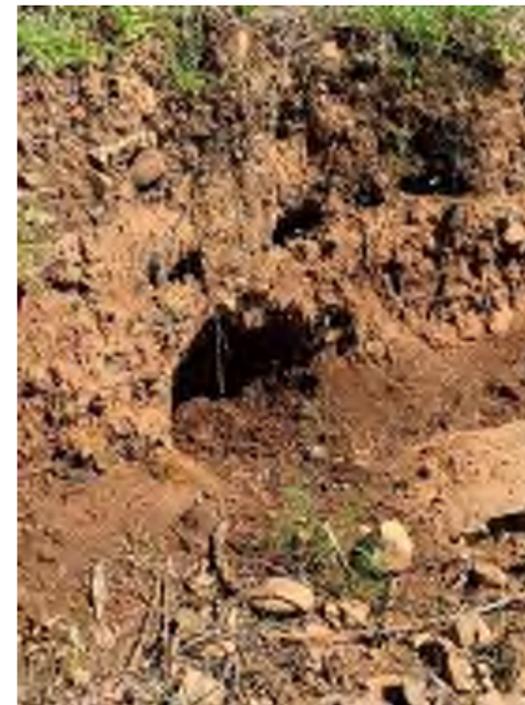
Photograph 40: View of colluvial sediments exposed by spill way erosion. Gravel and cobbles largely consist of sandstone with some latite from escarpments above

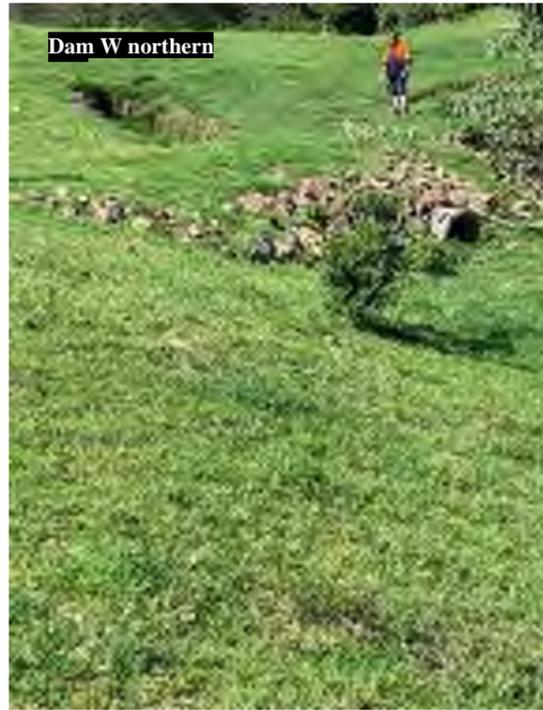
Photograph 41: View looking south west at storm water culvert north of the dam wall

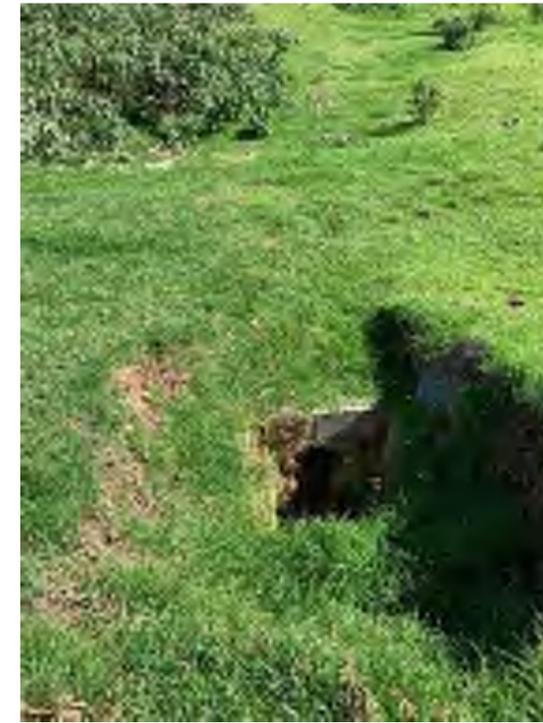
Photograph 42: View of the storm water culvert looking north from the Dam West

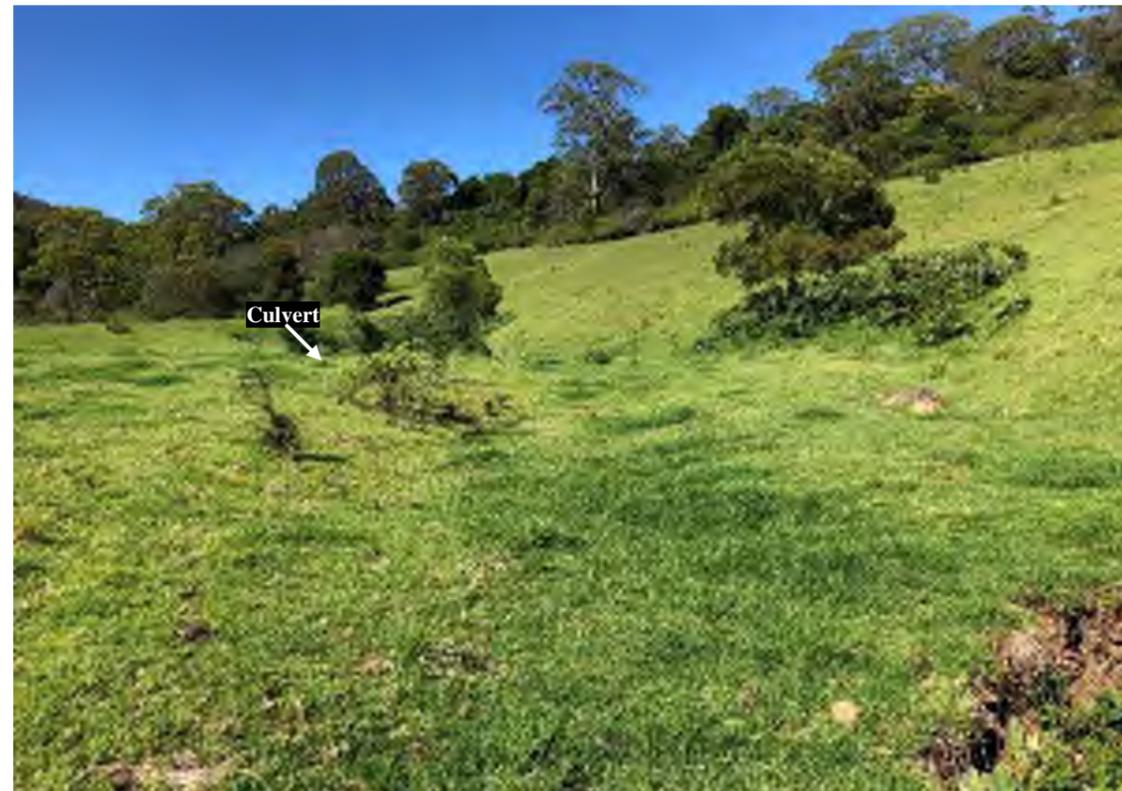
Photograph 43: looking south west showing the storm water channel through Area 3 looking back towards the culvert

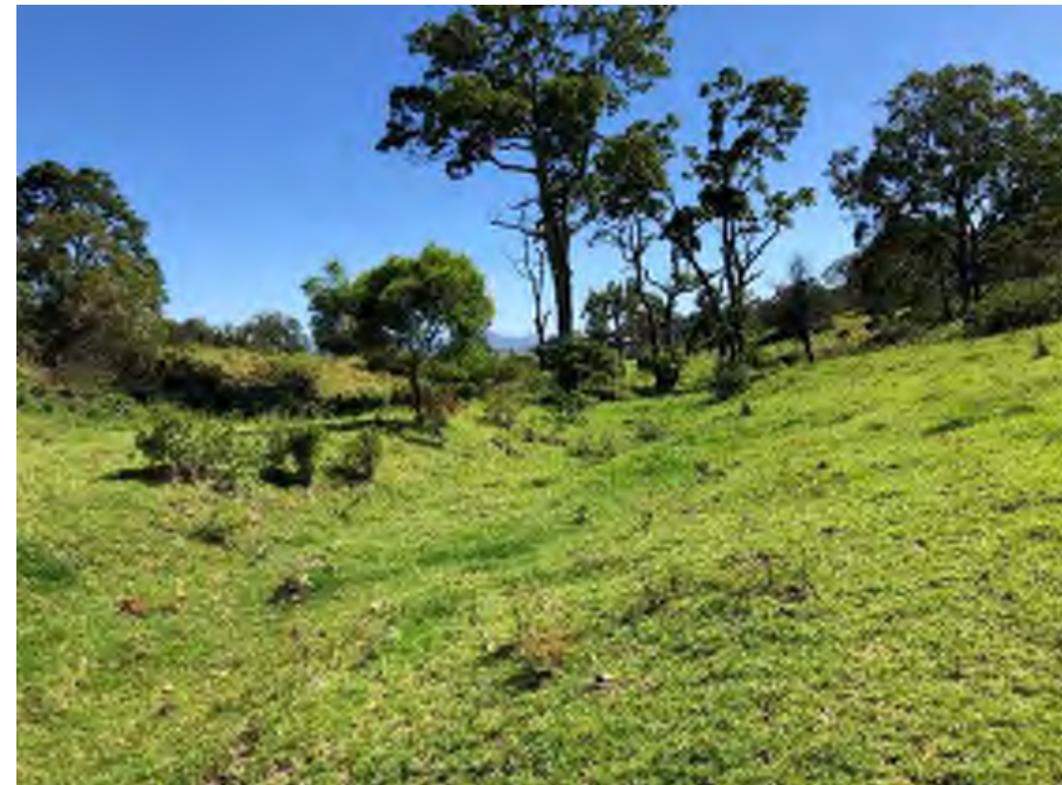
Photograph 44: looking north showing the storm water channel through the base of Area 3

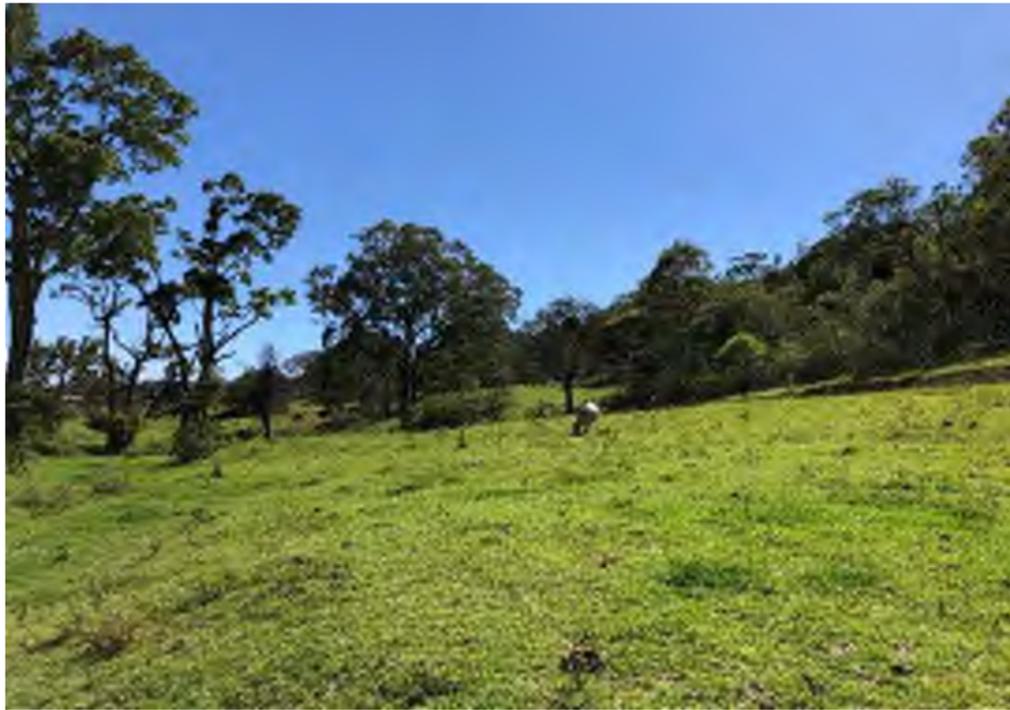
Photograph 45: View from western side of Area 3 looking east

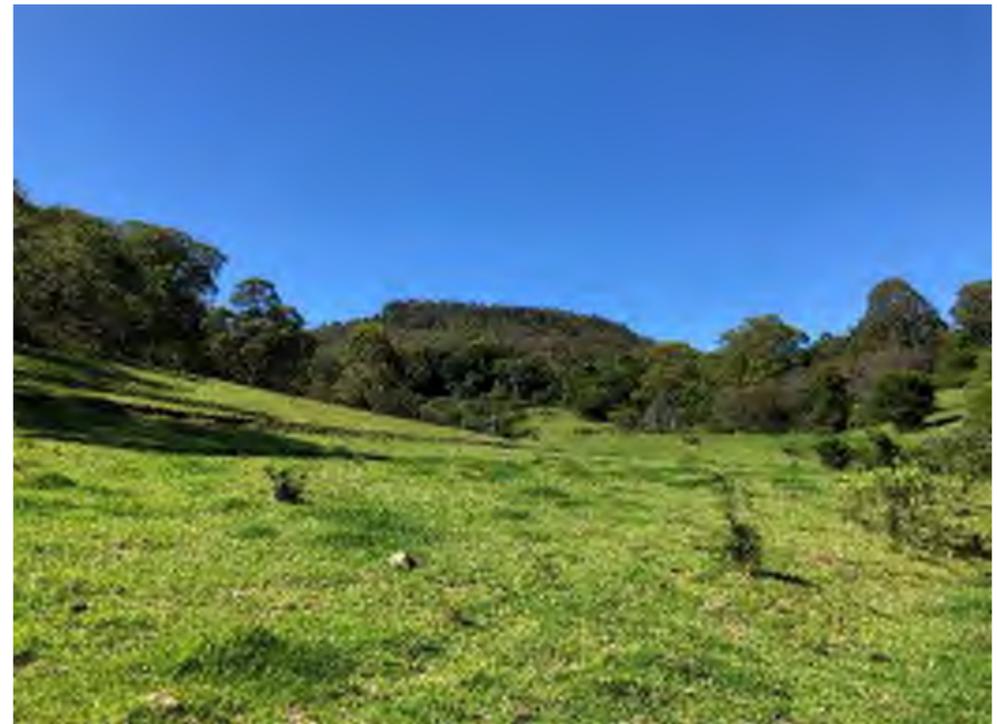
Photograph 46: View looking south west across the western side of Area 3 toward Dam West

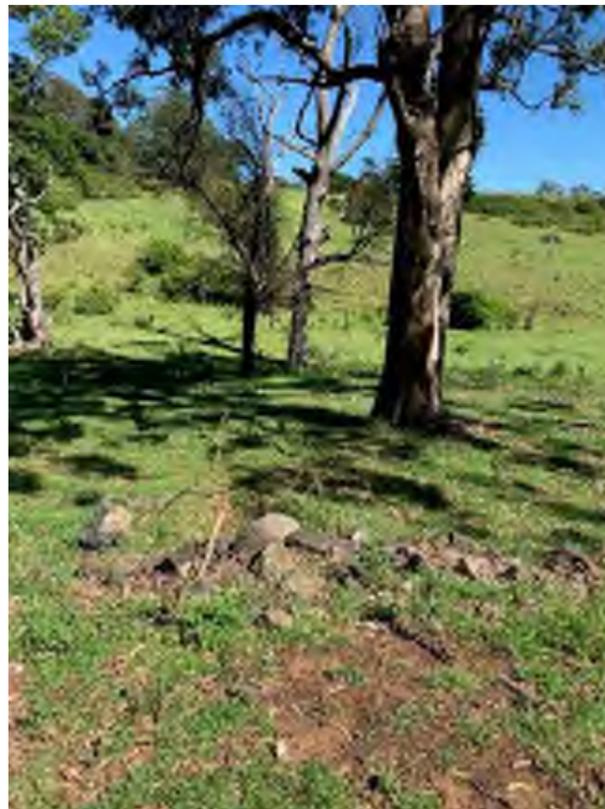
Photograph 47: Showing latite boulders and cobbles in Area 3 from Area 2s escarpment above

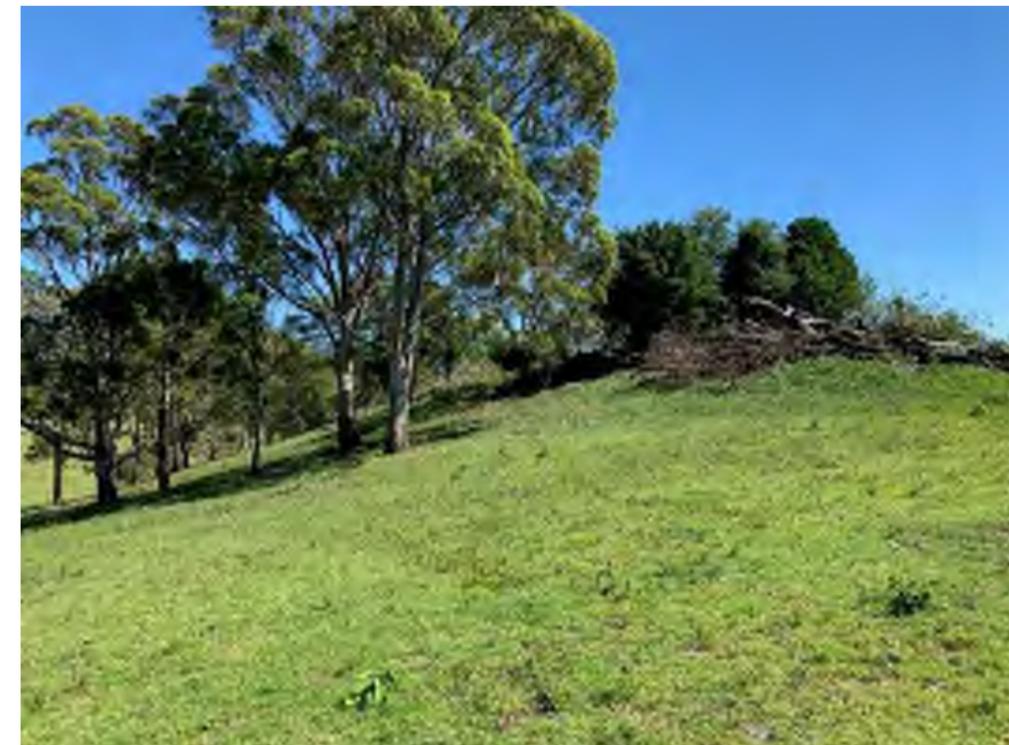
Photograph 48: View looking north at Area 4 from Area 3

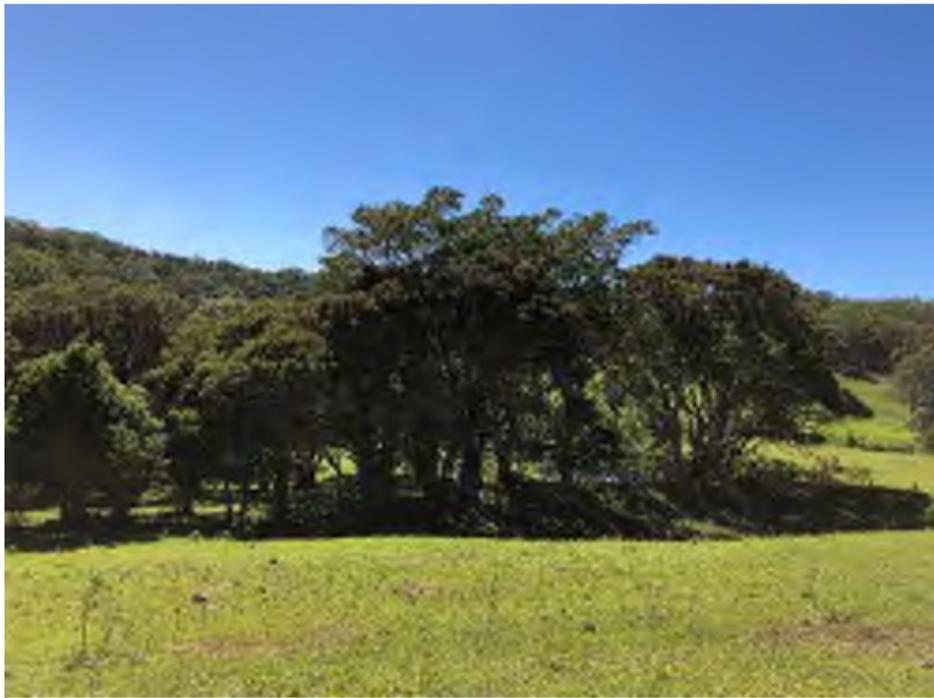
- A dam (named Dame South-East) is located on the eastern part of the site (refer photograph 53). This dam was partly full of water. No signs of seepage were visible down stream. There were minimal signs of erosion.

Photograph 53: View of south eastern section of Area 3.

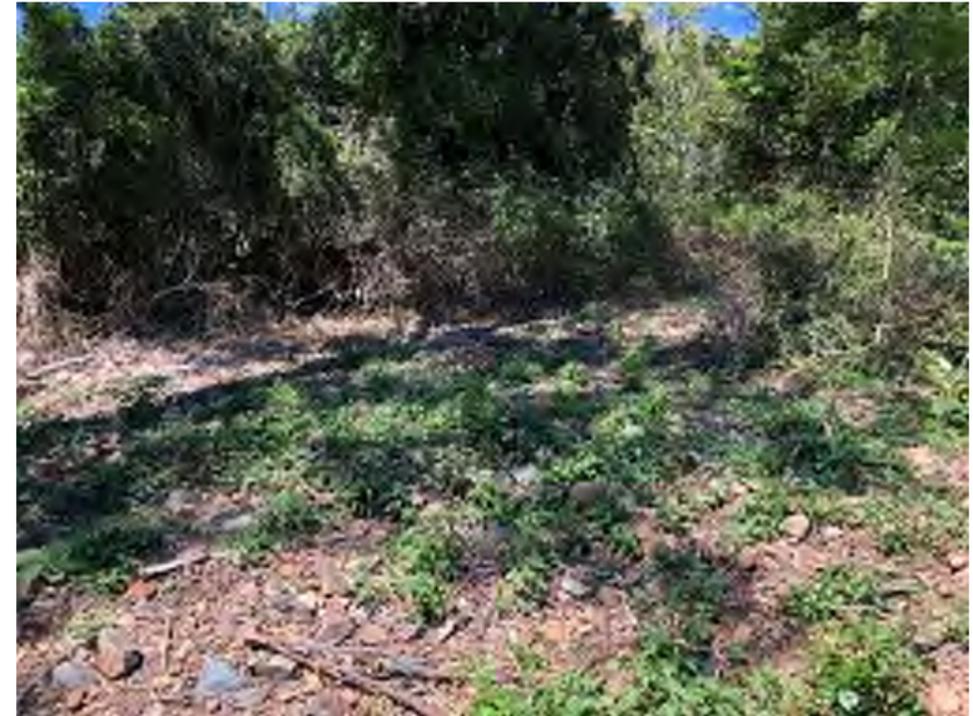
Photograph 54: looking south west up the steep slope of Area 2 from the eastern section of Area 3

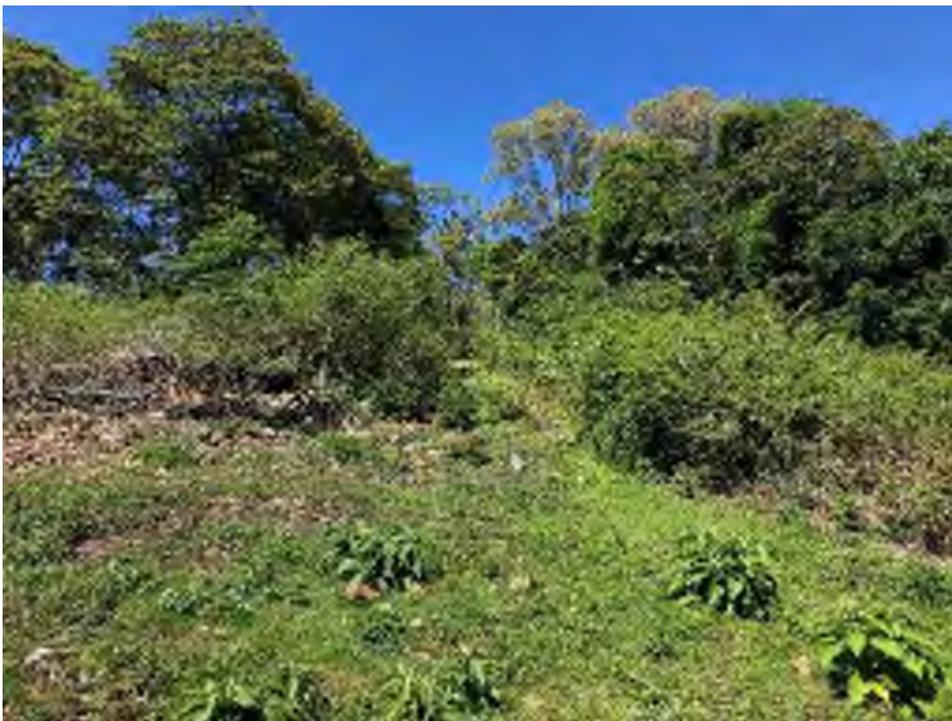
Photograph 55: View looking south from the eastern section of Area 3 up at Area 2. Showing an access track through Area 2 to Terrace 1A
