Residential Subdivision of No. 105 Cooby Road,  
Tullimbar NSW

Report on Preliminary Geotechnical Assessment

Our Ref: TERRA18320.Rep1.Rev1

15 August 2019

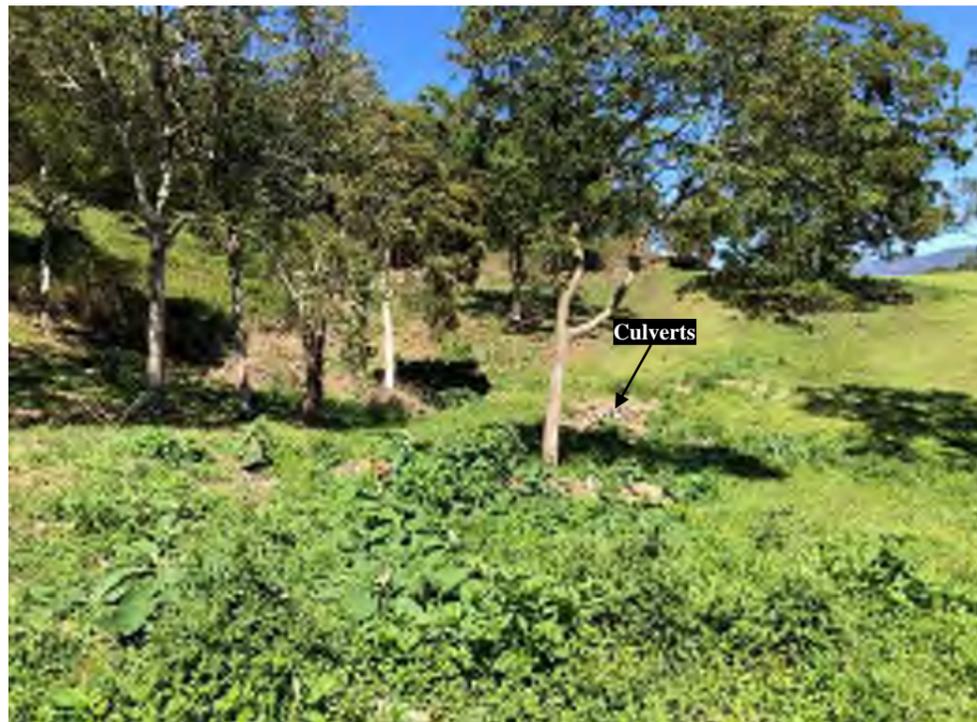
Photograph 57: View looking south west in Area 3 looking toward the culverts under the farm road

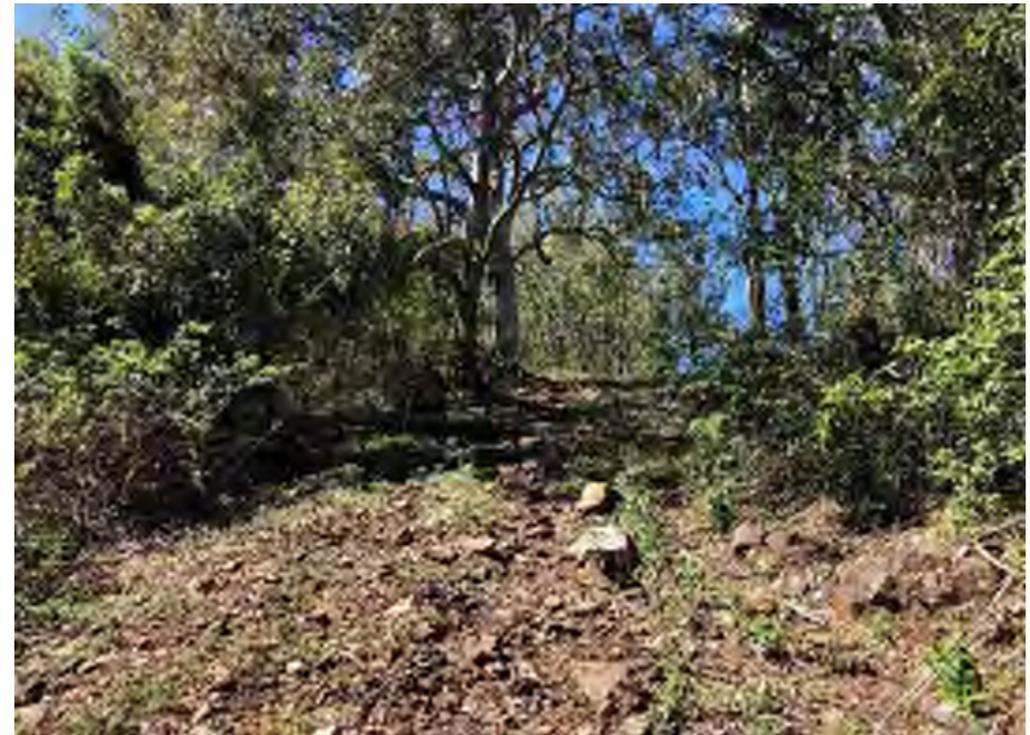
Photograph 58: looking south up an access track from area 3 up through Area 2 to Terrace 1A

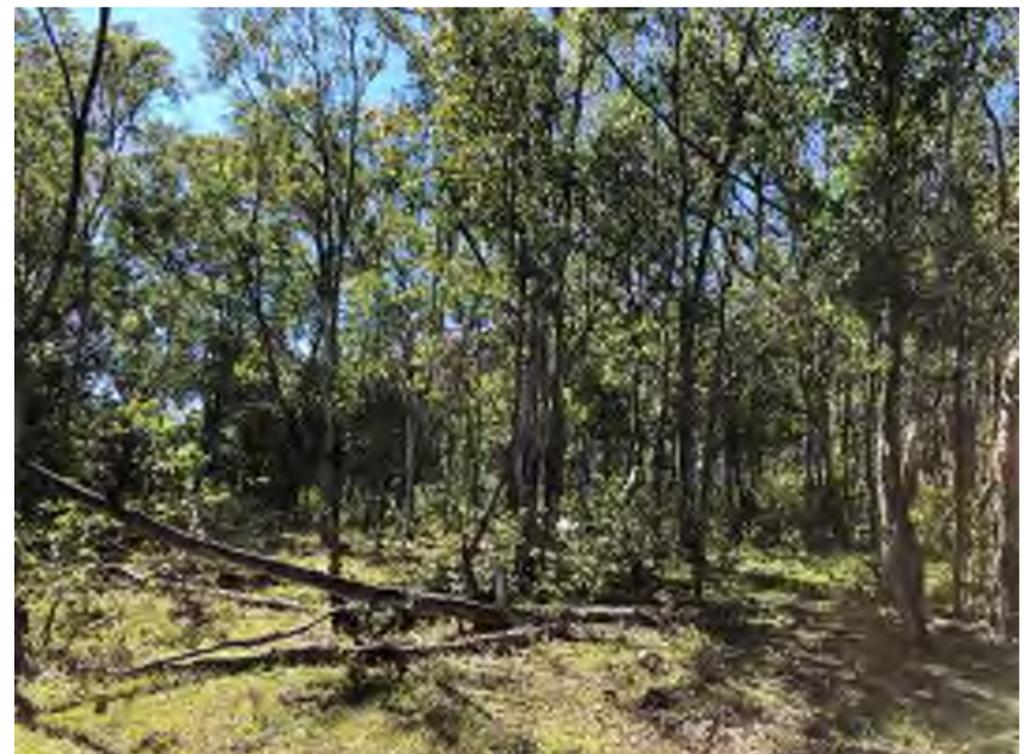
Photograph 60: looking east from the boundary between Area 2 and Terrace 1A

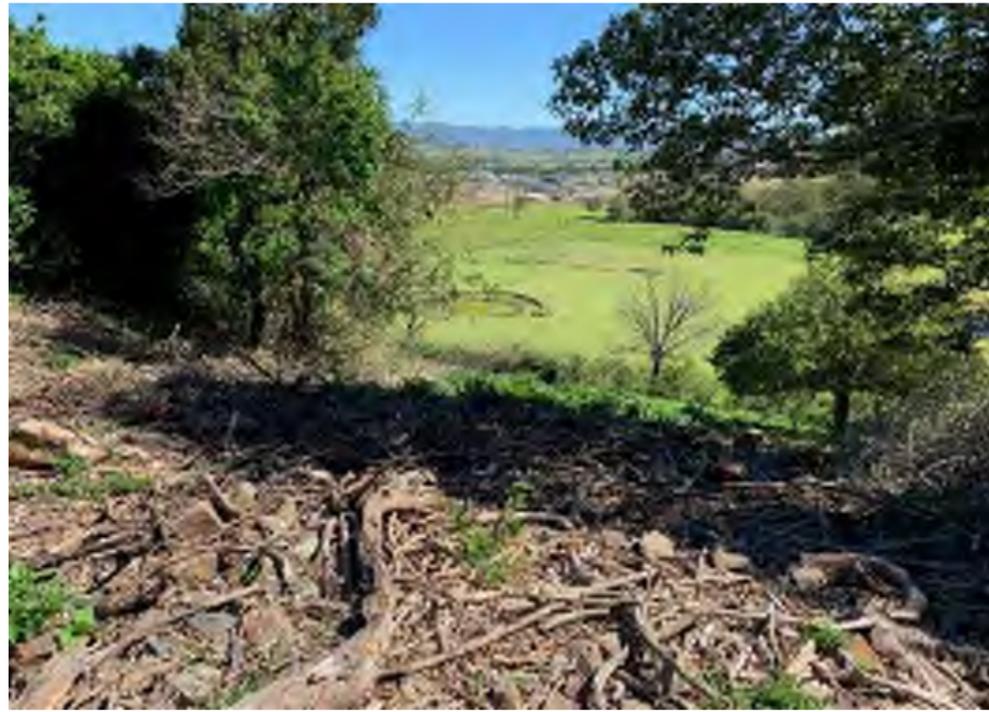
Photograph 61: View from the top of Zone 4 looking down the western slope

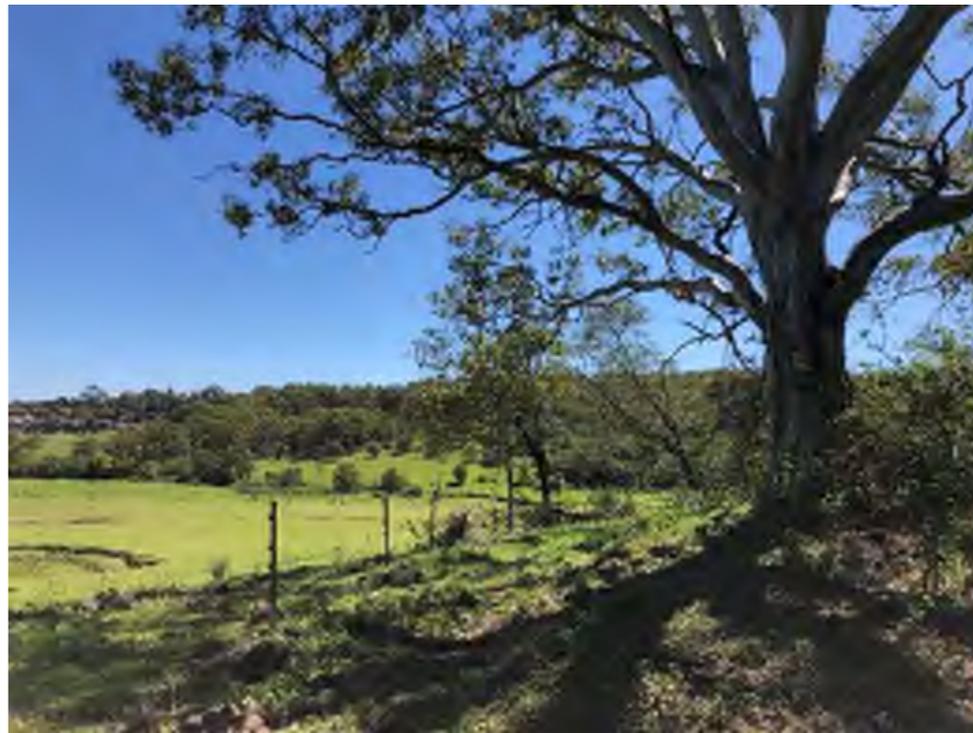
Photograph 63: View looking east at the northern side of Area 4

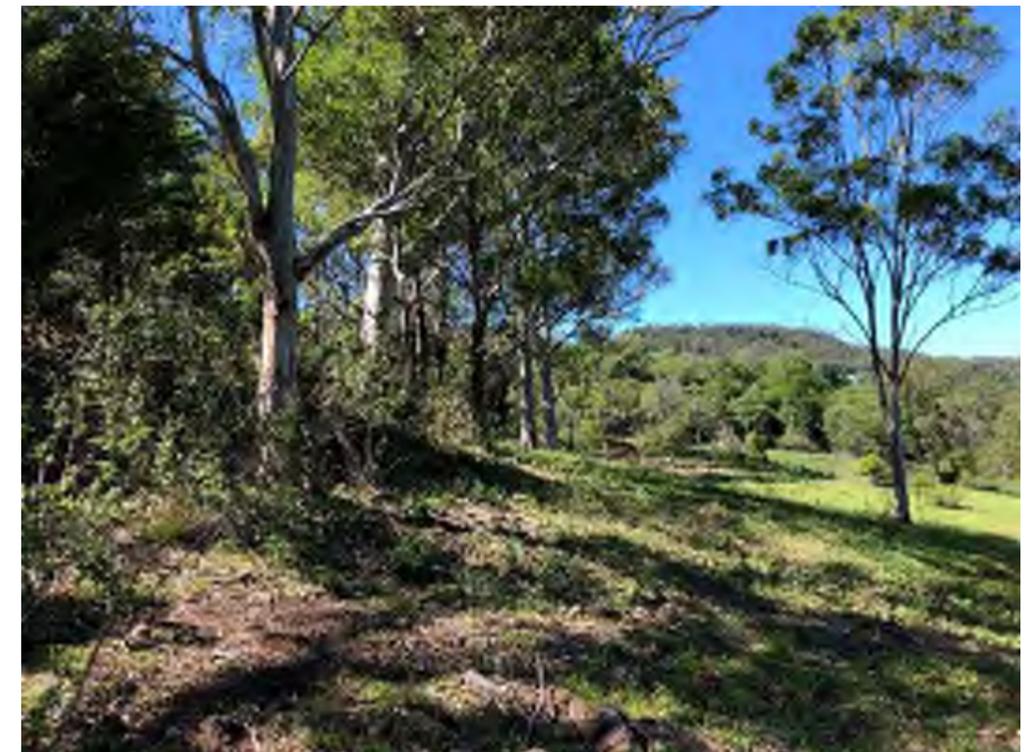
Photograph 64: Looking south down the western side of Area 4
