Report on  
Stability Assessment

Proposed Residential Subdivision  
South Creek West, Precinct 5, Cobbitty

Prepared for  
JJ Cobbitty Development Pty Ltd

Project 92225.06  
October 2025

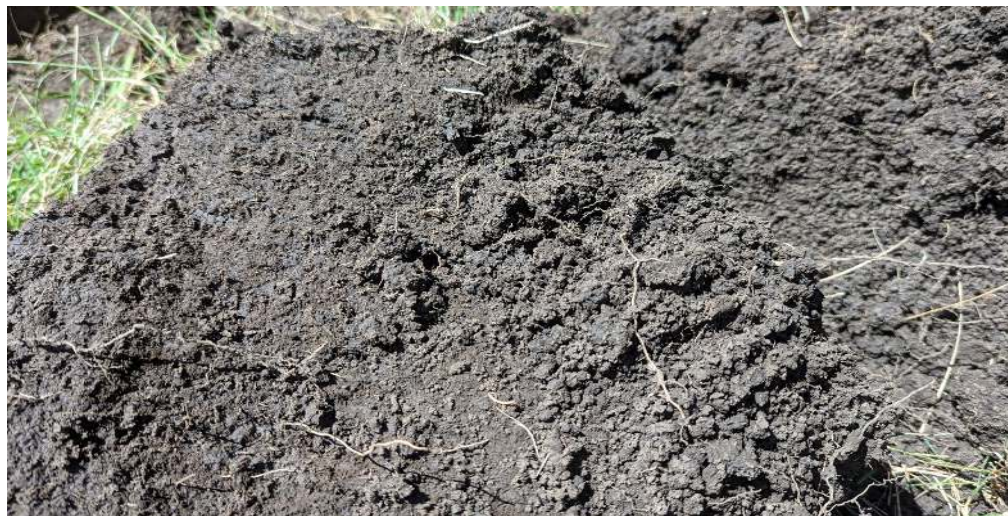
Photo 5 - View of inferred colluvial spoil from Test Pit 303

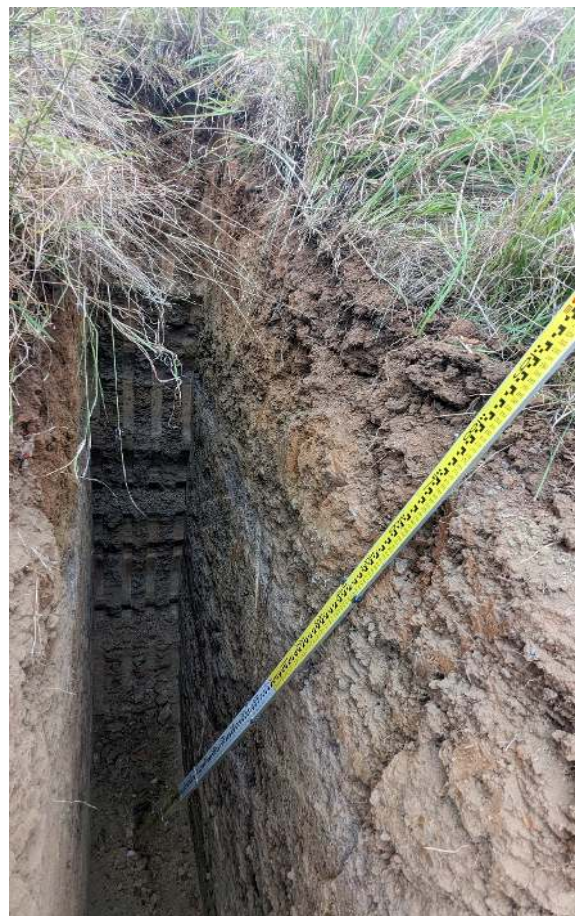
Photographs 8 and 9 - View of side and end of Test Pit 305

**REMARKS:** Grass cover at the surface. Located upslope of a nearby dam

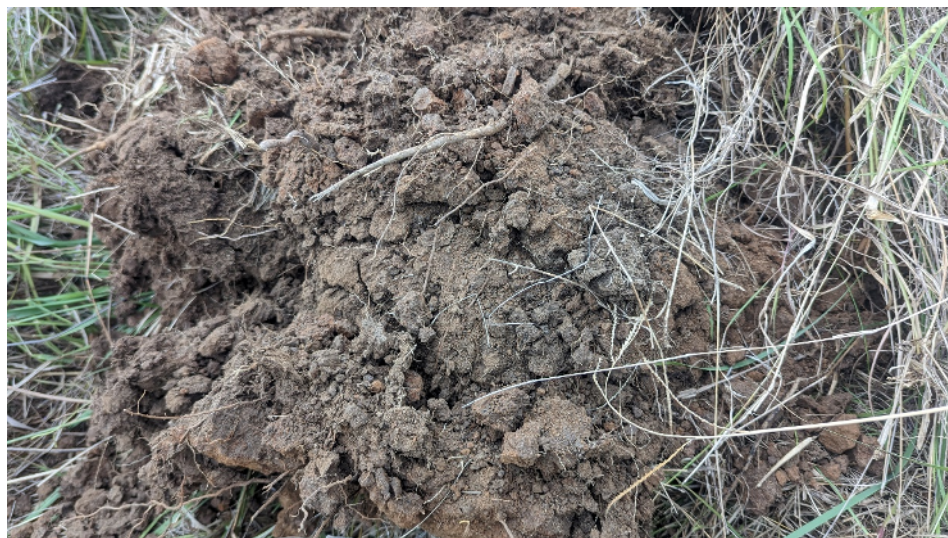
Photo 10 - View of inferred colluvial spoil from Test Pit 305

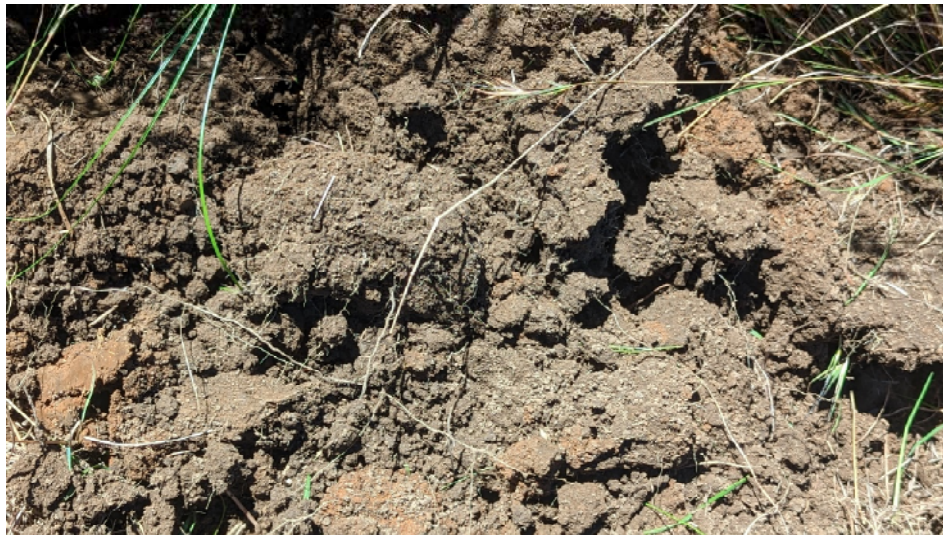
Photo 18 - inferred colluvial spoil from Test Pit 309

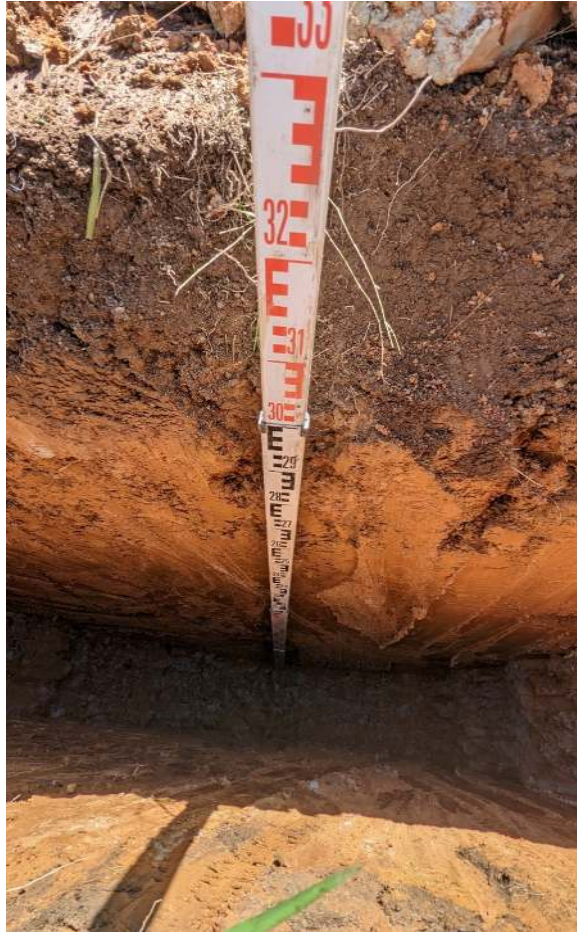
Photo 29 - View of side of Test Pit 316

**REMARKS:** Grass cover at the surface. Topsoil layer appears disturbed by past farming activity

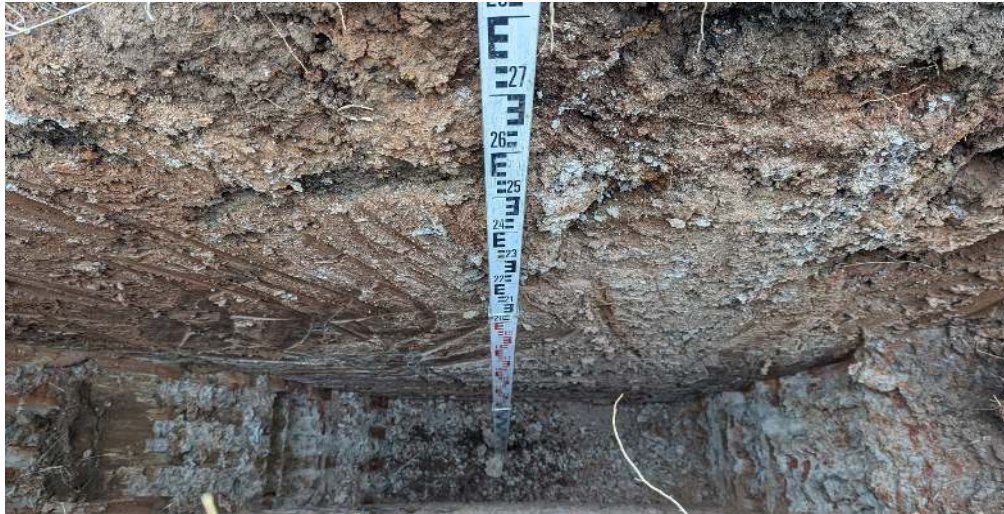
Photo 35 - View of side of Test Pit 320

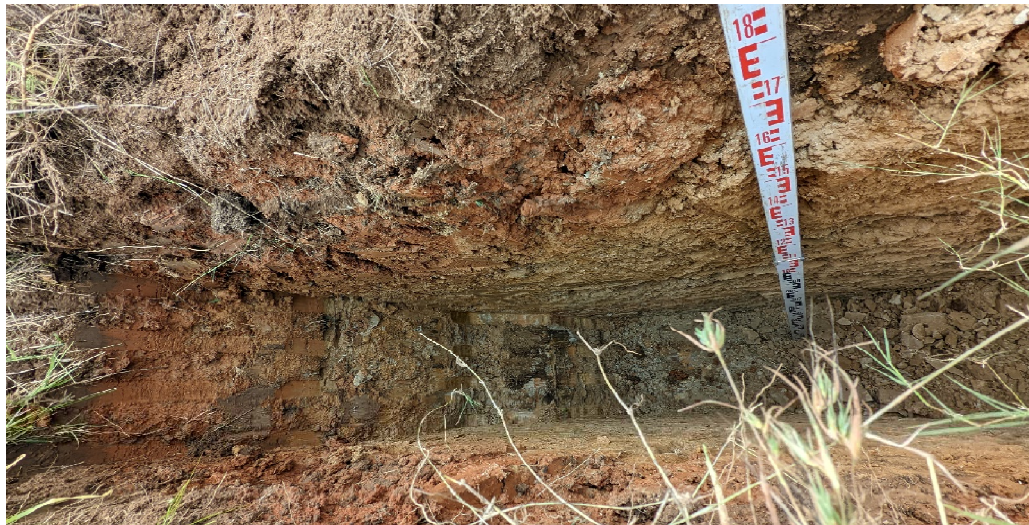
Photo 37 - View of side and end of Test Pit 321 (oblique view)

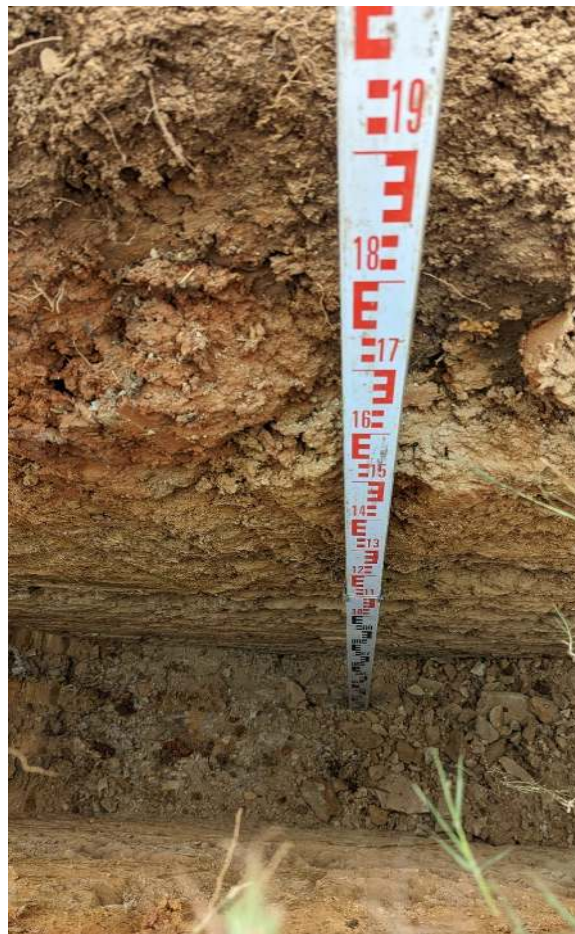
Photo 38 - View of side of Test Pit 321

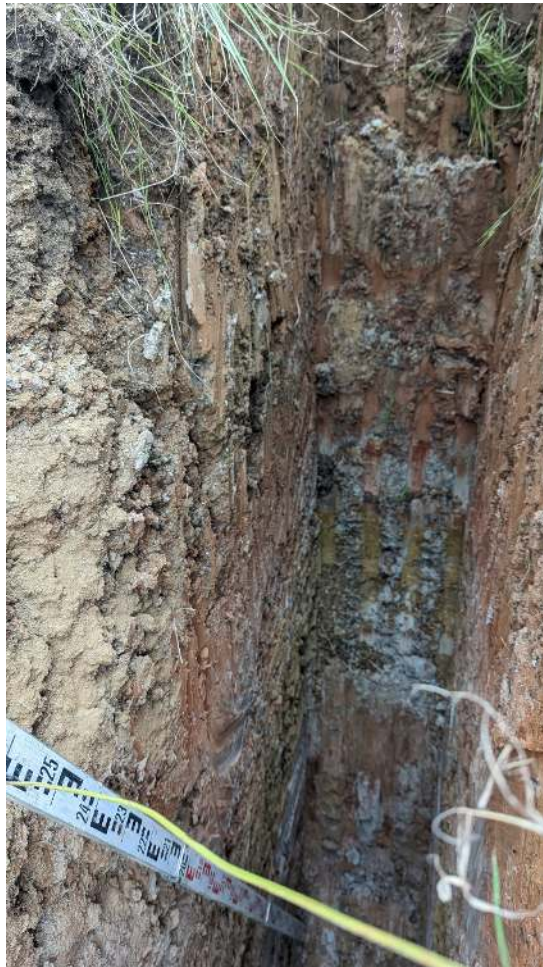
Photo 39 - View of end of Test Pit 322

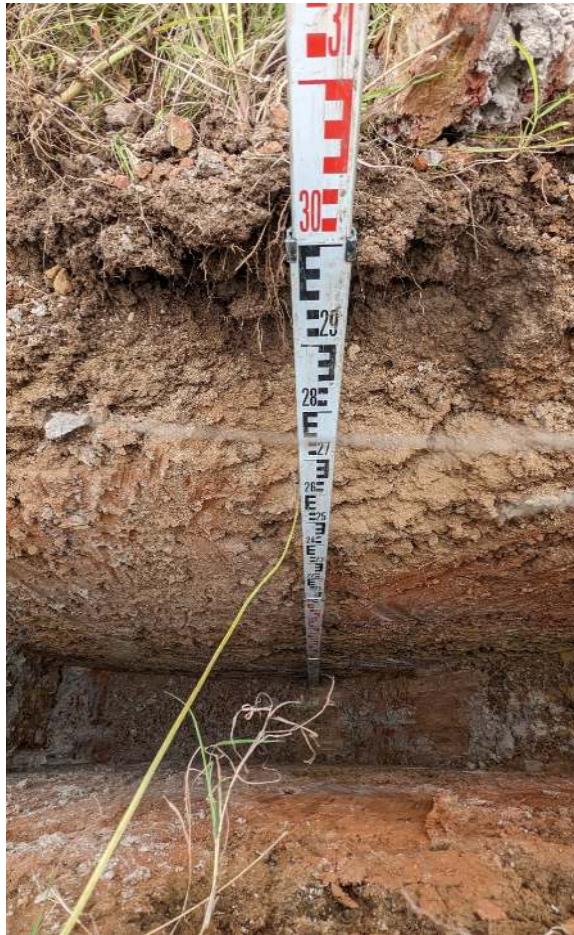
Photo 40 - View of side of Test Pit 322

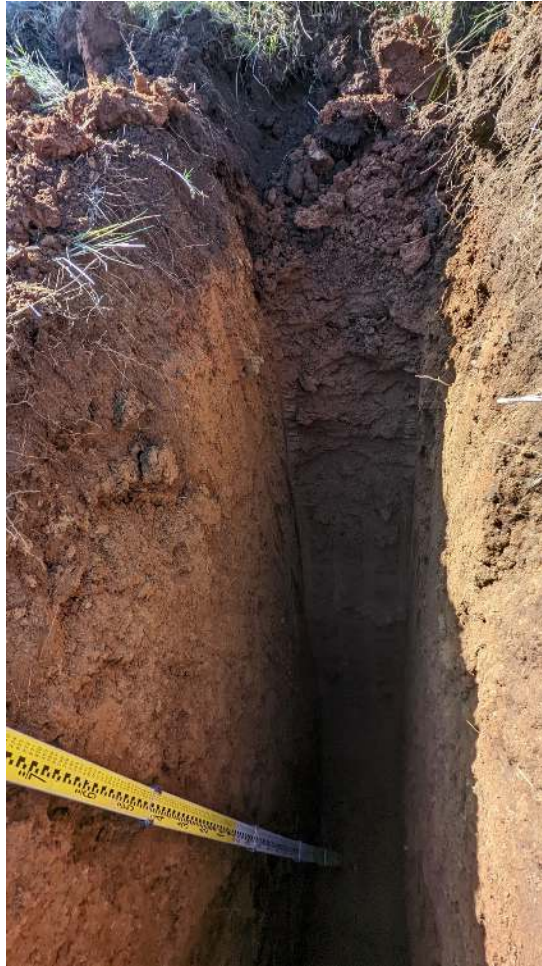
Photo 41 - View of end of Test Pit 323

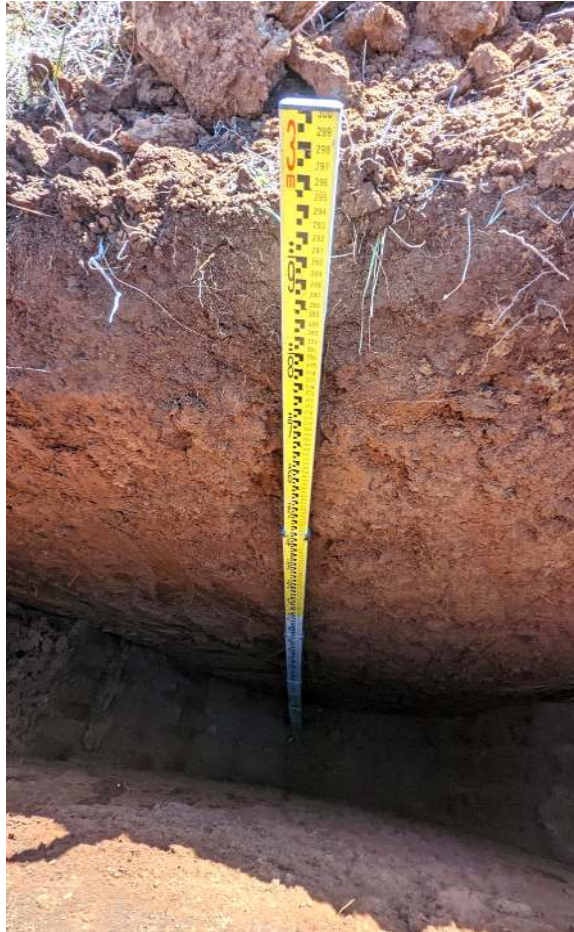
Photo 42 - View of side of Test Pit 323
