Report on
Preliminary Site Investigation

Proposed Appin (Part) Precinct
Appin, NSW

Prepared for
Walker Corporation Pty Ltd

Project 76589.06
October 2022

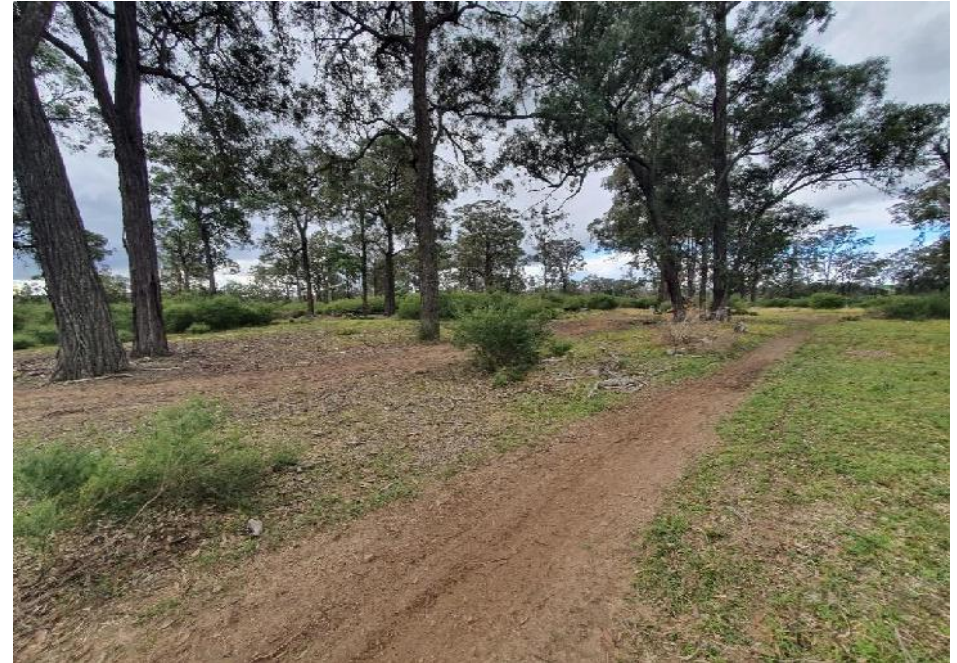
- Several informal dirt bike tracks were noted throughout the site (MRP 2; plate 2).
- An underground water system linking water troughs was present on some portions of the site. These pipe networks are sometimes known to be made of asbestos cement, this was not confirmed during the inspection.

Photo 2 - MX Track (MRP2)

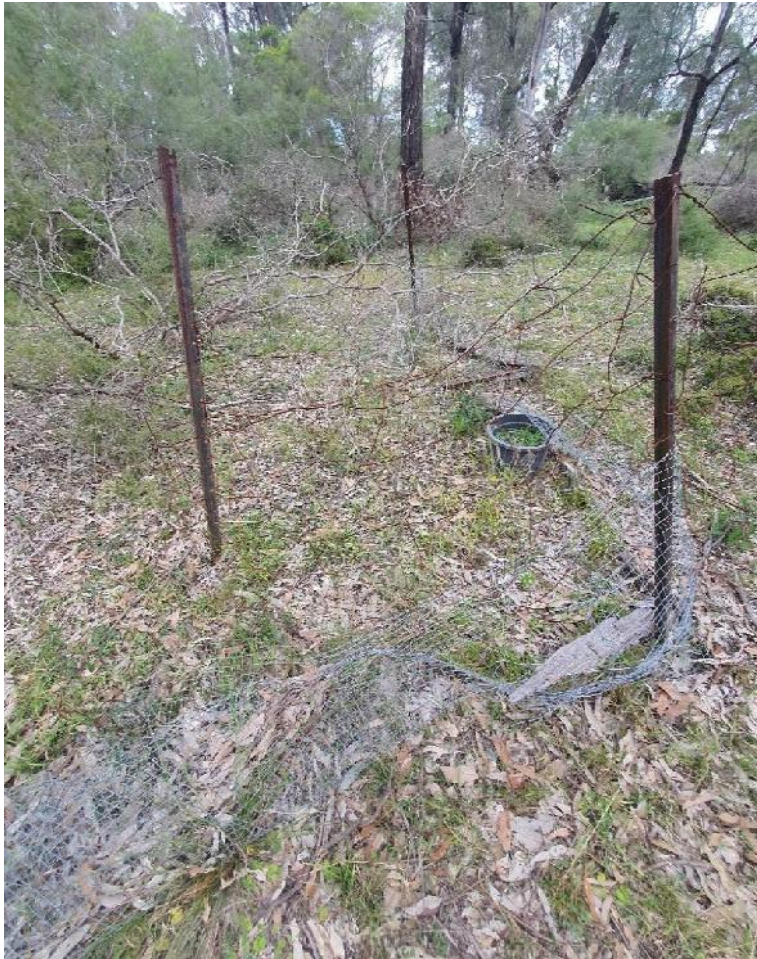
Photo 3 - Fenced Off Area (MRP3)

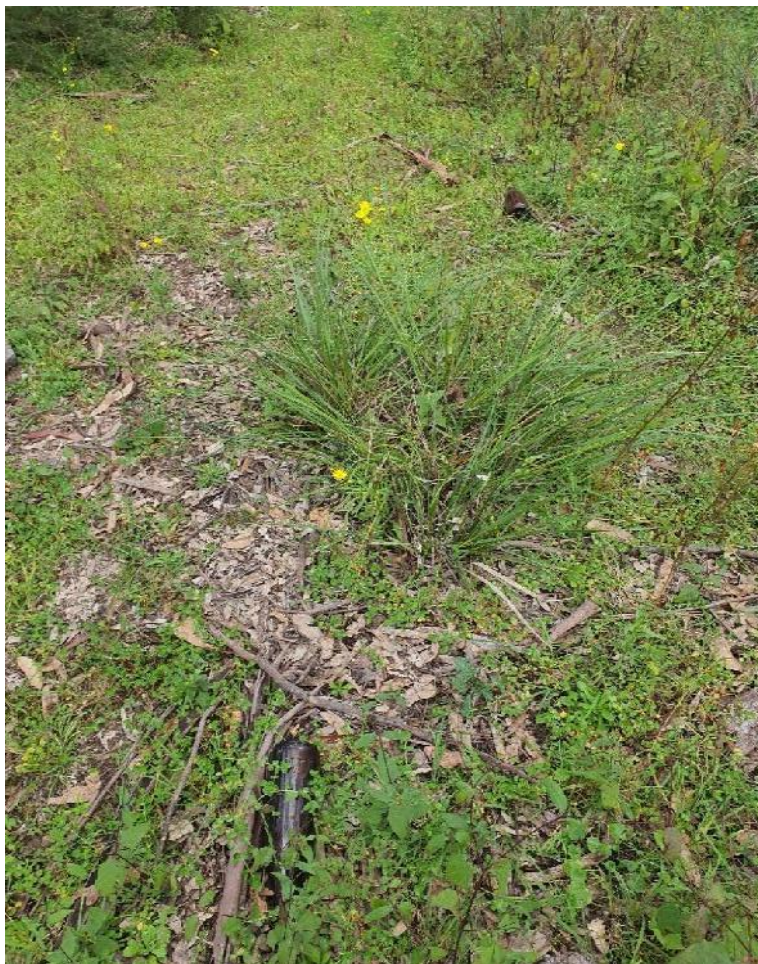
- Localised dumping was observed in some gullies and areas of the site which had not been secured, such as along the western portion near the Nepean River (MRP 5; plate 5, MRP12; plates 13 and 14, MRP 15 and 6; plates 17 to 21, MRP 45; plate 52) and to the rear (southern end) of lots on the eastern side of Macquariedale Road (MRP 51; plate 58, MRP 54; plates 61 and 62, MRP 56; plate 64).

Photo 5 - Lots of Bottles and Occasional Refuse (MRP5)

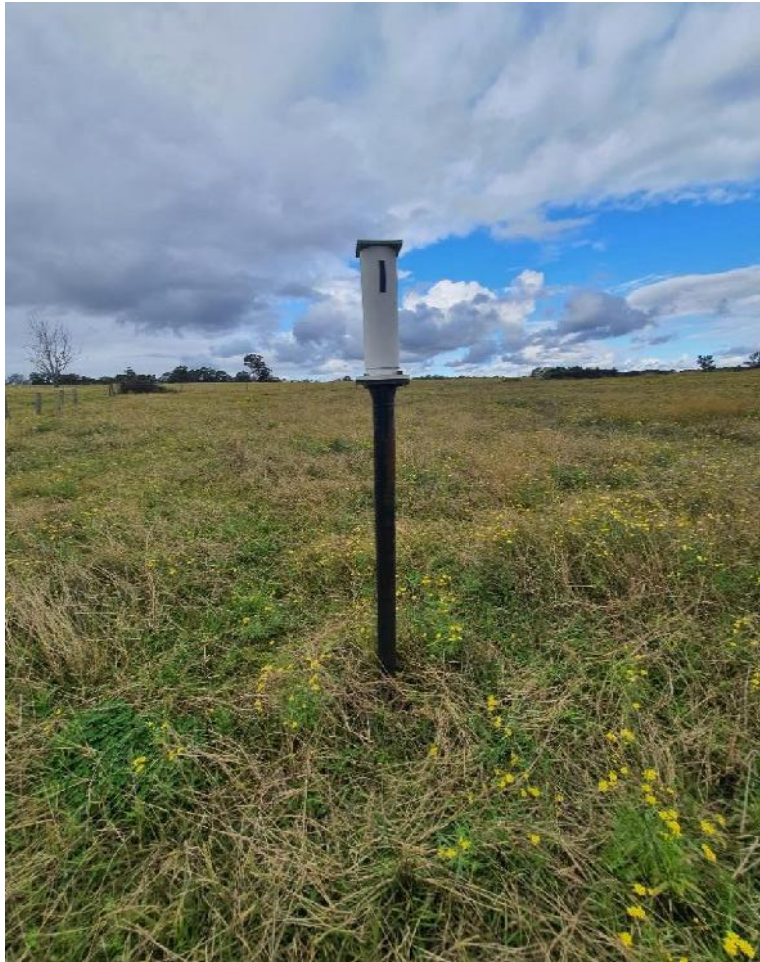
- Three monitoring bores belonging to BHP Billiton or South32 were observed on this portion of the site (MRP 8; plates 8 and 9, MRP28; plate 33 and MRP 53; plate 60).

Photo 9 - BHP Monitoring Bore (MRP8)

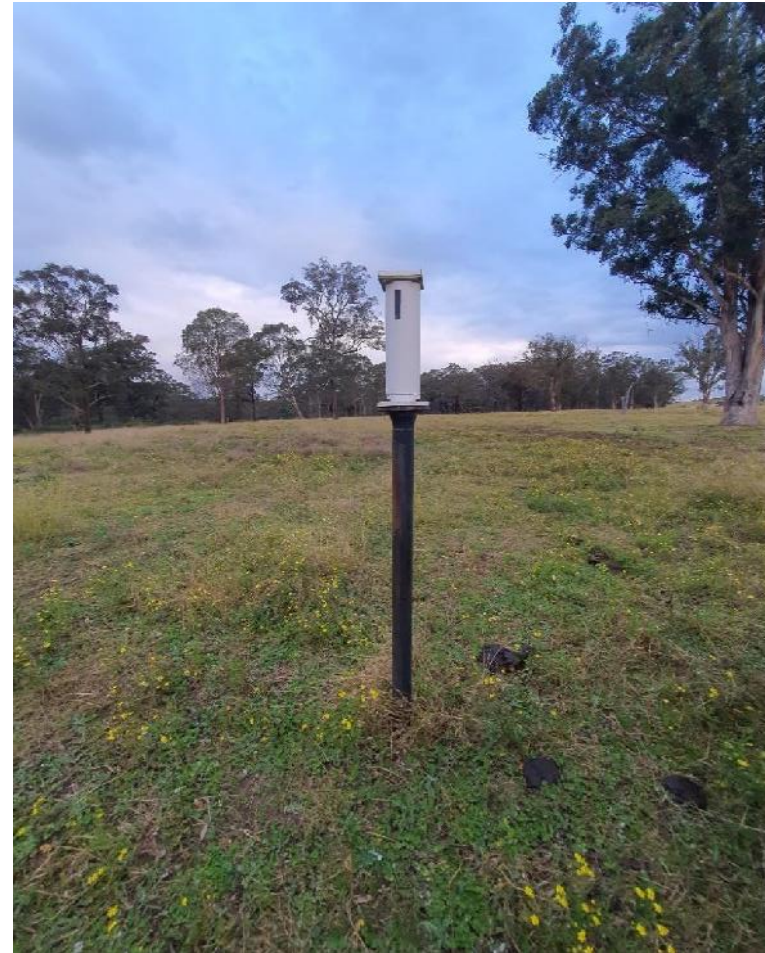
Photo 10 - BHP Monitoring Bore (MRP10)

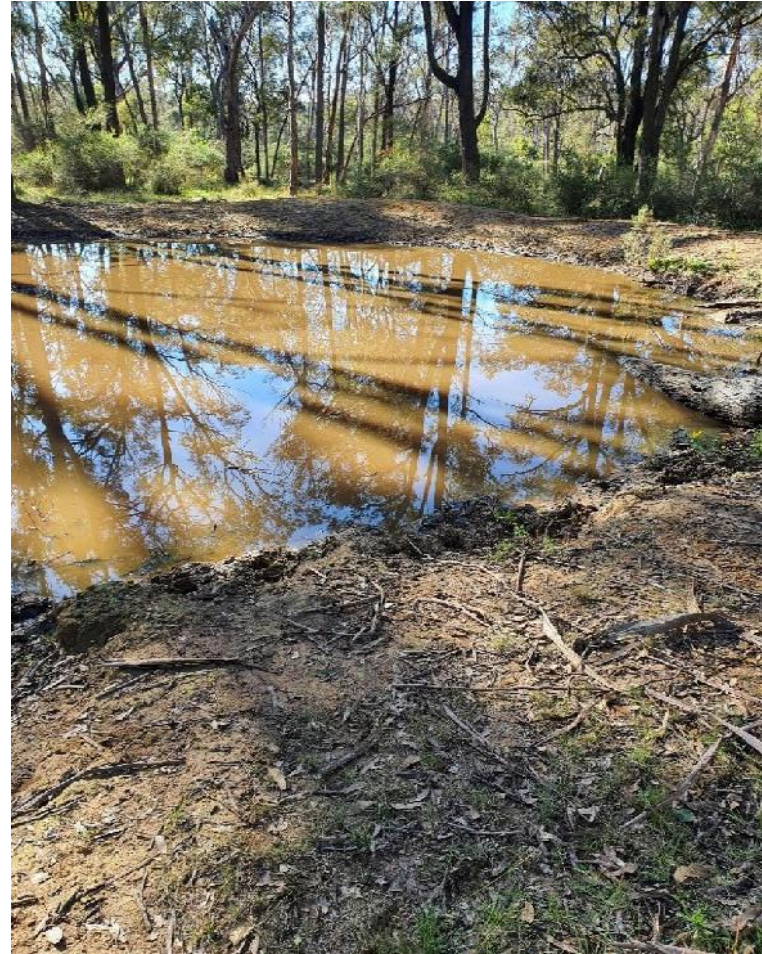
Photo 12 - Dam (MRP11)

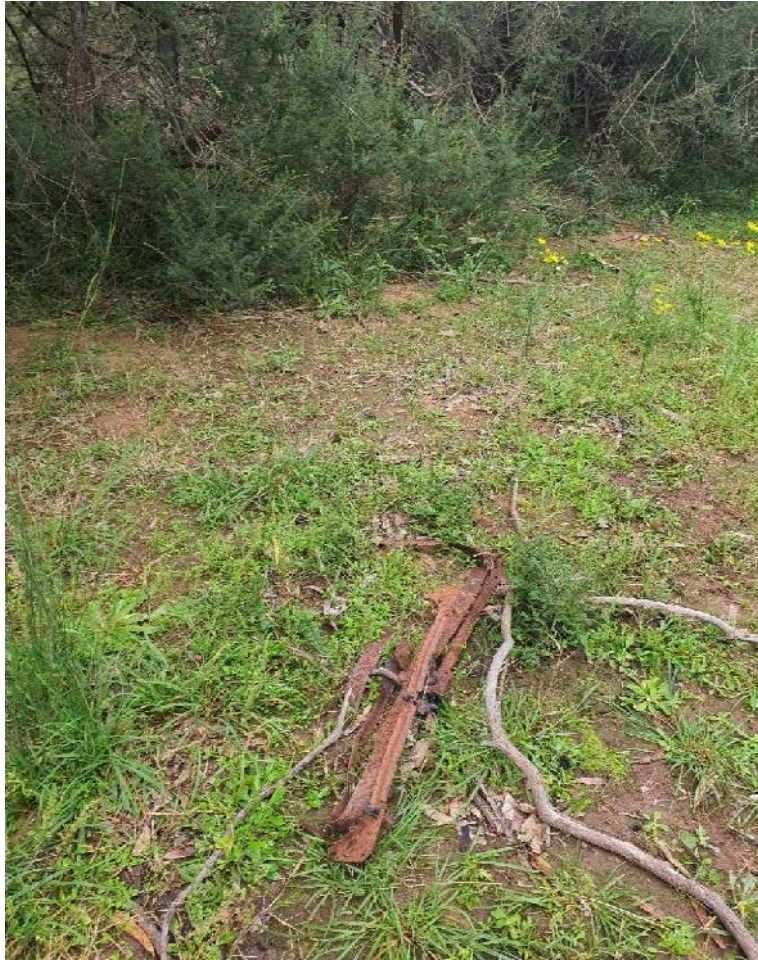
Photo 13 - Minor Refuse (MRP12)

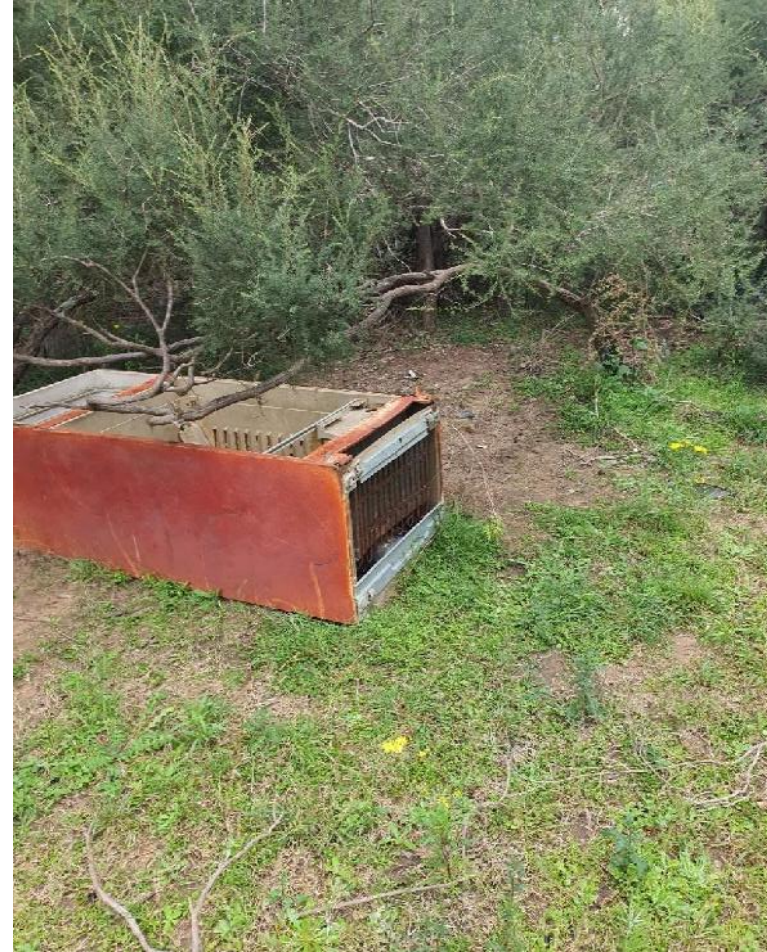
Photo 14 - Minor Refuse (MRP12)

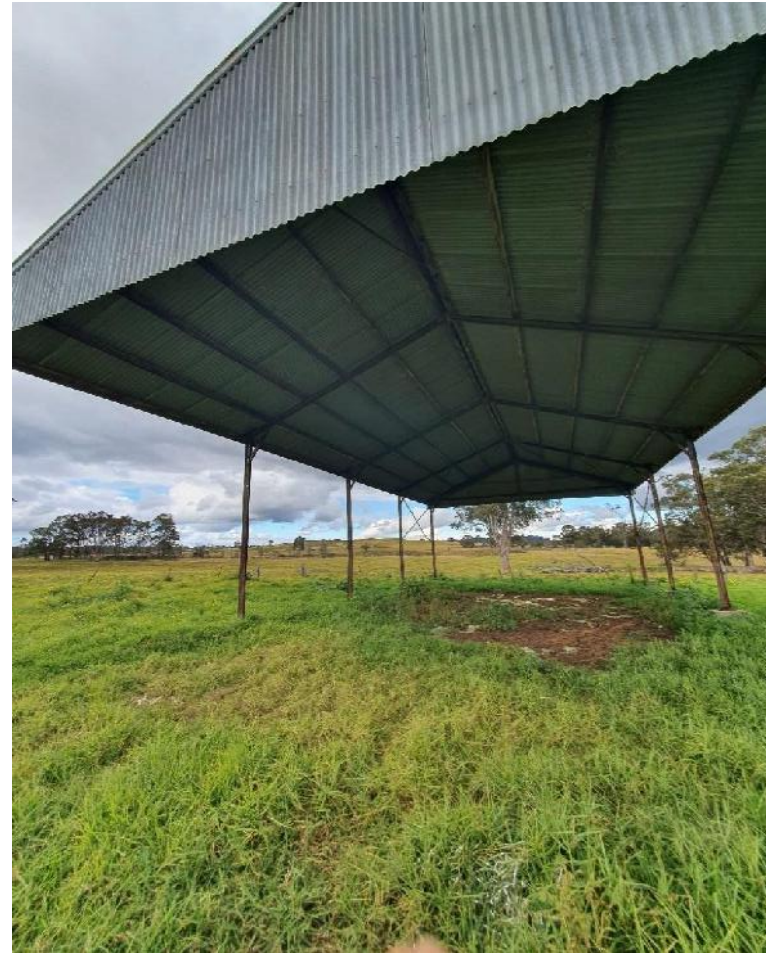
Photo 16 - Shed (MRP14)

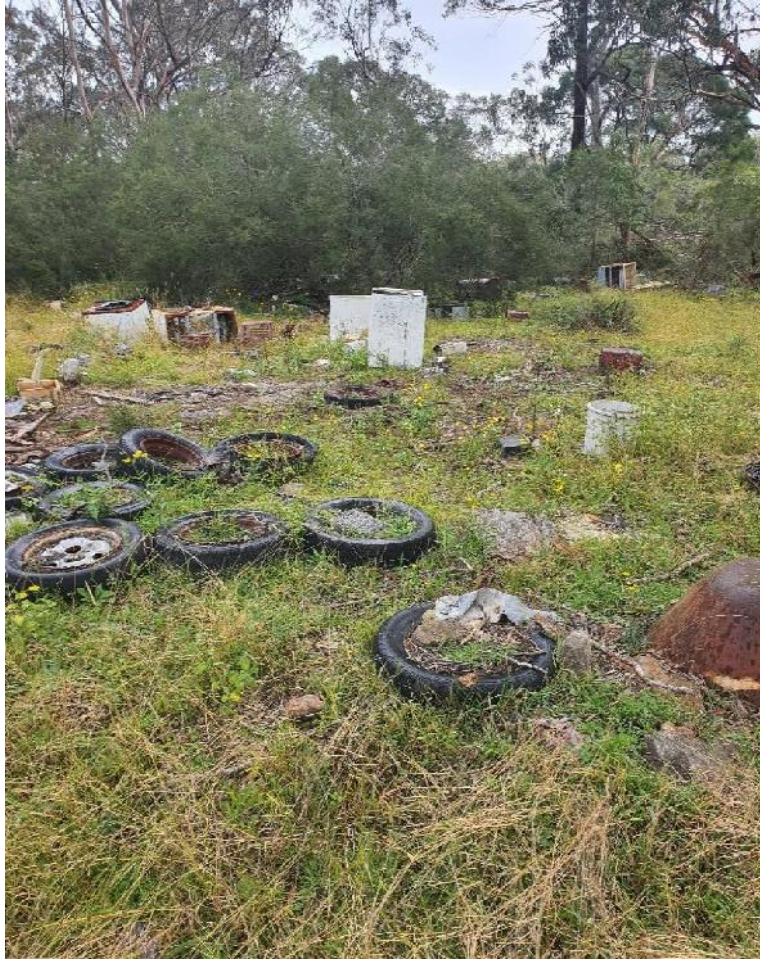
Photo 17 - Refuse (MRP15)

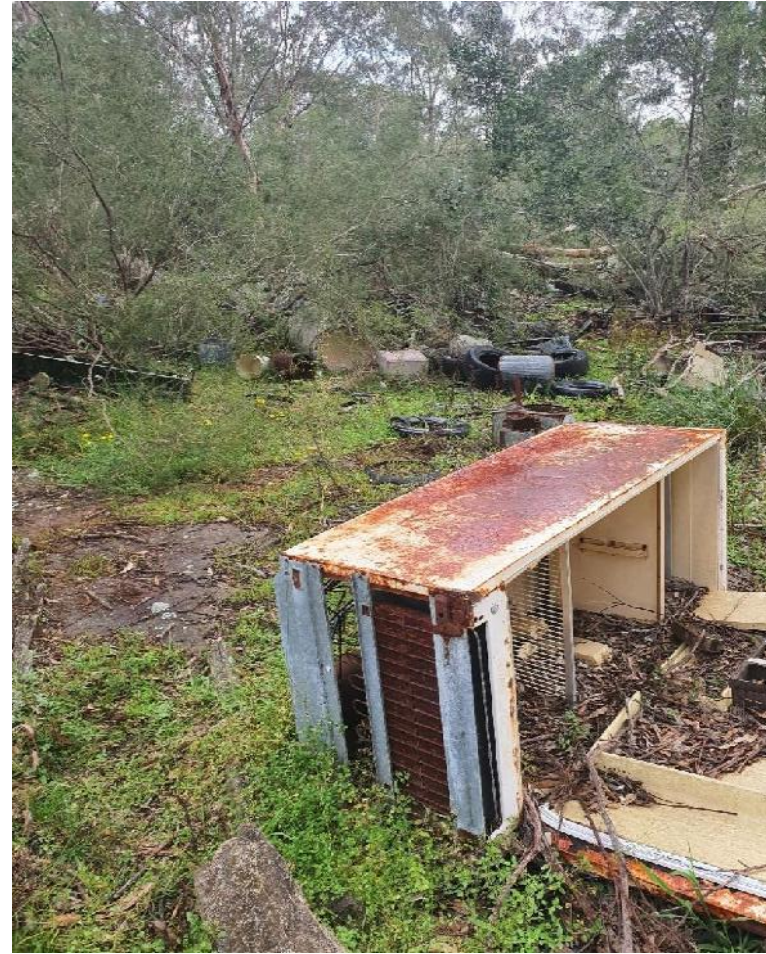
Photo 18 - Refuse (MRP15)

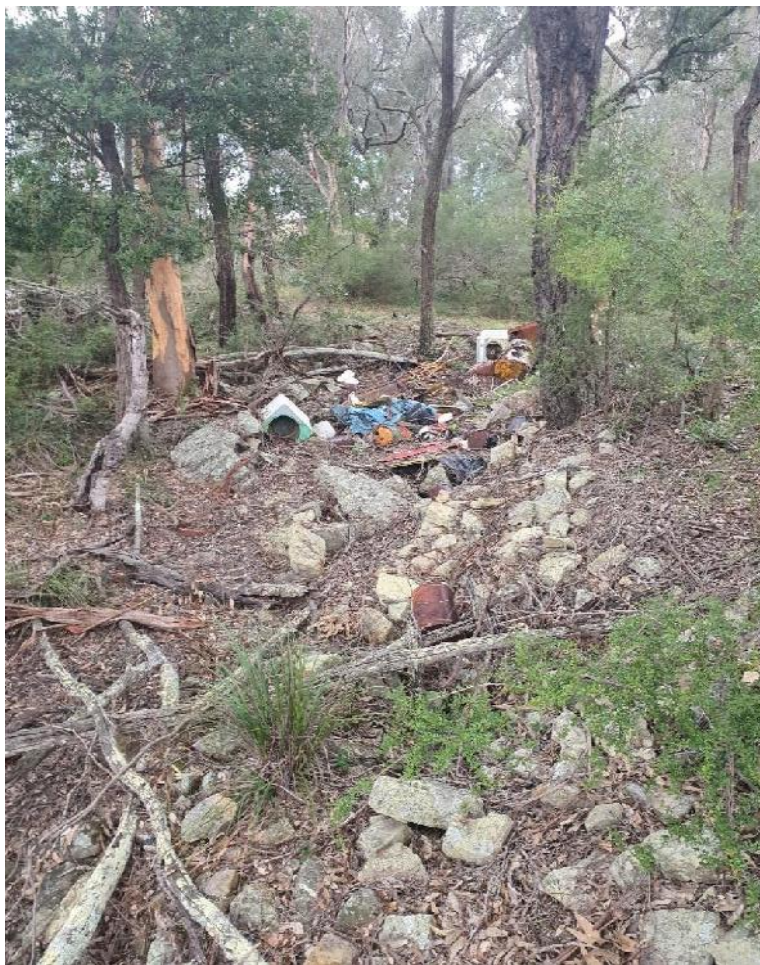
Photo 19 - Refuse (MRP16)

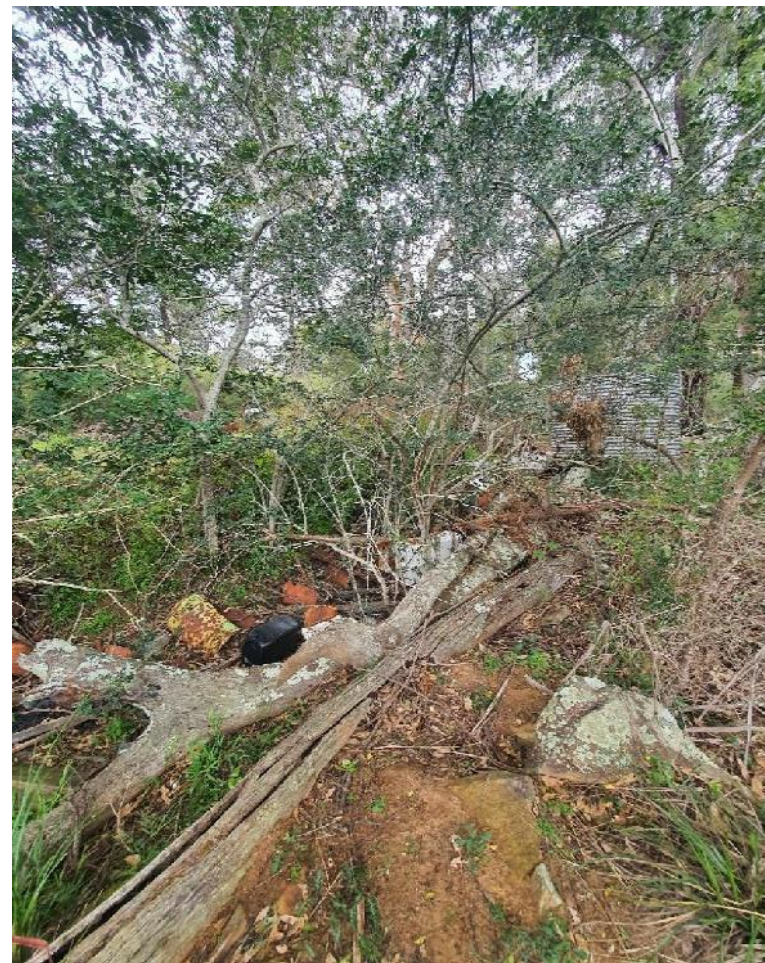
Photo 20 - Refuse (MRP16)

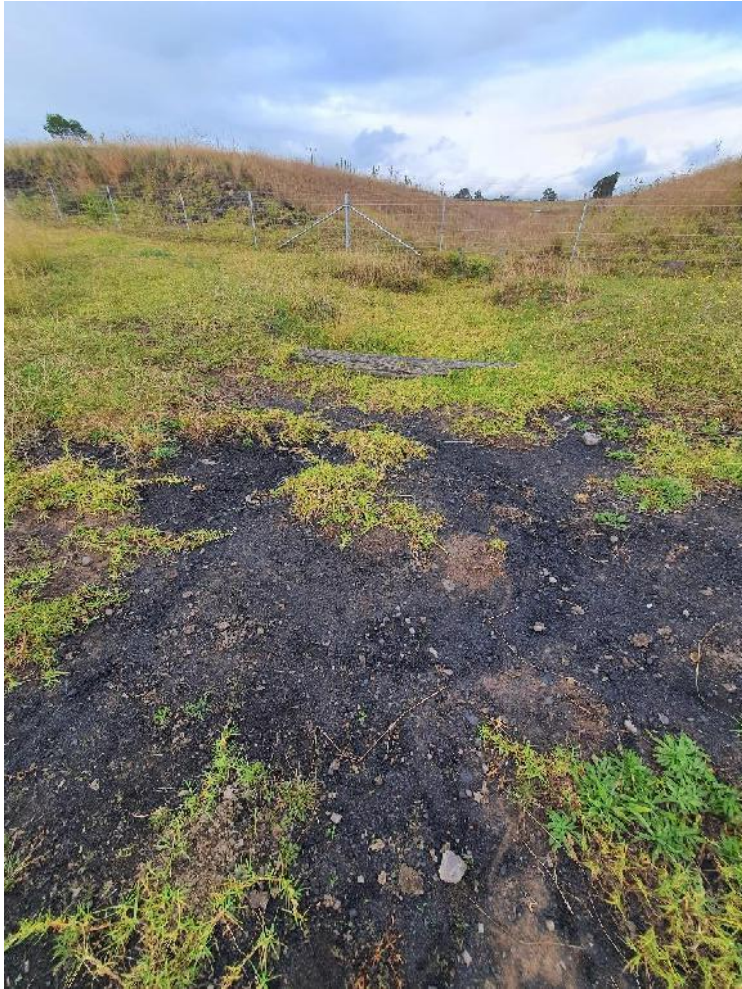
Photo 23 - Coalwash (MRP19)

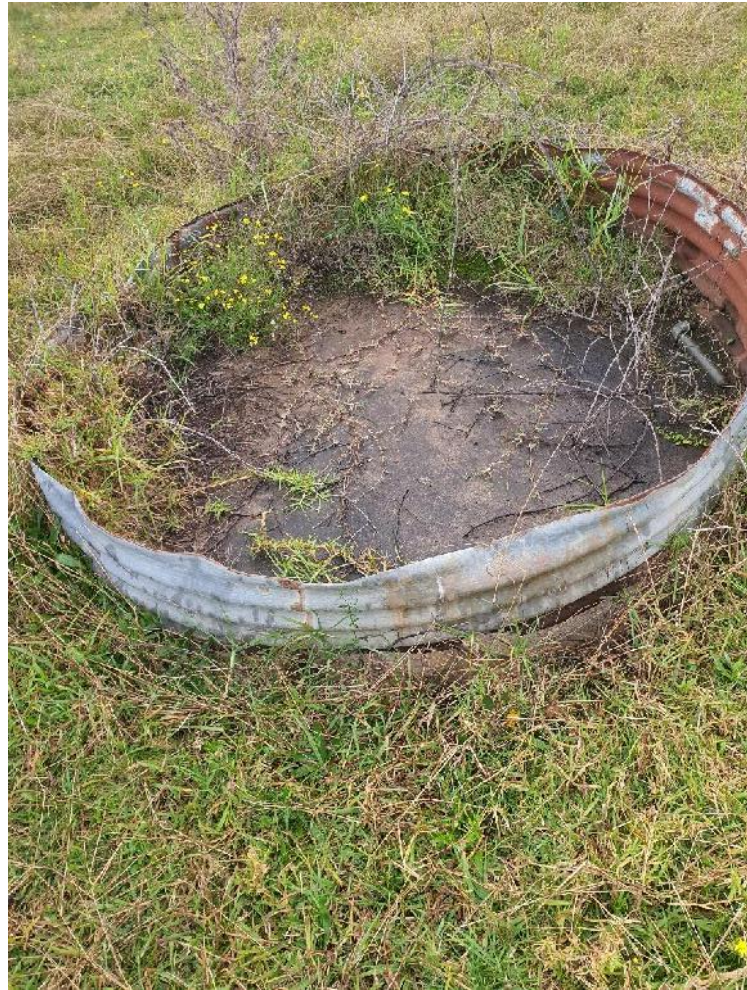
Photo 25 - Trough (MRP22)

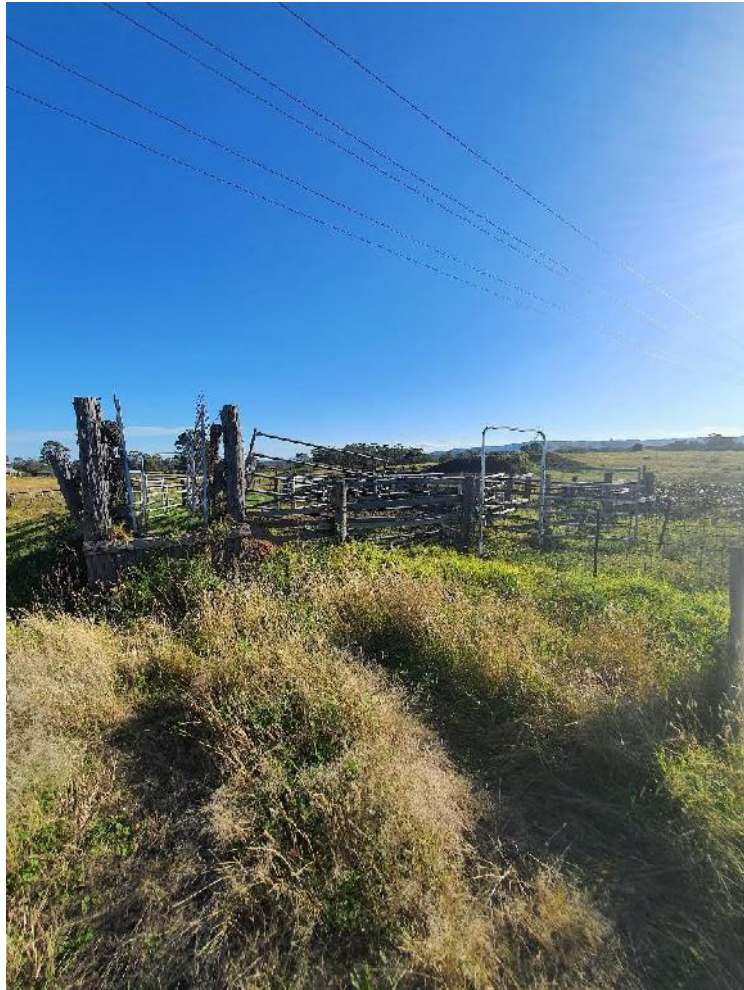
Photo 31 - Cattle Yards (MRP26)

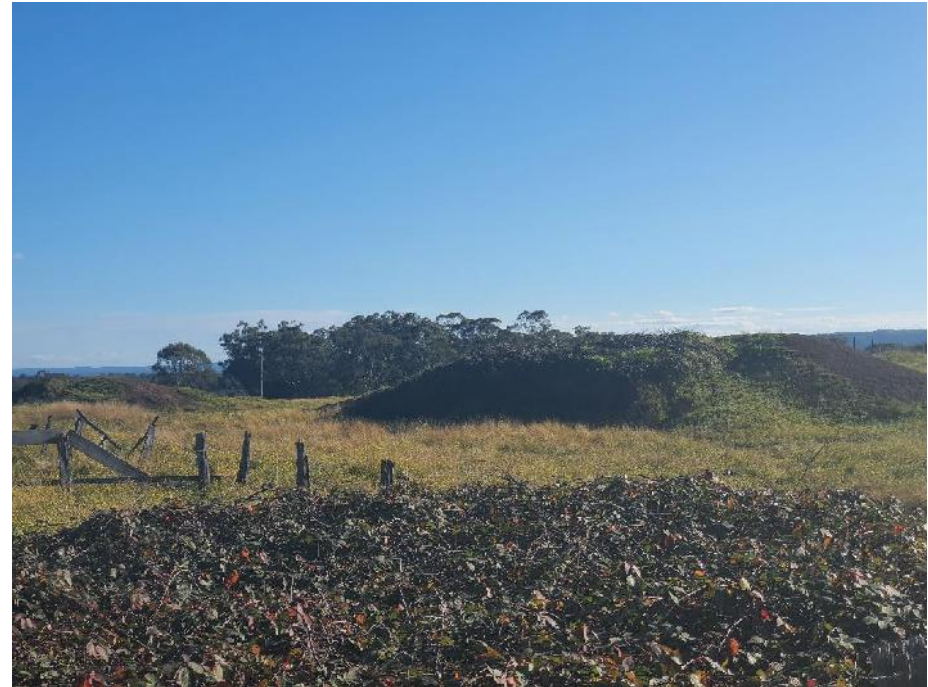
- Stockpiles and small mounds were occasionally observed such as next to the USC (MRP27; plate 32) and to the rear (north) of lots north east of Macquariedale Road (MRP40 to 44; plates 45 to 51). Minor fill mounds were observed at MRP 55 (plate 63) located in the south eastern part of this portion of the site. Building rubble was observed north of Macquariedale Road, near the USC (MRP 24; plates 27 to 29) and minor building rubble was observed on the north east portion at MRP (plate 39). A small sand stockpile was noted on a lot on the northern side of Macquariedale Road (MRP 39).
- Small areas of coal wash material was observed on the ground surface near the USC, at MRP 19 (plate 23).
- Several large stockpiles were observed at the intersection of Macquariedale Road and the USC.

Photo 32 - Stockpiles (MRP27)

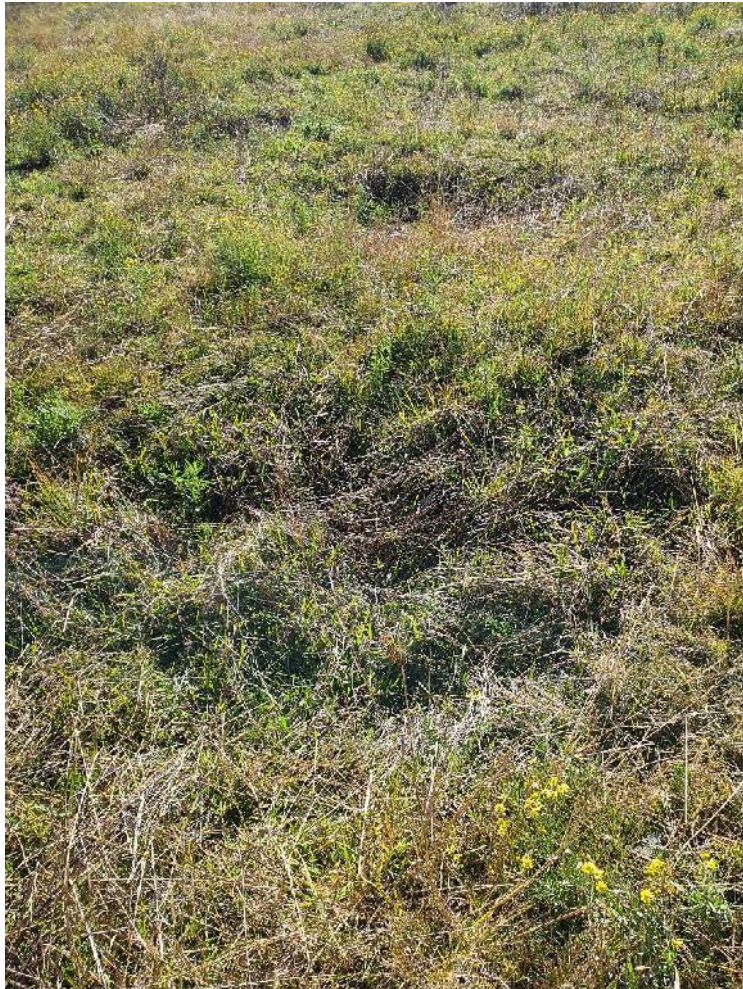
- An area of possible livestock burial was observed in the northern portion (MRP30; plate 35).

Photo 35 - Livestock Burial (MRP30)

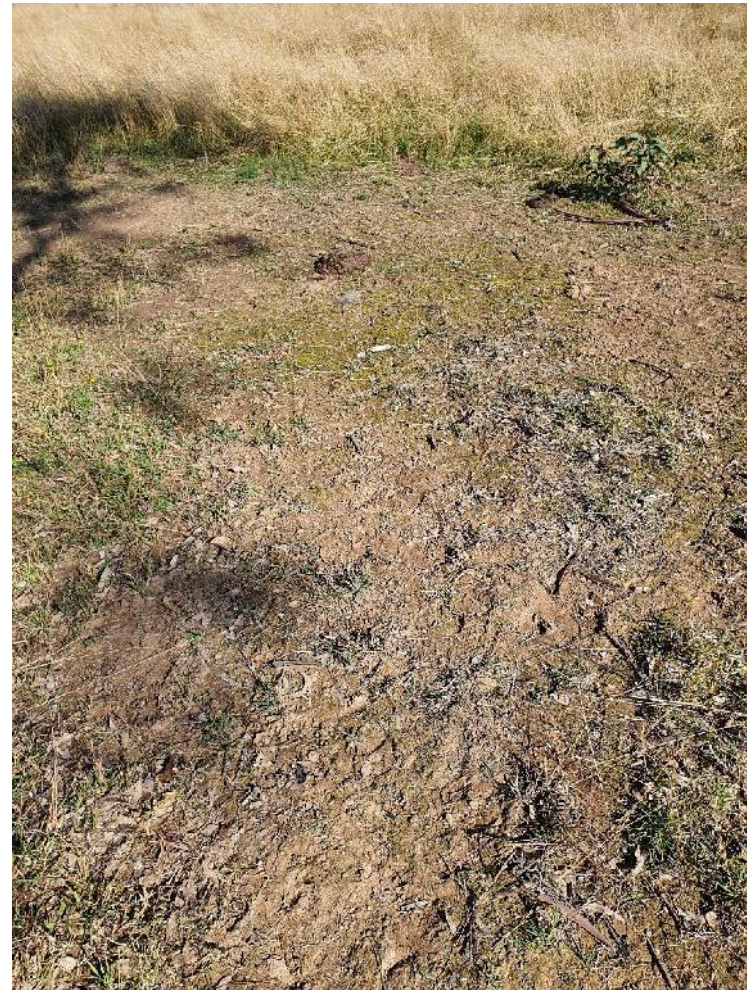
Photo 40 - Bare Eath (MRP34)

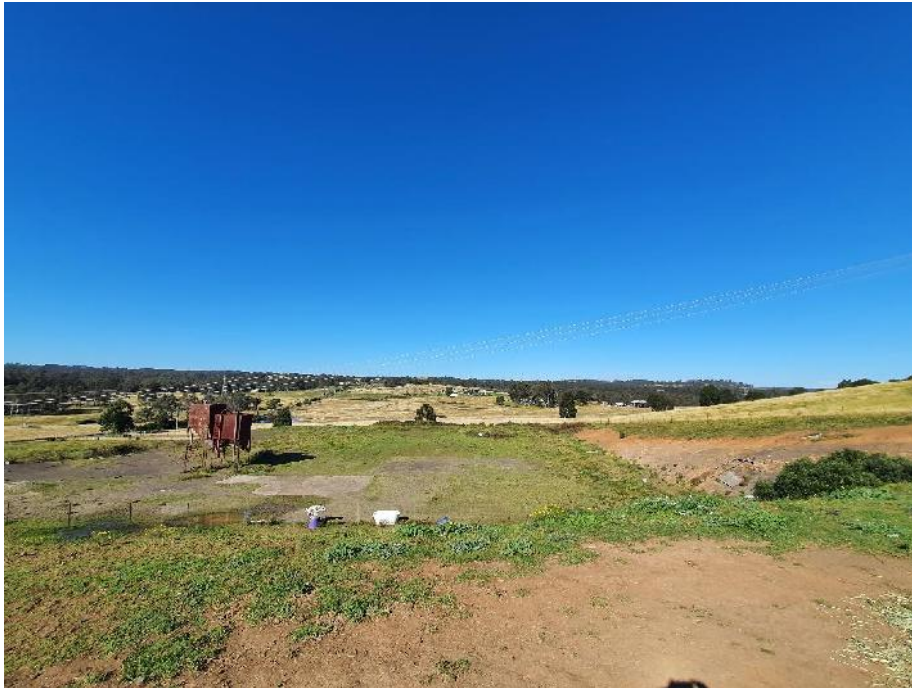
Photo 41 - Quarry and Fill (MRP35)

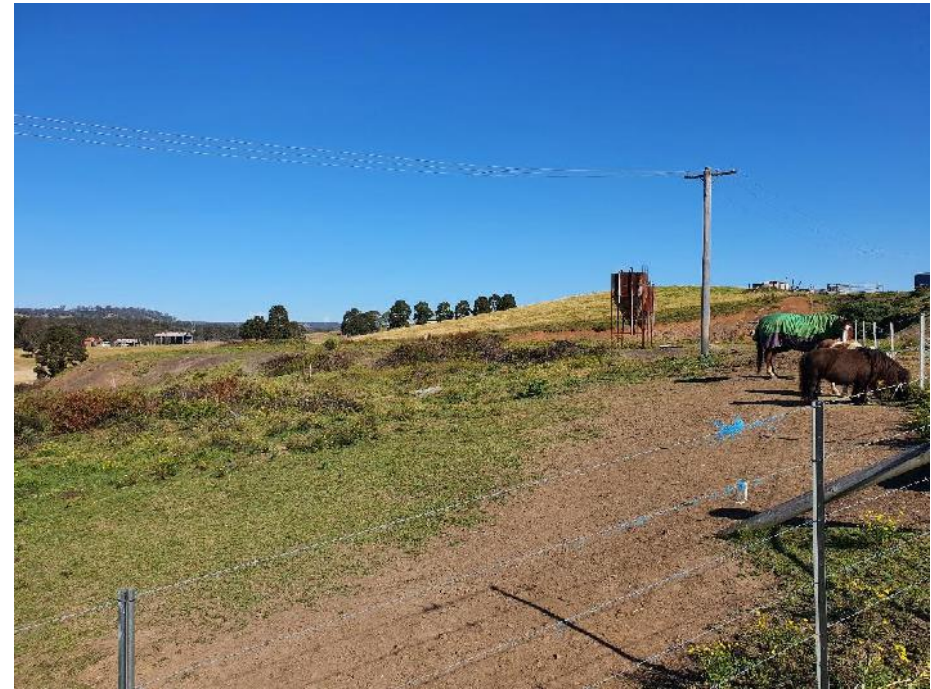
Photo 42 - Quarry and Fill (MRP35)

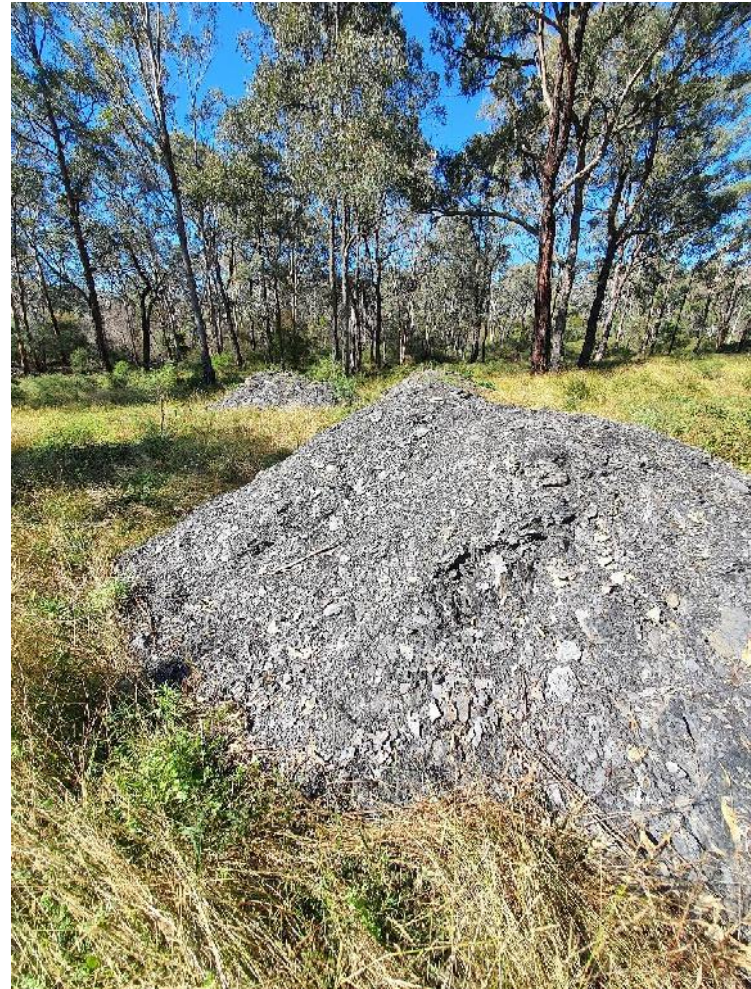
Photo 48 - Stockpile (MRP41)

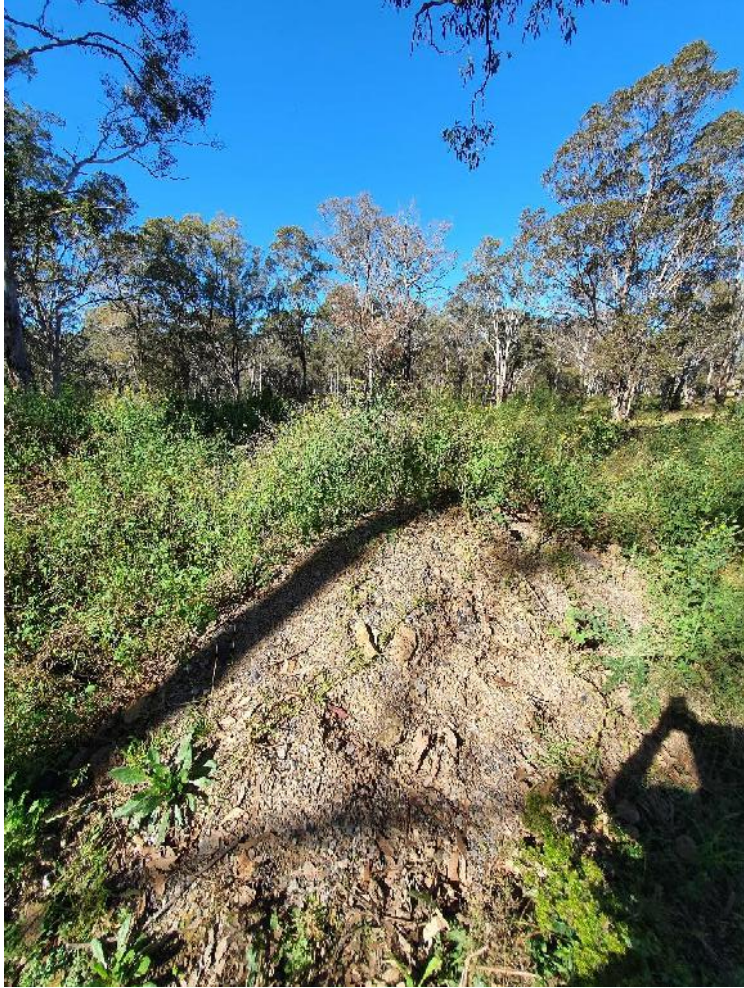
Photo 49 - Stockpile (MRP42)

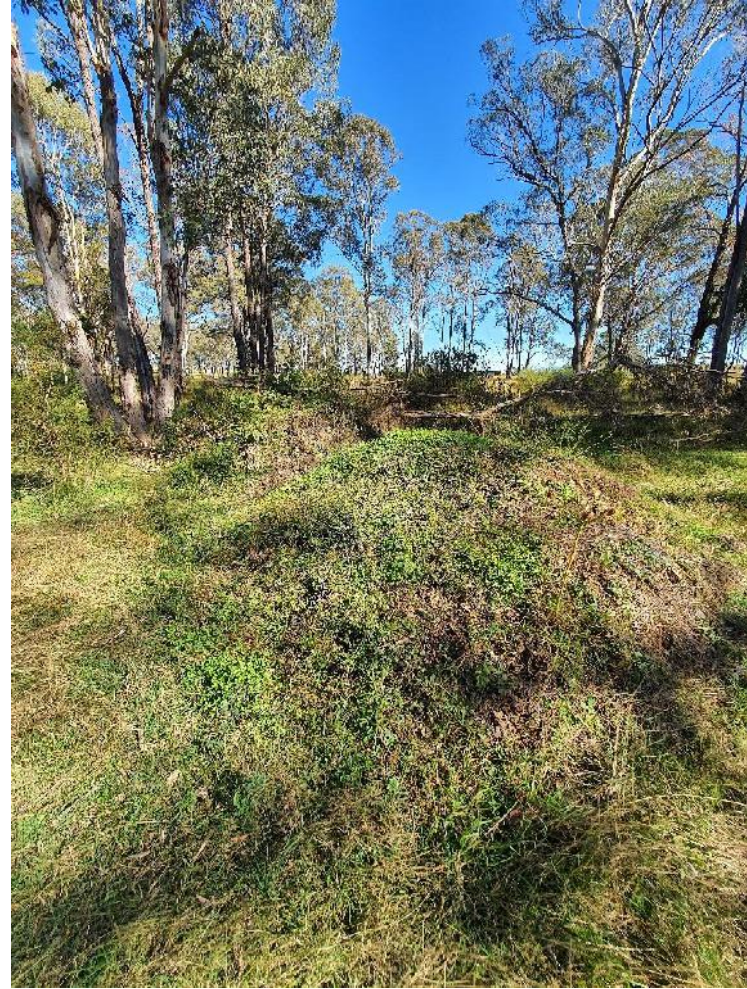
Photo 50 - Stockpile (MRP43)

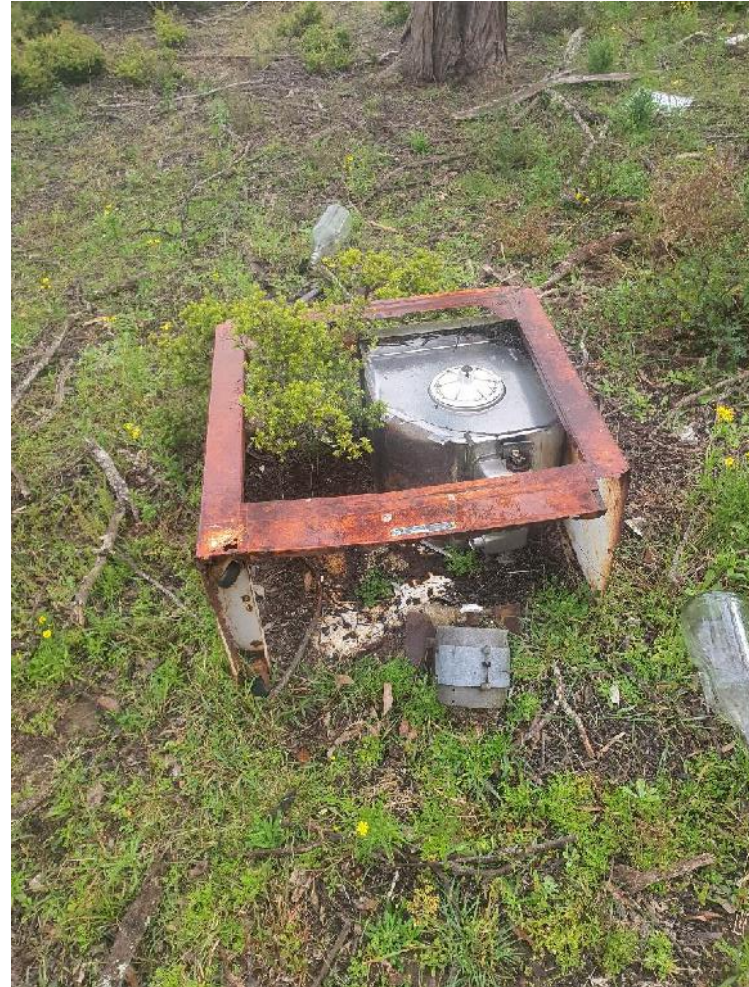
Photo 52 - Minor Refuge (MRP45)

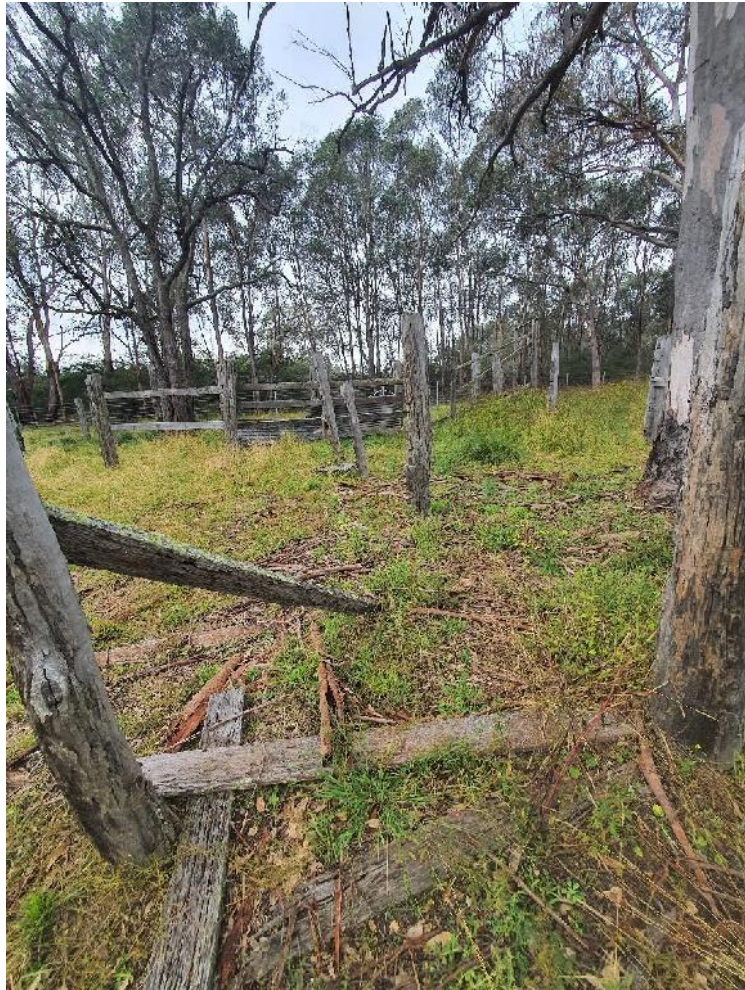
Photo 55 - Cattle Yard (MRP48)

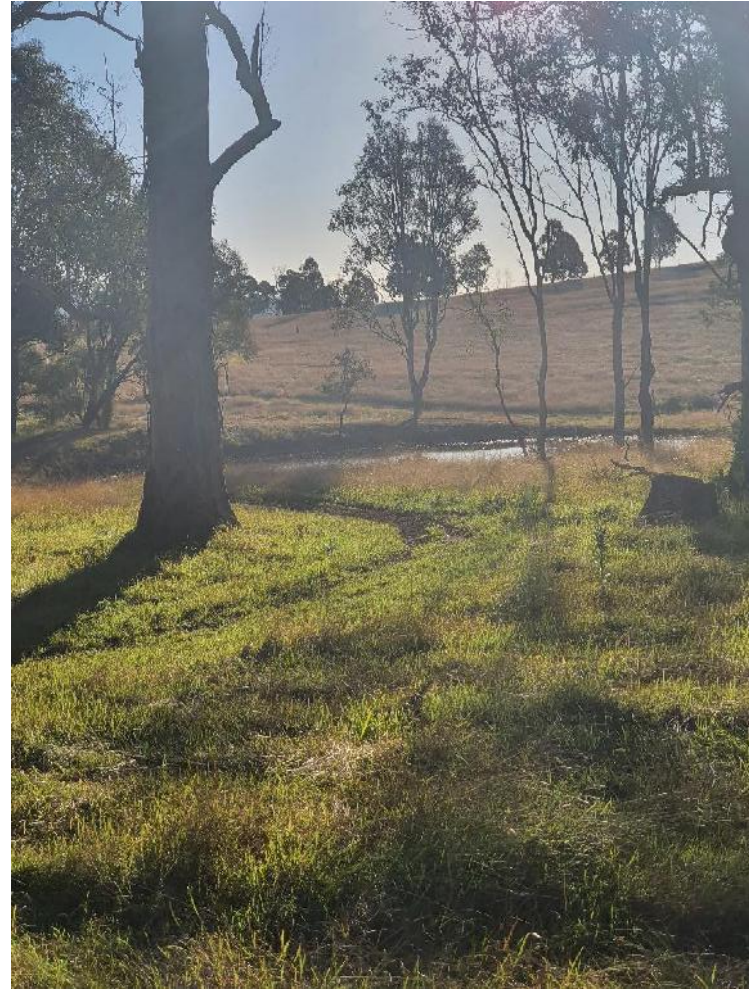
Photo 56 - Dam (MRP49)

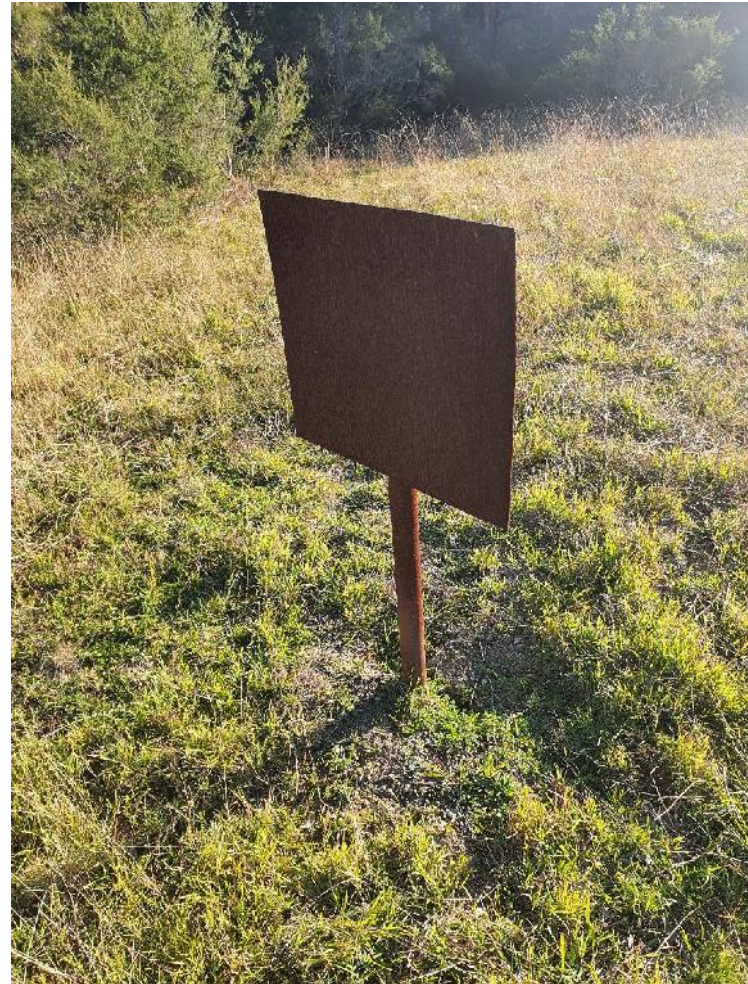
Photo 60 - Appin 4 Well (MRP 53)

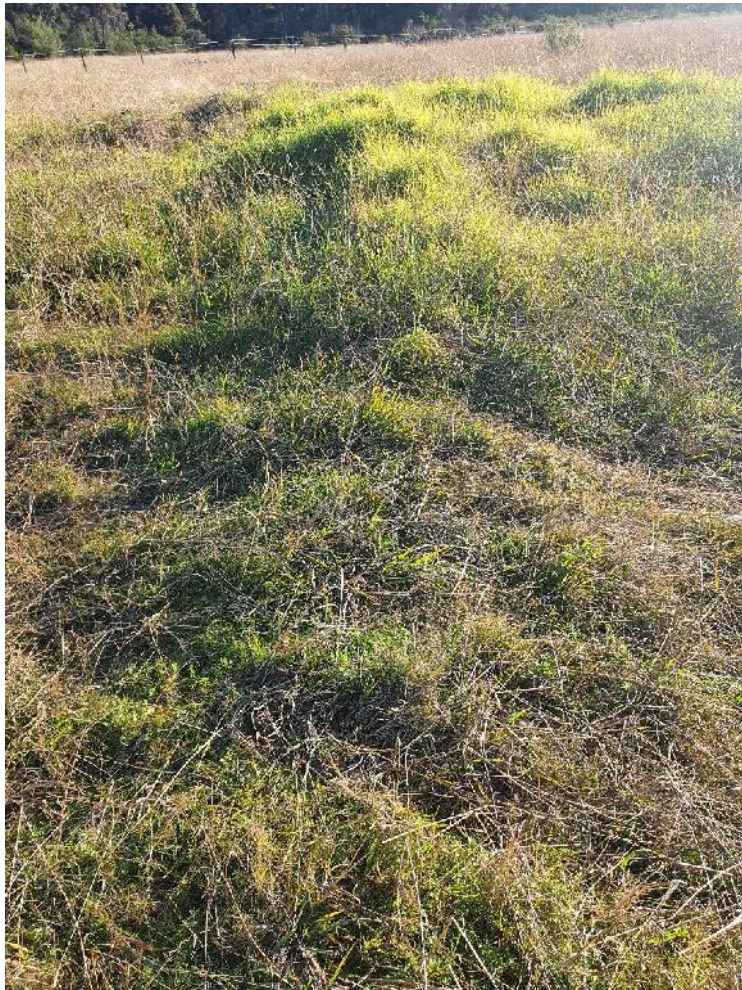
Site walkover				55	Minor fill mound covered with grass.	Yes	5-6	Low - Medium	Targeted investigation of stockpile
	Site walkover				57	Timber power poles	Yes	9-5	Medium	Targeted investigation of immediate surrounding surface soils
	Site walkover				63	Stockpiles containing brick and other construction and demolition rubble	Yes	5-7	Low - Medium	Targeted investigation of stockpile
	Site walkover				64	Dam wall	Yes	2-110	Low	Targeted investigation (wall / sediments)
	Site walkover				65	Building rubble and loose soil - appears to have been tipped here.	Yes	5-8	Low - Medium	Targeted investigation of stockpile
	Site walkover				68	Possible filled ground	Yes	3-31	Low - Medium	Targeted investigation for filling
	Site walkover				73	Second dam observed opposite key feature 65 / MRP 72	Yes	2-111	Low	Targeted investigation (wall / sediments)
	Site walkover				77	Timber power pole easement (likely part of Brooks Point Road easement)	Yes	9-6	Medium	Targeted investigation of immediate surrounding surface soils

Photo 63 - Minor Fill Mound (MRP55)

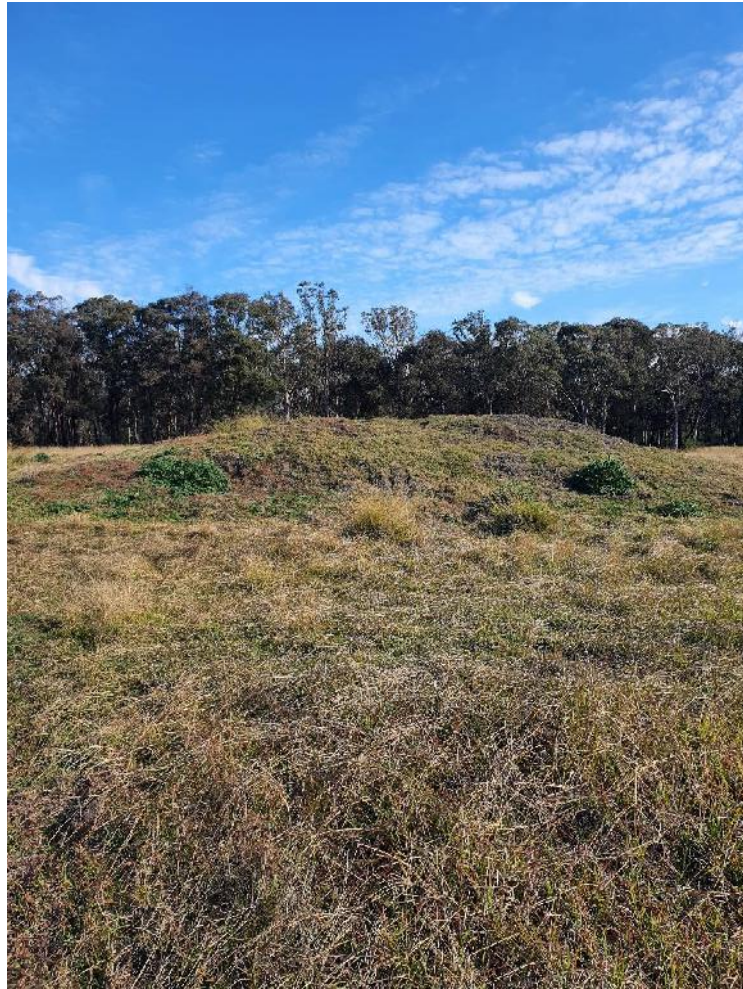
- Systematic dumping was observed along Elladale Road including construction and demolition materials (MRP 65; plates 74 to 76, MRP 67; plate 78, MRP 70; plate 81 and MNP 76; plates 86 to 88).
- Several stockpiles were noted along Elladale Road (MRP 59; plate 67, MRP60; plates 68 and 69, MRP 61 to 63; plates 71 and 72).
- Farm dams were scattered throughout the area, the majority of which were observed to have embankments constructed from locally derived material. One dam embankment was noted to contain building rubble.
- Several timber power pole alignments were encountered.
- There were several houses in this area (i.e. along Brooks Point Road) some of which may be derelict and many of which were of the age which would indicate that hazardous building materials may be present.

Photo 67 - Stockpiles (MRP59)
