Report on
Preliminary Site Investigation

Proposed Appin (Part) Precinct
Appin, NSW

Prepared for
Walker Corporation Pty Ltd

Project 76589.06
October 2022

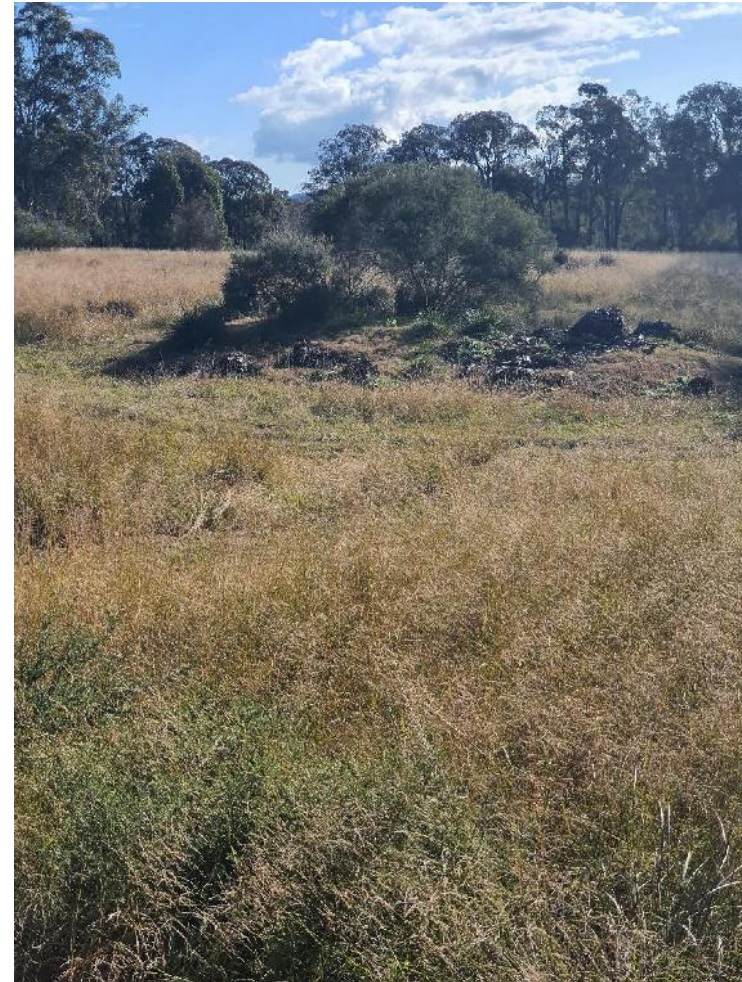
- Systematic dumping was observed along Elladale Road including construction and demolition materials (MRP 65; plates 74 to 76, MRP 67; plate 78, MRP 70; plate 81 and MNP 76; plates 86 to 88).
- Several stockpiles were noted along Elladale Road (MRP 59; plate 67, MRP60; plates 68 and 69, MRP 61 to 63; plates 71 and 72).
- Farm dams were scattered throughout the area, the majority of which were observed to have embankments constructed from locally derived material. One dam embankment was noted to contain building rubble.
- Several timber power pole alignments were encountered.
- There were several houses in this area (i.e. along Brooks Point Road) some of which may be derelict and many of which were of the age which would indicate that hazardous building materials may be present.

Photo 68 - Waste Stockpiles (MRP60)

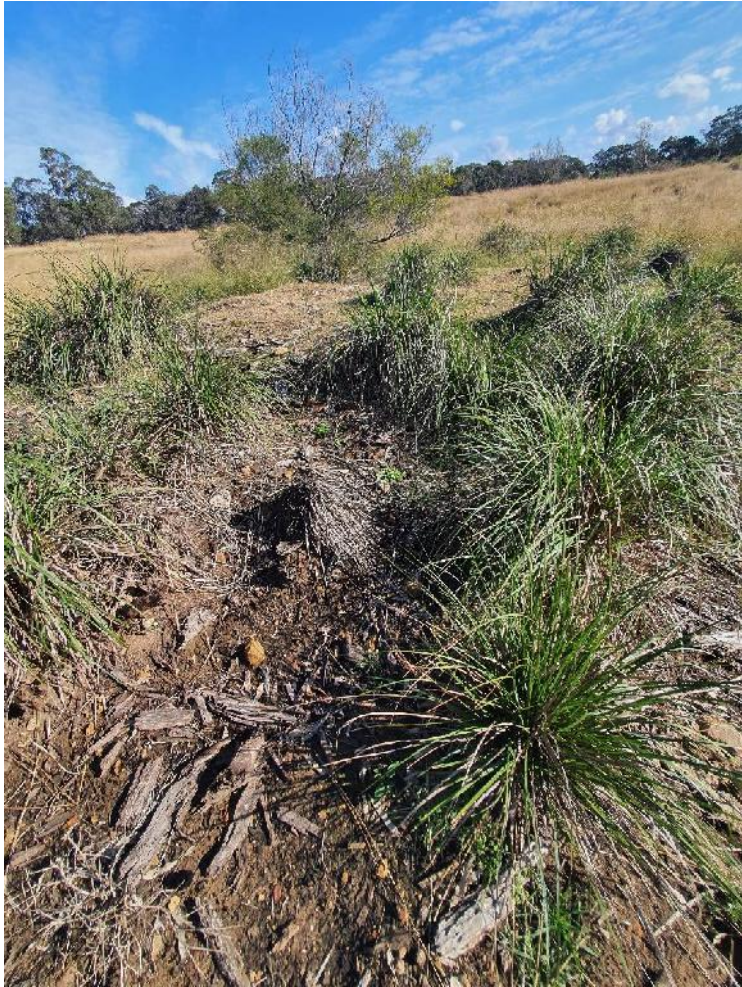
Photo 69 - Waste Stockpiles (MRP60)

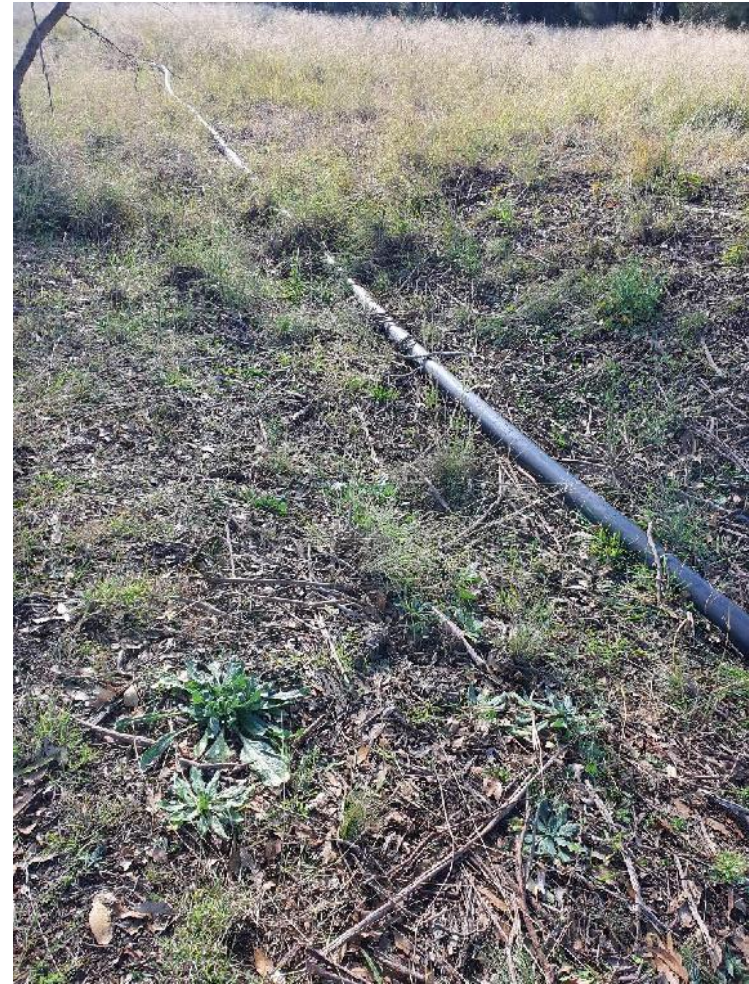
Photo 70 - Polypipe Along Road (MRP61)

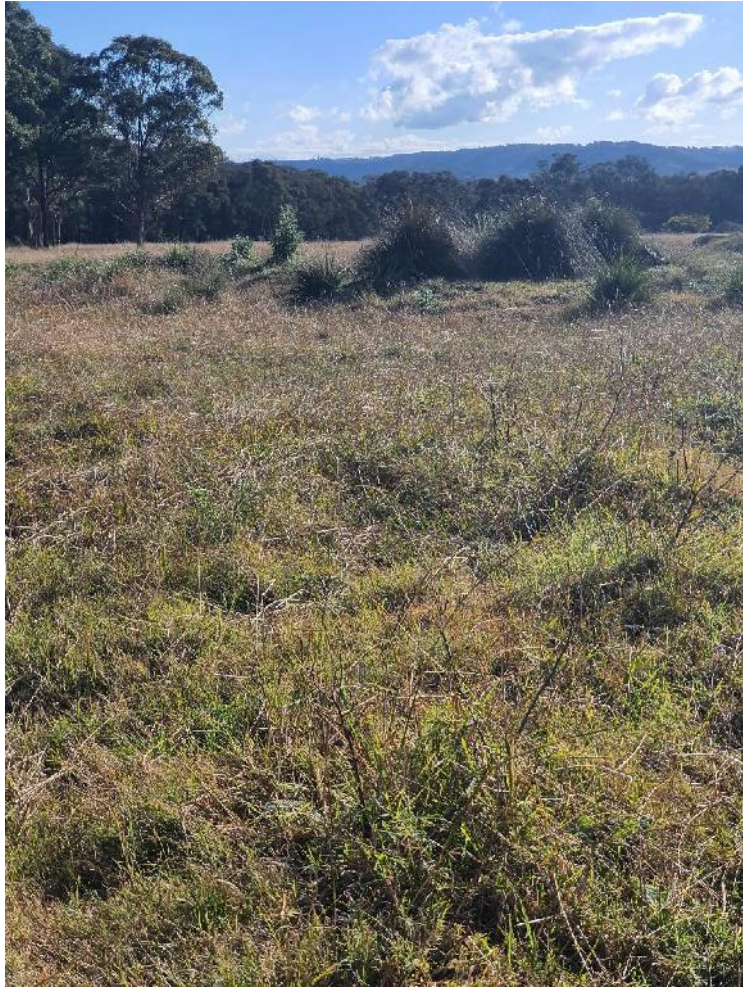
Photo 71 - Stockpiles (MRP62)

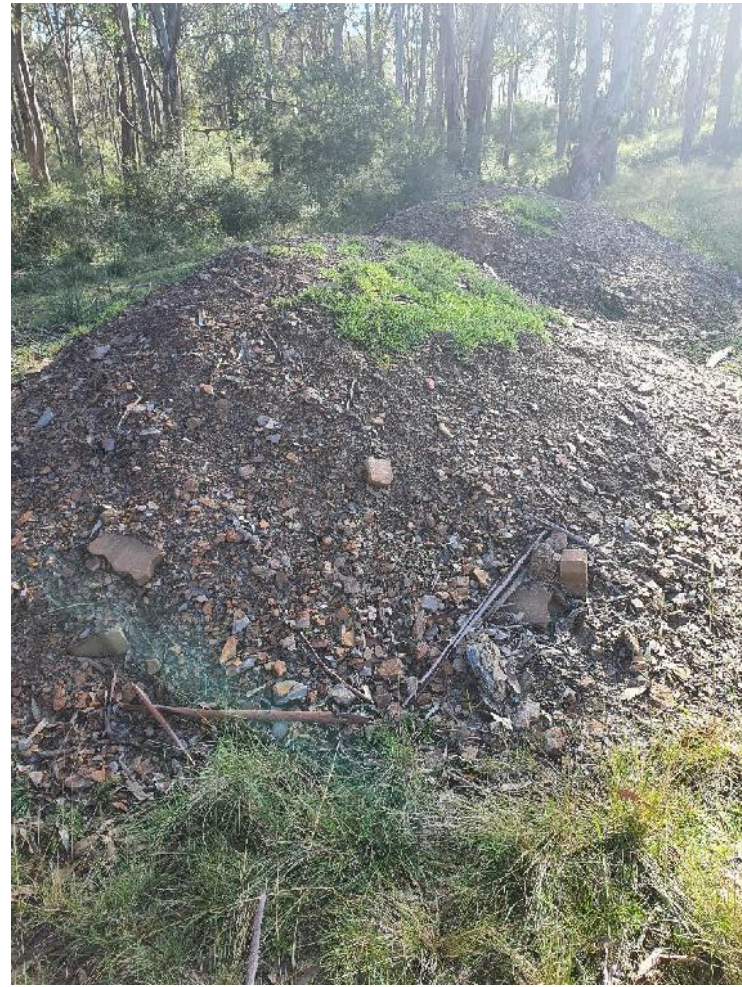
Photo 72 - Stockpiles (MRP63)

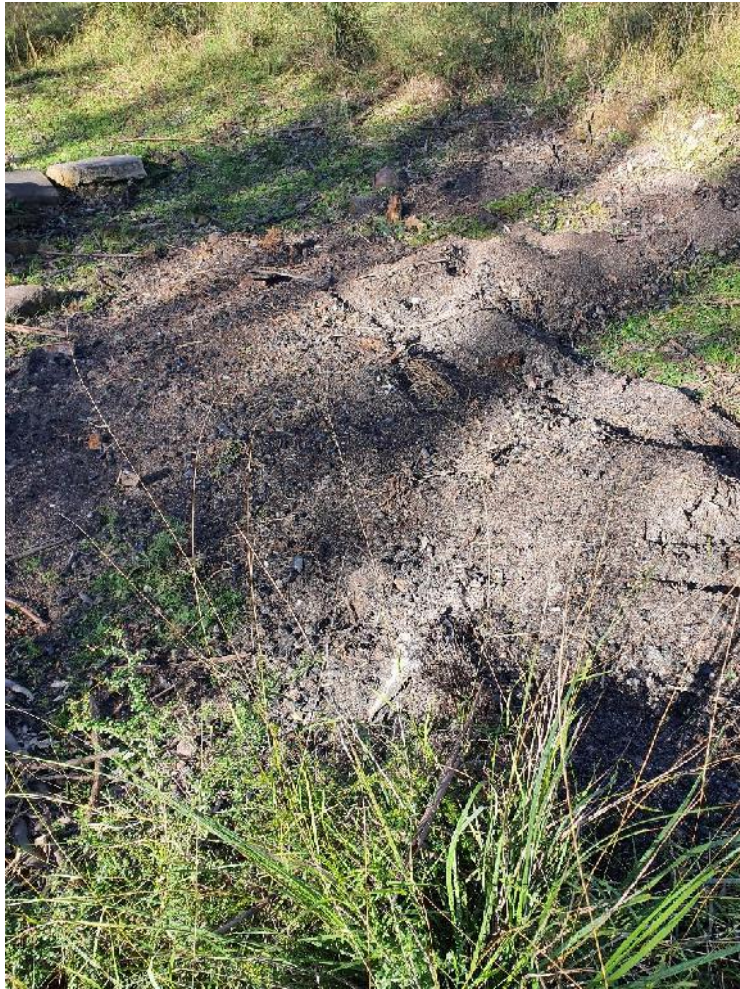
Photo 75 - Dumped Building Rubble (MRP65)

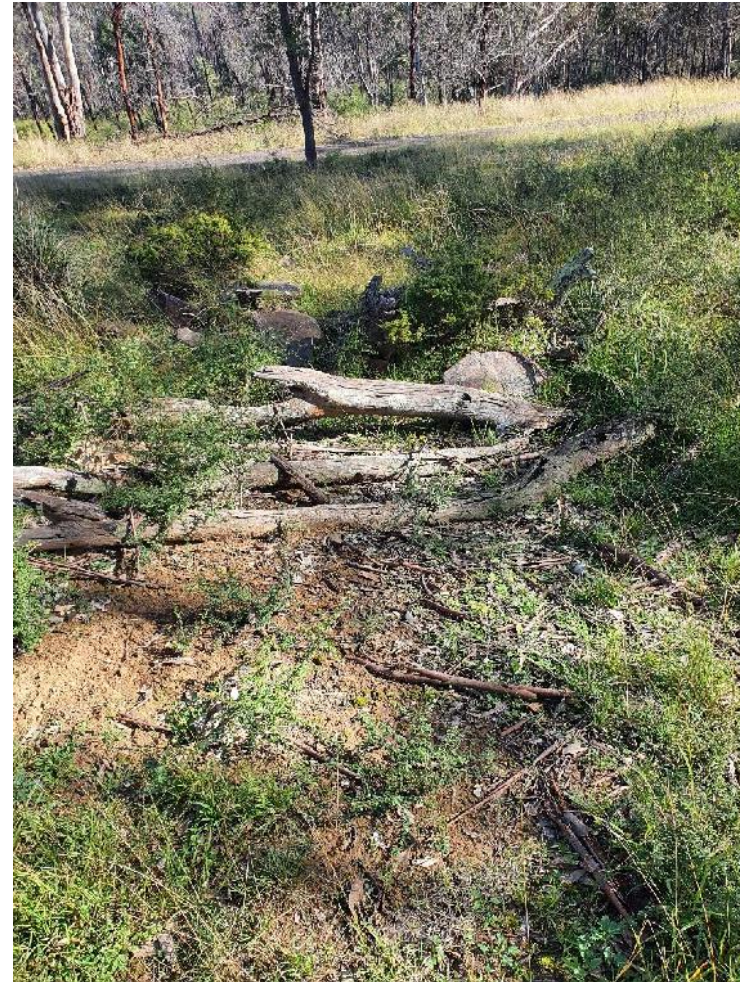
Photo 76 - Dumped Building Rubble (MRP65)

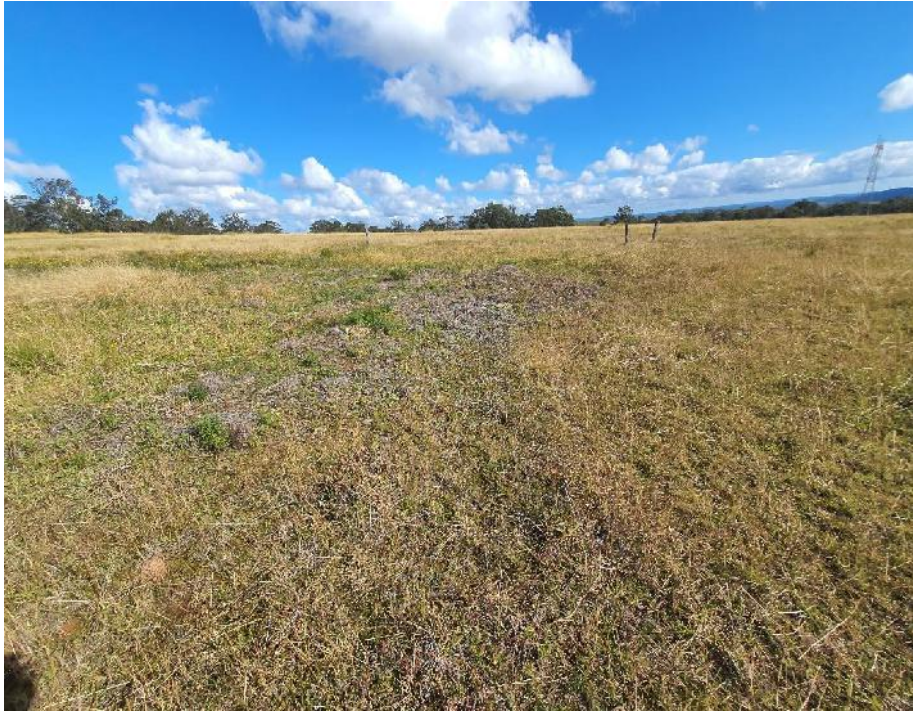
Photo 79 - Possible Filled Ground (MRP68)

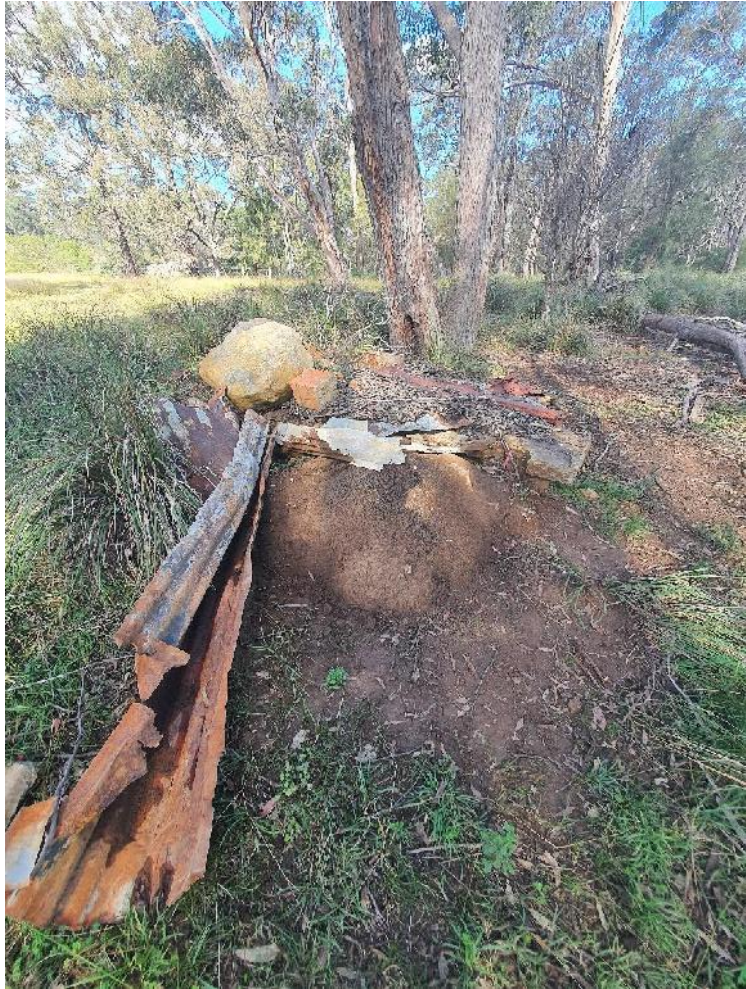
Photo 81 - Minor Refuse (MRP70)

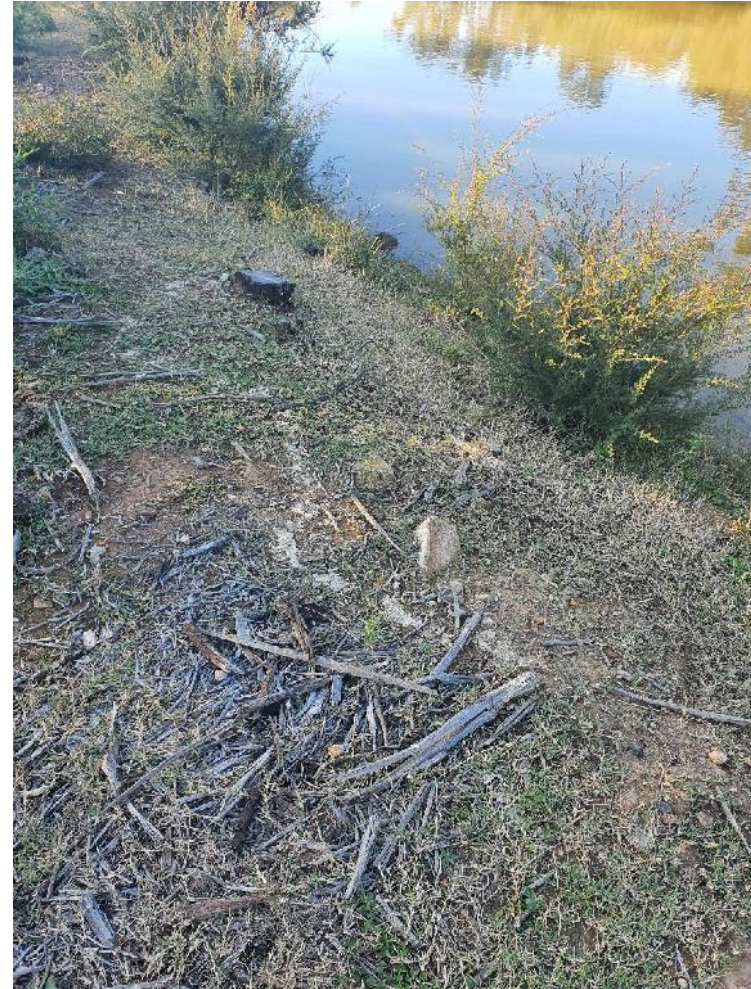
Photo 82 - Dam Wall, Locally Sourced (MRP71)

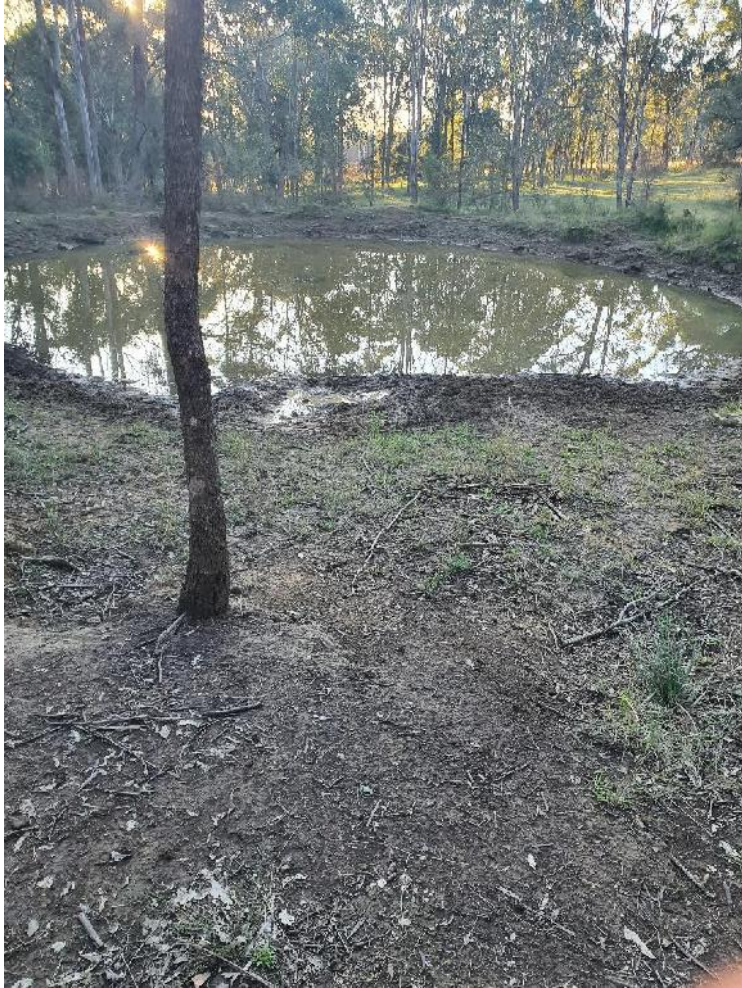
Photo 83 - Dam (MRP73)

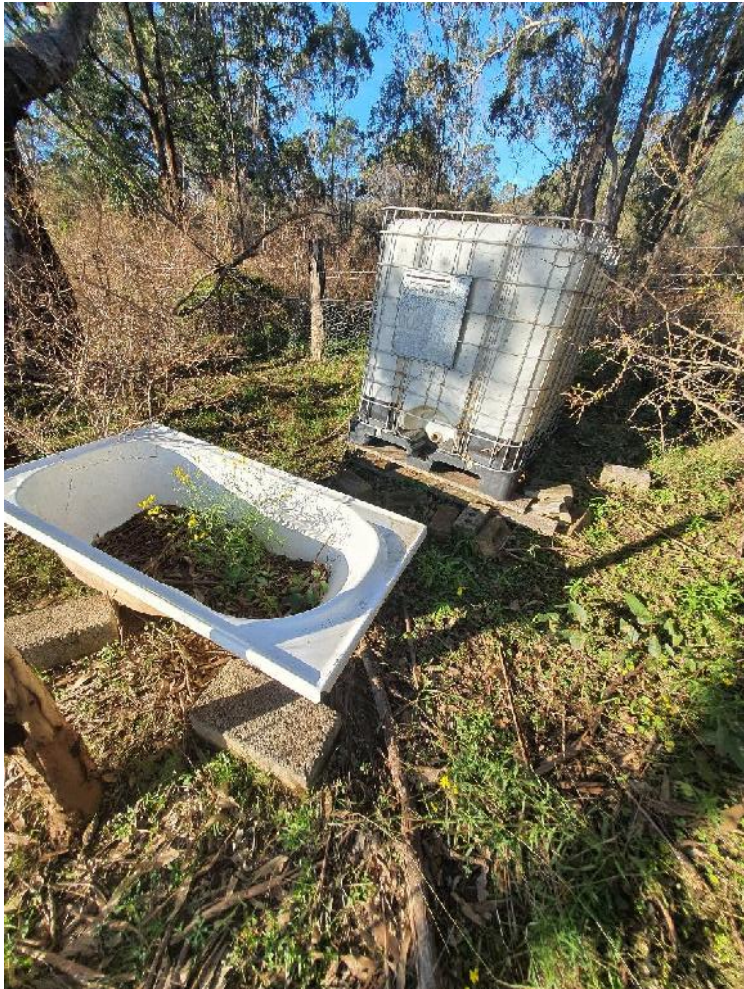
Photo 85 - Trough with IBC (MRP75)

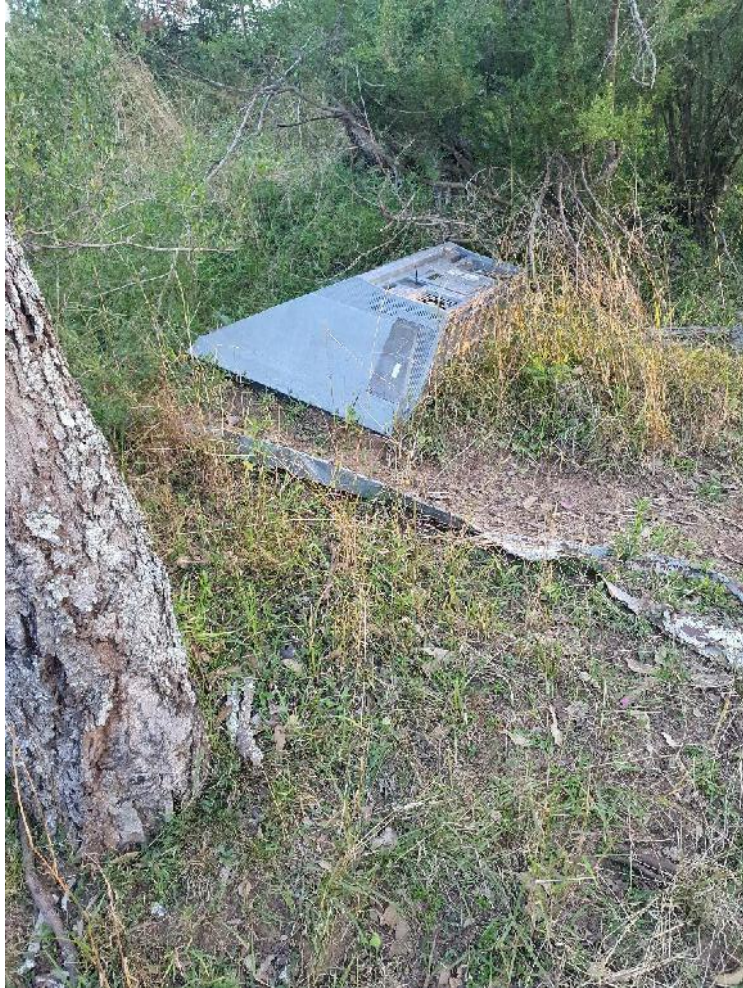
- Localised dumping was observed in some gullies largely minor refuse (MRP 83; plate 93) and cars and machinery (MRP 105; plate 121) with the exception of MRP 96 (plates 108 – 111) and 97 (plate 112) where dumping appeared to be widespread and systematic. An area of waste tyre dumping was noted at MRP 111 (plates 125 to 127).

Photo 93 - Minor Refuse (MRP83)

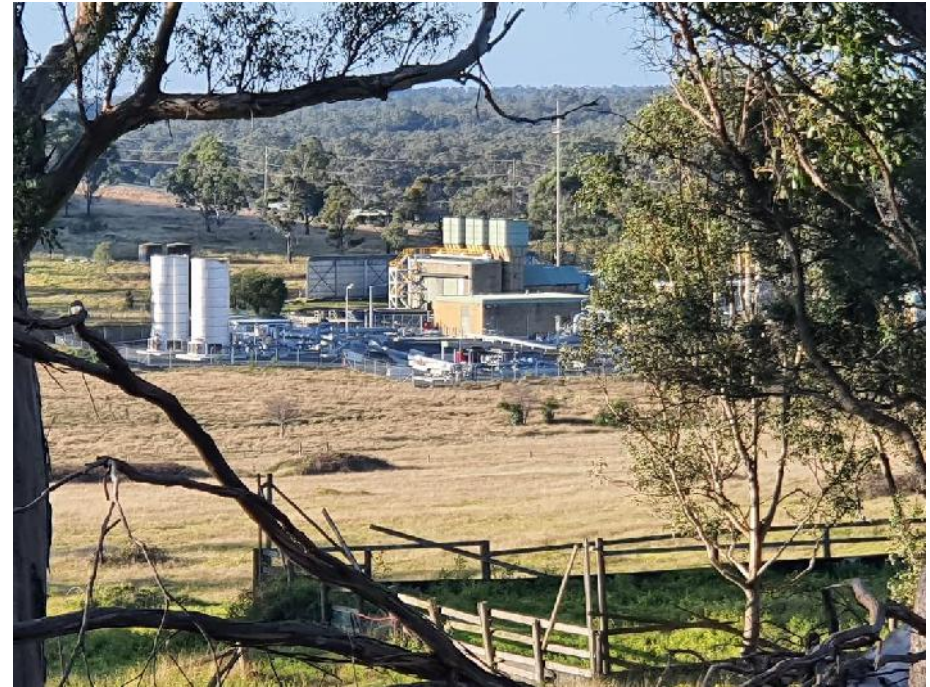
Photo 94 - Appin Powerplant (MRP84)

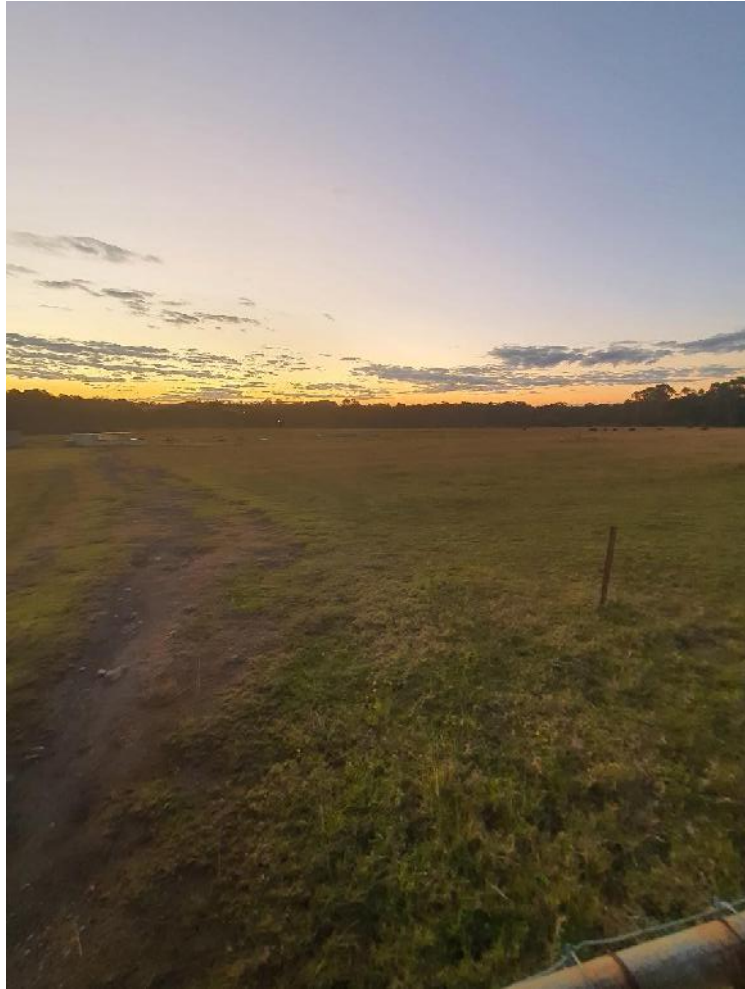
- The dairy farm operations area (MRP 89) likely has some chemical storage but closer inspection was not possible at the time of the walk over.
- A model plane airfield was noted at MRP 85 however inspection of this portion of the site was not possible at the time of the walk over. A heritage house (former dairy farm) is located near to the airfield MRP 86; plate 96).

Photo 95 - Model Airfield (MRP85)

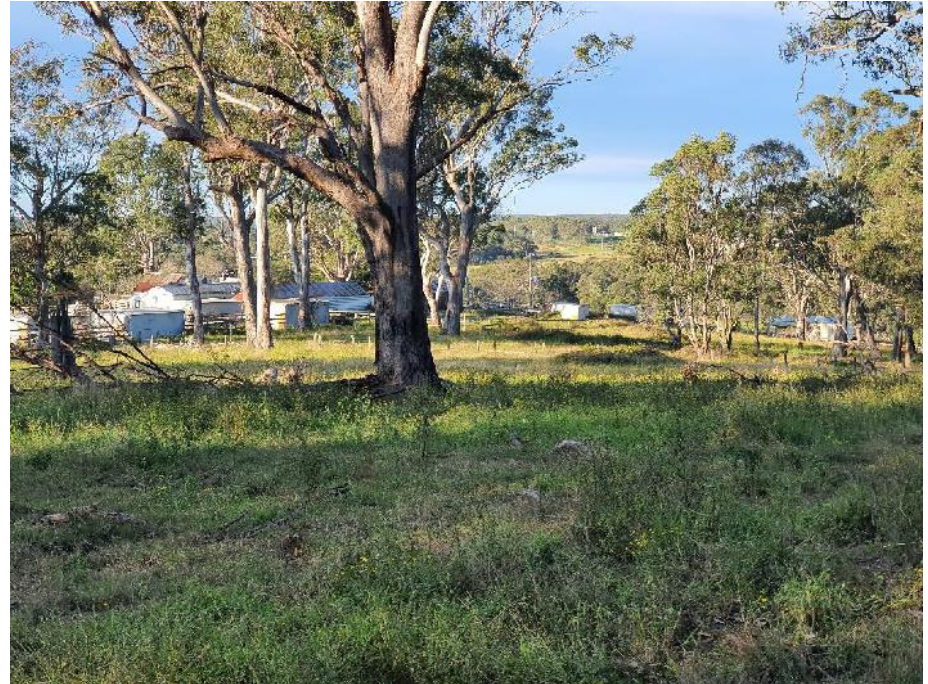
Photo 96 - Heritage House (MRP86)

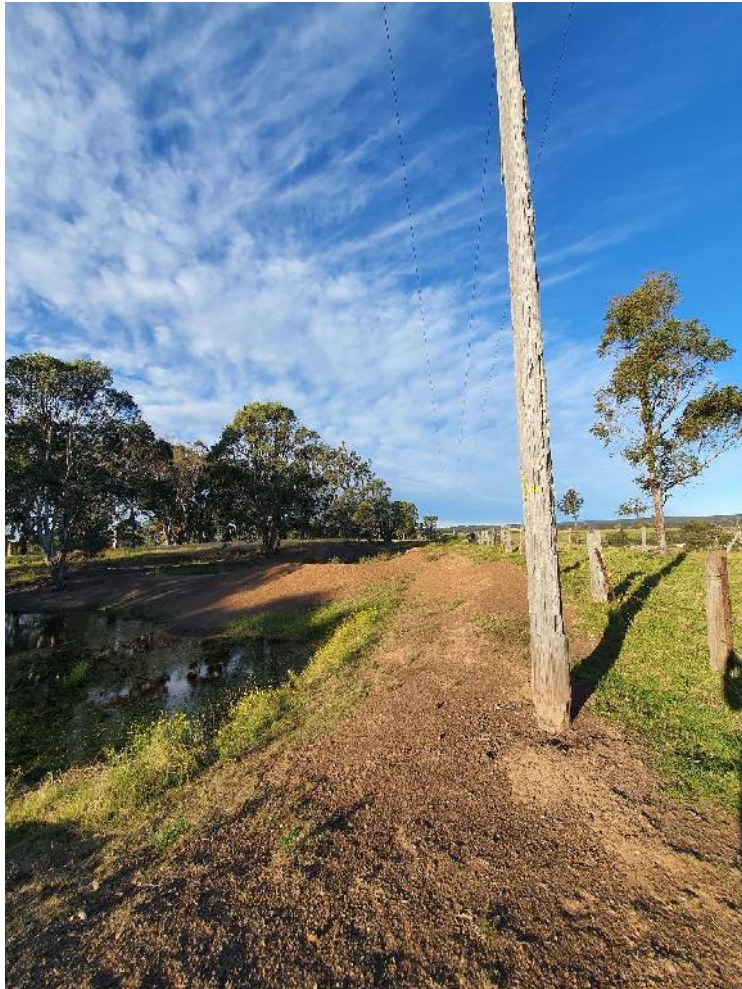
Photo 97 - Powerpoles (MRP87)

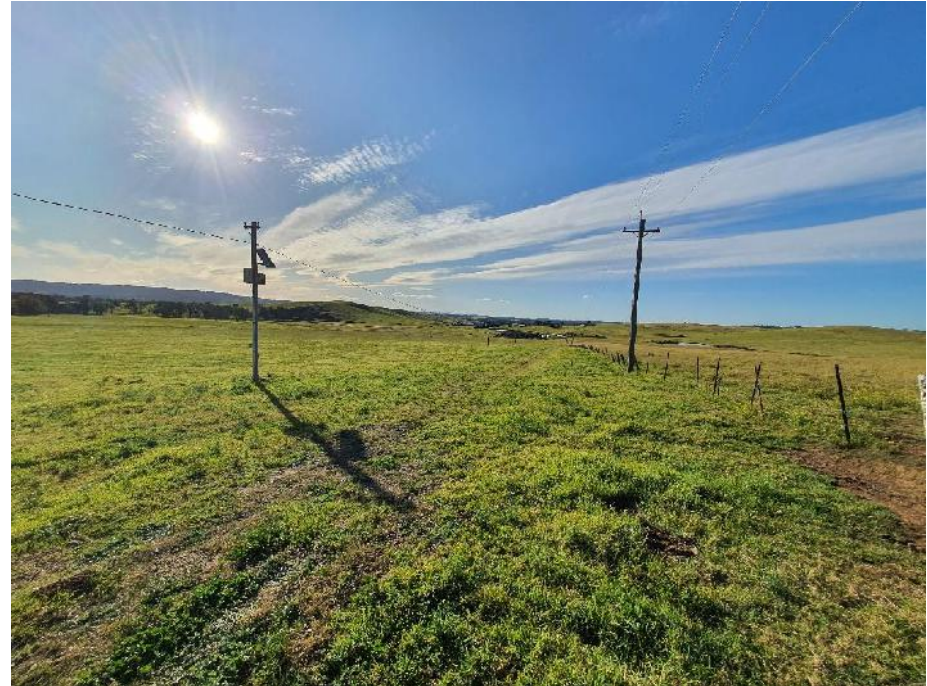
Photo 98 - Powerpoles (MRP88)

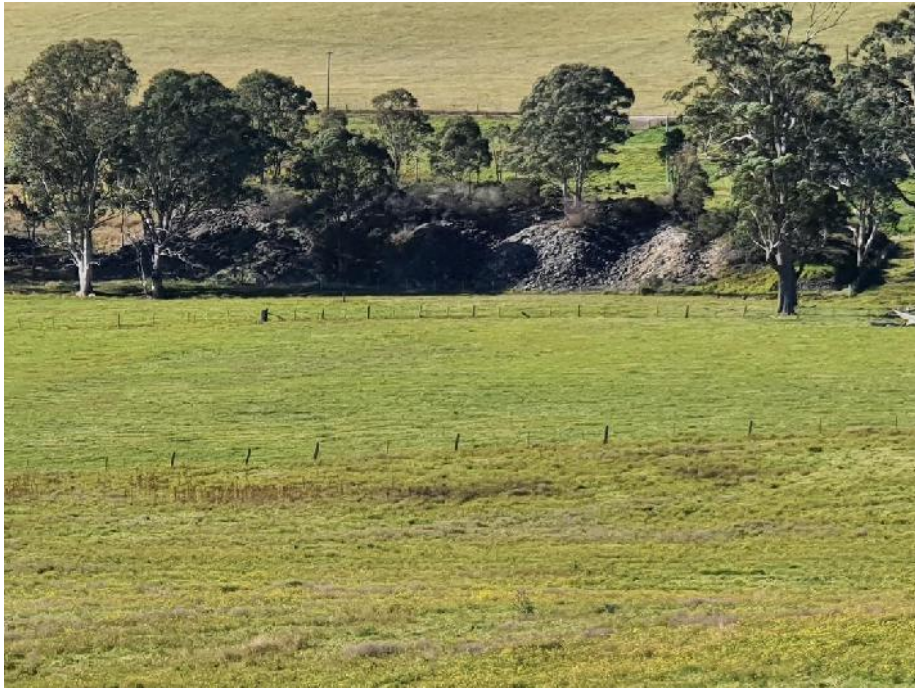
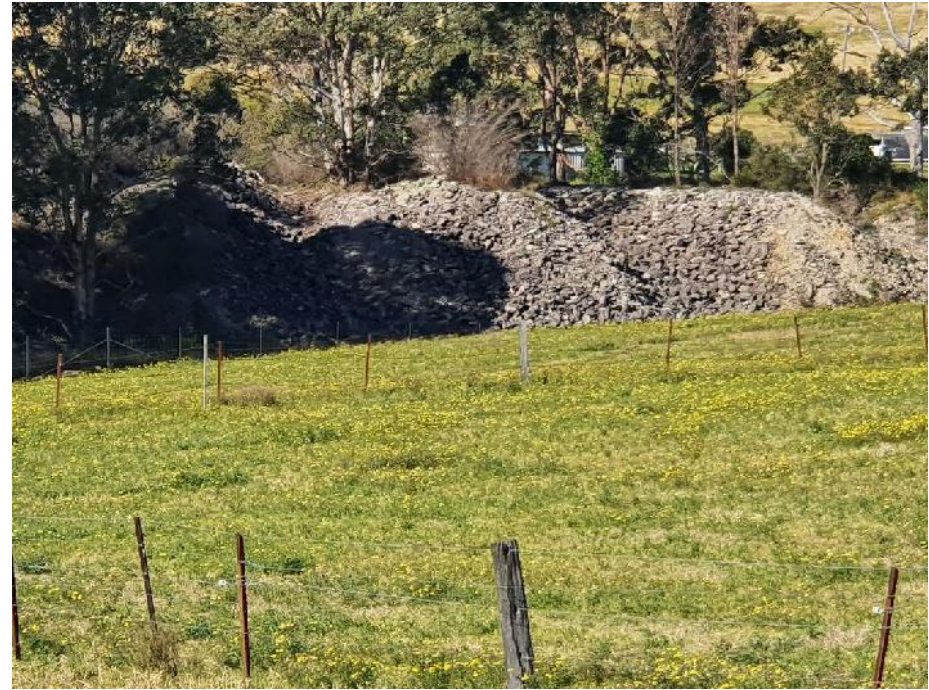
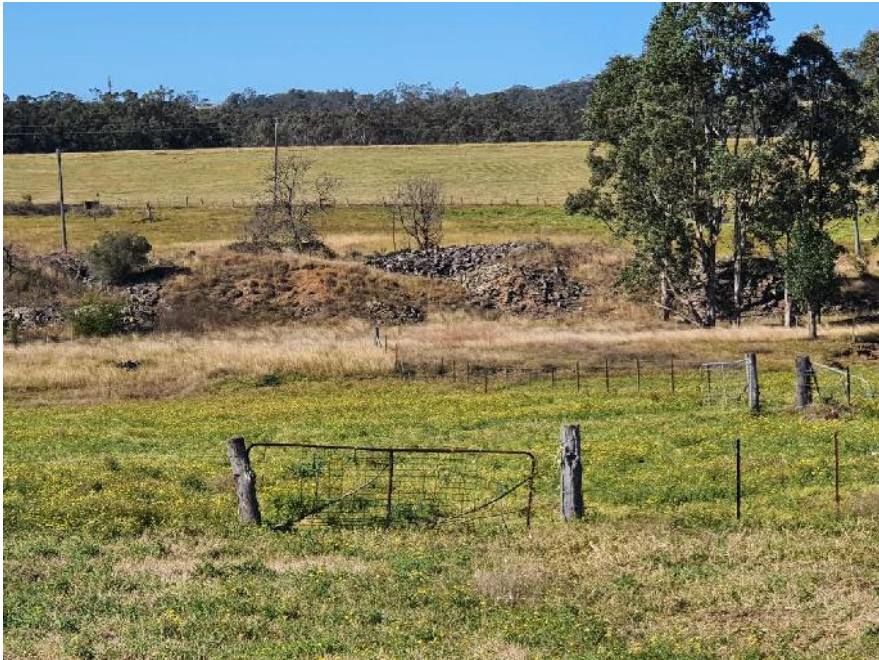
- Internal roads were surfaced with coal wash in places (MRP 110; plate 124).
- Stockpiles were observed at MRP 92 (plate 102) and large stockpiles at MRP 90 (plates 99 to 101), likely associated with construction of the Cataract Tunnel and possibly the USC.

Photo 99 - Spoil Stockpiles (MRP90)

Photo 100 - Spoil Stockpiles (MRP90)

Photo 101 - Spoil Stockpiles (MRP90)

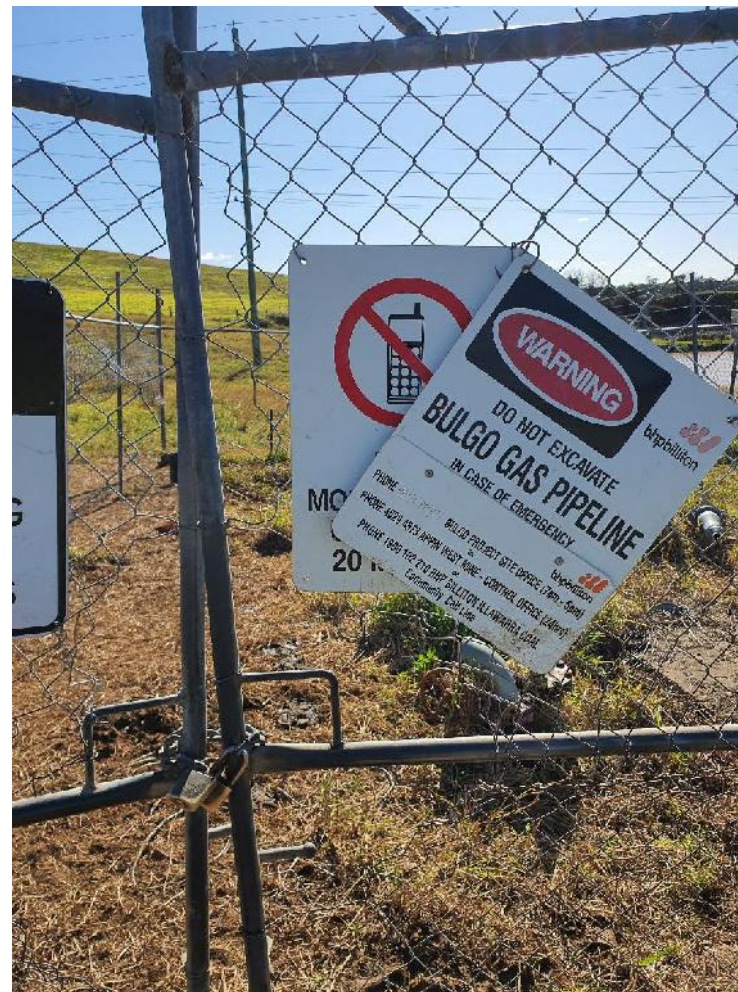
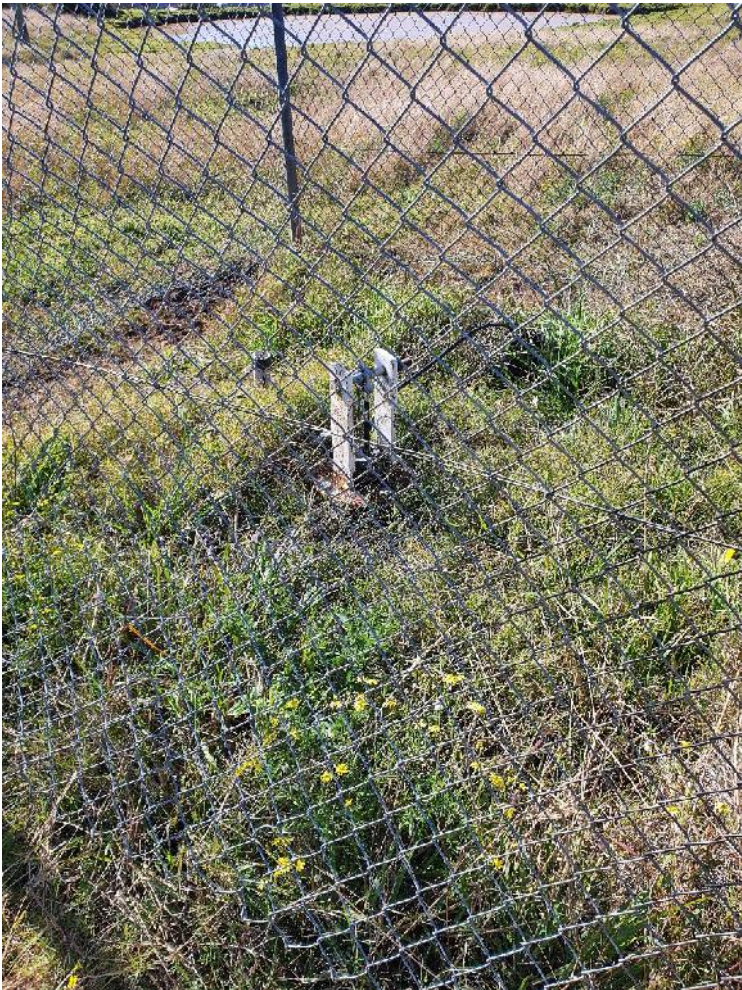
- A coal seam gas well network was observed in the west (MRP 93; plates 103 to 105) near Appin Colliery) centre (MRP 94; plate 106) and south of the site (MRP 98 and 99; plates 113 and 114) and a pipeline extending towards the south west (MRP 101; plate 116, MRP 102; plate 117) adjacent to the creek in the south west portion of the site. A mine communication antenna was also observed (MRP 100; plate 115).
- As with the remainder of the site, several timber power pole alignments were encountered throughout.

Photo 104 - Gas Wells (MRP93)

Photo 105 - Gas Wells (MRP93)

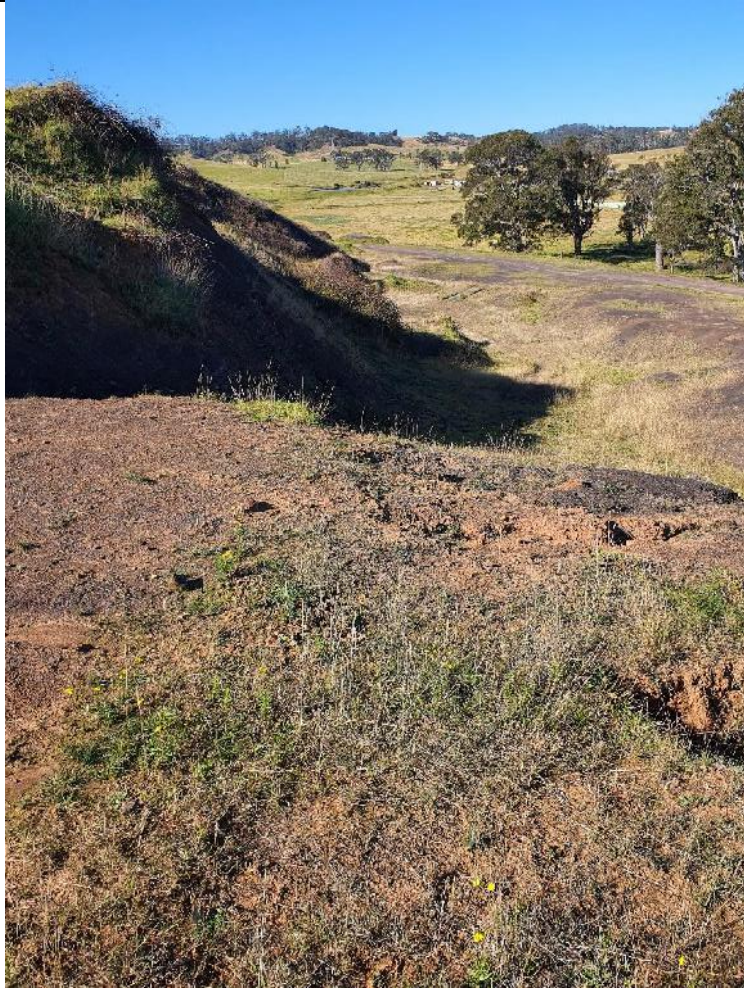
Photo 107 - Quarry (MRP95)

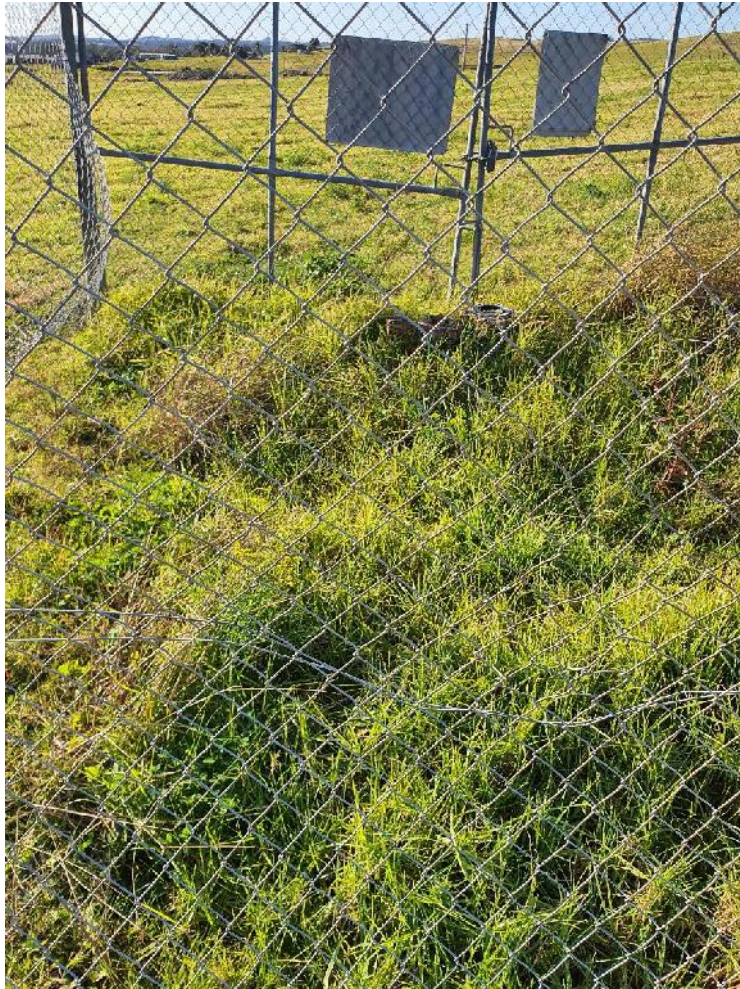
Photo 113 - Gas Wells (MRP98)

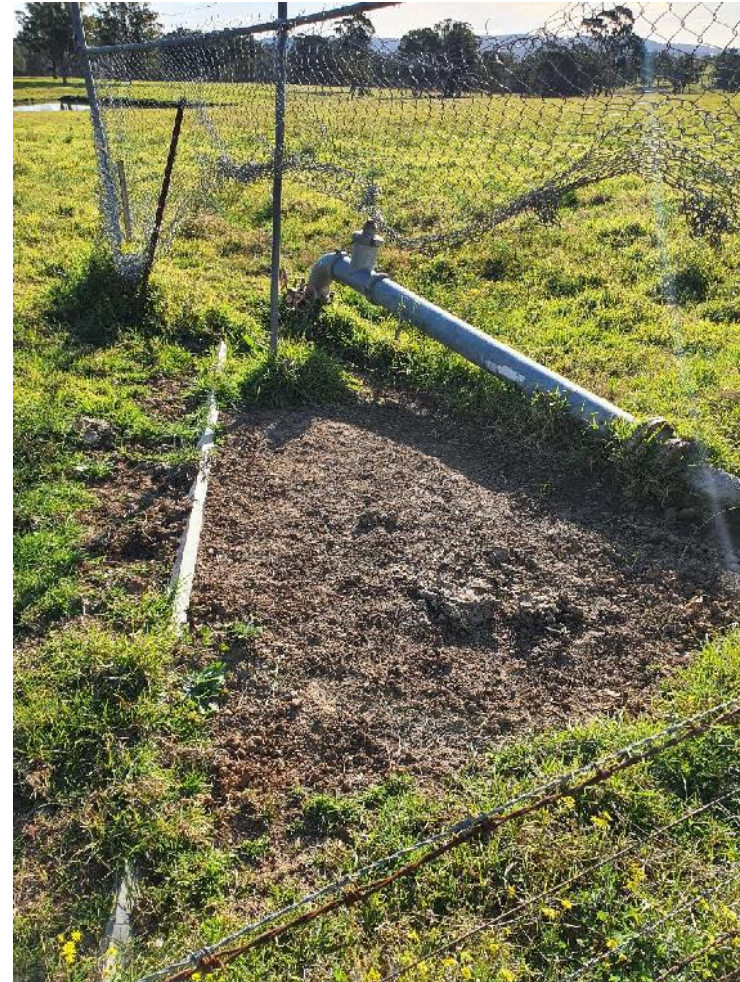
Photo 114 - Gas Wells (MRP99)

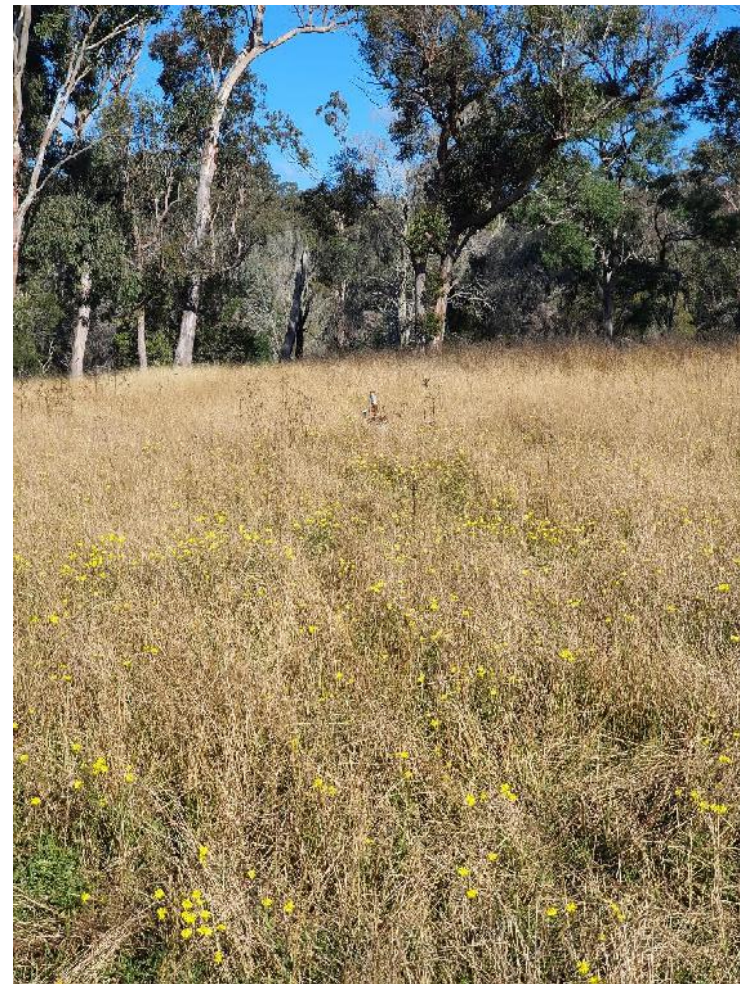
Photo 116 - Gas Wells (MRP101)

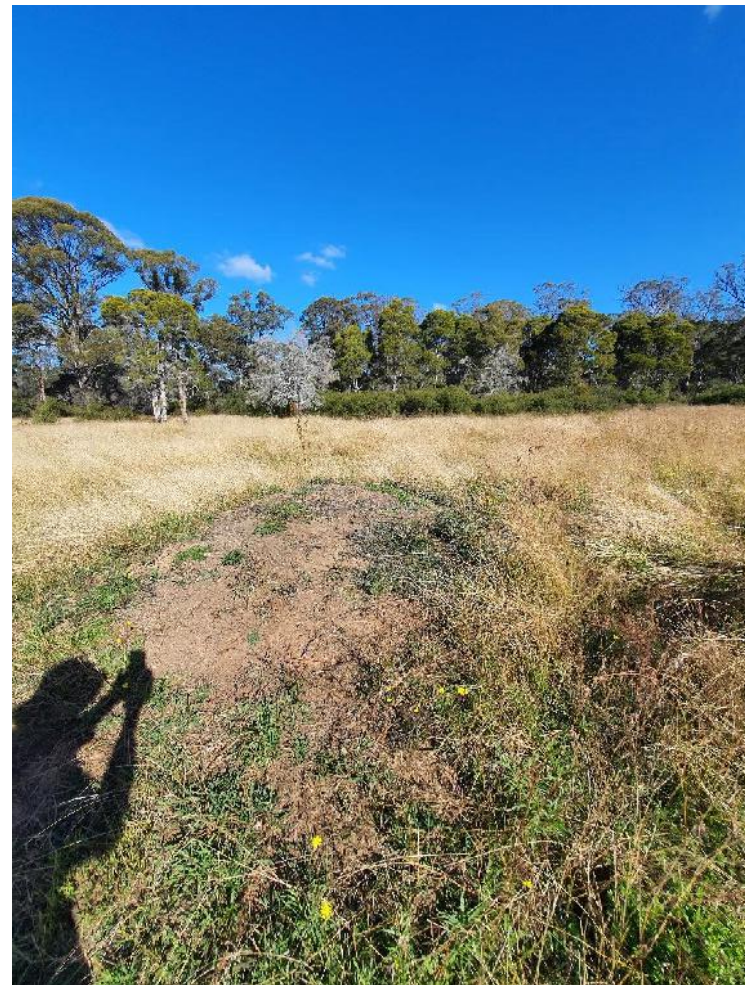
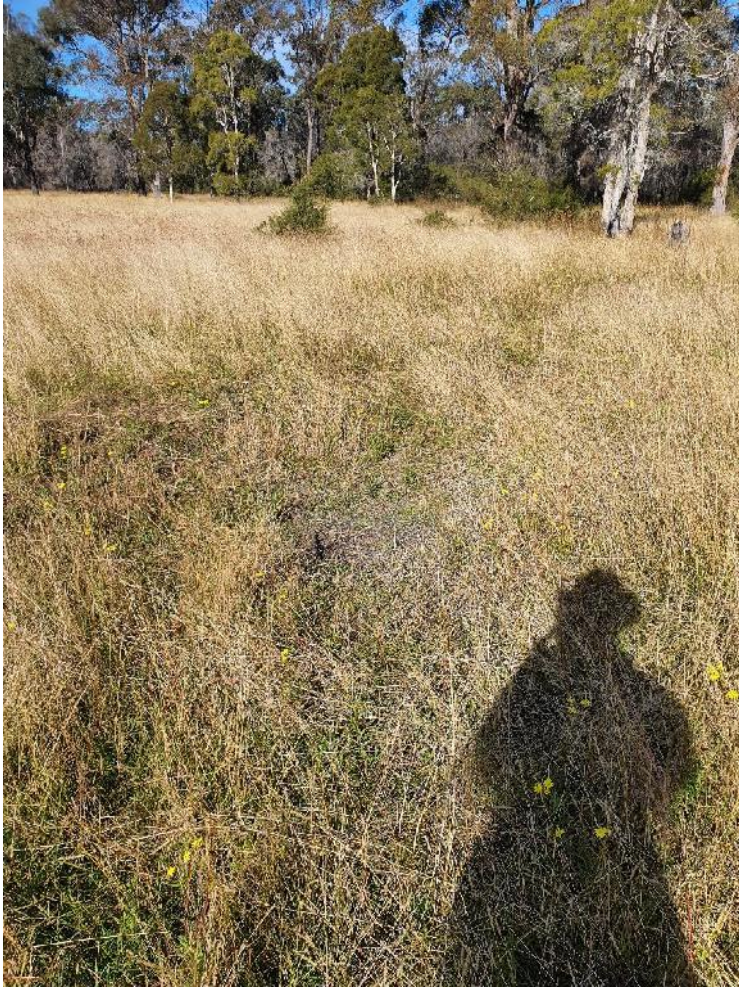
- An area of possible livestock burial was observed (MRP 103; plates 118 and 119).
- Fuel storages were noted in above ground storage tanks at water pumps, specifically MRPs 89, 108 and 115 (plates 130 and 131). A discarded AST was also noted at MRP 112 (plate 128).

Photo 118 - Disturbed Ground (MRP103)

Photo 119 - Disturbed Ground (MRP103)

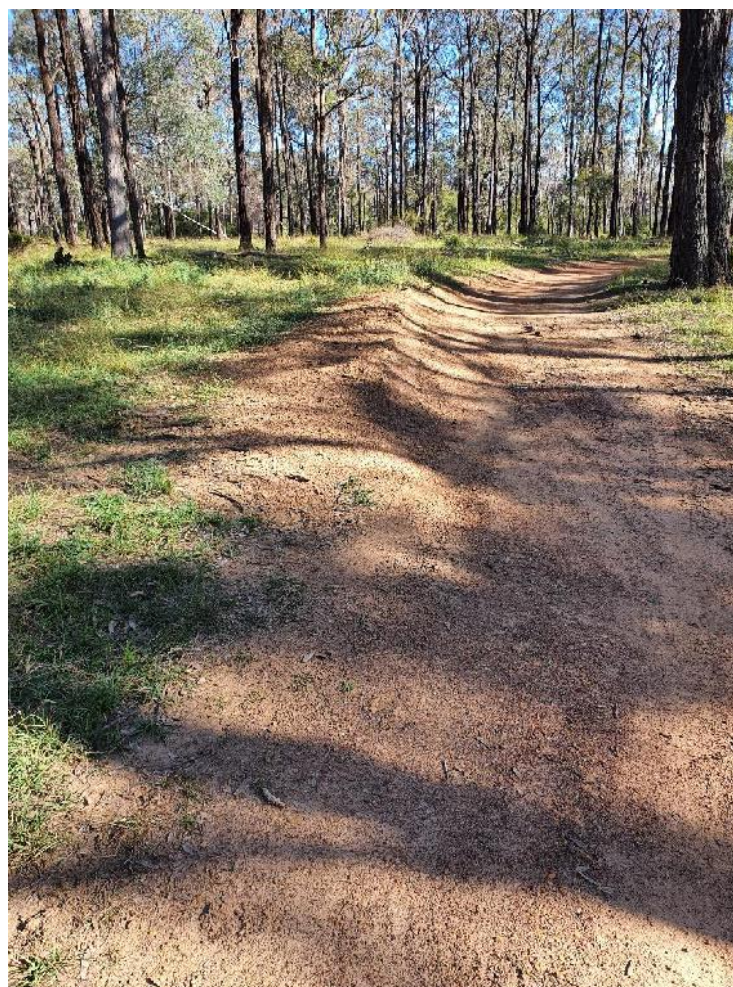
Photo 122 - Dirtbike Tracks (MRP106)

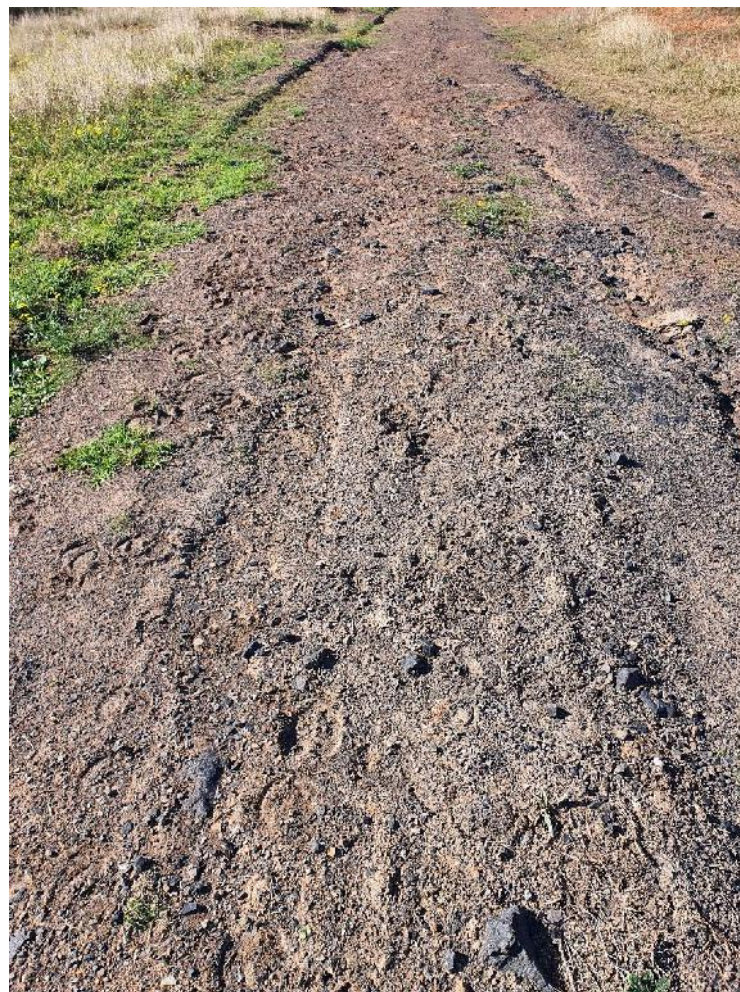
Photo 124 - Coalwash Surfacing on Road (MRP110)
