Report on
Preliminary Site Investigation

Proposed Appin (Part) Precinct
Appin, NSW

Prepared for
Walker Corporation Pty Ltd

Project 76589.06
October 2022

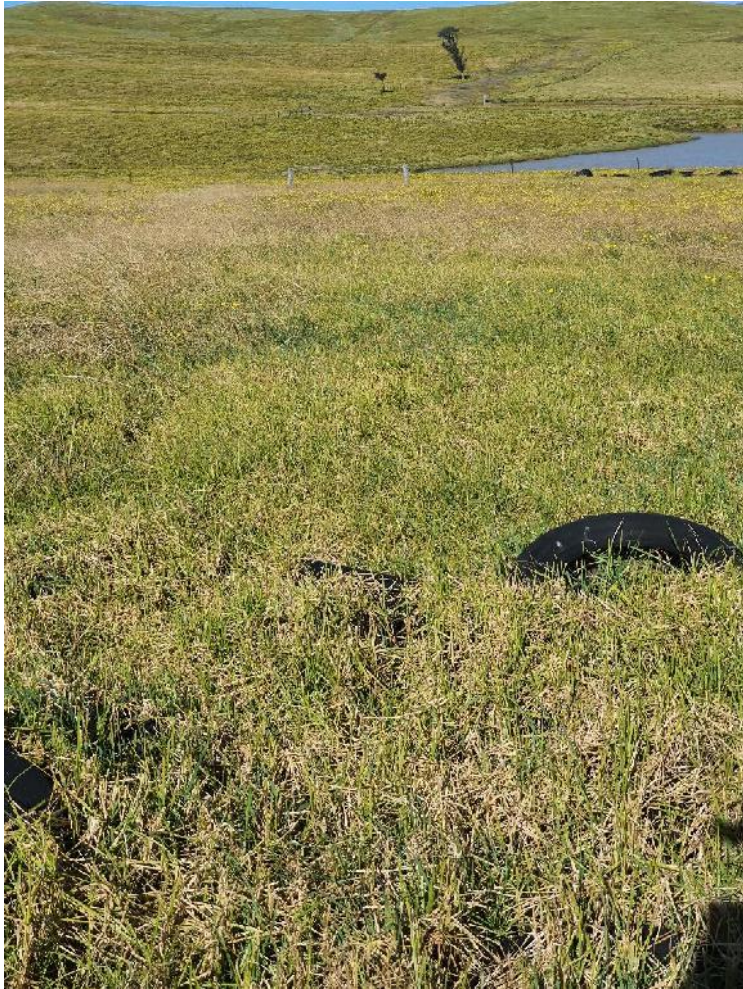
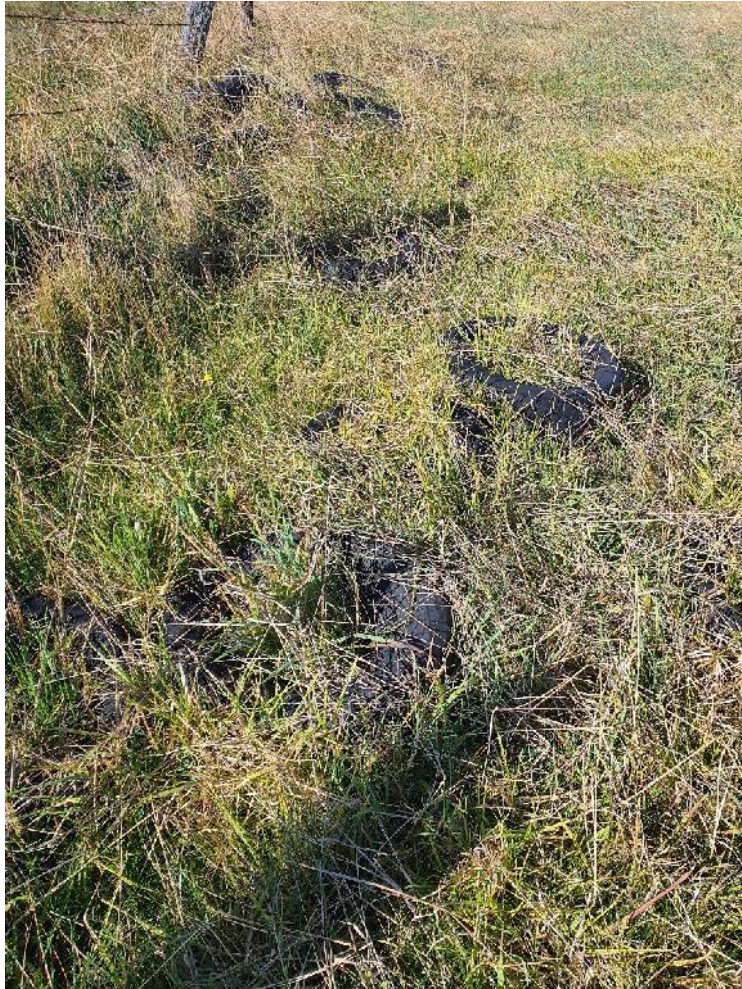
- Localised dumping was observed in some gullies largely minor refuse (MRP 83; plate 93) and cars and machinery (MRP 105; plate 121) with the exception of MRP 96 (plates 108 – 111) and 97 (plate 112) where dumping appeared to be widespread and systematic. An area of waste tyre dumping was noted at MRP 111 (plates 125 to 127).

Photo 125 - Waste Tyres (MRP111)

Photo 127 - Waste Tyres (MRP111)

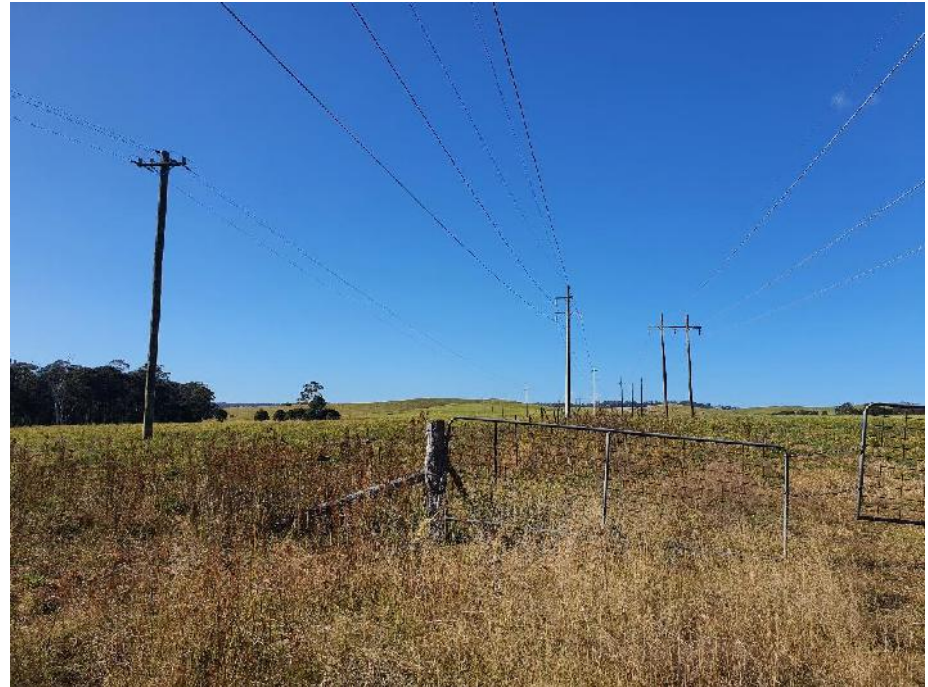
Photo 132 - Powerpoles (MRP116)
