CONSERVATION WORKS SCHEDULE

RAITH
74 -92 Fern Avenue, Bradbury

November 2018

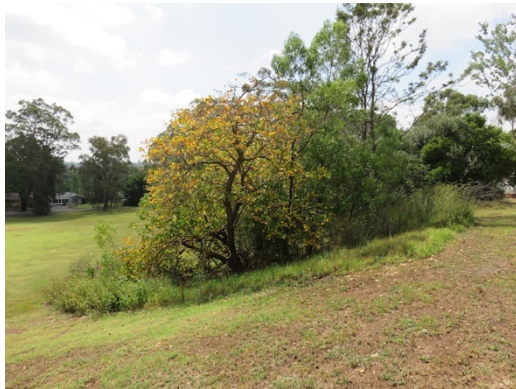
Former southern driveway alignment to right
Original tree and garden group

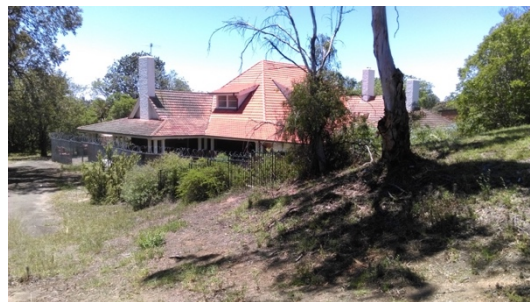
Raith from the former driveway approach

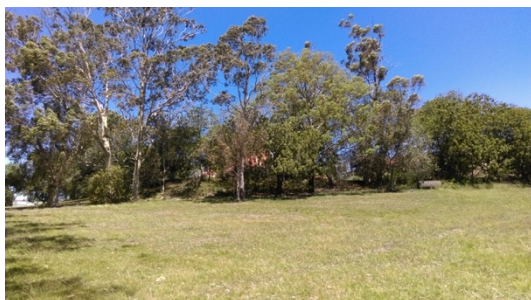
View of house platform from open area

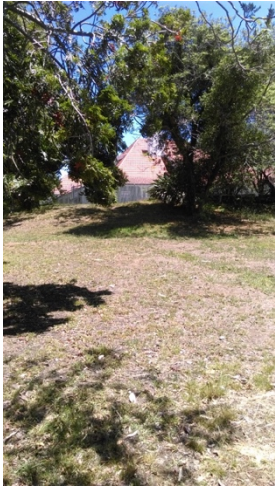
House glimpsed form fern avenue entry

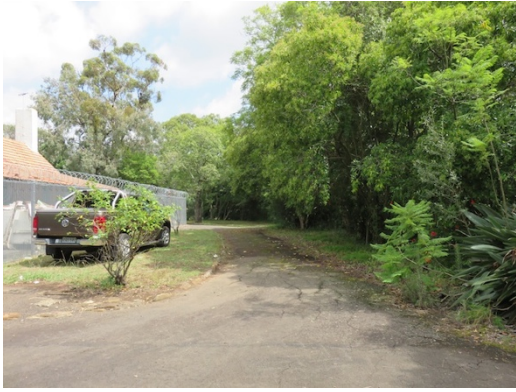
Former circular drive

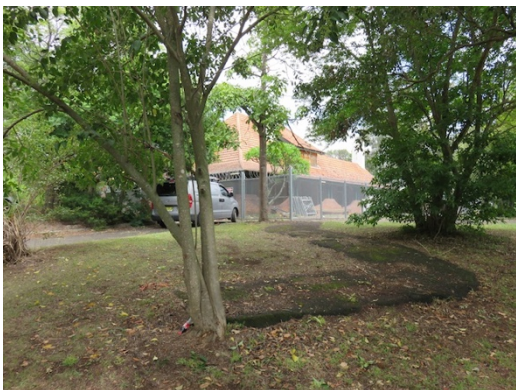
Former pathway entrance from Fern Avenue Drive
(Post childrens Home)

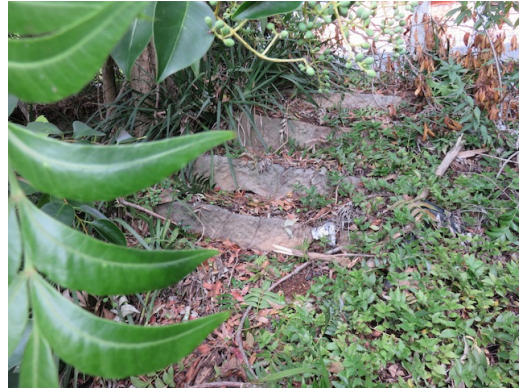
Detail of Sandstone Steps

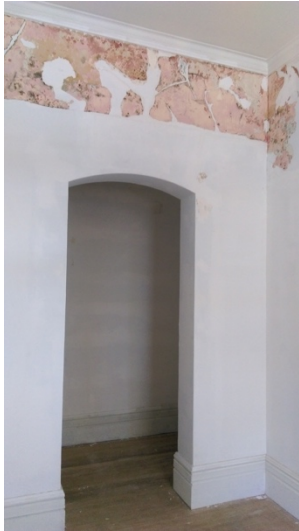
Room 1 conservation issues

Room 1 Reception	High	Refix loose skirting boards	Immediate	Carpenter	\$500.00
Repainting	High	Note previous colour schemes for walls include : - Eu de Nil - Rich Cream - Eggshell blue	After repairs	Painter	See Cyclical maintenance cost below.
Room 2 Study	High	Ceiling paint peeling – test for chemical /oil deposits.	Immediate	Specialist Renderer damp / render / toxin removals	Included above
Room 3 / 4 Vestibule to sitting room	High	Remove drainage pipe from redundant bathroom over. Repair and repaint	Immediate	Carpenter / plasterer	\$2500.00
Hall 2 – western end	High	Substantial sub floor damage area, substantial damp area.	Immediate	Carpenter / renderer toxin specialist	See above
Room 6 Bedroom	High	Floor damage – remaining fire damage, termites, floor bounce.	Immediate	Carpenter	\$3000.00
Bath 1	High	After wall treatment noted above, refit bathroom with new fitout to functioning bathroom – retain existing	Prior to occupation	Builder	\$10000.00

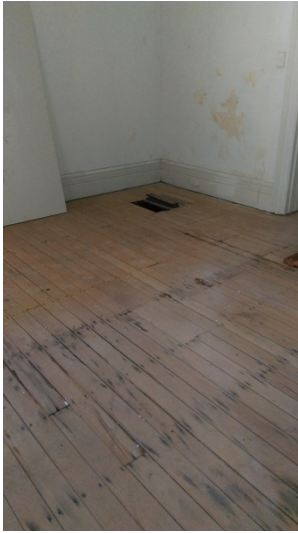
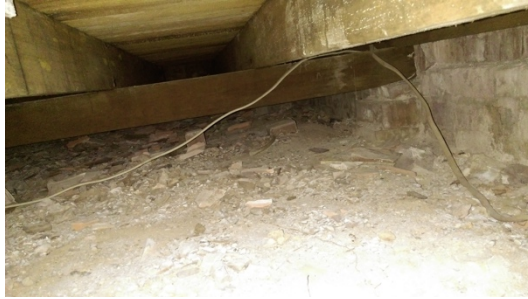
Room 6 and 7 Conservation Issues to floor
