**BROOKVALE PUBLIC SCHOOL
2-8 OLD PITTWATER ROAD, BROOKVALE**

ALTERATIONS & ADDITIONS INCLUDING CONSTRUCTION OF A NEW SCHOOL HALL

**DA 2019/0411 – NORTHERN BEACHES COUNCIL
SYDNEY NORTH PLANNING PANEL REF. PPSSNH-24
PANEL MEETING 25 SEPTEMBER 2019**

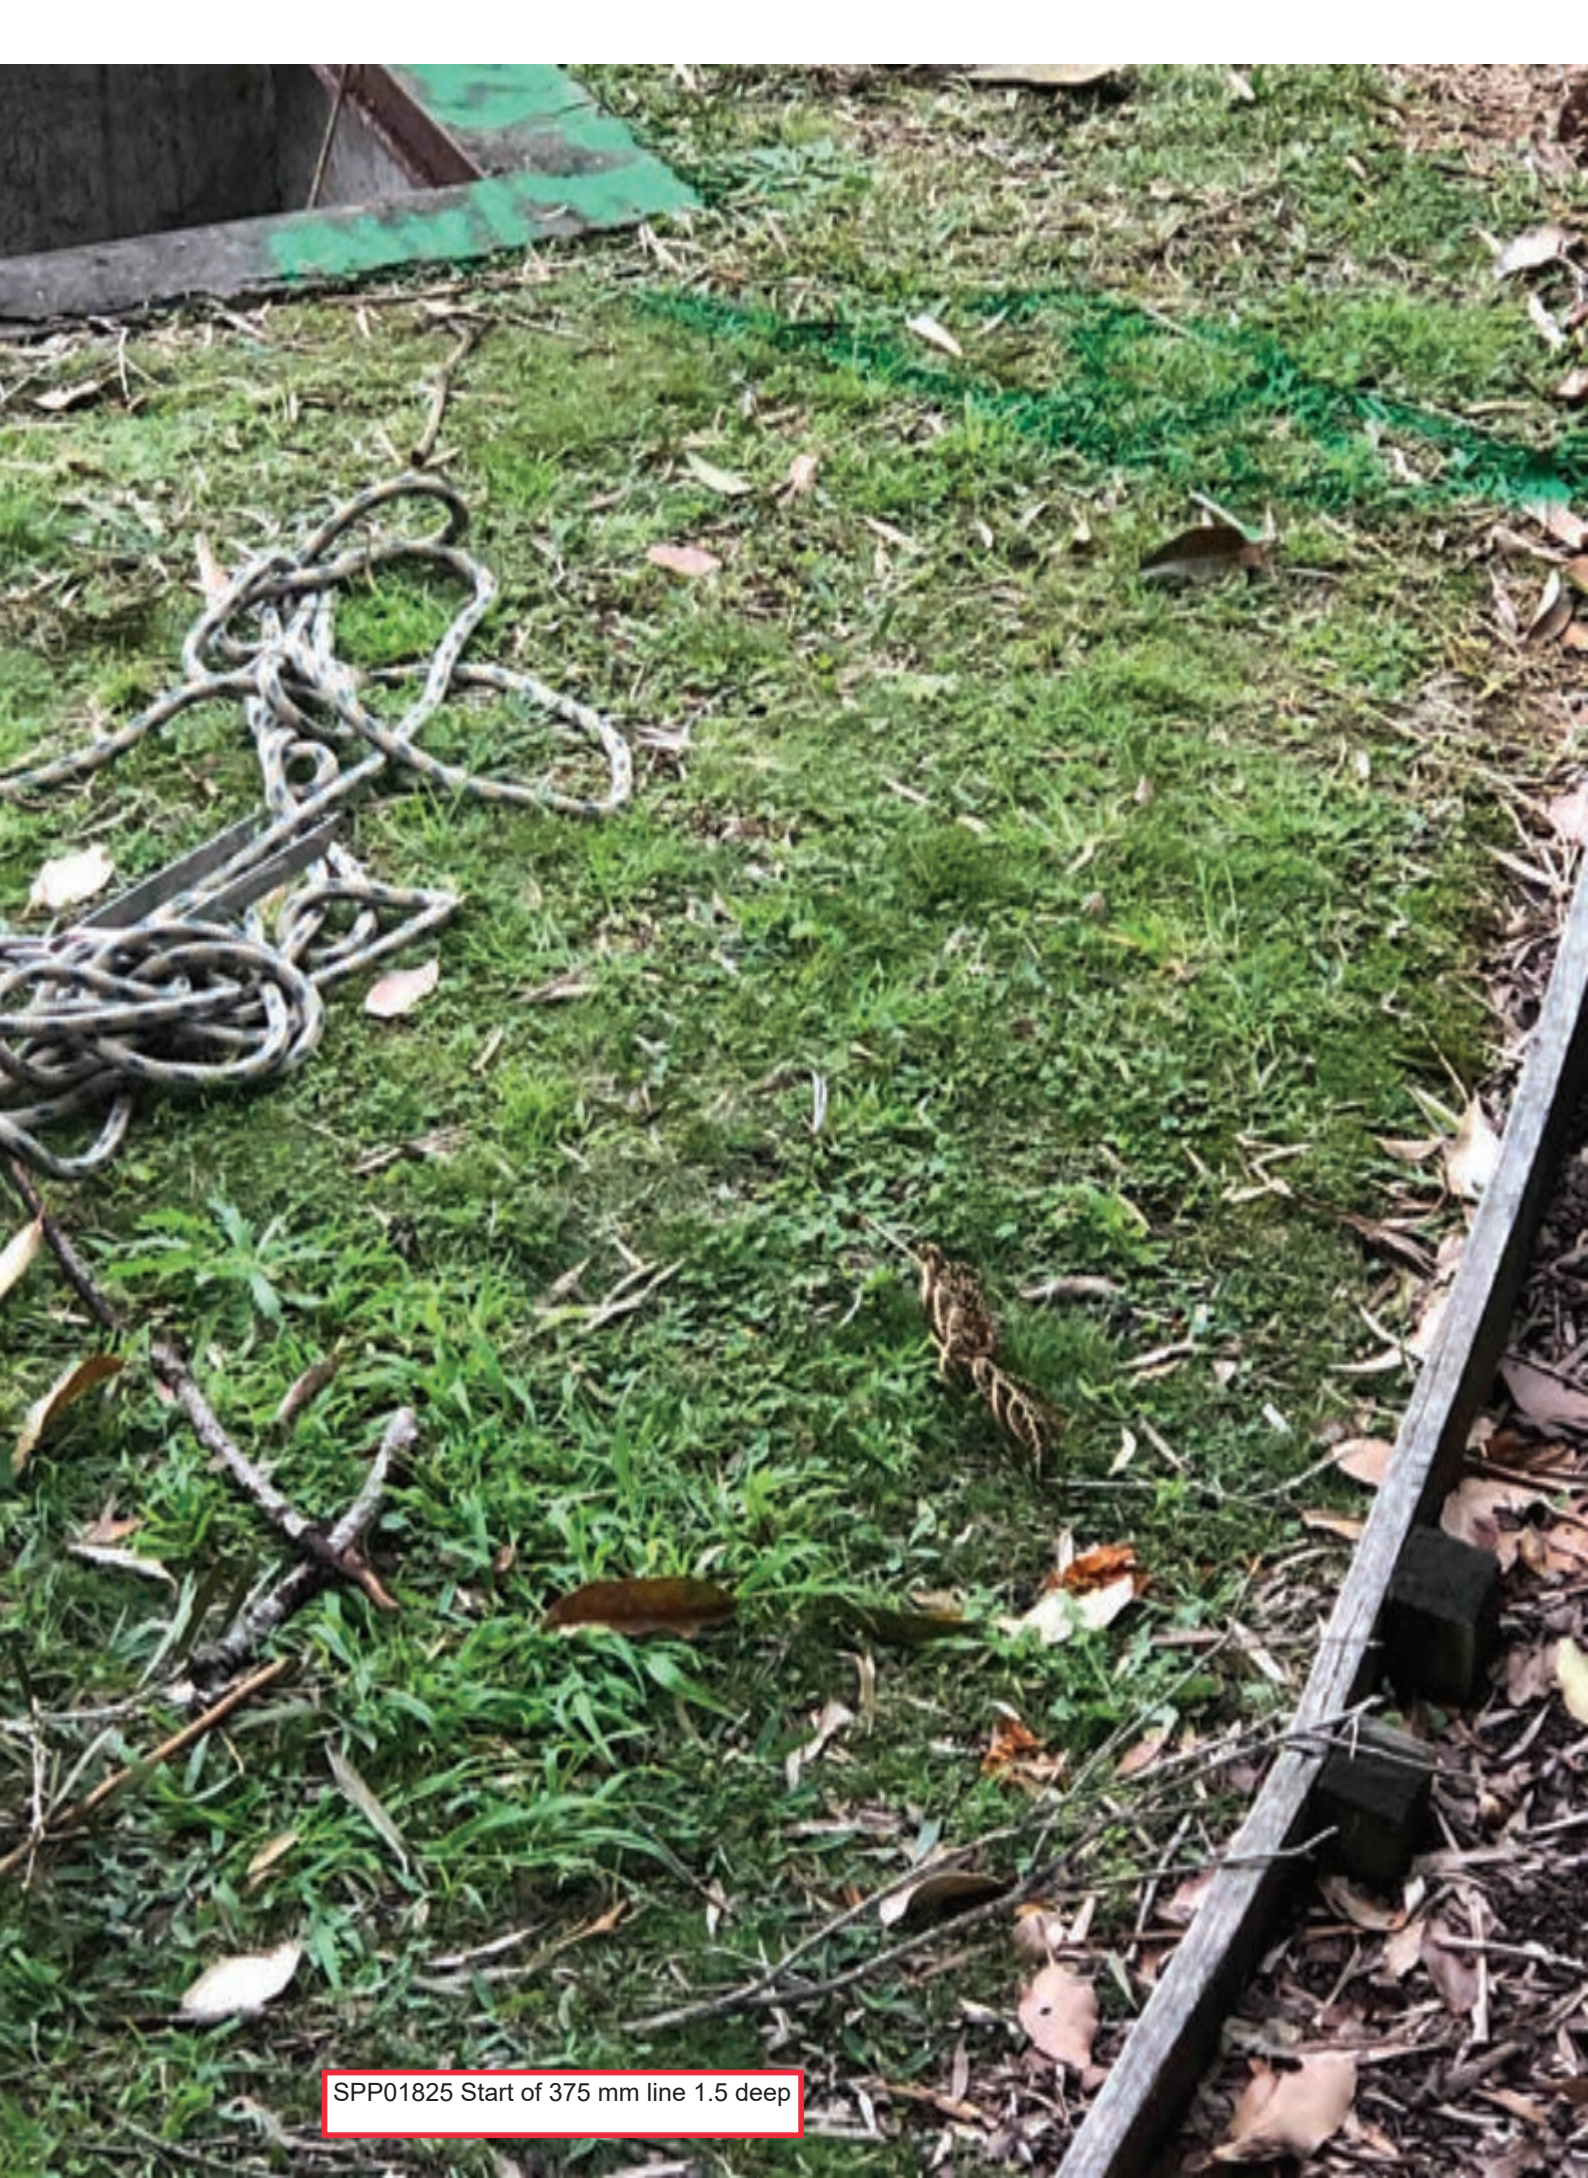
SPP01825 Start of 375 mm line 1.5 deep

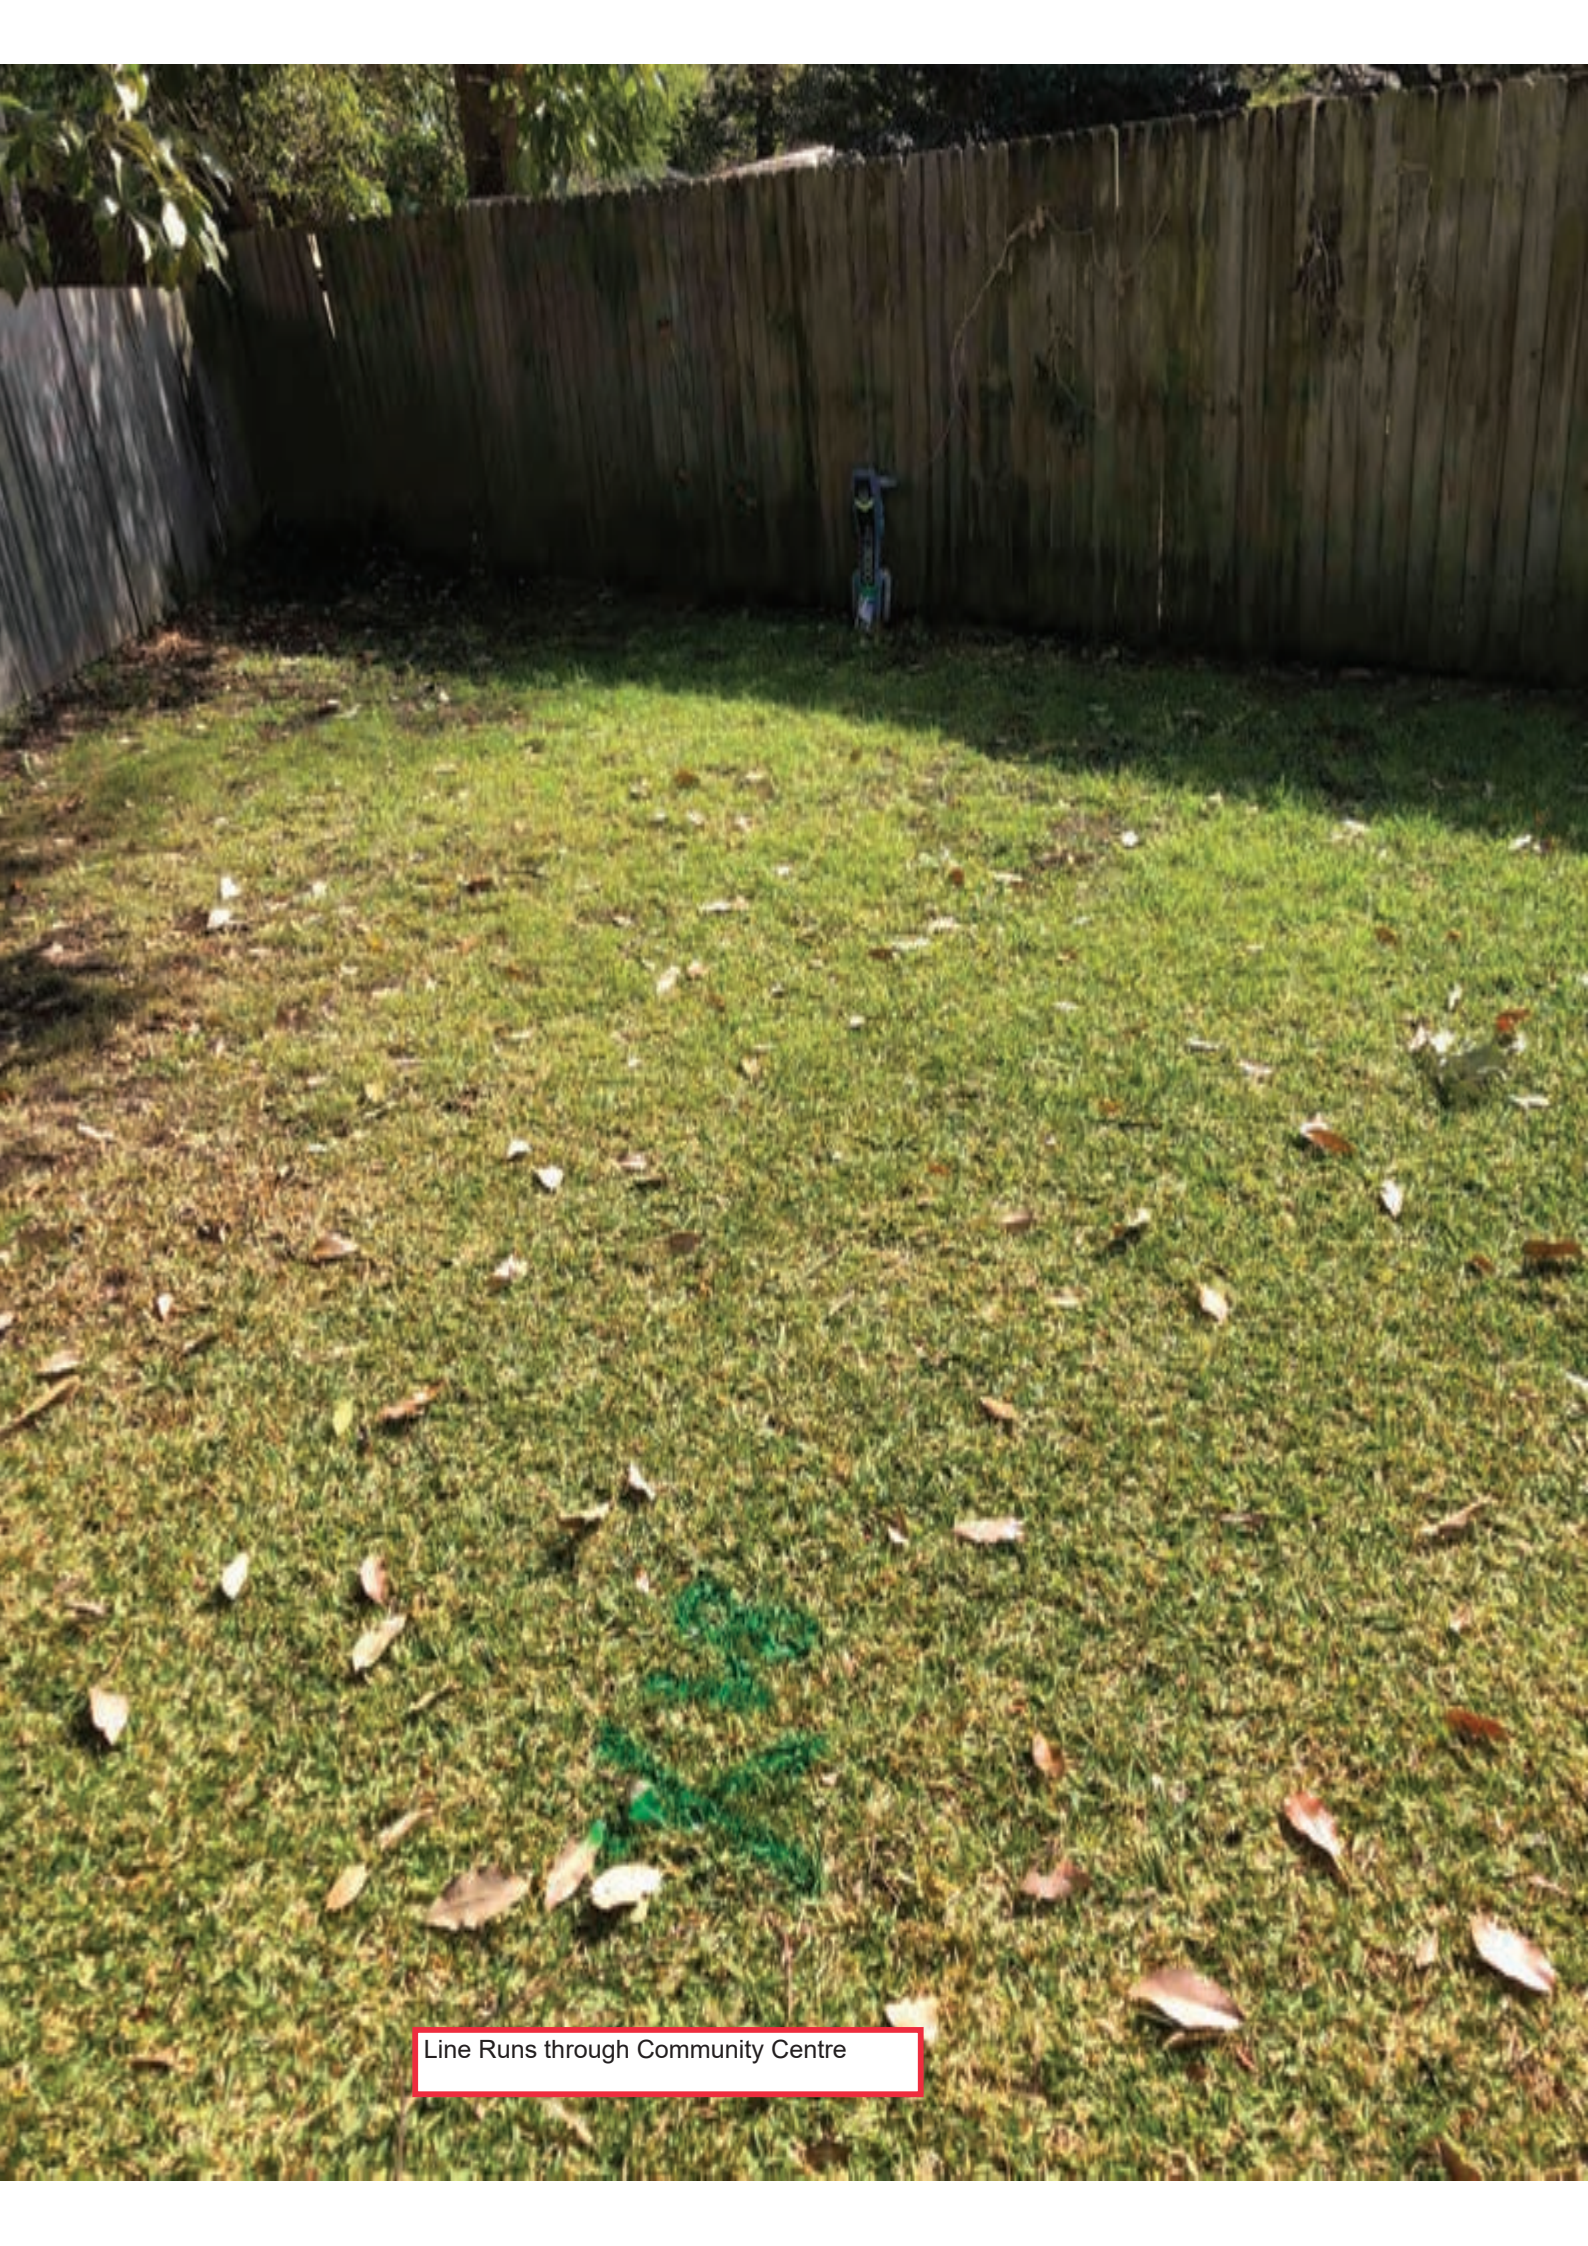
Line Runs through Community Centre

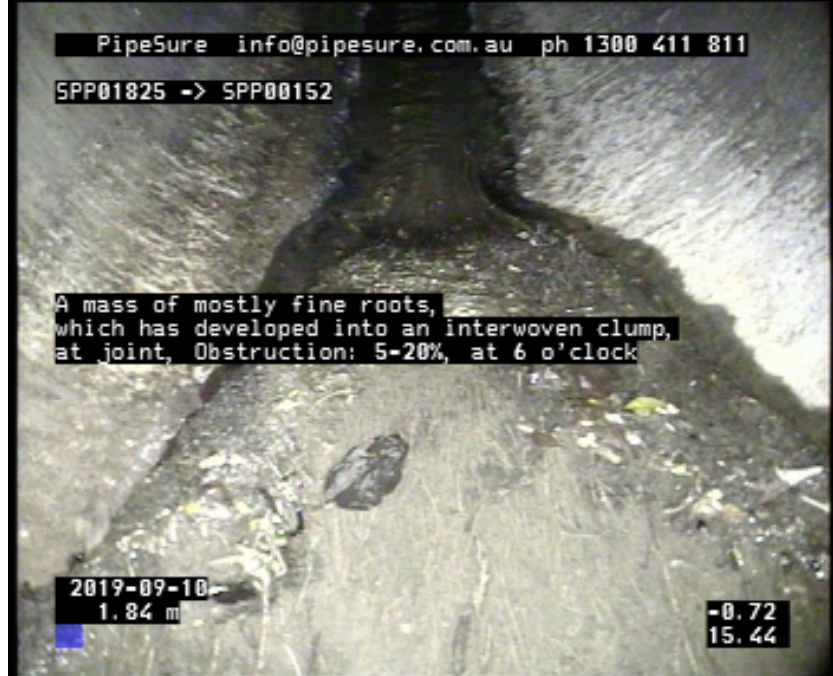
Photo: 1_3A, Media No:: 100919_1, 00:00:57
1.84m, A mass of mostly fine roots, which has developed into an interwoven clump, at joint, Obstruction: 5-20%, at 6 o'clock

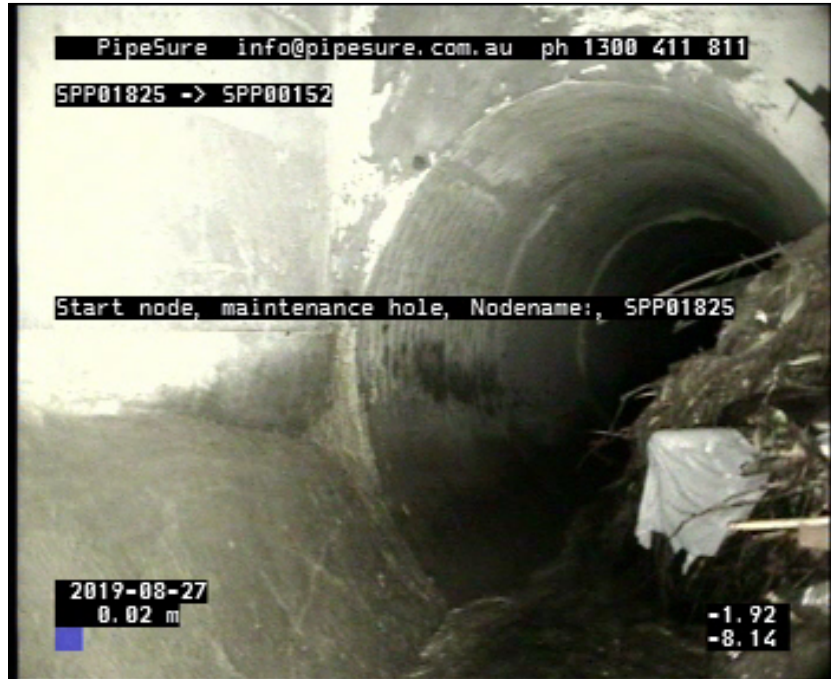
Photo: 1_1B, Media No:: 280819_1, 00:00:12
0m, Start node, maintenance hole, Nodename:, SPP01825

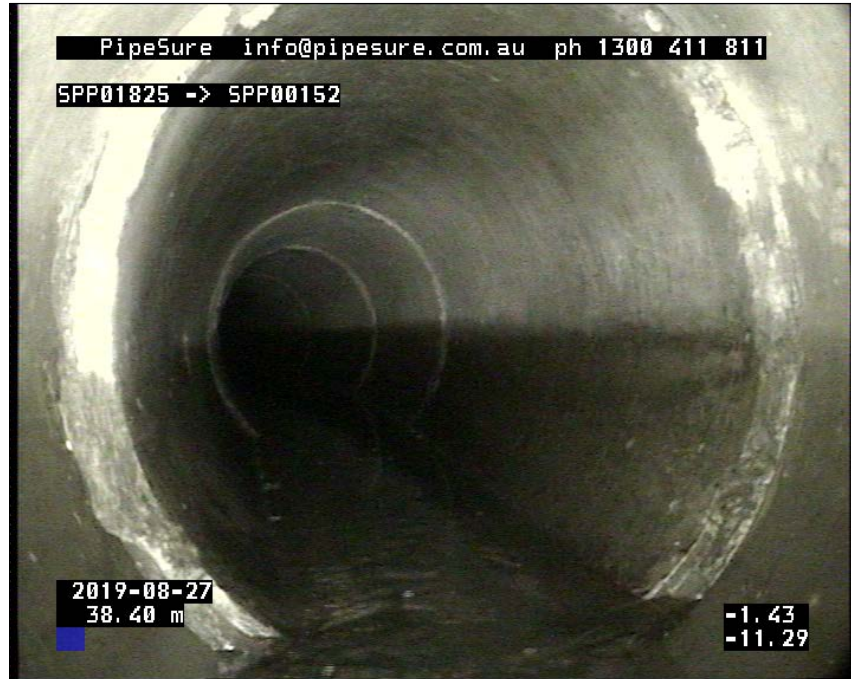
Photo: 1_6B, Media No:: 280819_1, 00:10:54
38.4m, The conduit curves to the left, length: 2 mm

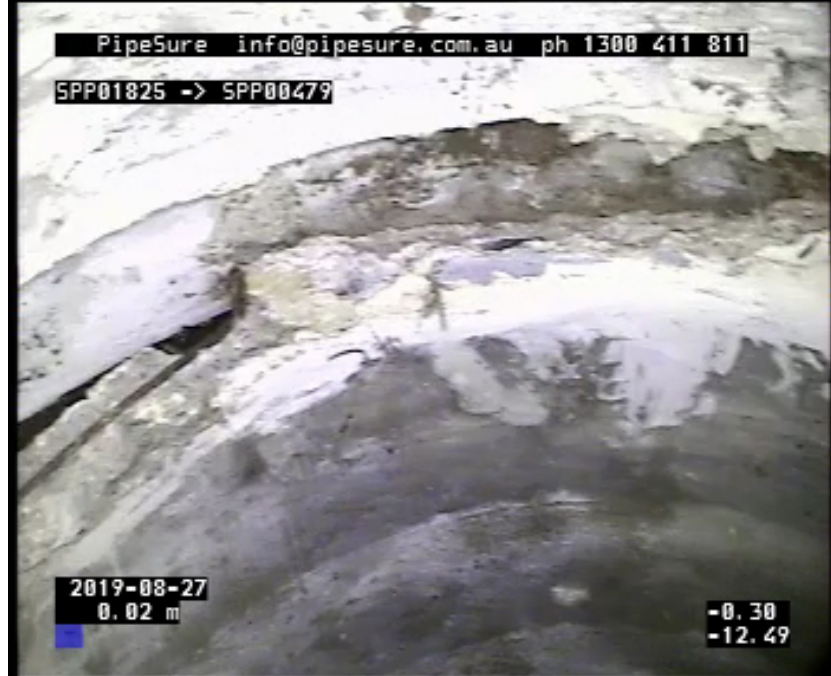
Photo: 3_2A, Media No:: 280819_1, 00:00:39
0.02m, Joint displaced longitudinally, longitudinal displacement: >30mm, at 11 o'clock

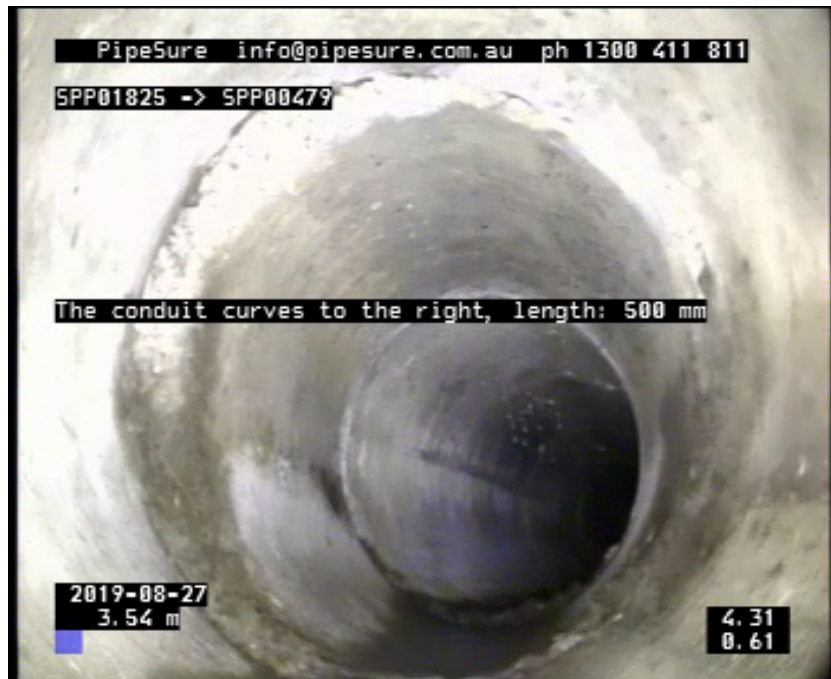
Photo: 3_5A, Media No:: 280819_1, 00:02:22
3.54m, The conduit curves to the right, length: 500 mm

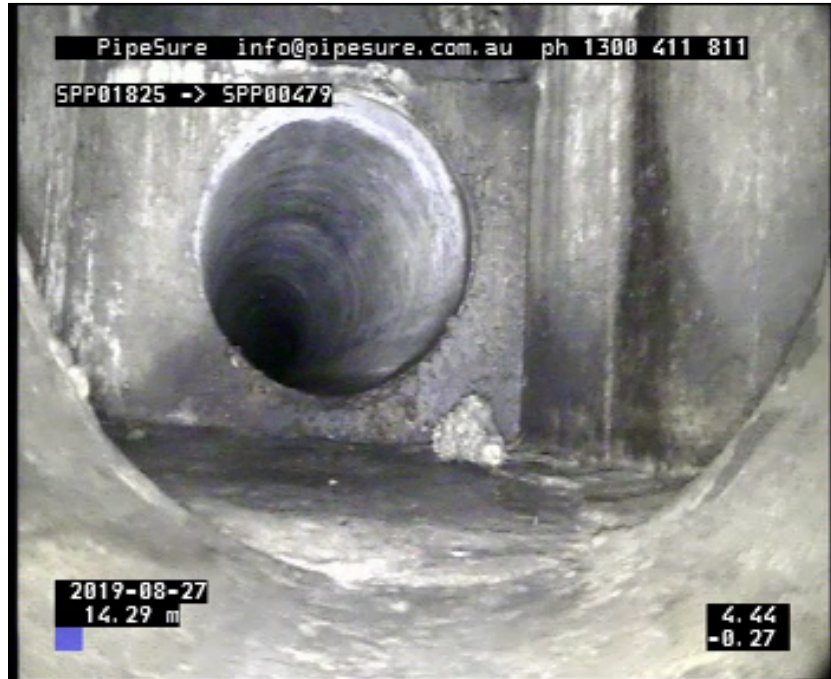
Photo: 3_11A, Media No:: 280819_1, 00:08:37
15.3m, Finish node, maintenance hole, Nodename:, BURIED PIT

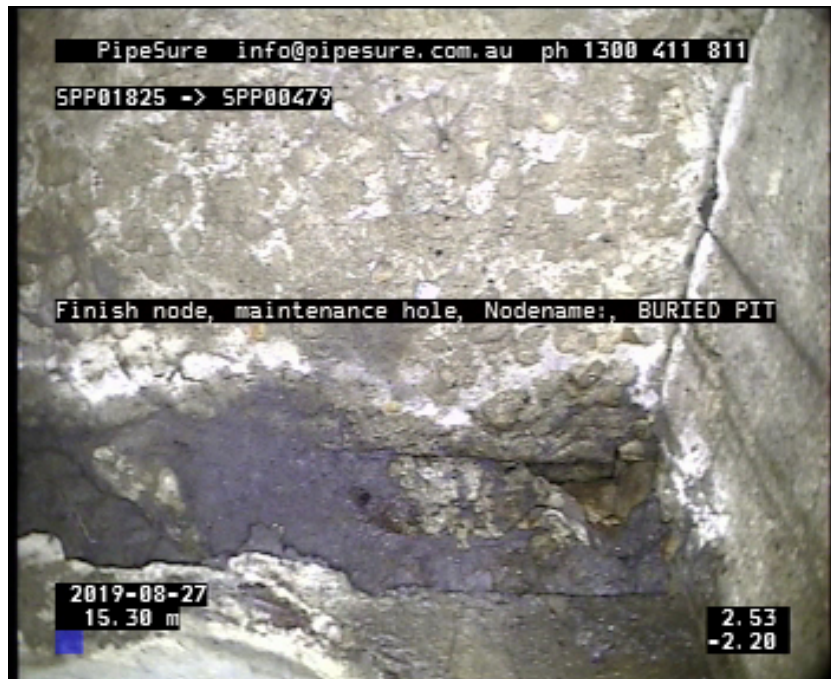
Photo: 3_11B, Media No:: 280819_1, 00:08:37
15.3m, Finish node, maintenance hole, Nodename:, BURIED PIT

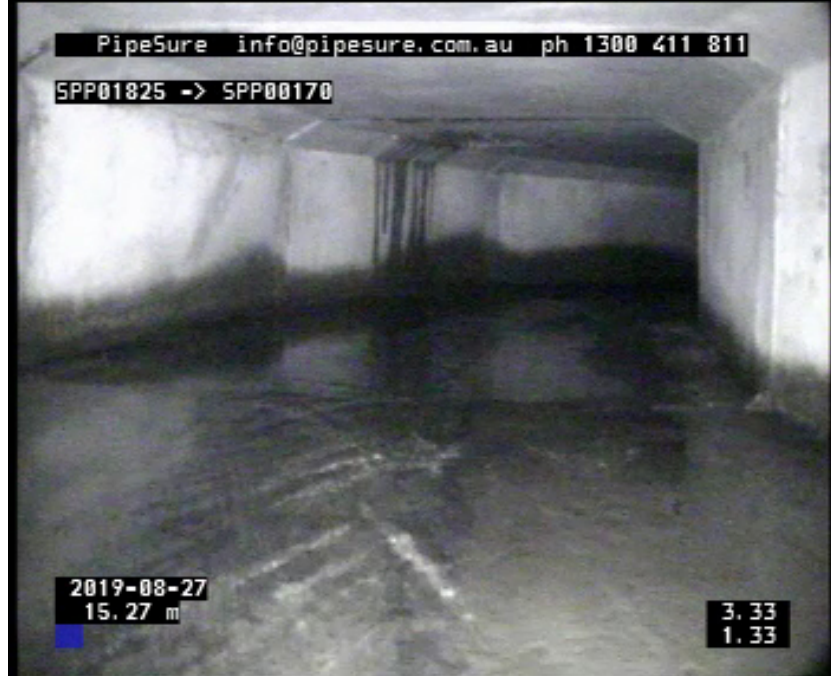
Photo: 4_3A, Media No:: 280819_1, 00:05:03
17.58m, The conduit curves to the right, length: 1000 mm

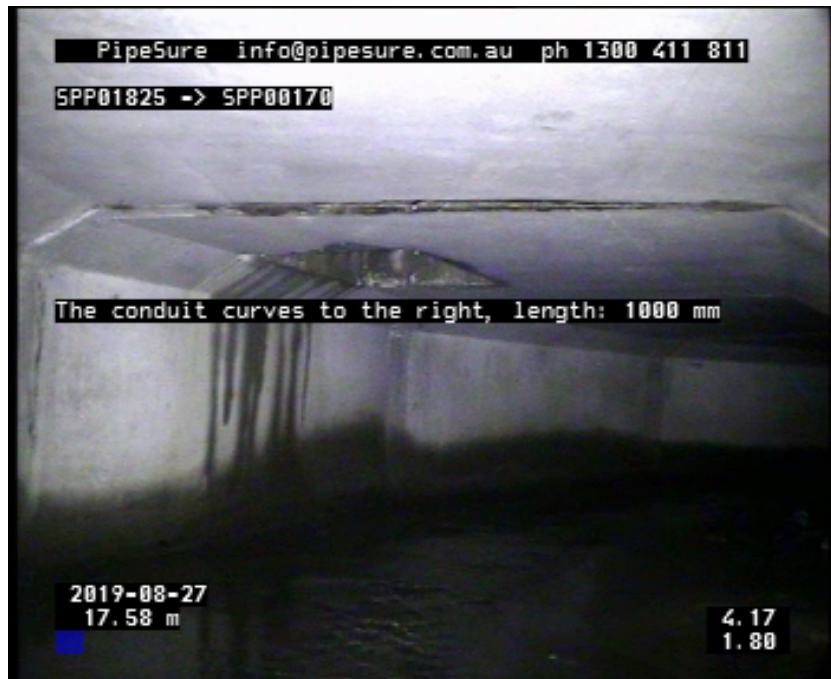
Photo: 4_3B, Media No:: 280819_1, 00:05:03
17.58m, The conduit curves to the right, length: 1000 mm

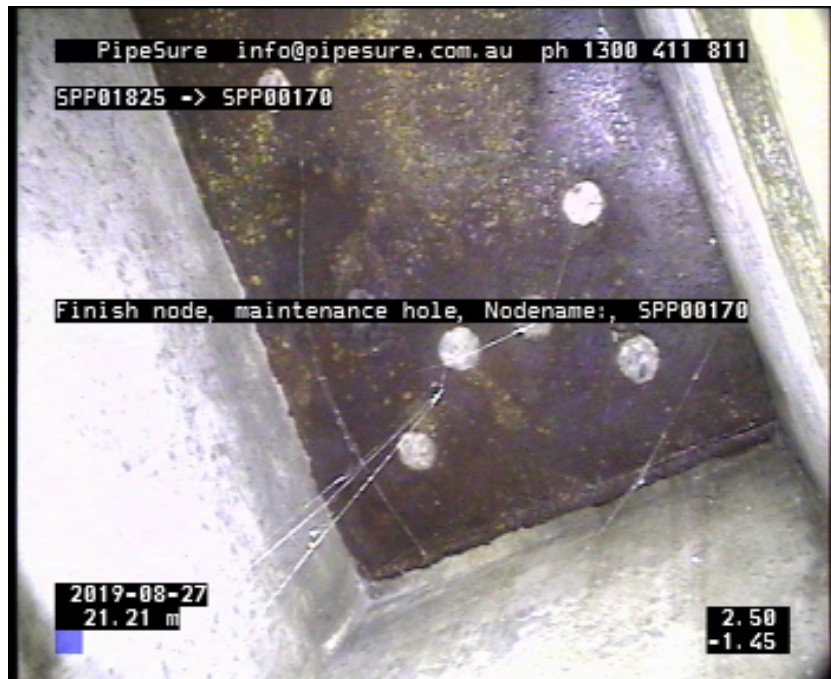
Photo: 4_5A, Media No:: 280819_1, 00:06:09
21.21m, Finish node, maintenance hole, Nodename:, SPP00170
