DA Structural Report

Malthouses 1, 2 and Maltsters House The Maltings, Mittagong

Colliers International / 29 August 2024

221582

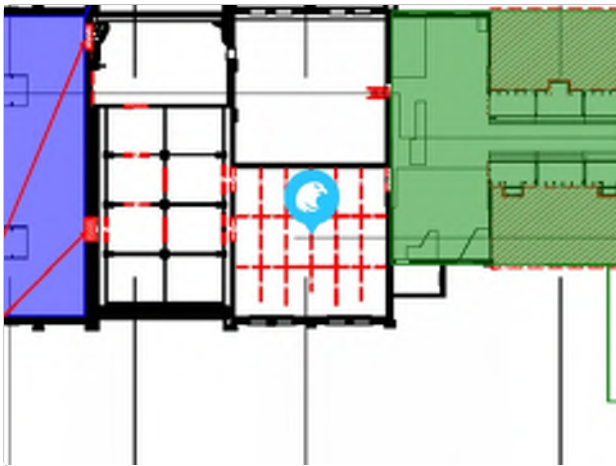
Spot 55

REMARKS
Unsafe to inspect close up
Species hard to identify but is mixed nsw hardwood originally SG2 F22
End of rafters

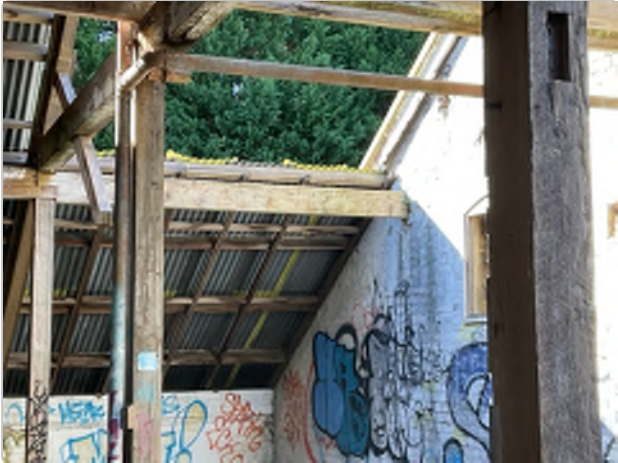
Spot 53

SEVERITY
Major

REMARKS
Suspect out of grade

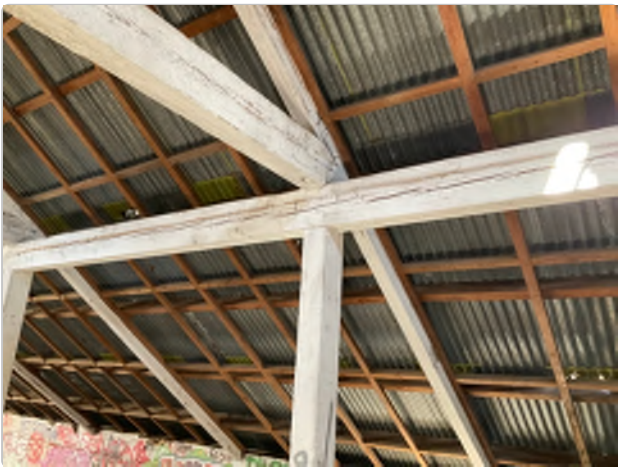
Spot 52

REMARKS
Out of grade

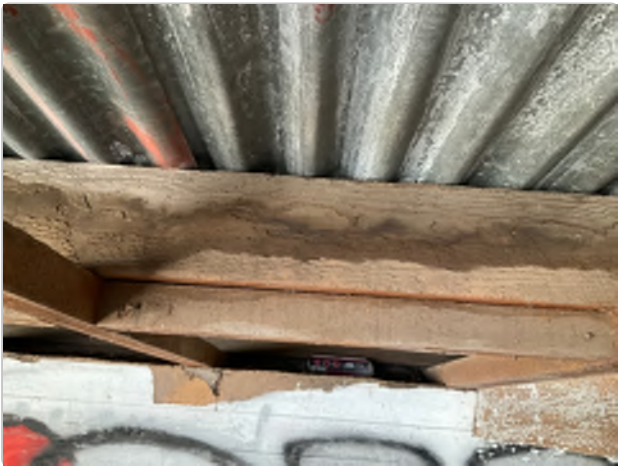
Spot 49

REMARKS
Size: 120x60
C-C: 1120
Redwood: likely to be Californian red fir
All visible likely to be sound where there is roofing and unsound where no roofing. treat as F11 where sound
Imported softwood

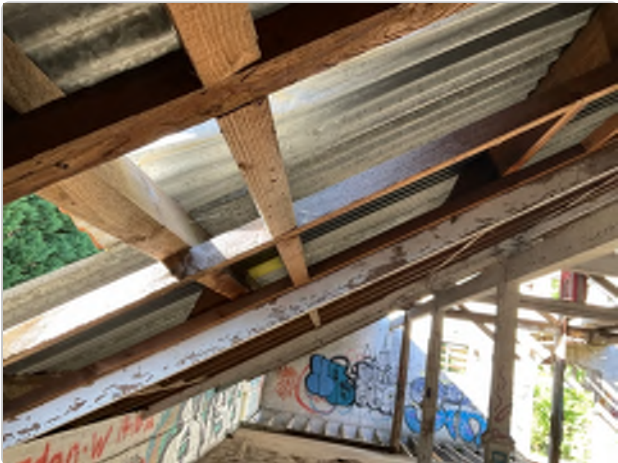
Spot 48

All largely in good condition treat as F11

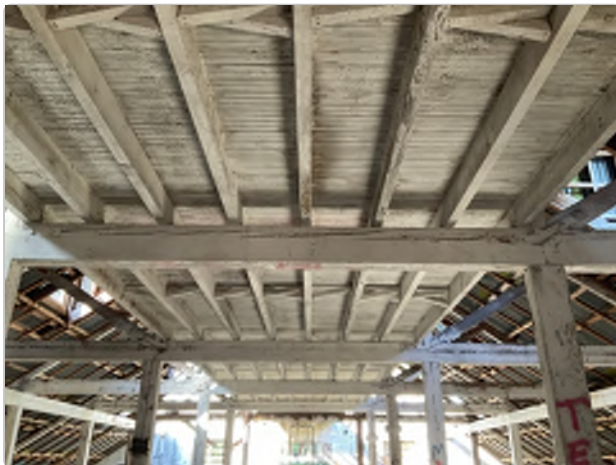
Spot 45

DEFECT
split

REMARKS
Centre section of bottom chord 5 splits face to face
Repair

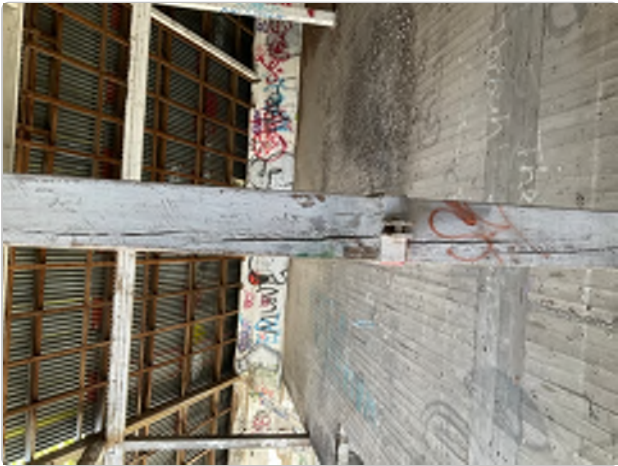
Spot 43

DEFECT
Split

REMARKS
Every post that has metal bracing/repairs is considered Out of grade
Span 3430

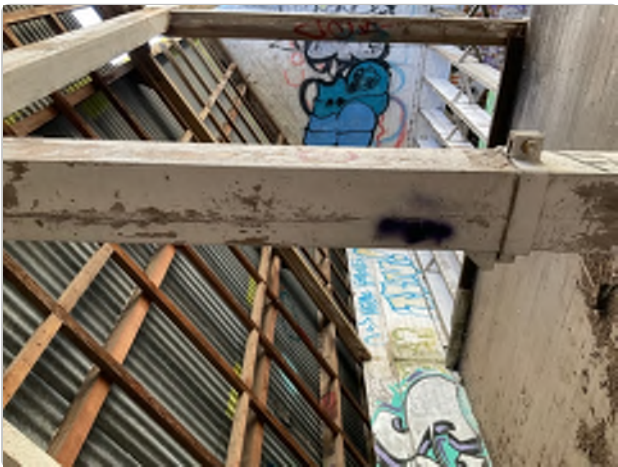
Spot 42

DEFECT
split

REMARKS
Out of grade

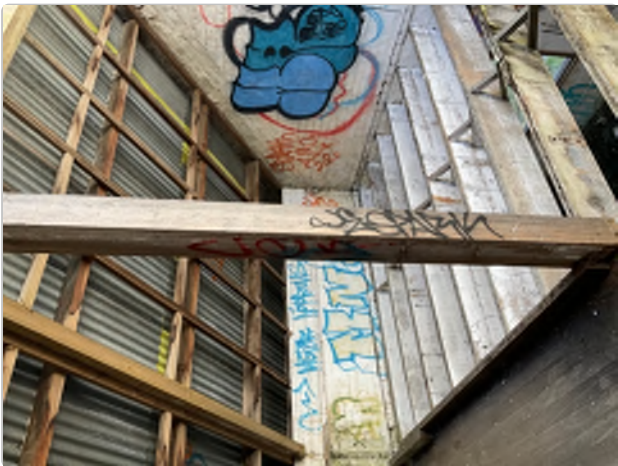
Spot 41 [↗](#)

DEFECT
none

REMARKS
Size
200x150
Repair and split on so many may indicate size too small for the load or poor quality timber

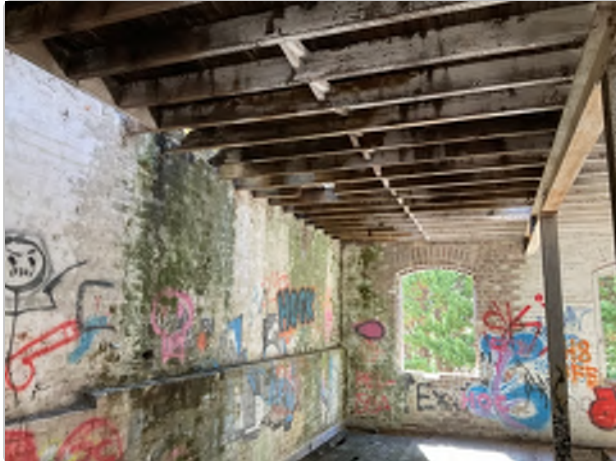
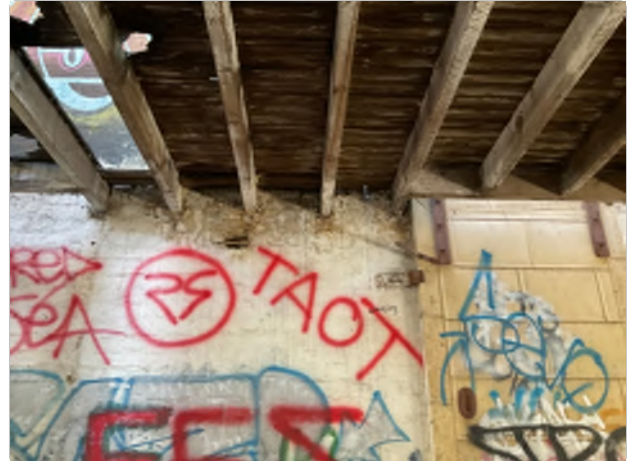
Spot 41 [↗](#)

DEFECT
Rot

REMARKS
As with the decay in the lower floor end beams are all suspect to rot and decay

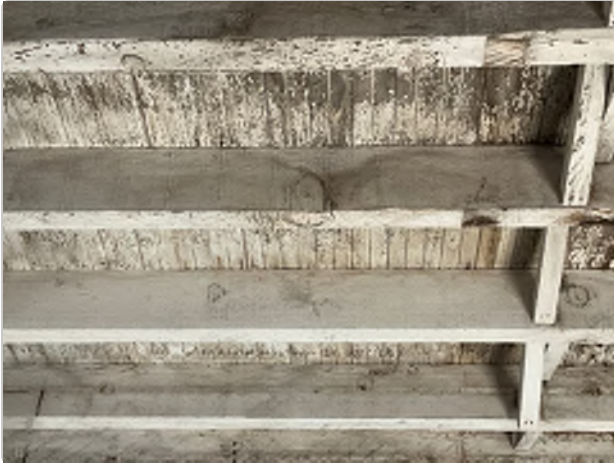
Spot 36

DEFECT

Excessive knot with checking around it

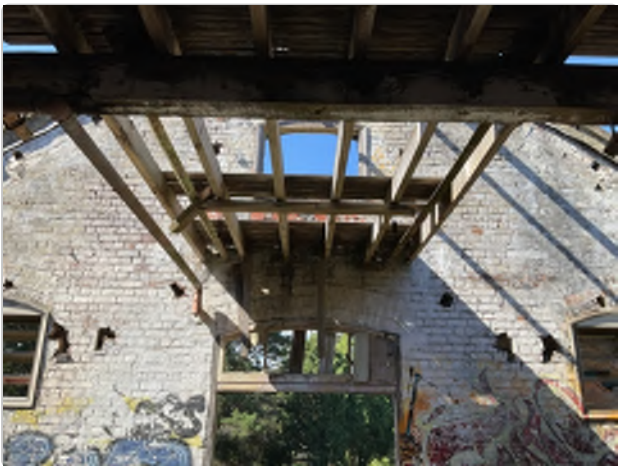
Spot 35 [↗](#)

DEFECT
combined

All unsound

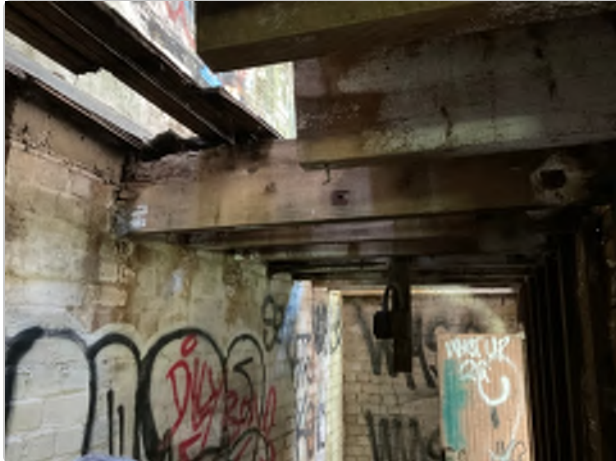
Spot 34 [↗](#)

DEFECT
Rot

REMARKS
Members connected to wall are rotten at connection all suspect

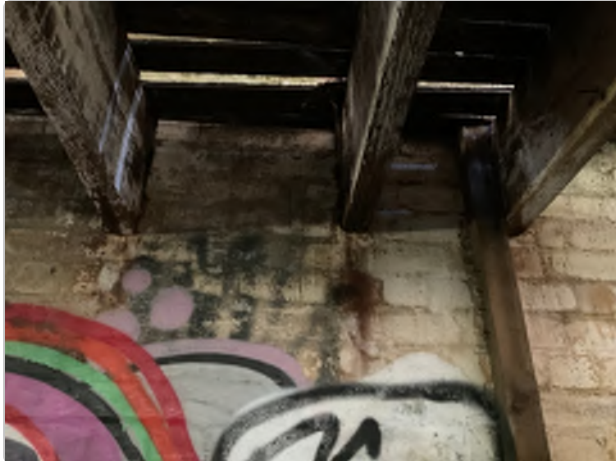
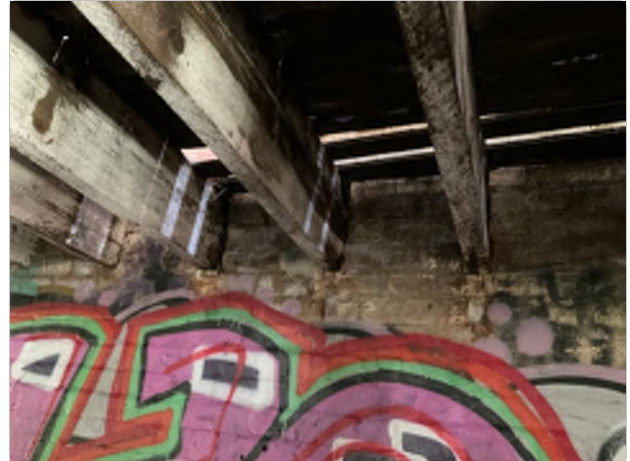
Spot 33

DEFECT
Rot

REMARKS
Decayed

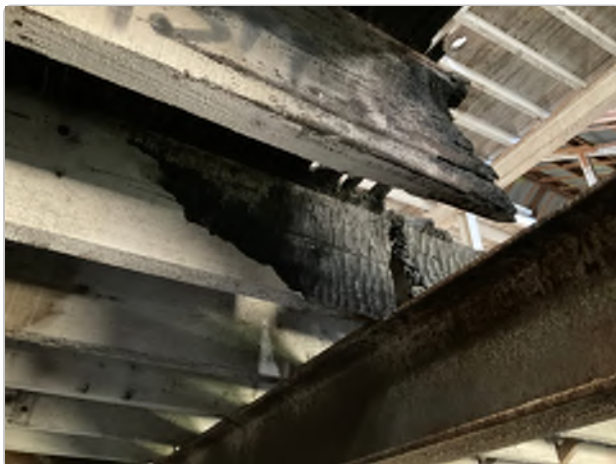
Spot 31 [↗](#)

DEFECT
Fire damage

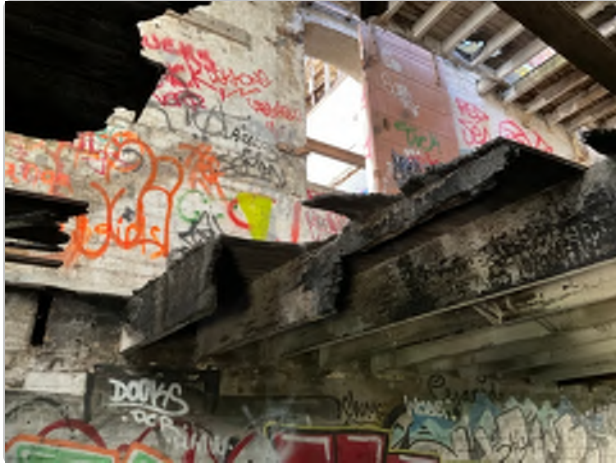
Spot 30 [↗](#)

DEFECT
fire

REMARKS
1-4 missing, 5 fire damage, 6 and 7 ok, 8 fire damage

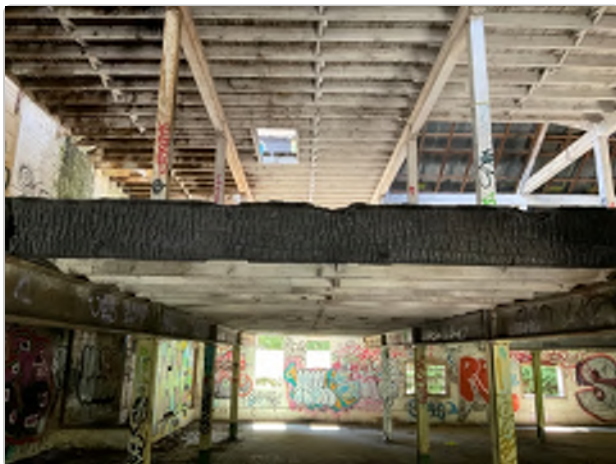
Spot 29 [↗](#)

DEFECT
Fire Damage

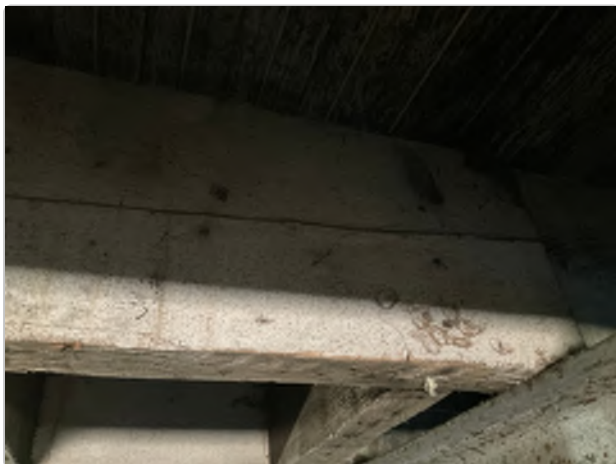
Spot 28 [↗](#)

DEFECT
End Split

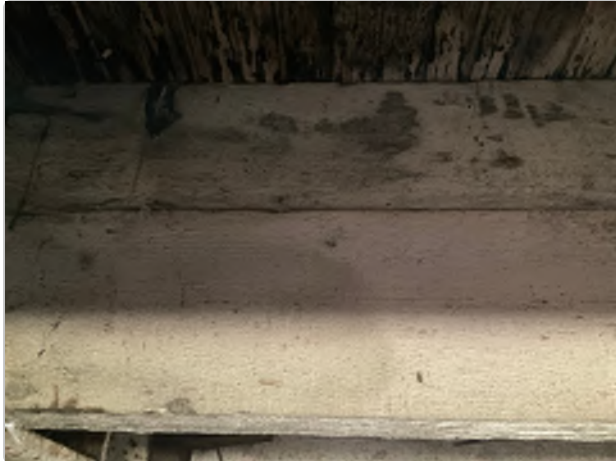
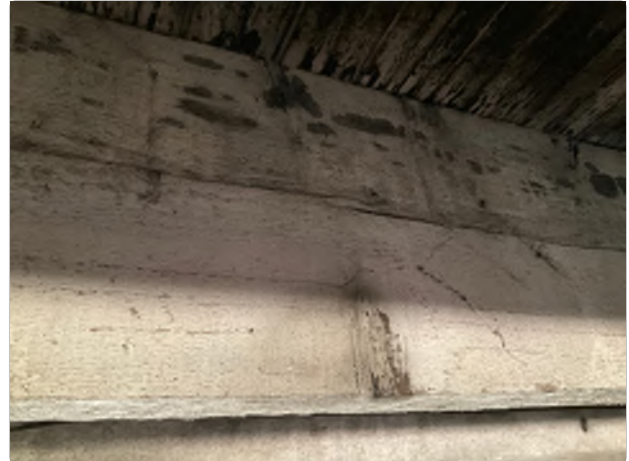
Spot 27 [↗](#)

DEFECT
End Split

REMARKS
600mm

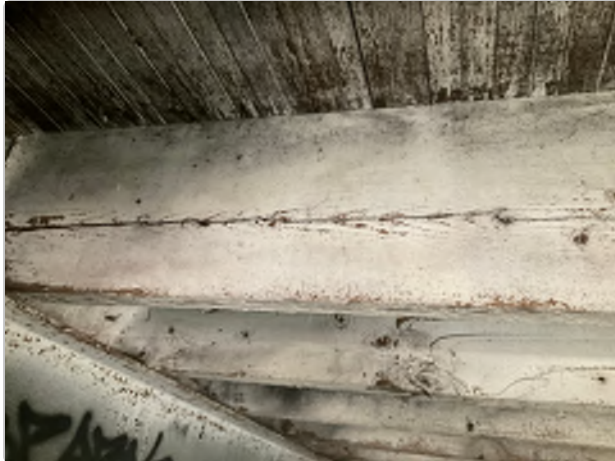
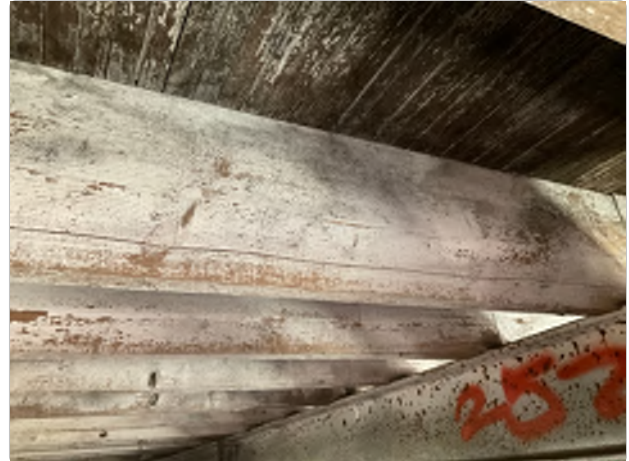
Spot 26 [↗](#)

DEFECT
End Split

REMARKS
End to end

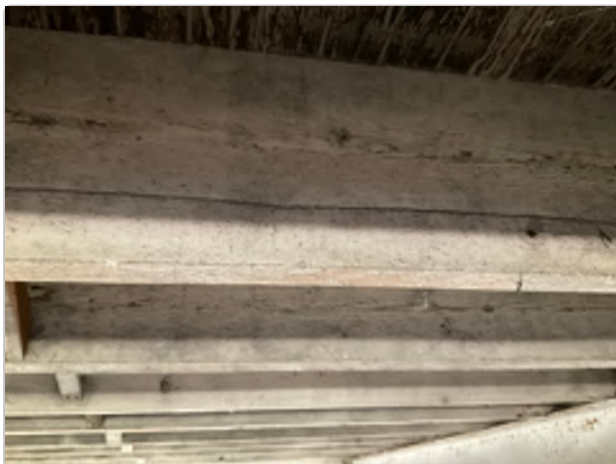
Spot 25 [↗](#)

DEFECT
Fracture/shake

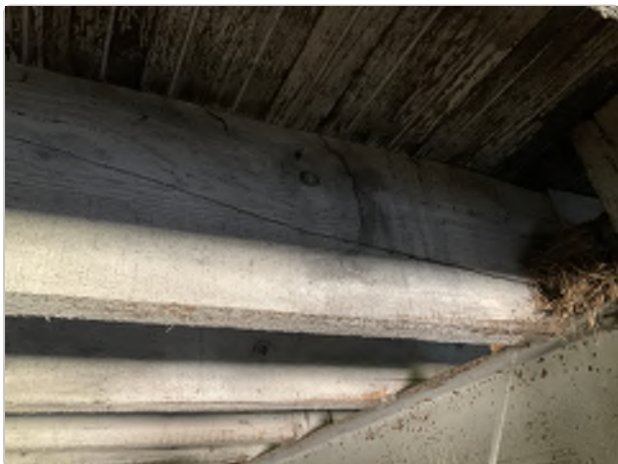
Spot 24 [↗](#)

DEFECT
End Split

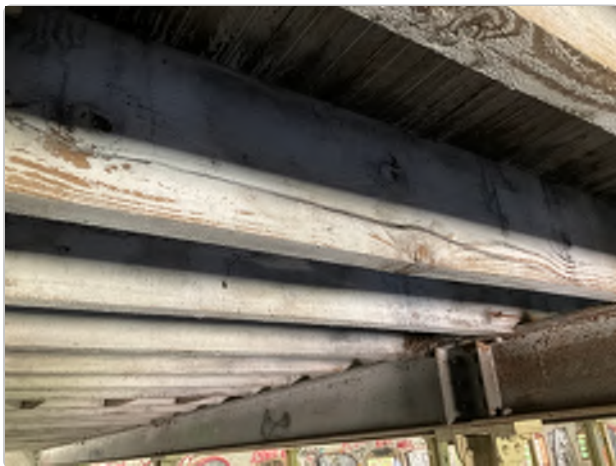
Spot 23 [↗](#)

DEFECT
Fracture/split

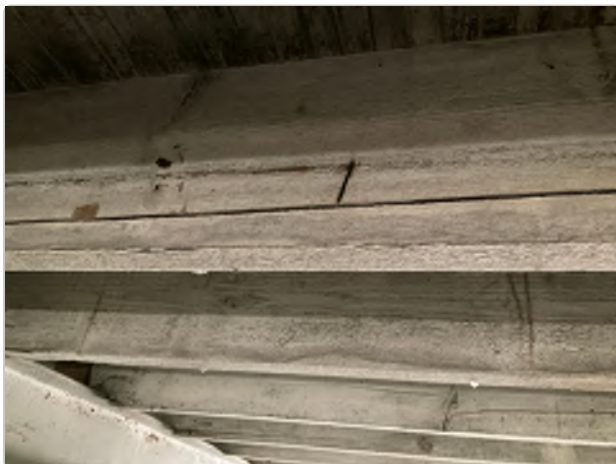
Spot 22 [↗](#)

DEFECT
Check

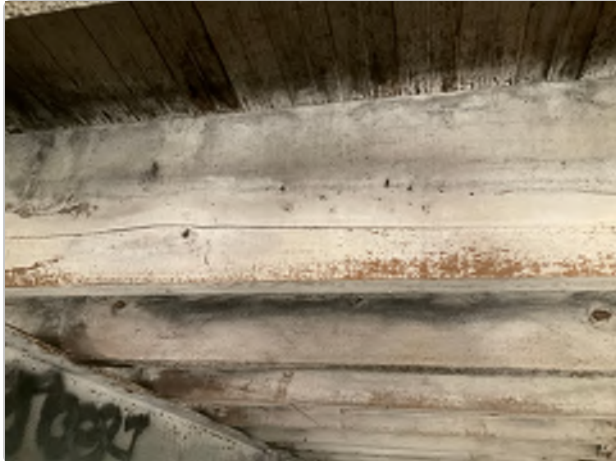
Spot 21 [↗](#)

DEFECT
Check

REMARKS
Not face to face

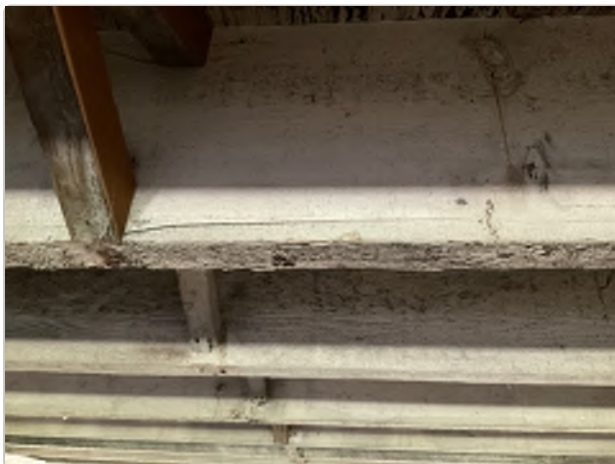
Spot 20

DEFECT
Check

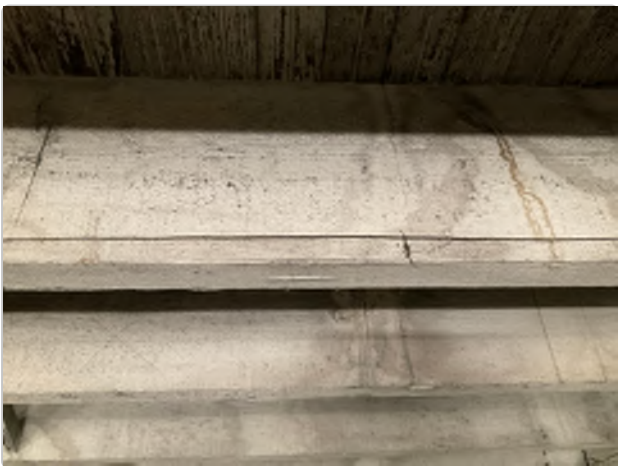
Spot 19

DEFECT
Check

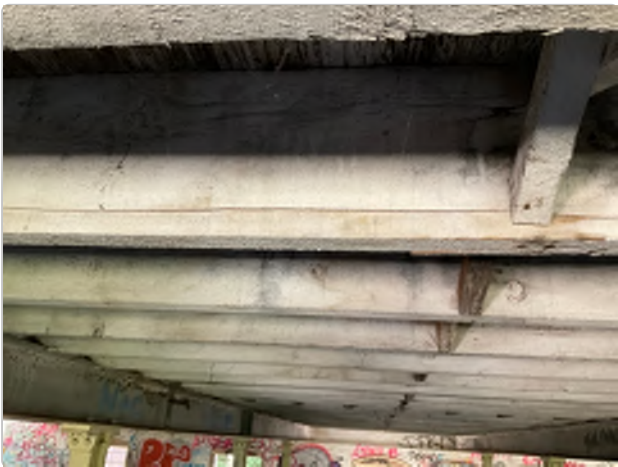
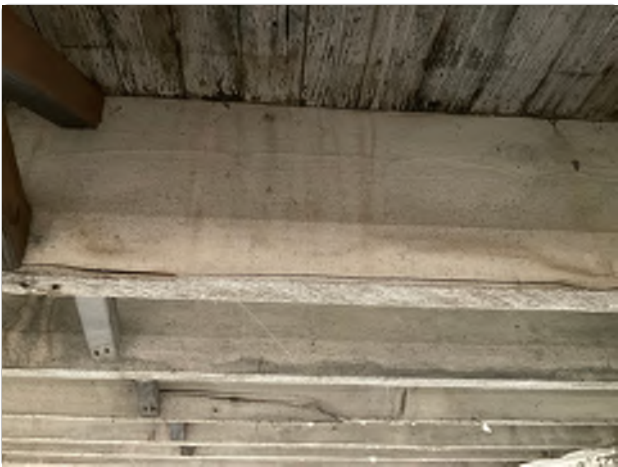
Spot 18 [↗](#)

DEFECT
Check

REMARKS
Repair

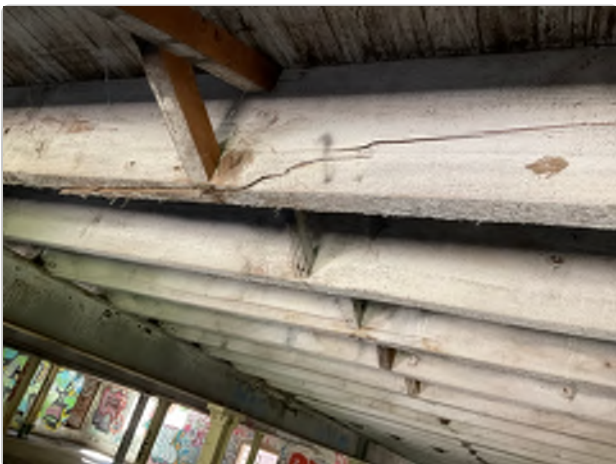
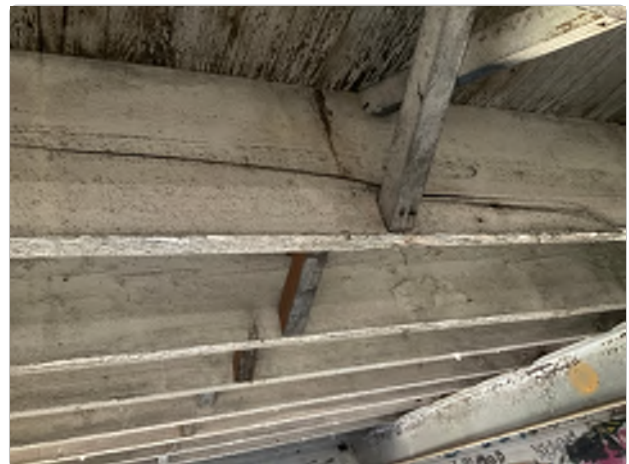
Spot 17

DEFECT
Fracture

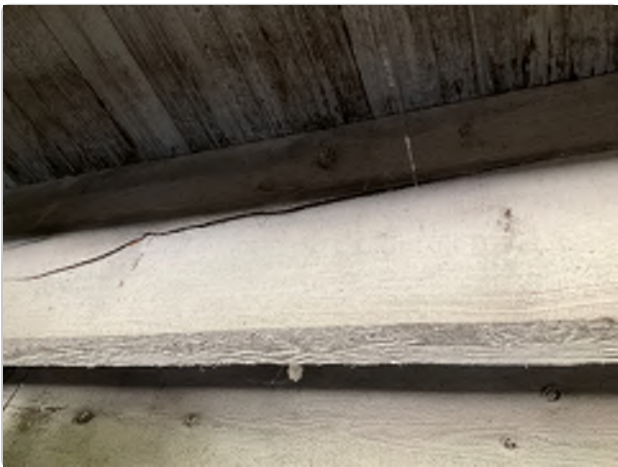
Spot 16

DEFECT
Shake

REMARKS
Repair

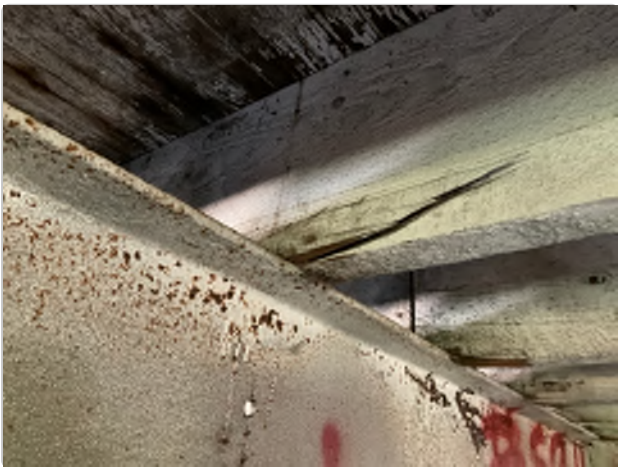
Spot 15 [↗](#)

DEFECT
Fracture

REMARKS
Repair

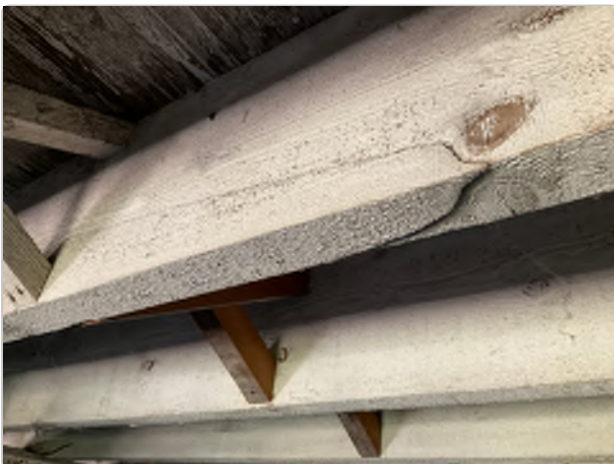
Spot 14

DEFECT
Fracture

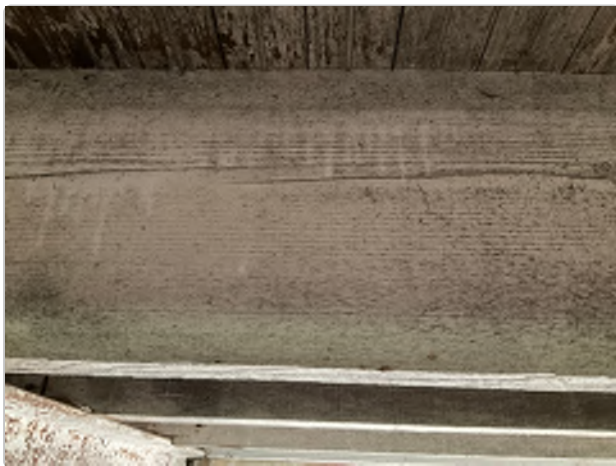
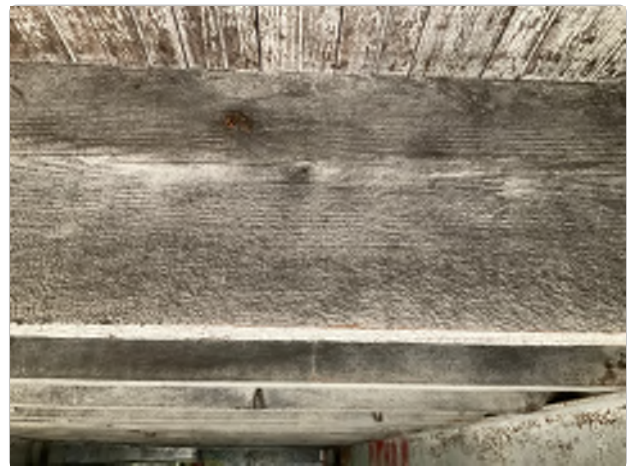
Spot 13

DEFECT
Split face to face

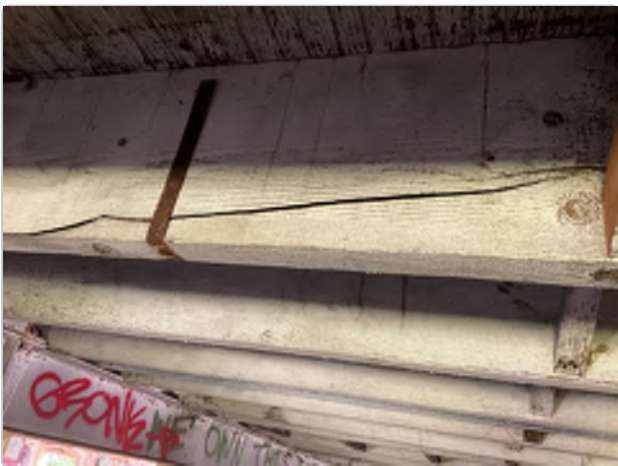
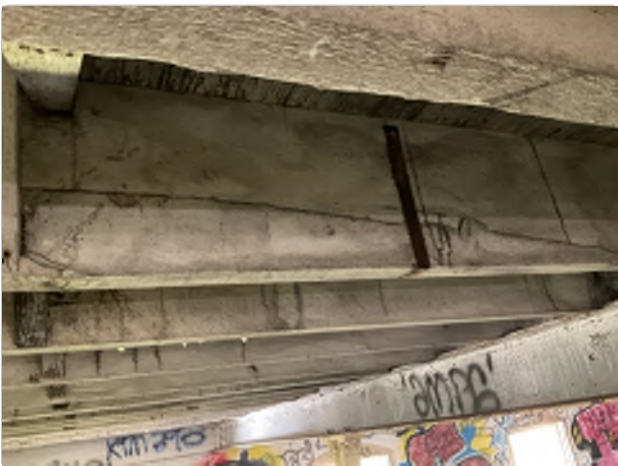
Spot 11 [↗](#)

DEFECT
Fracture

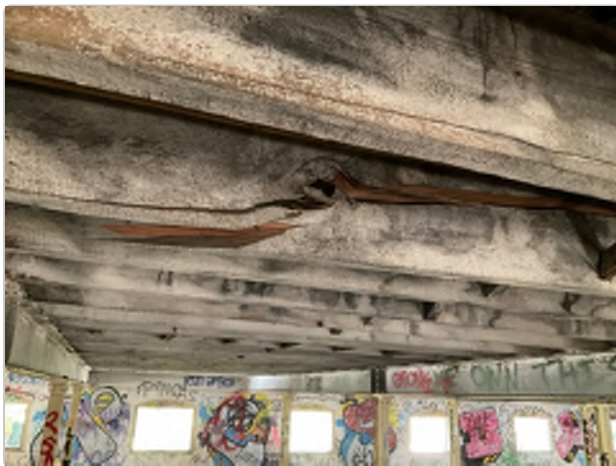
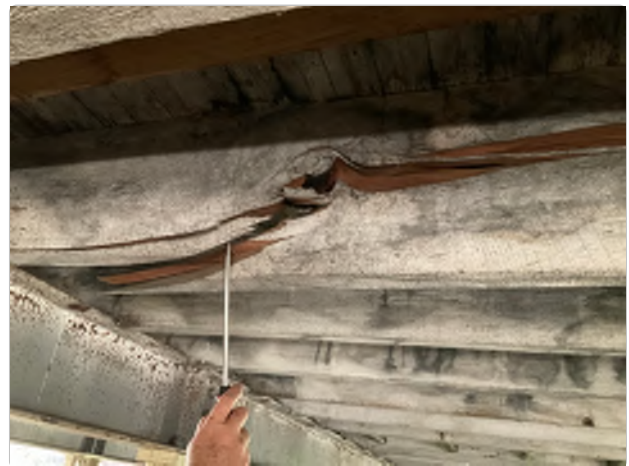
Spot 10

DEFECT
fracture

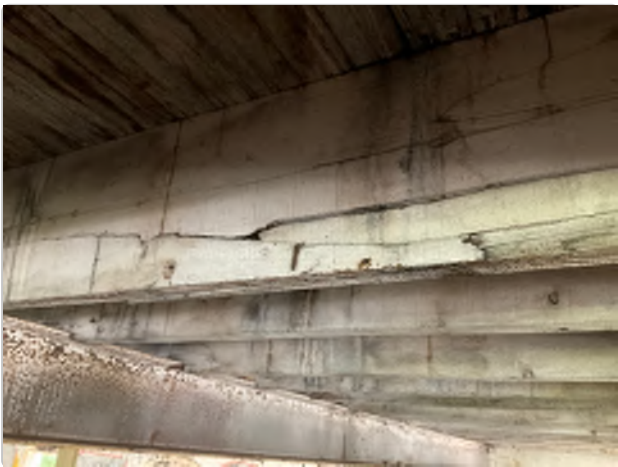
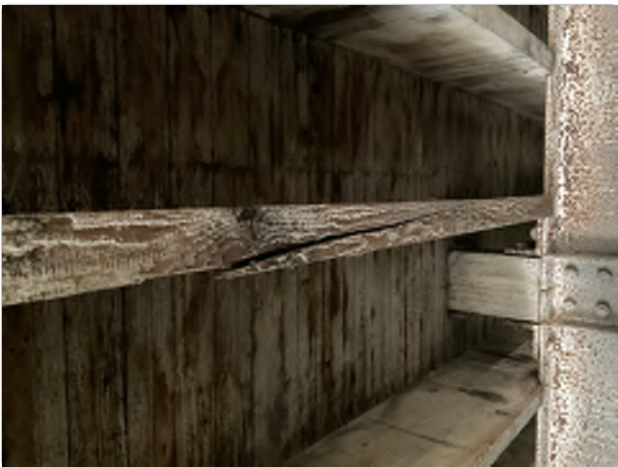
Spot 9

DEFECT
Fracture

REMARKS
Unserviceable

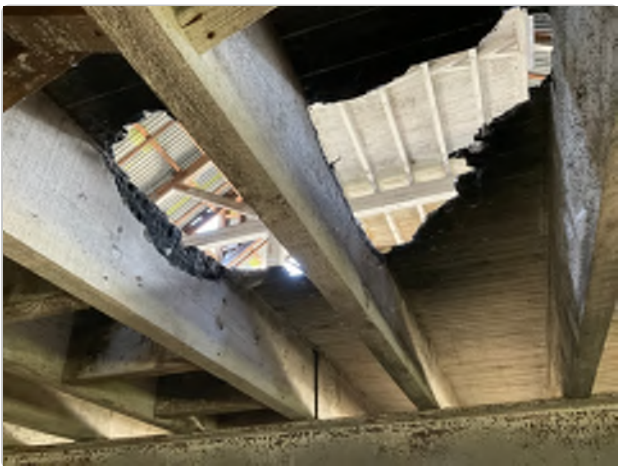
Spot 8

DEFECT
fire damage

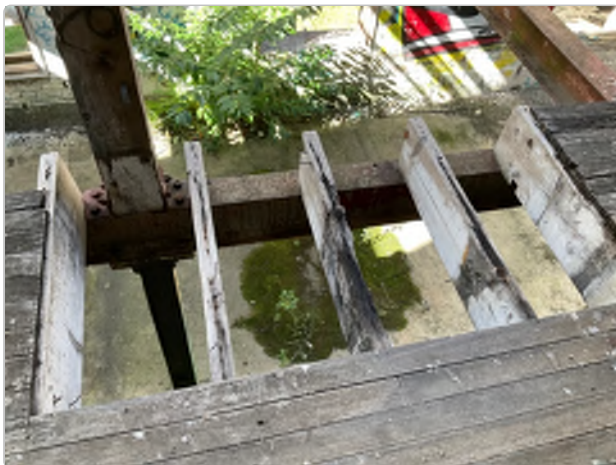
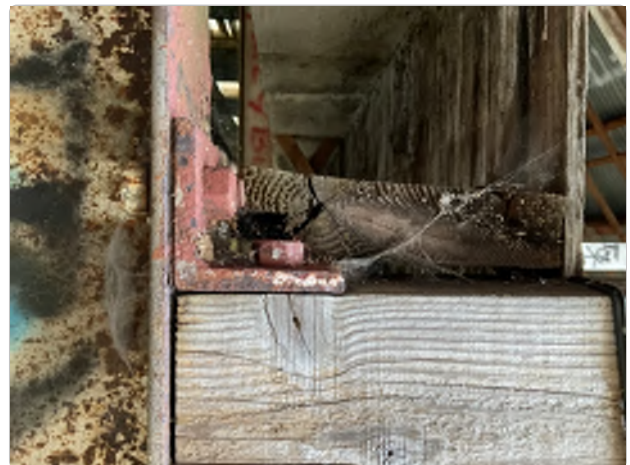
Spot 6

DEFECT
none

REMARKS
1 and 3 rot
Short bearers
notches are not affecting structural grade
Connections are sitting on bolt

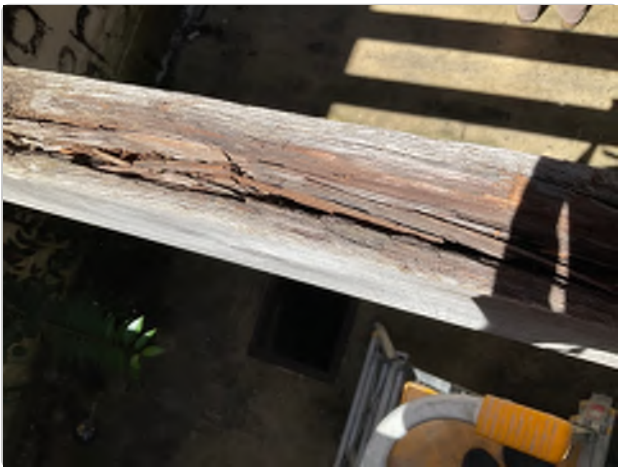
Spot 2

DEFECT
Rot

REMARKS
Decayed top 75mm for all members, plate besides

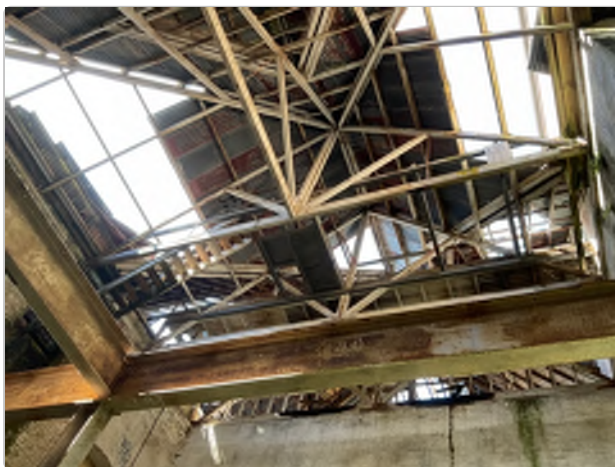
DEFECT
none

REMARKS
Unsafe for physical inspection

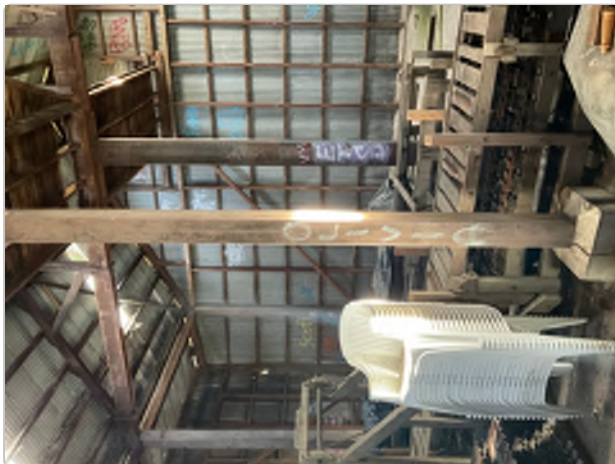
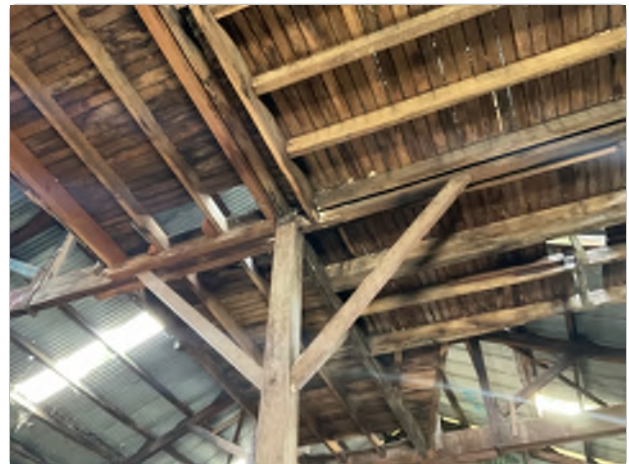
Spot 91 [↗](#)

DEFECT
Rot

Rot at top of post under walkway and connected bottom cord and joists
This post 170x170mm
Joist 110x75

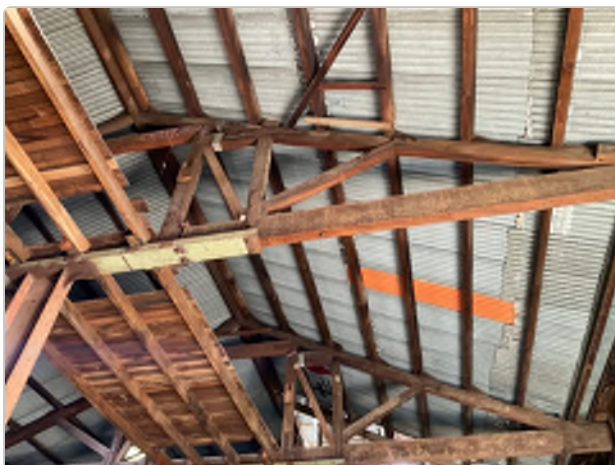
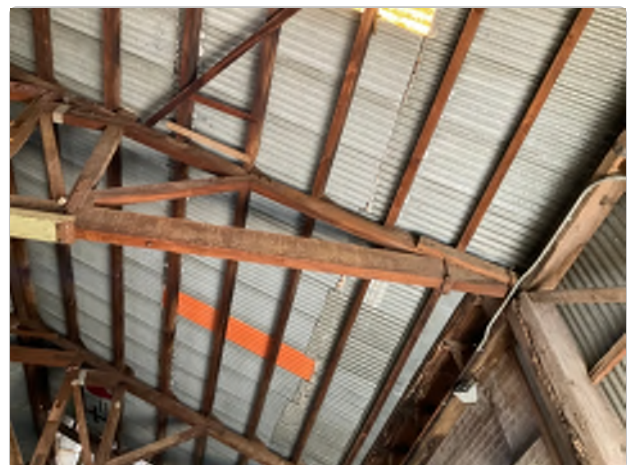
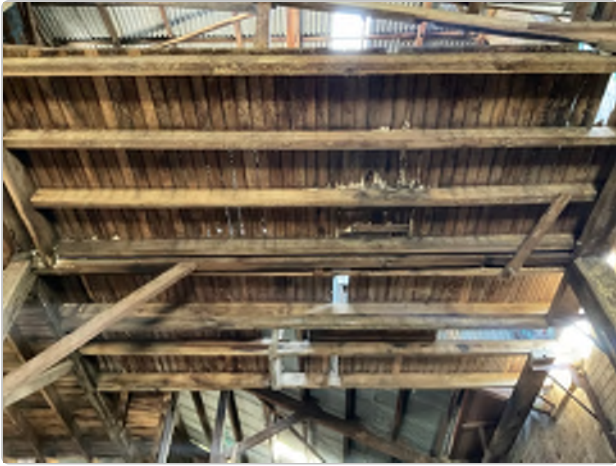
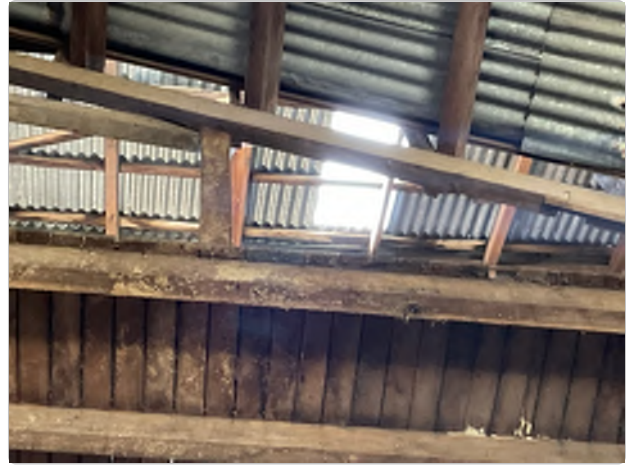
Spot 89

DEFECT
None

Roof truss in general good condition. Some areas of roof sheeting have holes mainly walkway affected, trusses are OK. Trusses are Oregon F11

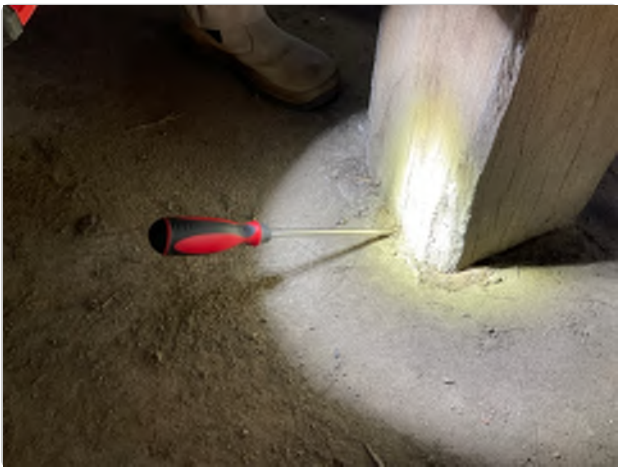
Spot 87

DEFECT
Rot

REMARKS
Severe decay 50mm

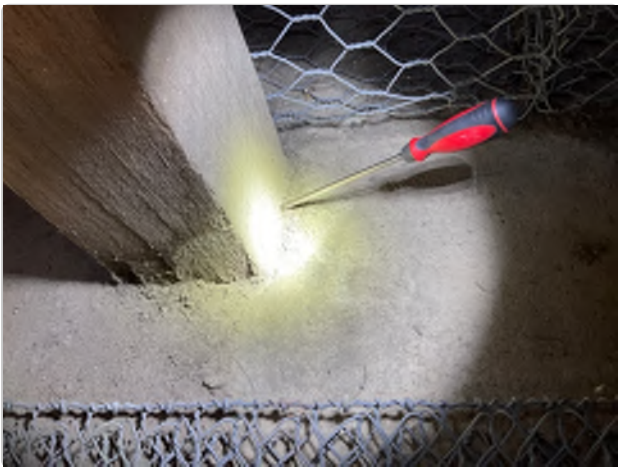
Spot 86

DEFECT
Rot

REMARKS
Severe decay at ground 50mm

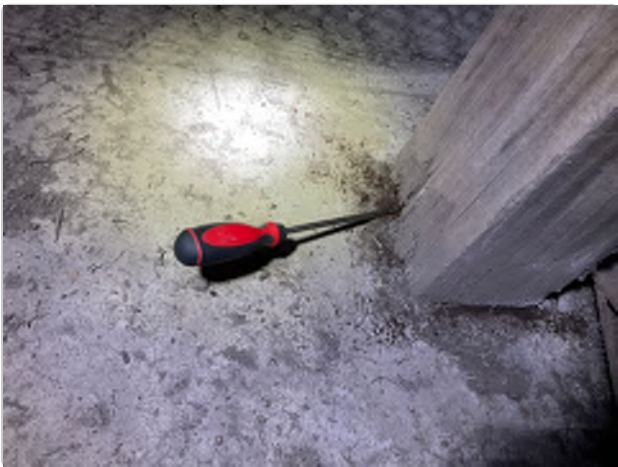
Spot 85

DEFECT
Rot

REMARKS
Severe decay at ground

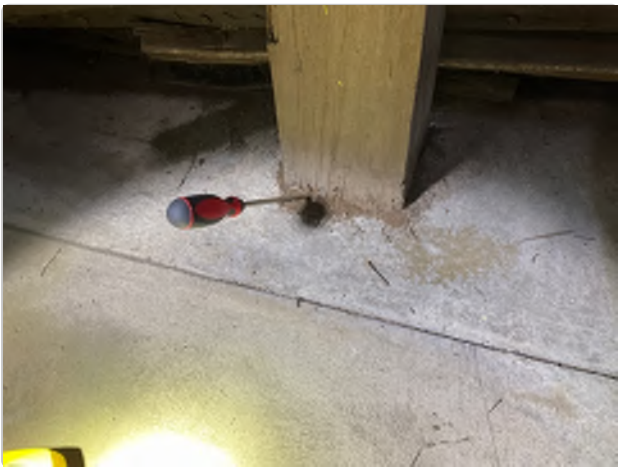
Spot 84

DEFECT
Rot

REMARKS
Severe decay at ground level

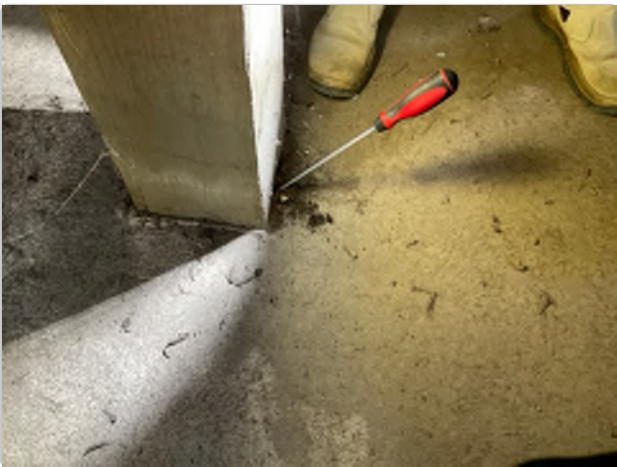
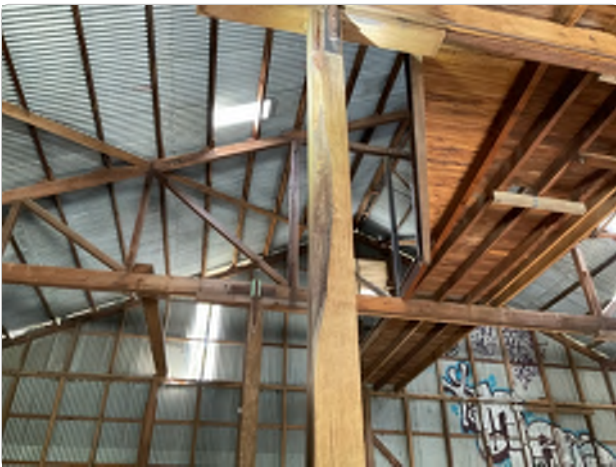
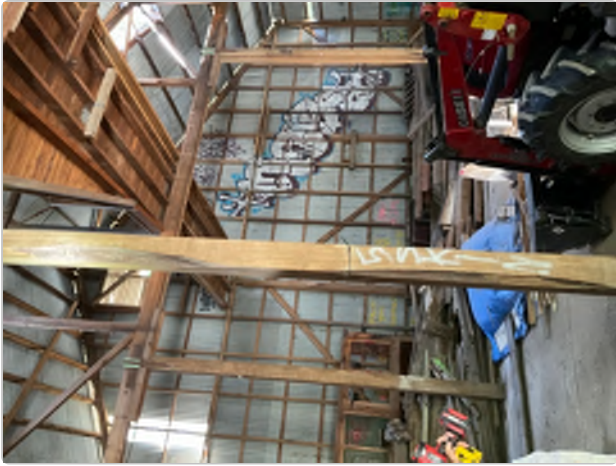
Spot 84 [↗](#)

DEFECT
rot and want and wane

REMARKS
Out of grade but repairable

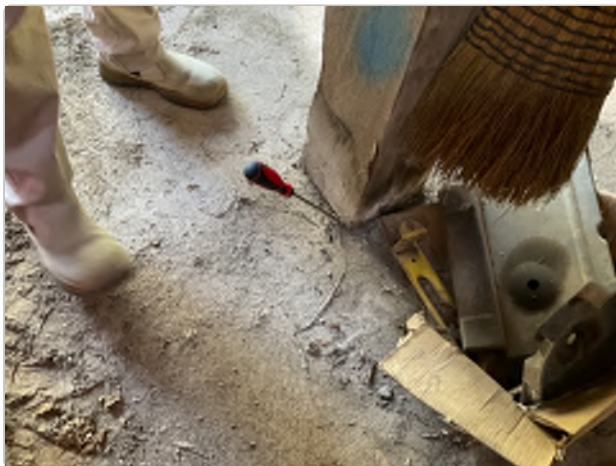
Spot 82

DEFECT

Rot

Decay 25mm

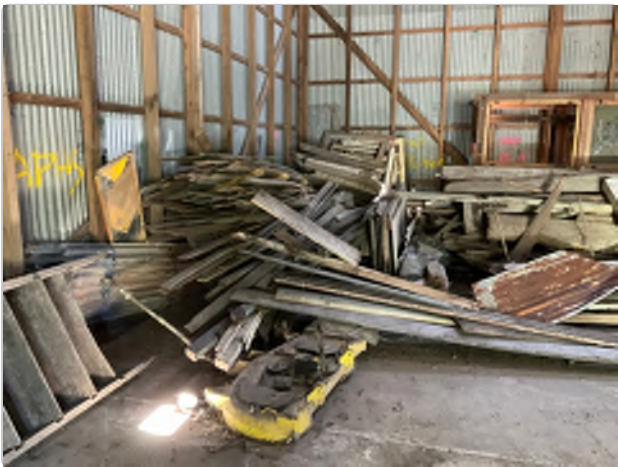
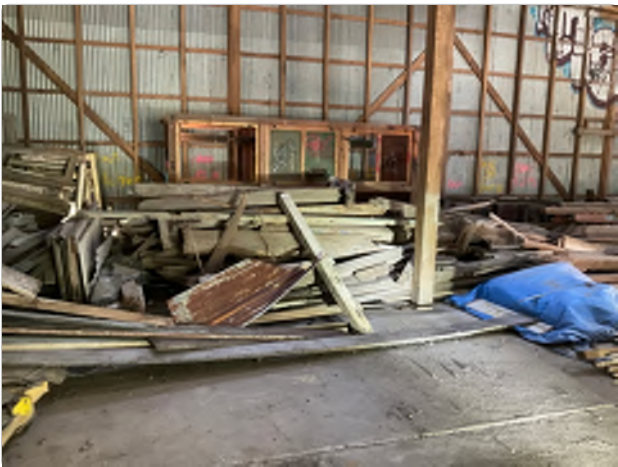
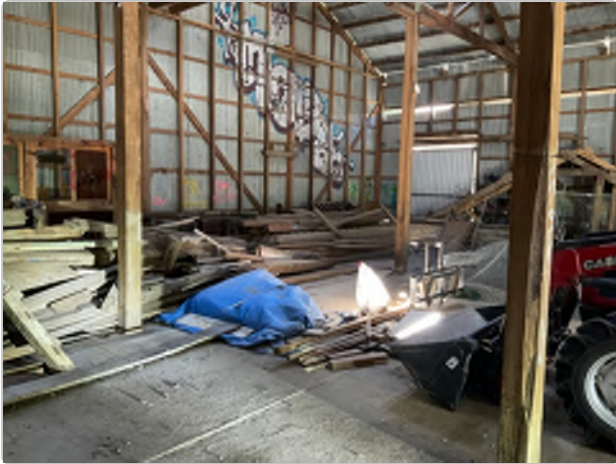
Spot 82 [↗](#)

DEFECT
debris

REMARKS
Could not inspect due to access

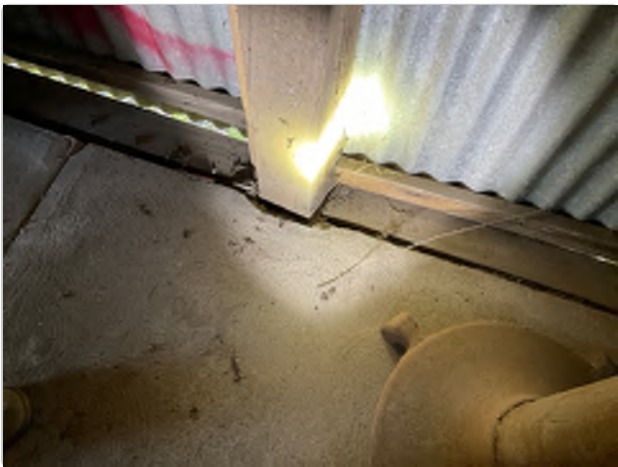
Spot 80

DEFECT
Rot

REMARKS
Attachment of post to plate is minimal

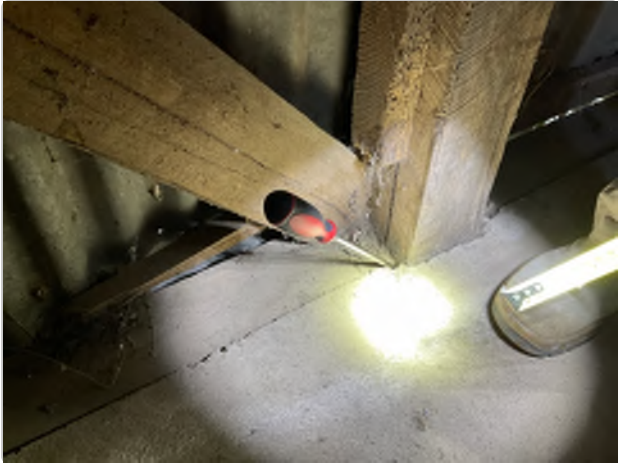
Spot 79

DEFECT
Rot

REMARKS
Minor decay in corner

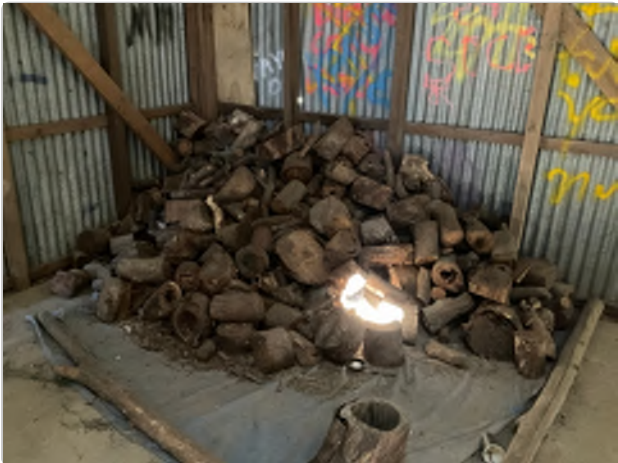
Spot 78

DEFECT
termite loose timber

REMARKS
Loose timber shows signs of termite damage and presence, ideally removed
Cannot inspect behind

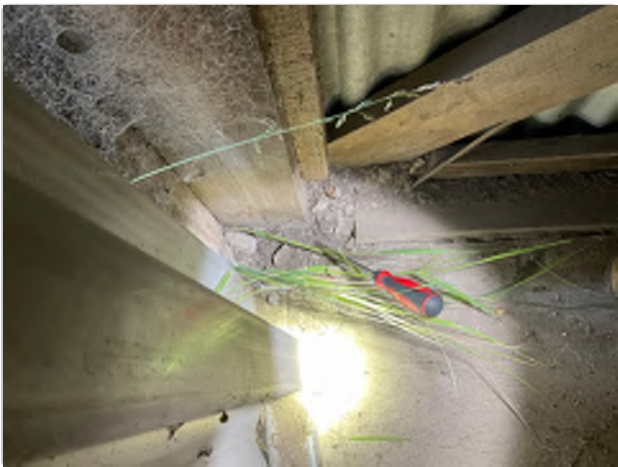
Spot 77

DEFECT
Rot

REMARKS
Rot at ground level

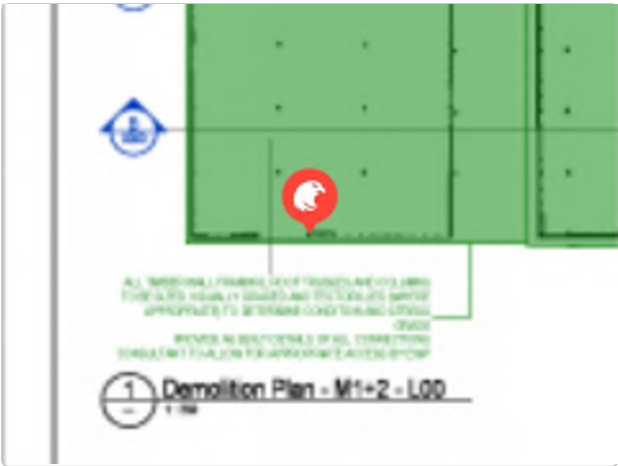
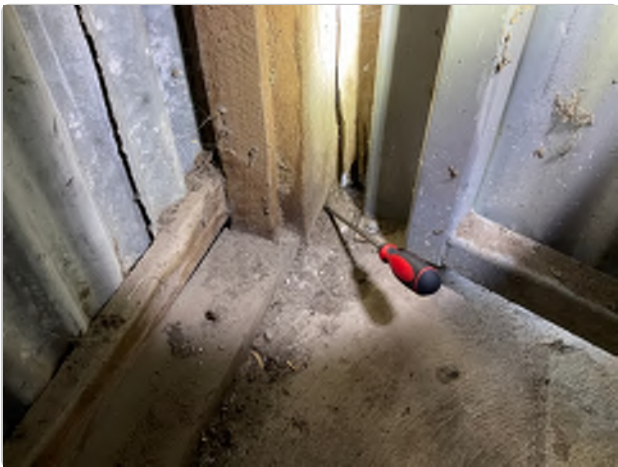
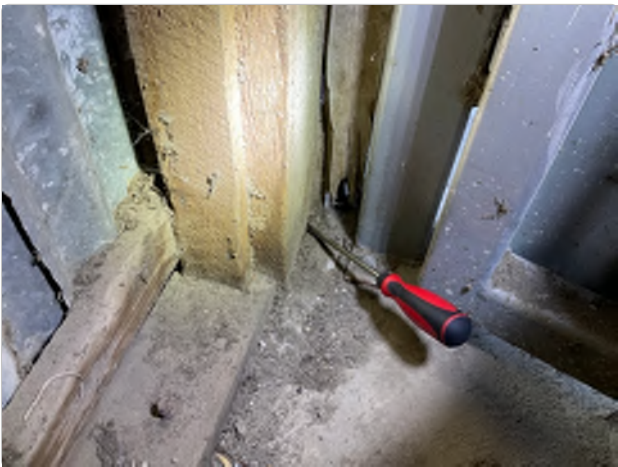
Spot 76 [↗](#)

DEFECT
Rot

REMARKS
Decayed at ground level

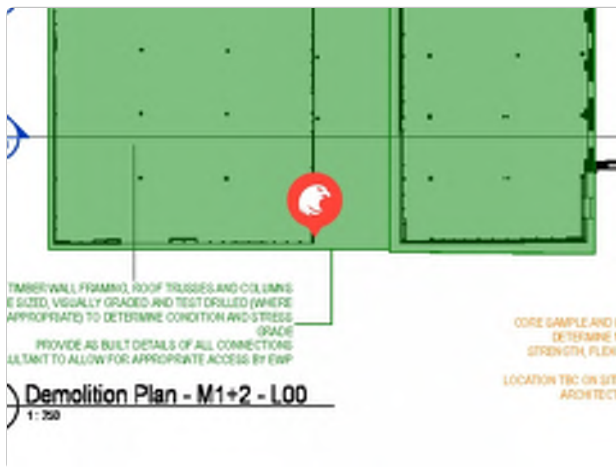
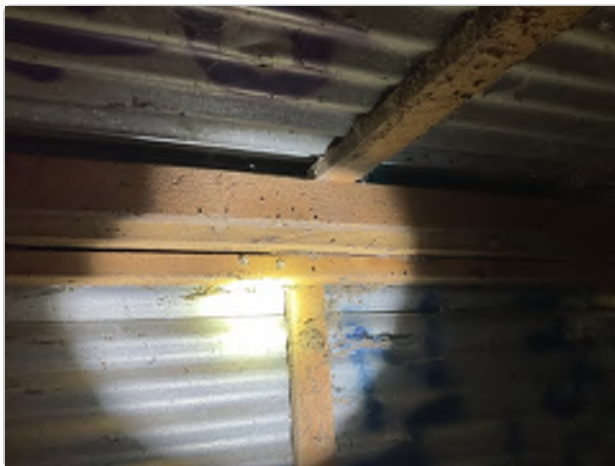
Spot 75

DEFECT
Termites

Termite damage minimal and in battening
Battening around the post 75x38
Belt rail 75x38 @1000mm c-c
Stud framing 95x75 @900mmc-c
Cross brace 145-50mm
