DA Structural Report

Malthouses 1, 2 and Maltsters House The Maltings, Mittagong

Colliers International / 29 August 2024

221582

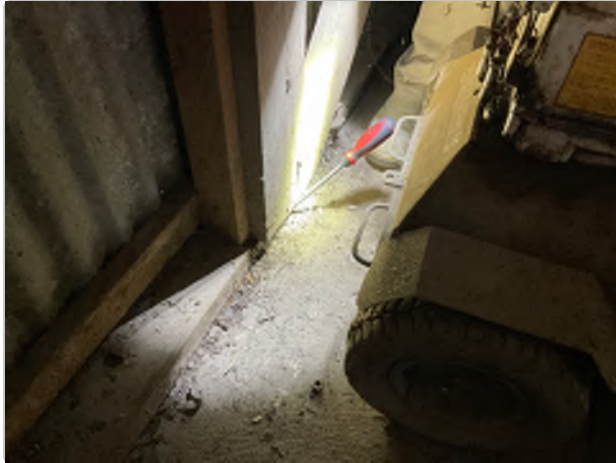
Spot 74

DEFECT
none

REMARKS
Area had debris could not inspect closely, decay in bottom plate/sill plate

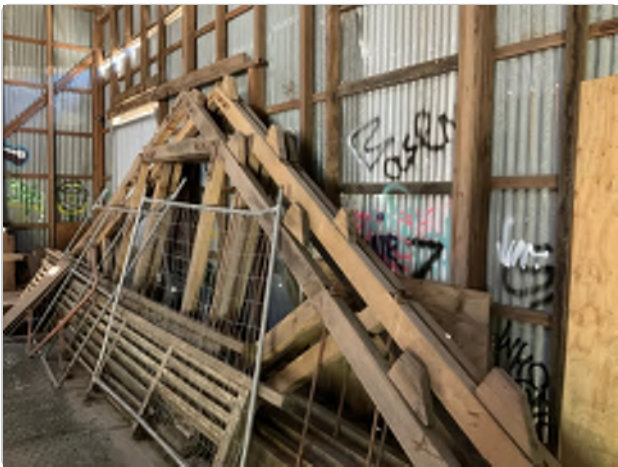
Spot 73

DEFECT
Rot

REMARKS
Post decayed at ground line

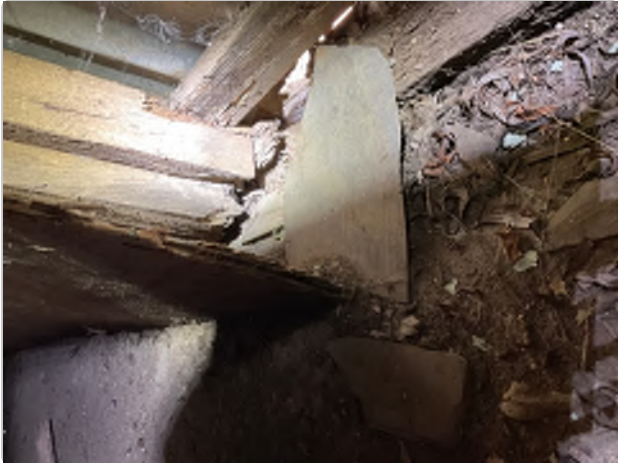
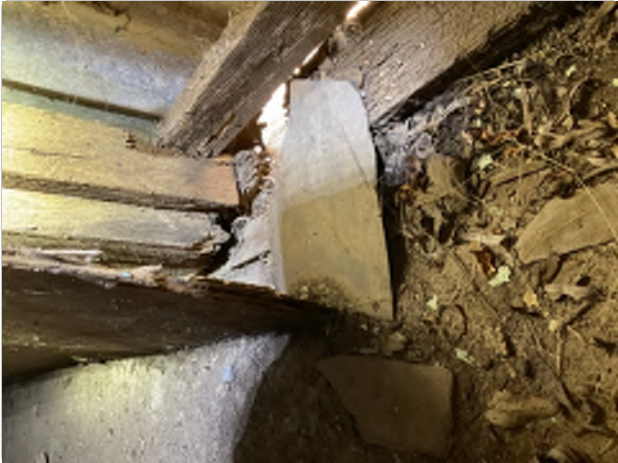
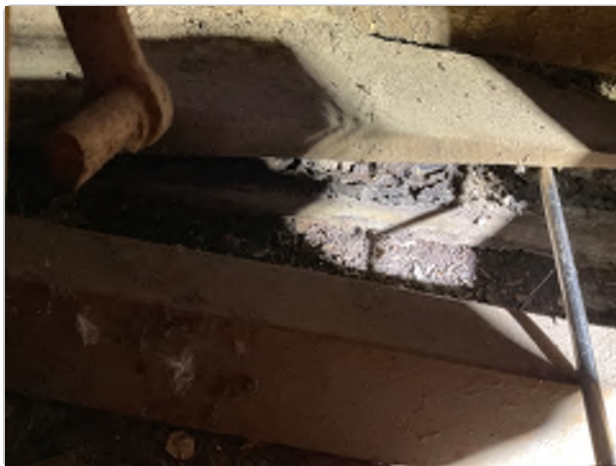
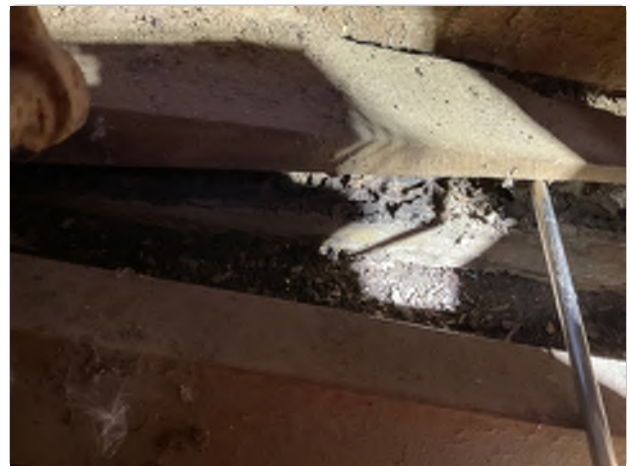
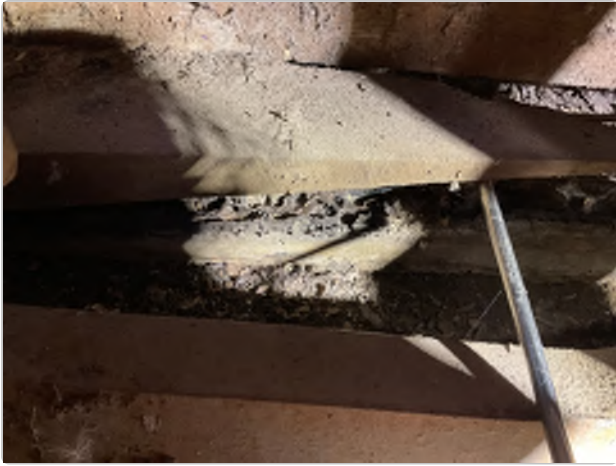
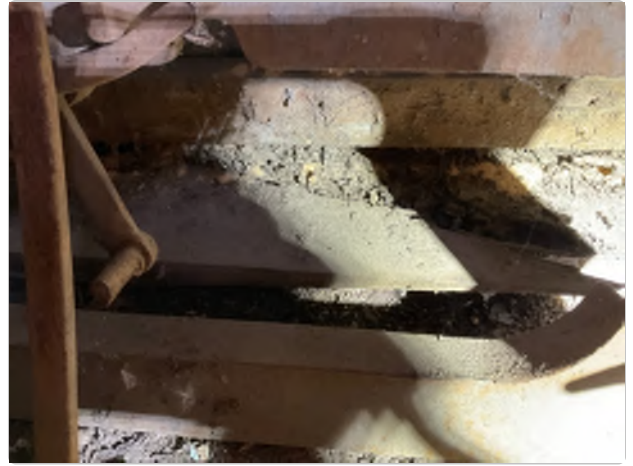
Spot 72 [↗](#)

DEFECT
Termites

Post bottom plate and door framing termite damage. Active termites

Hardwood post seems largely unaffected due to Oregon presence (termites move through soft timber wherever they can) potential that hardwood post bottom compromised

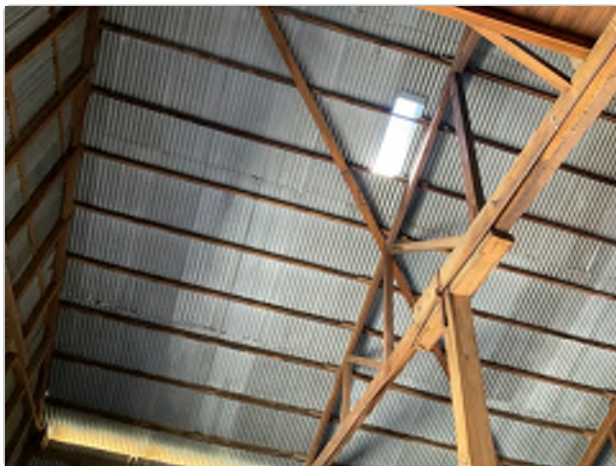
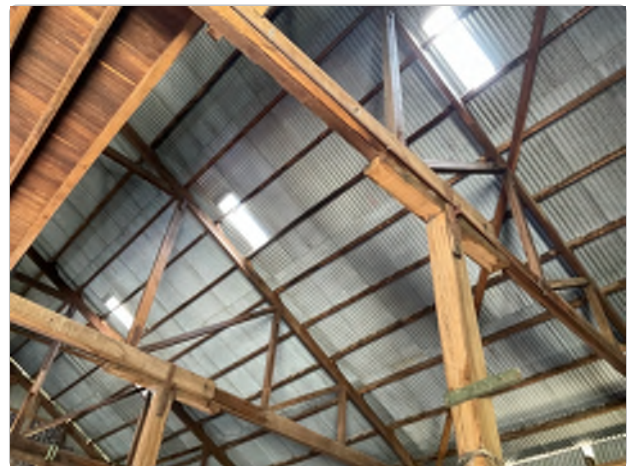
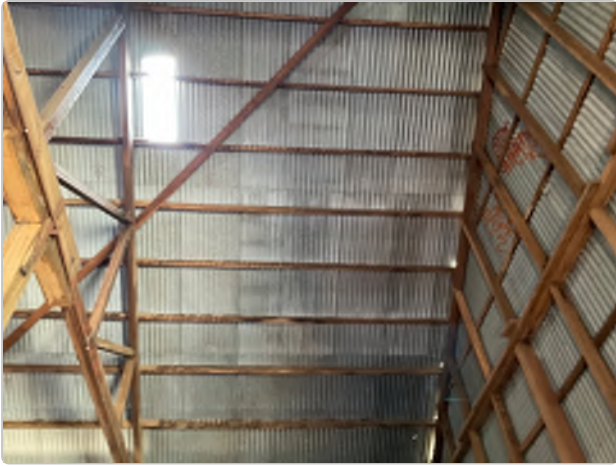
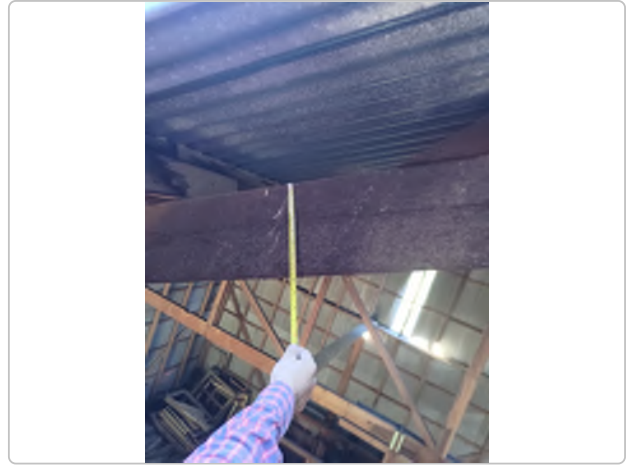
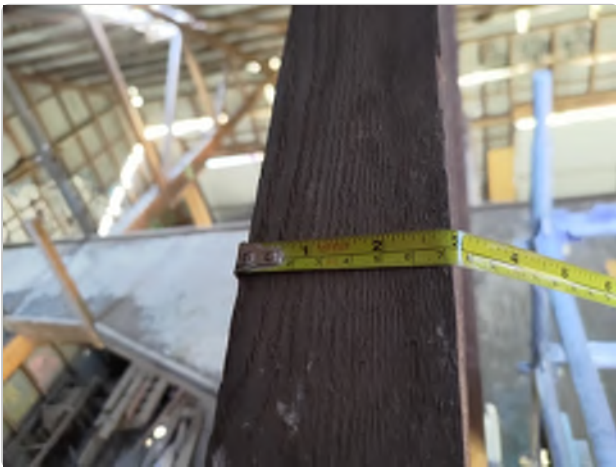
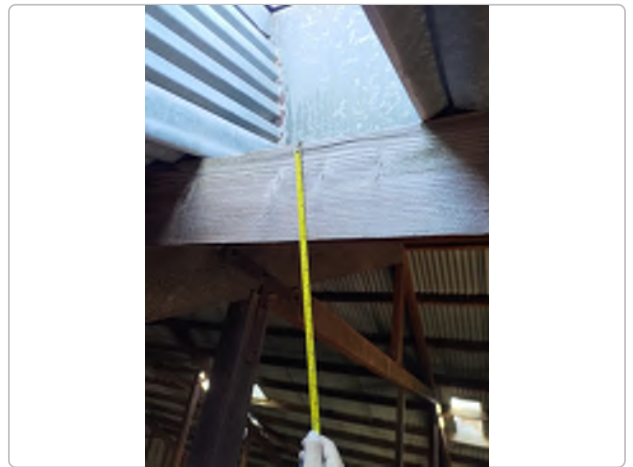
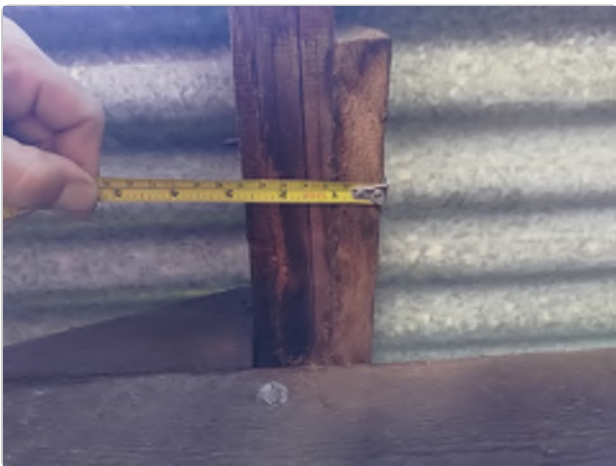
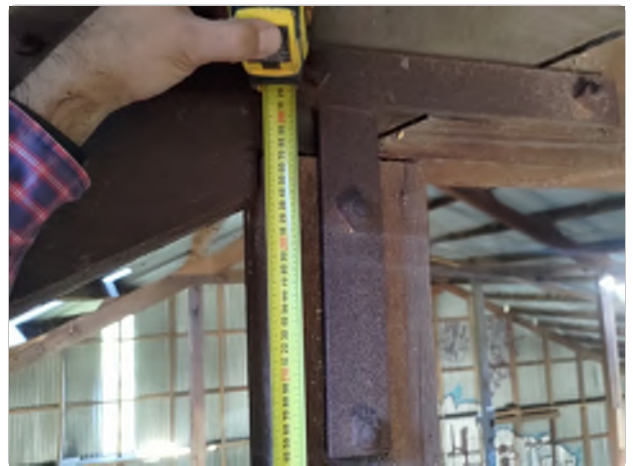
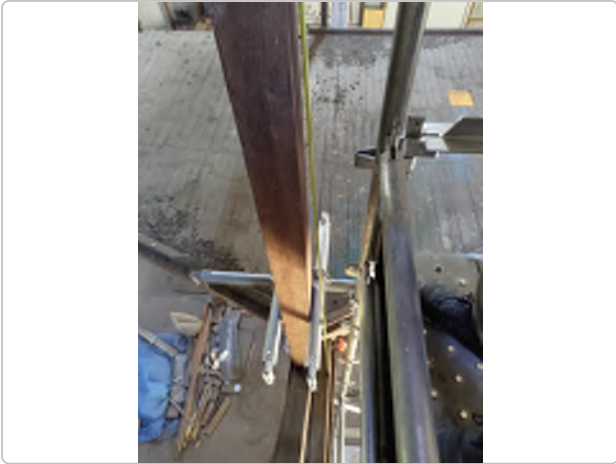
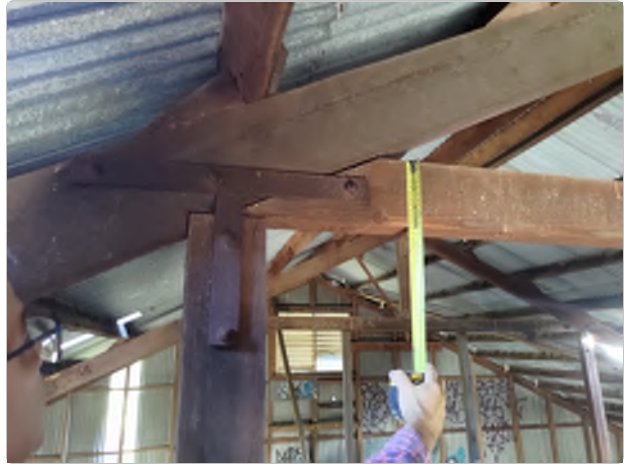
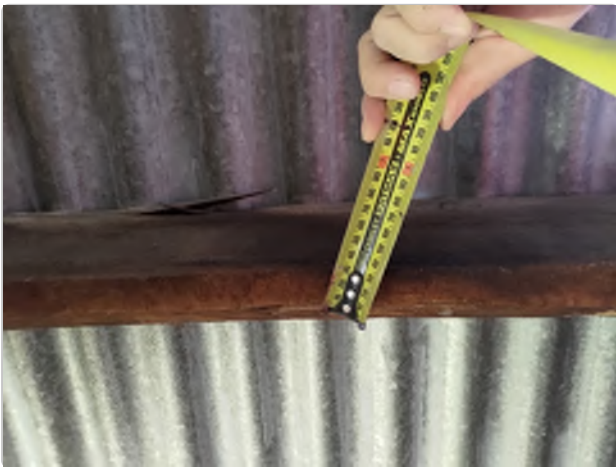
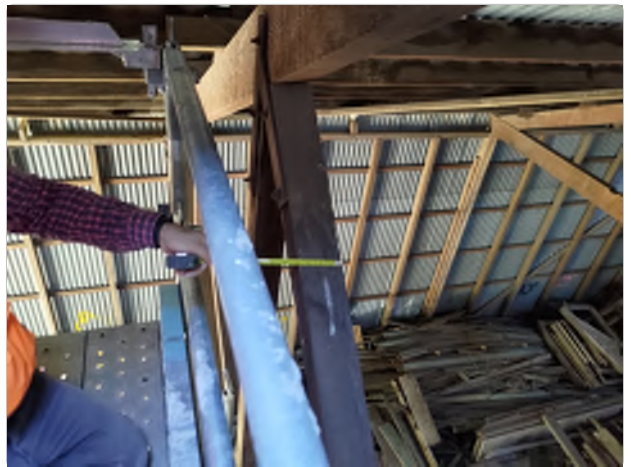
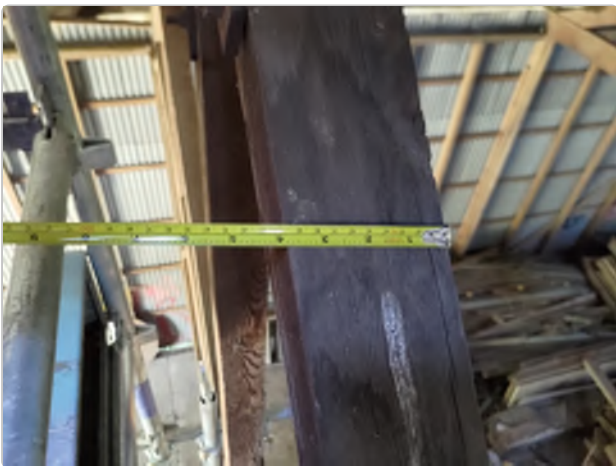
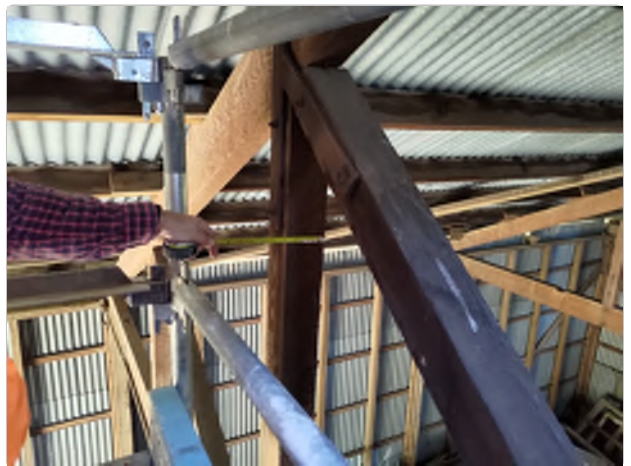
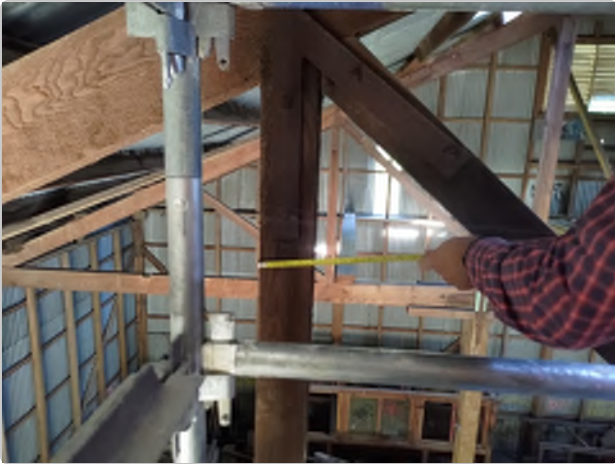
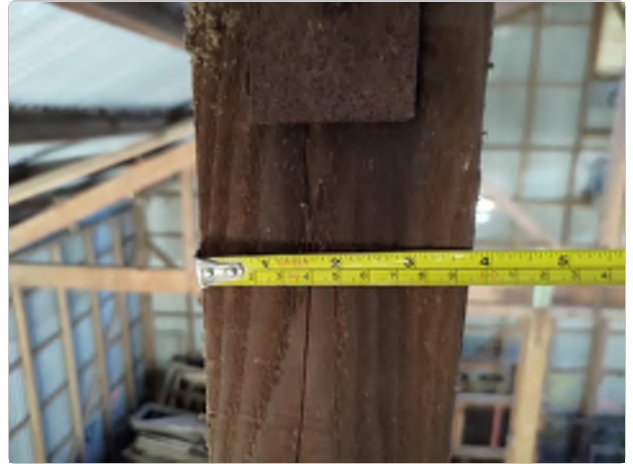
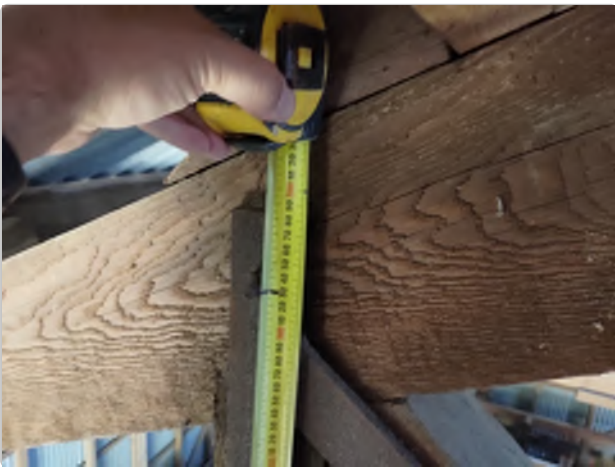
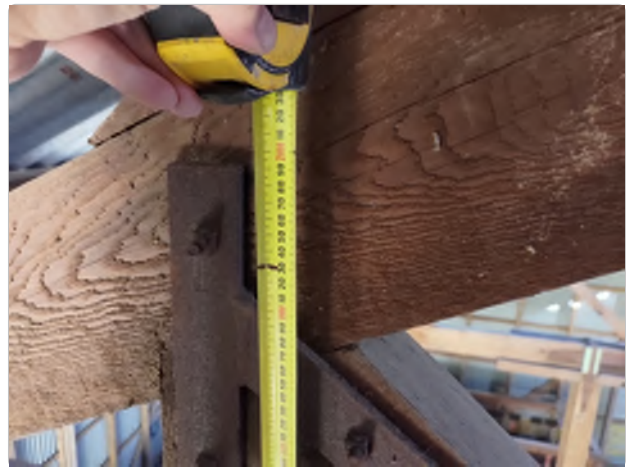
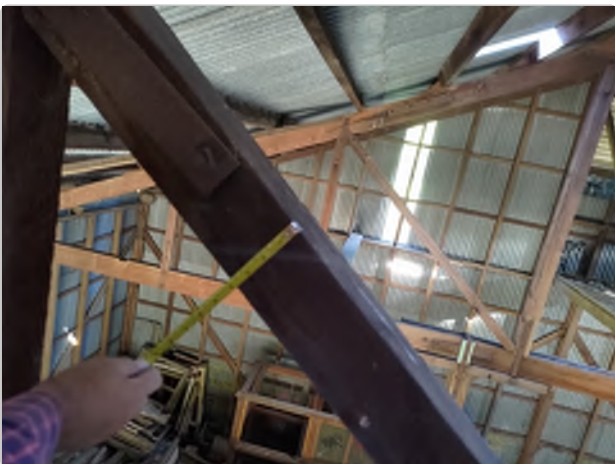
Spot 71 [↗](#)

DEFECT
none

REMARKS
Shed roof in general good condition all mixed nsw hardwood

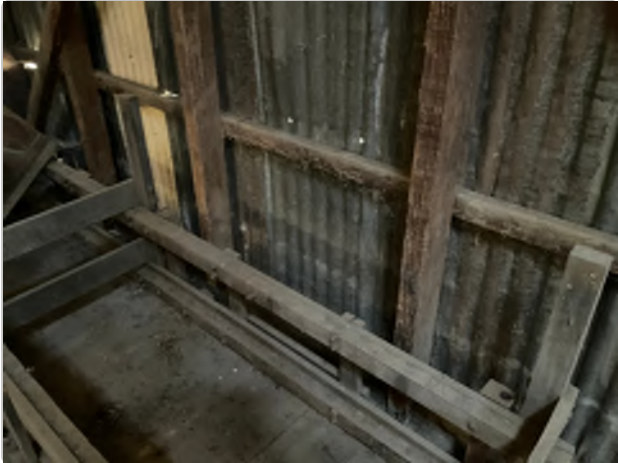
Spot 70

| DEFECT Rot | | |
| REMARKS Rot at ground level | | |

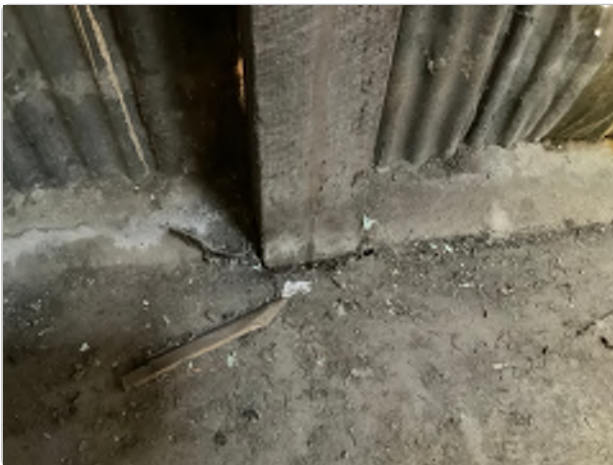
Spot 68

DEFECT
Rot

REMARKS
Decay at ground line 30mm
Oregon

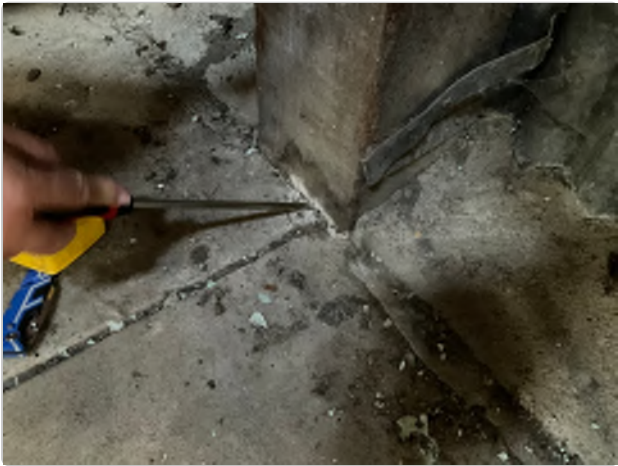
Spot 67 [📍](#)

DEFECT
notch

REMARKS
Void at ground line
Hardwood

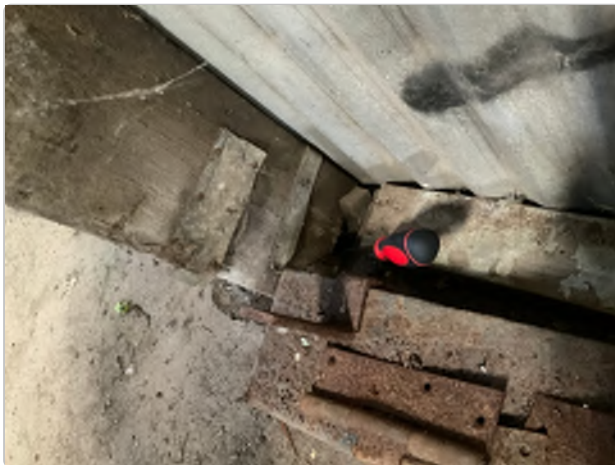
Spot 66

DEFECT
Rot

REMARKS
Size 170x170 Oregon post
Rot at ground level

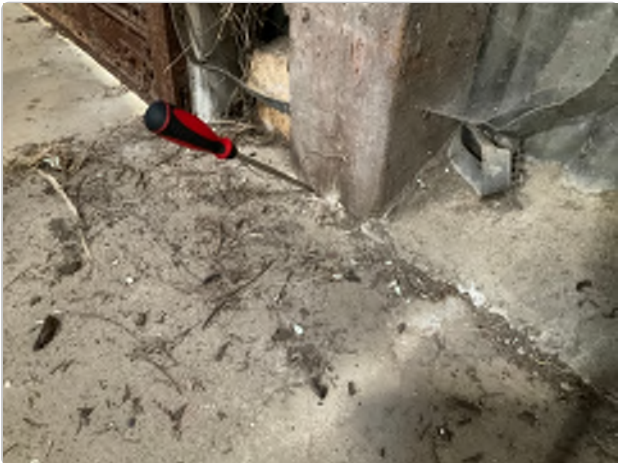
Spot 65

DEFECT
Rot

REMARKS
Rot at the bottom of some end wall framing set in concrete, repair

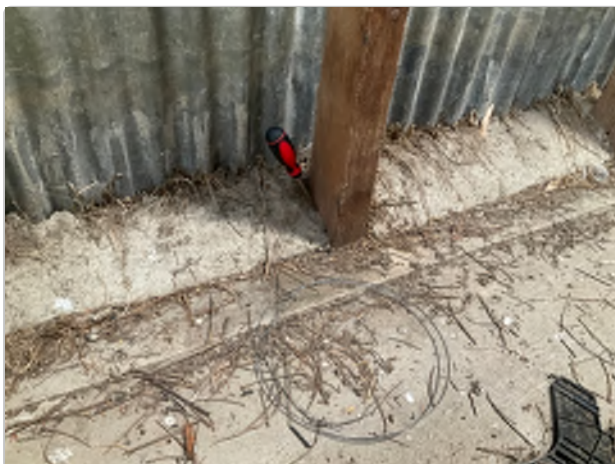
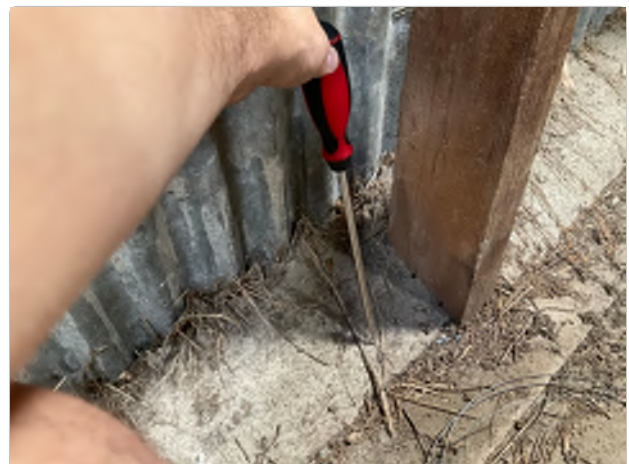
Spot 64 [↗](#)

DEFECT
Rot

Decay at the bottom at ground level about 30mm deep
Size: 250mm x 240mm
75mm x 120mm
240 mm x 110mm

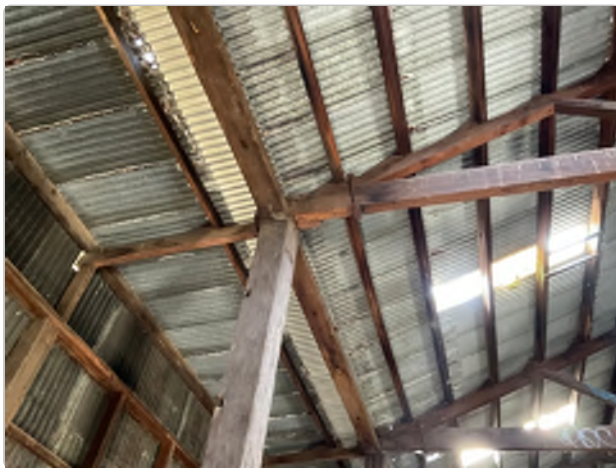
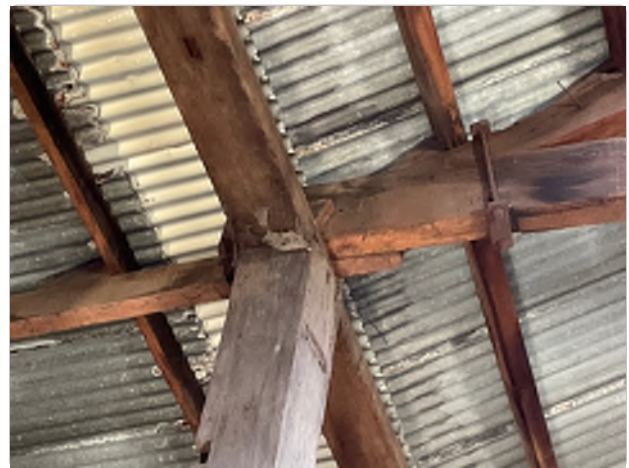
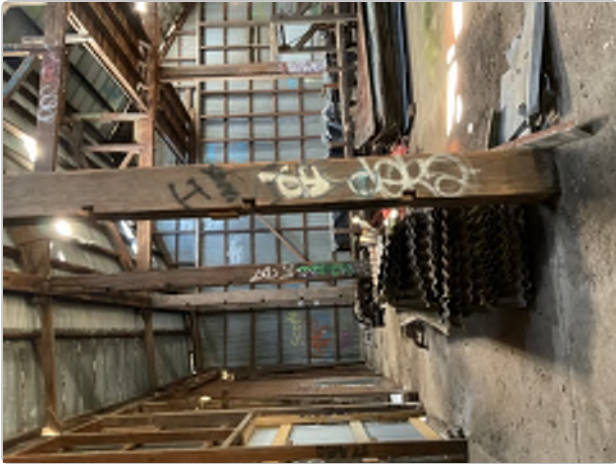
Spot 63 [📍](#)

DEFECT
Rot

End wall framing decayed at ground line
Wall framing Oregon
Sizes: centre hardwood 210x100, 75x50 notches
Vertical Oregon 120x75 @1060c-c
Horizontal Oregon 75x50 @1080c-c
Diagonal brace Oregon 100x75

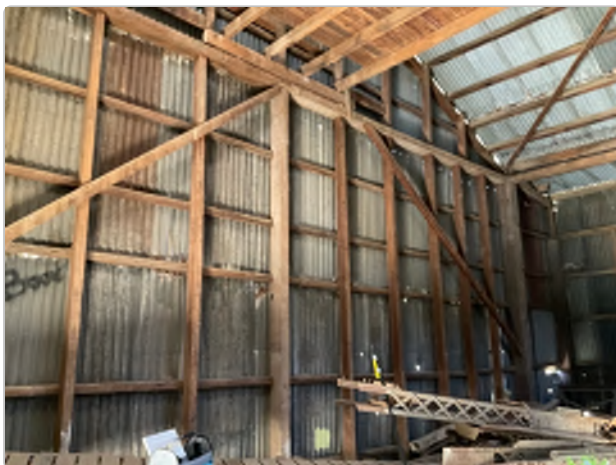
Spot 62

DEFECT
Rot

REMARKS
Complete decay at ground line

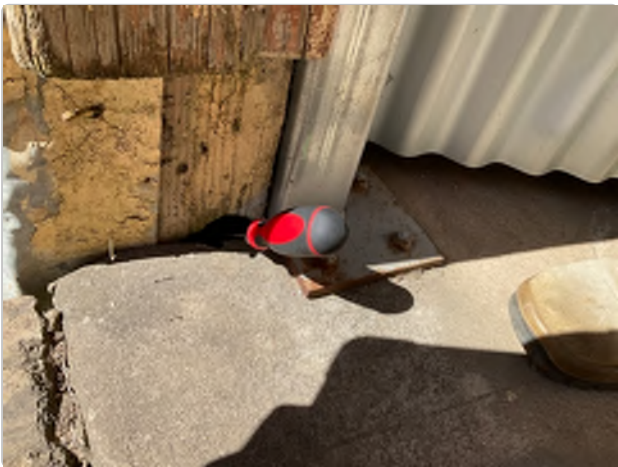
Spot 61 [🔗](#)

DEFECT

rot and termites

Complete decay at ground line

Extent of termite damage hard to determine OOG

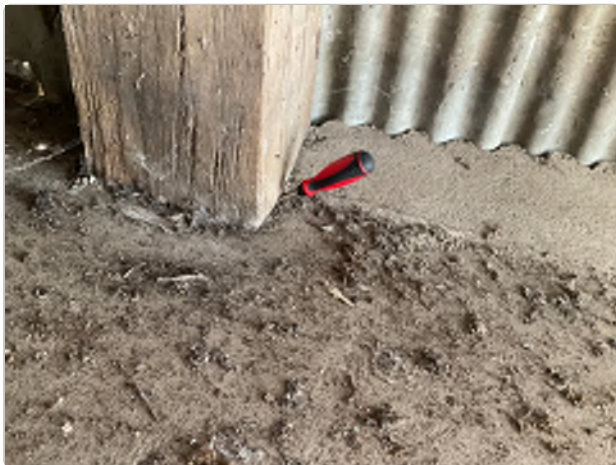
Spot 60 [🔗](#)

DEFECT
Rot

REMARKS
Complete decay at ground line

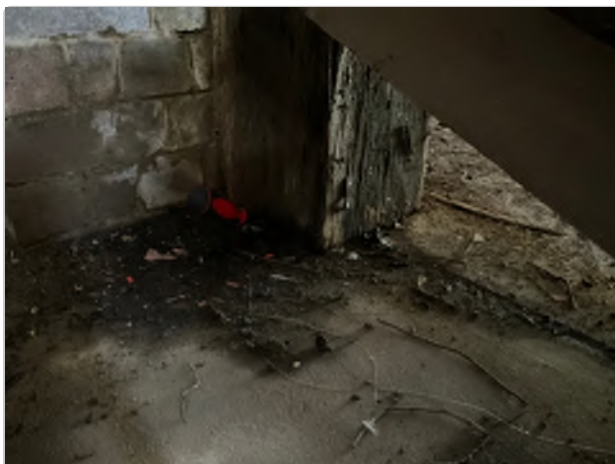
Spot 59 [🔗](#)

DEFECT
missing section

REMARKS
Repair

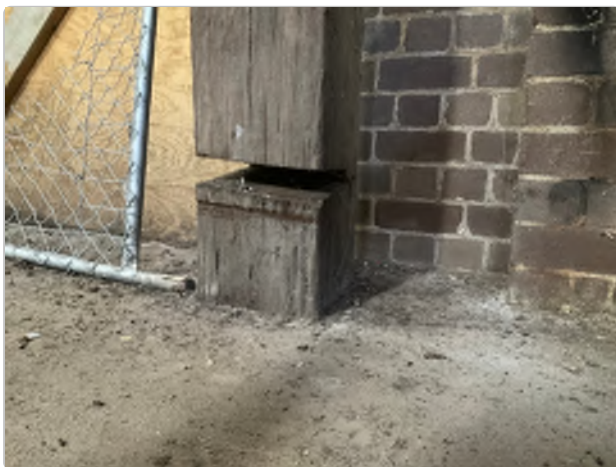
Spot 58 [🔗](#)

DEFECT

Rot

Hearding is no issue but severe each at the bottom

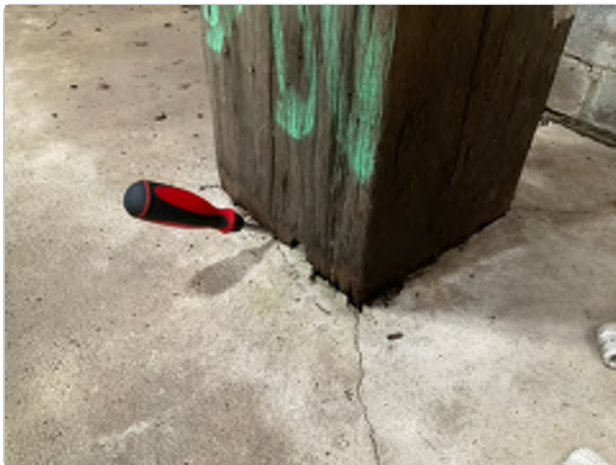
Spot 57

DEFECT
Termites

REMARKS
Termite tracks on outside post sound

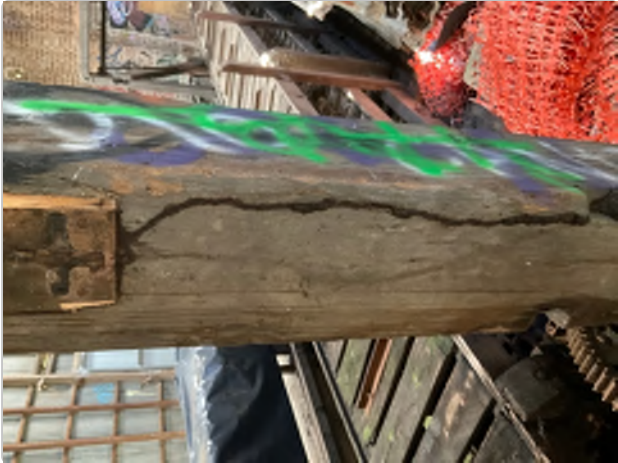
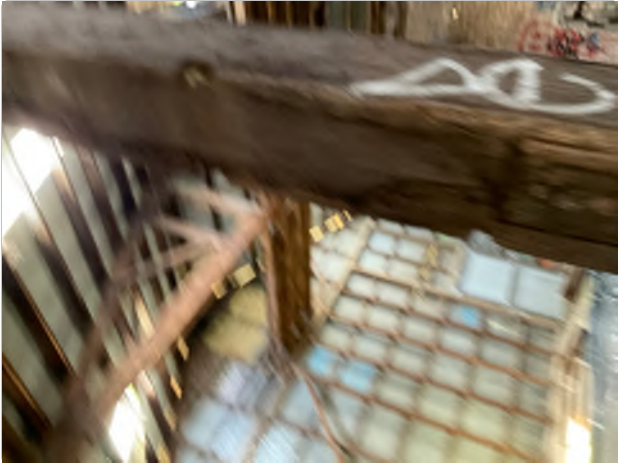
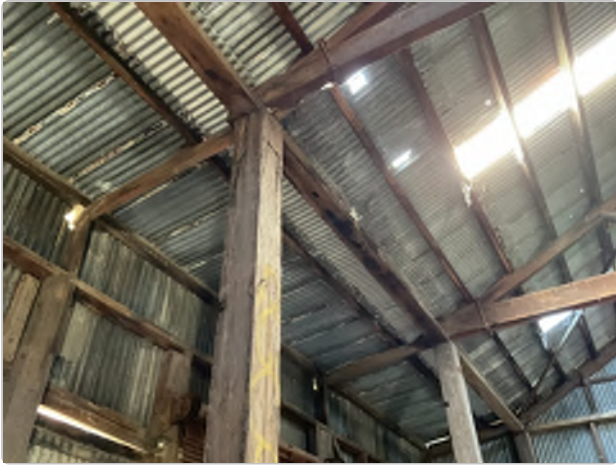
Spot 56 [↗](#)

DEFECT
none

REMARKS
Size: 240x240
Mixed nsw hardwood
Span 2320mm
